Transport Accident
Investigation
Commission

Final report

***Aviation inquiry AO-2022-001
Ultramagic Balloons, N-250, ZK-MET
Pilot ejection from basket on landing
Lyndhurst, near Methven
1 January 2022***

May 2023

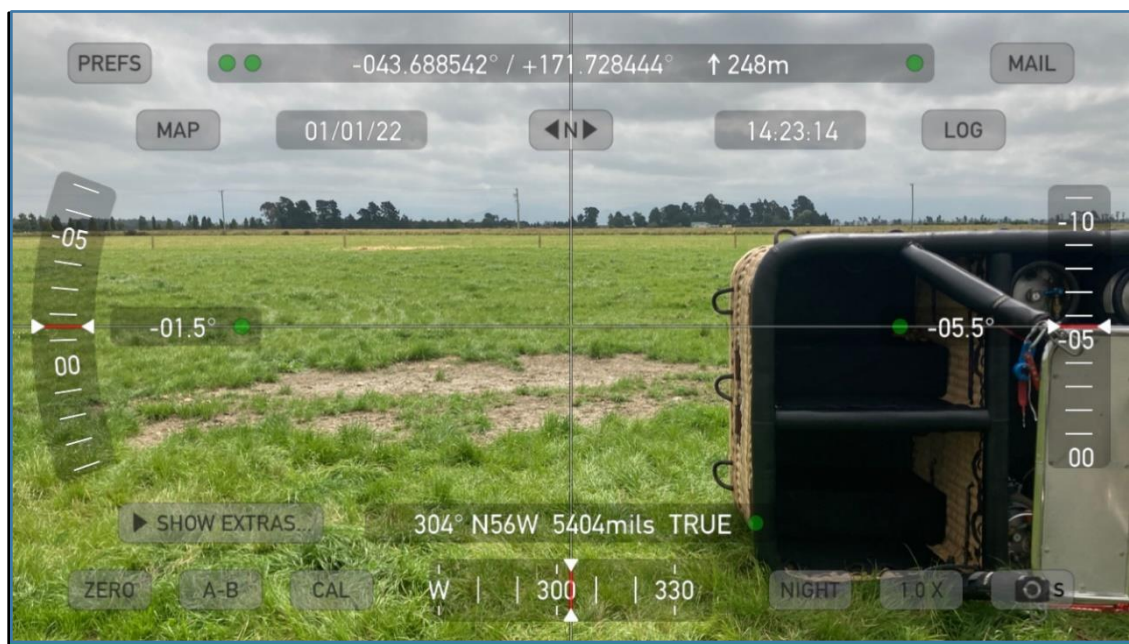
Figure 3: Landing area – looking back at the approach path

approach path was over the power lines then a relatively steep descent to the second paddock.

- 2.11. Approaching the landing spot, the pilot activated the balloon's fast deflation system (FDS)⁵ by pulling down on the rip line⁶ connected to a vent at the top of the envelope.⁷ The basket landed upright initially, then "bounced", tipping over on the second contact with the ground. The balloon landed at about 0907.

- 2.12. The pilot was ejected from the basket after it bounced. The basket passed over the pilot. Witness marks on the ground indicated the pilot was then dragged along the ground.

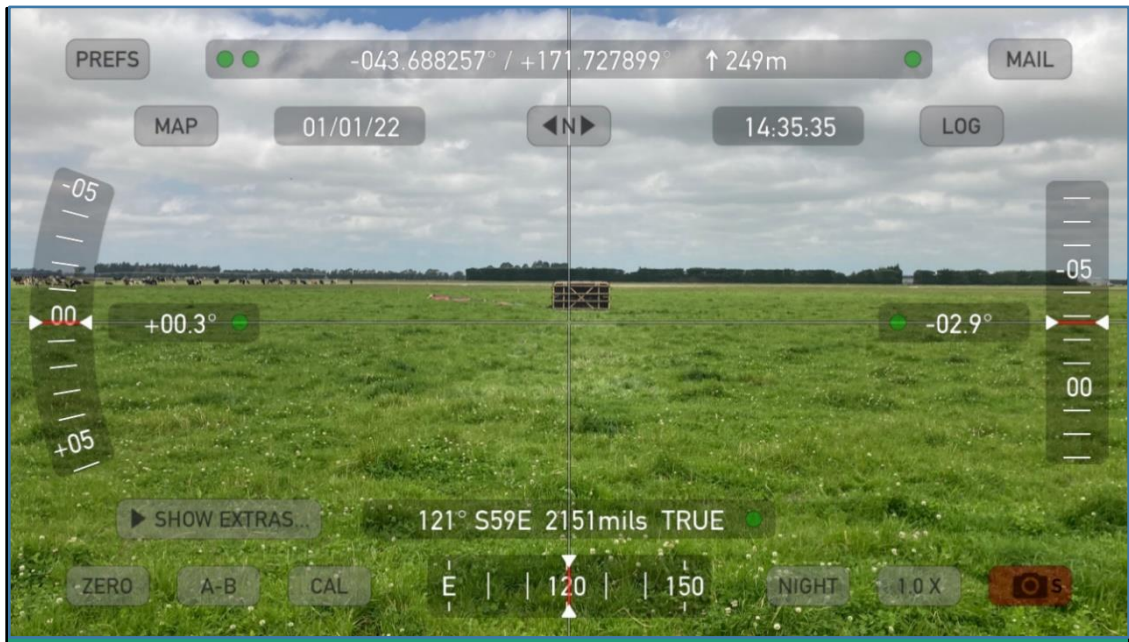
Figure 4: Landing area – looking forward in the direction of travel

- 2.13. The basket and deflating envelope came to rest about 35 metres from the initial touchdown point, with all passengers remaining in their braced landing positions. Witnesses recalled that one passenger reminded the others to remain in the basket until after the envelope had deflated, in accordance with the earlier passenger briefing.

- 2.14. The pilot's final position was behind the basket with the rip line caught around their neck, resulting in serious injury. The passengers were not injured, and the envelope and basket were not damaged.

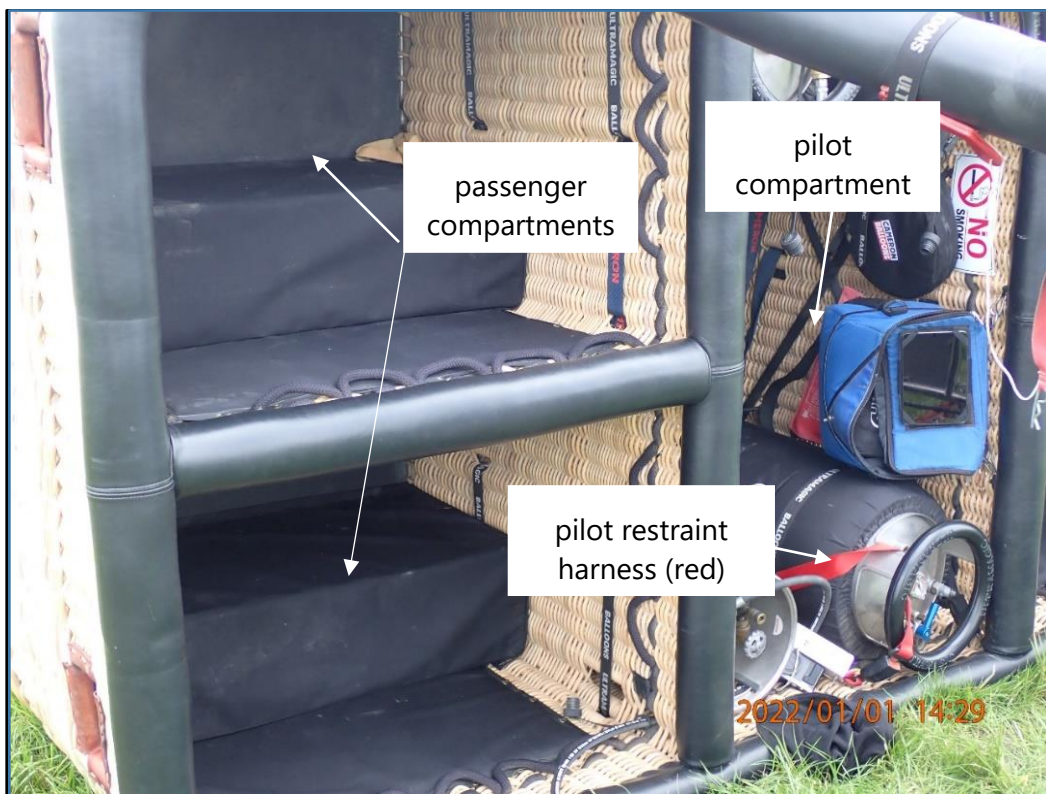
Figure 5: View inside the basket – the pilot restraint harness

- 2.16. At about 0940 emergency services arrived at the site, having been called by one of the passengers. The pilot was transported to hospital with serious injuries. They have since made a full recovery.
- 2.17. The balloon was fitted with a pilot restraint harness. The pilot and witnesses recalled that the pilot was not wearing the pilot restraint harness during the flight. See Figure 5.

- 3.4. The landing was firm enough to tip the basket over. However, this was not unusual,¹⁴ and its eventuality was included in the passenger briefings. Had the pilot been wearing a pilot restraint harness on landing, it is **virtually certain** that it would have been a routine landing with no adverse outcome.

- 6.3. **On 30 March 2023, the Commission recommended that the Secretary of Transport review and revise Civil Aviation Rules Part 91 to mandate the wearing of pilot restraint harnesses during critical phases of commercial balloon flights. (001/23)**
- 6.4. On 13 April 2023, the Secretary of Transport replied in part:

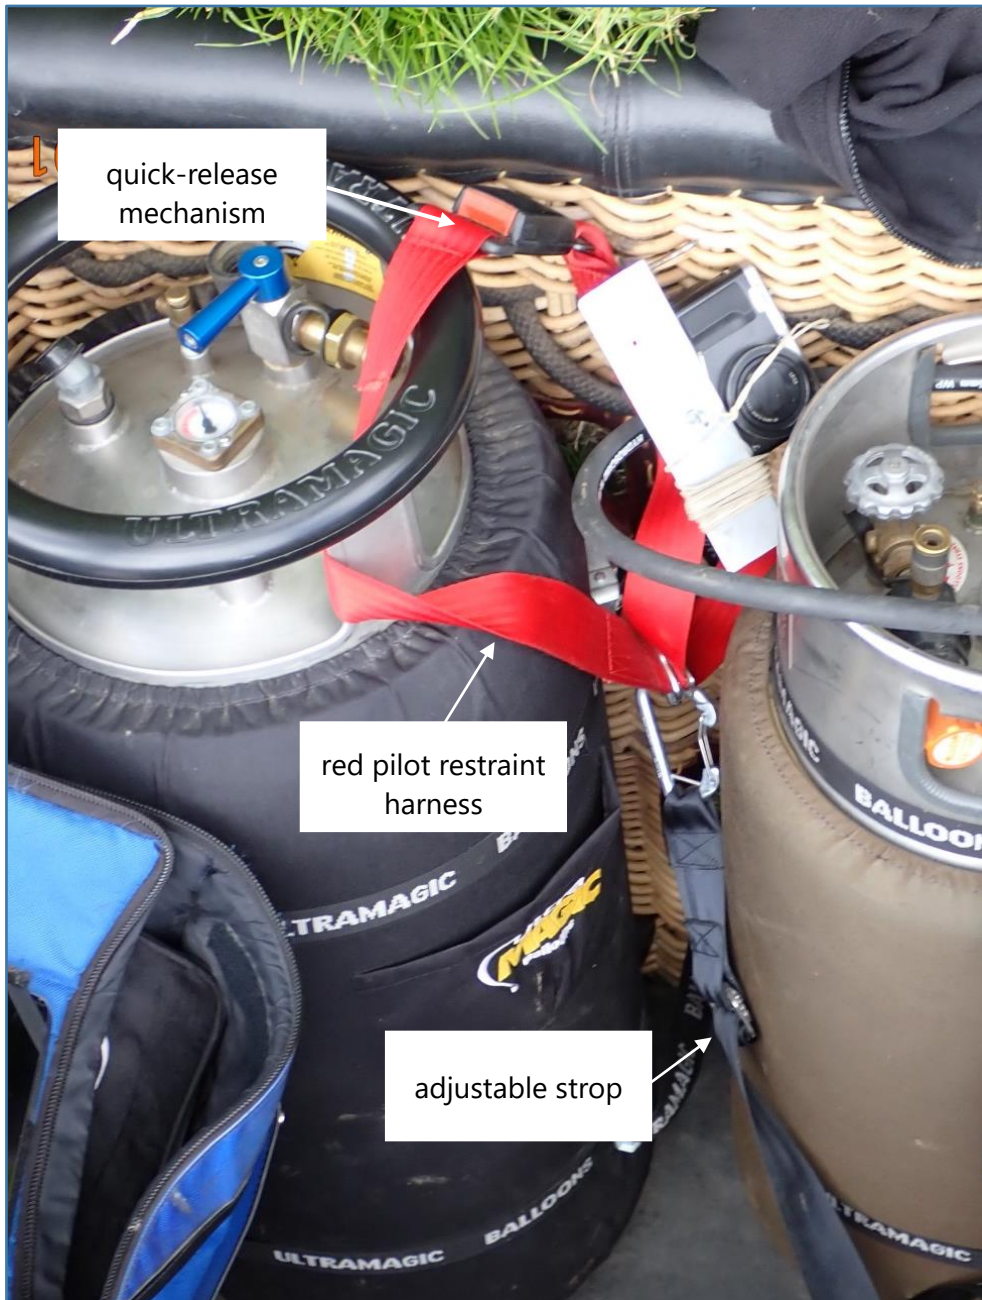
Figure 7: Pilot restraint harness

- 2.24. ZK-MET was an Ultramagic Balloons, N-250 hot air balloon, manufactured in Spain in 2020 and imported new to New Zealand the same year.
- 2.25. The basket was a double T partitioned basket with four passenger compartments, capable of taking up to 12 passengers. The pilot stood in the centre partition with the gas bottles and control lines.⁸ See Figure 6.
- 2.26. The engine consisted of three combination blast/whisper burners with four liquified-petroleum-gas fuel tanks giving a nominal endurance of greater than three hours.
- 2.27. The basket was fitted with a dedicated pilot restraint harness, installed at manufacture. The pilot restraint harness consisted of a waist belt with a quick-release mechanism, which was attached via an adjustable strop to a dedicated hard point on the floor of the basket. See Figure 7.

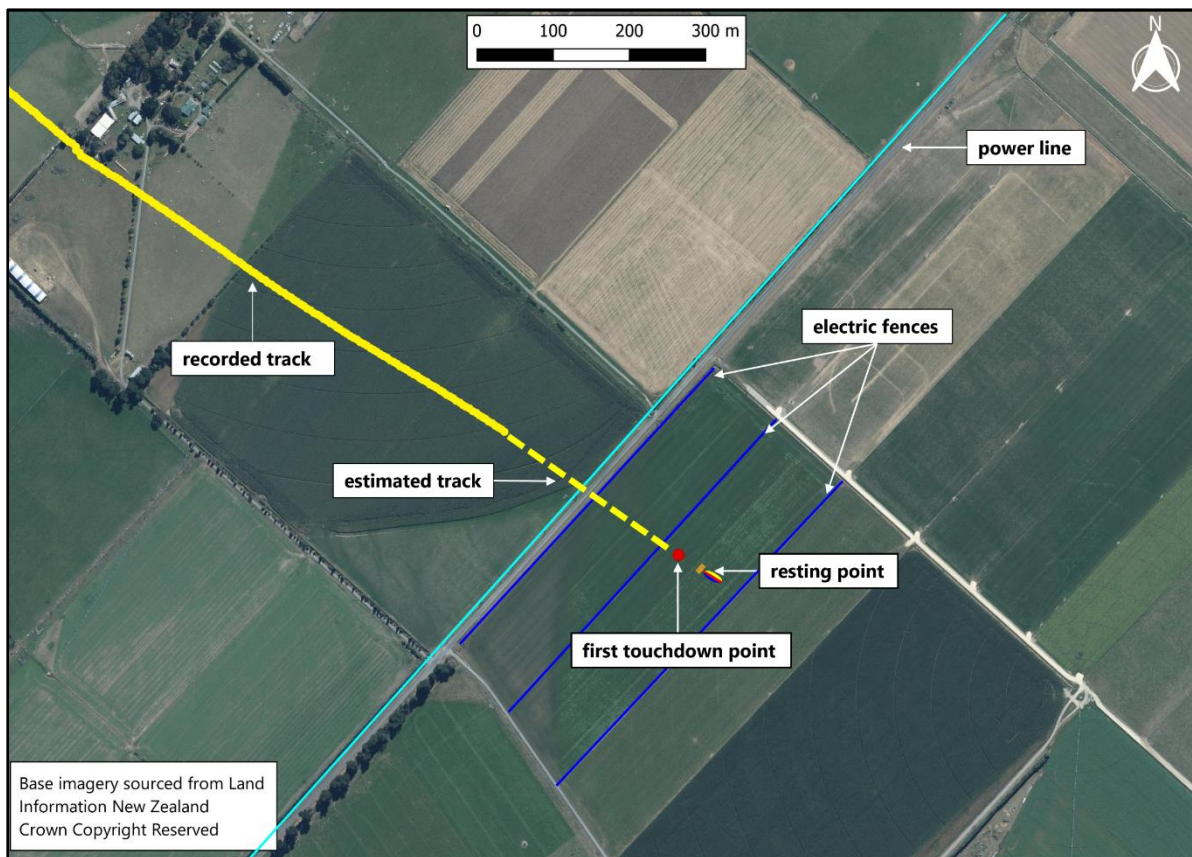
Figure 8: Image of the landing area

2.30. The paddock was the second in a series of paddocks that were rectangular in shape, with the long edge parallel to the road and perpendicular to the direction of travel of the balloon. The ground was grassed but hard.

2.31. There was a low-voltage distribution power line running parallel to the road, on the western side. The power lines ran about 6 metres above the ground.
