Transport Accident
Investigation
Commission

Preliminary Report

Aviation inquiry A0-2022-001
Ultramagic, S.A. N-250, ZK-MET
Pilot ejection from basket on landing
Lyndhurst, near Methven
1 January 2022

March 2022

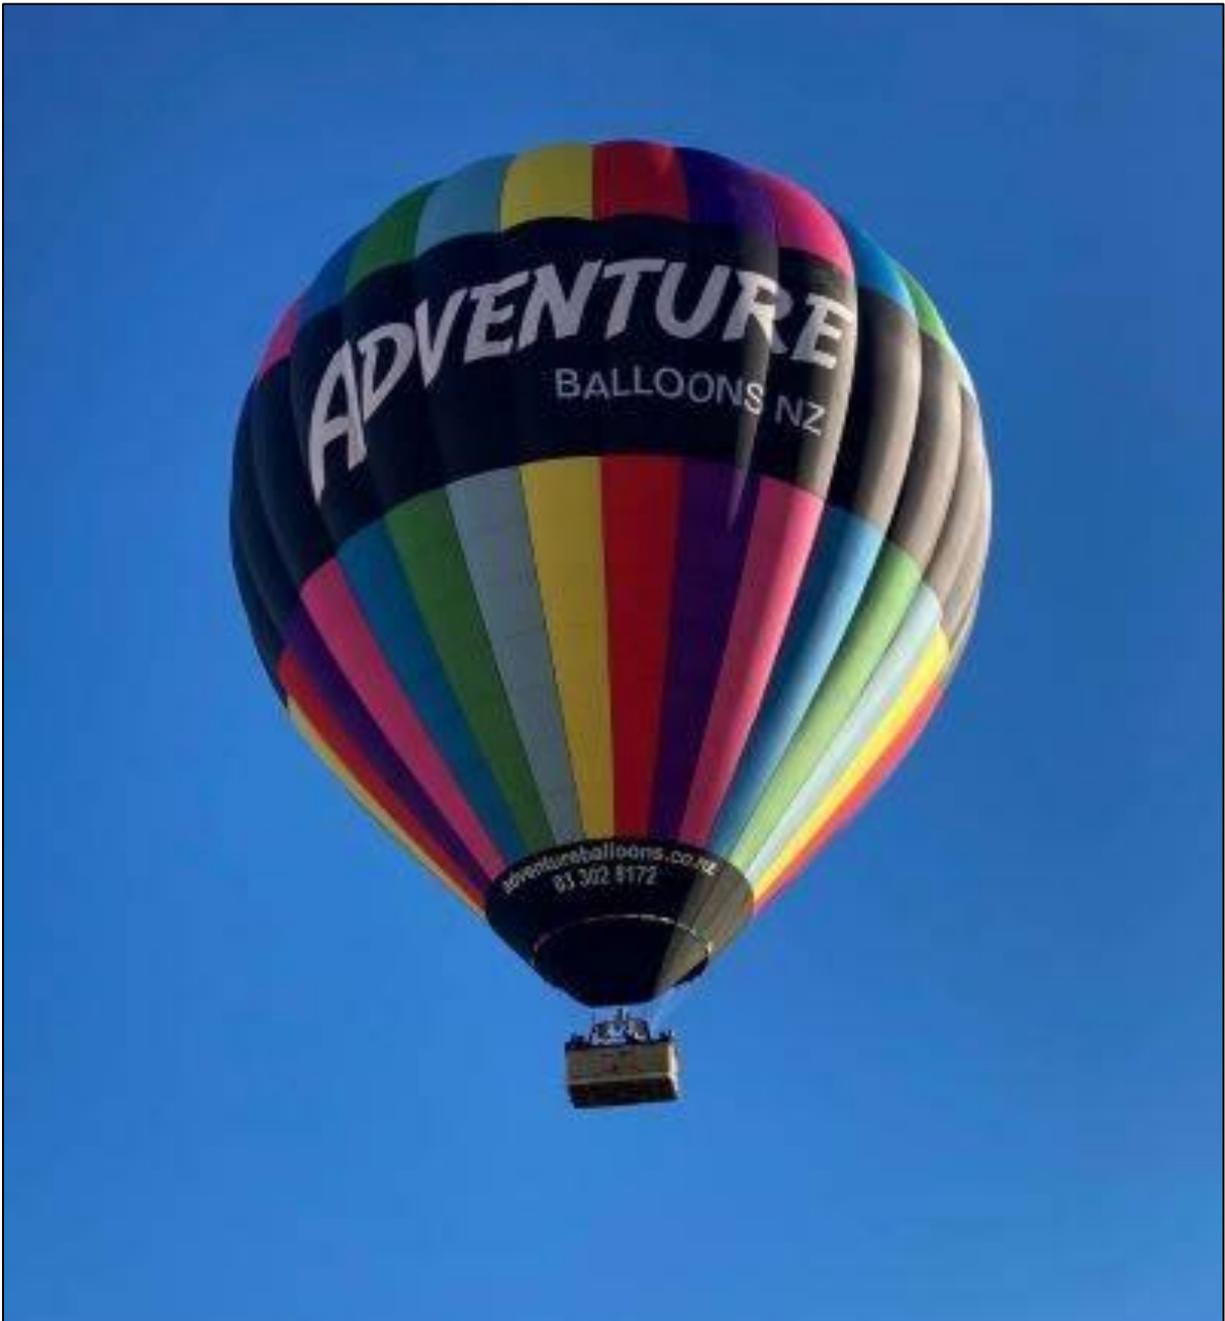
Figure 1: Ultramagic N-250, ZK-MET
(Credit: Adventure Balloons NZ)

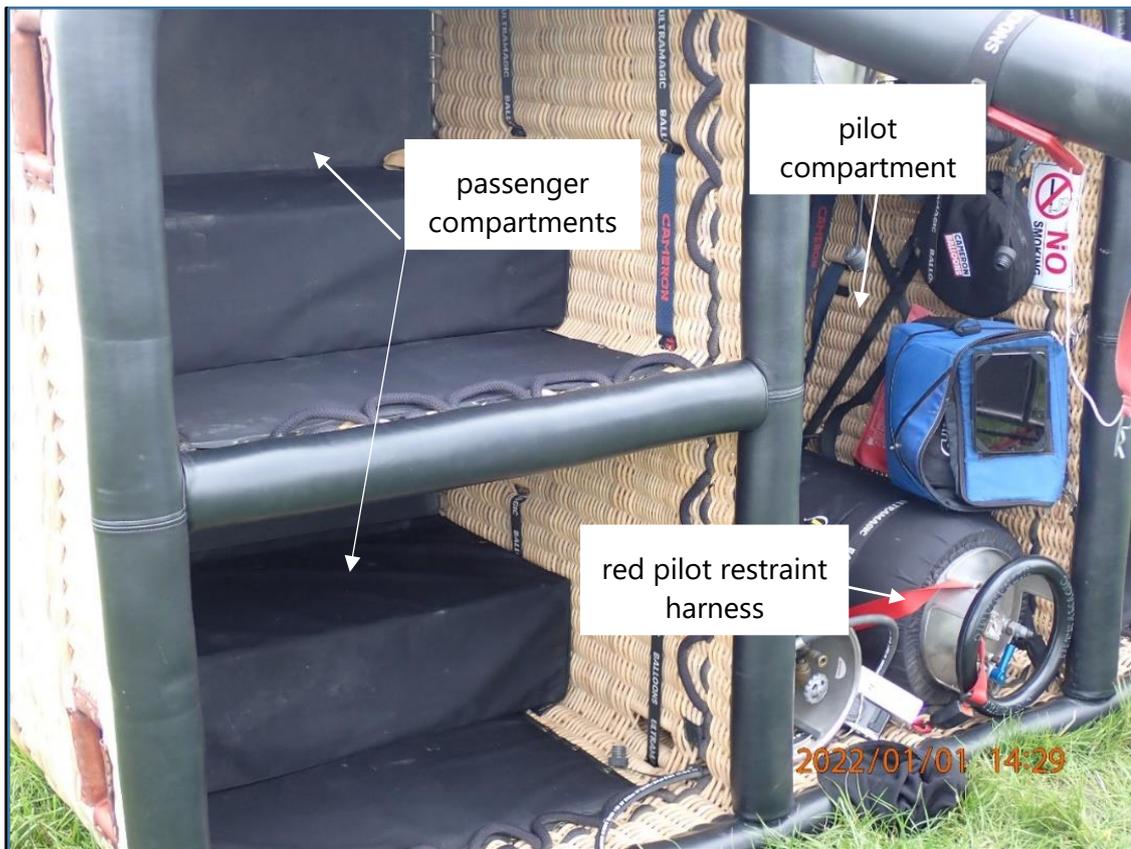
- 1.6. The balloon was fitted with a pilot restraint harness. The pilot and witnesses recalled that the pilot was not wearing the harness during the flight.

Figure 3: View inside basket – pilot harness

- 3.3. **On 22 February 2022 the Commission recommended that the Director of Civil Aviation take prompt steps to mandate the wearing of pilot restraint harnesses during critical phases of commercial balloon flights. (001/22)**
