Transport Accident
Investigation
Commission

Final report

Aviation inquiry AO-2023-010
Kawasaki BK117 B-2, ZK-HHJ
Collision with terrain
Mount Pirongia
19 September 2023

April 2025

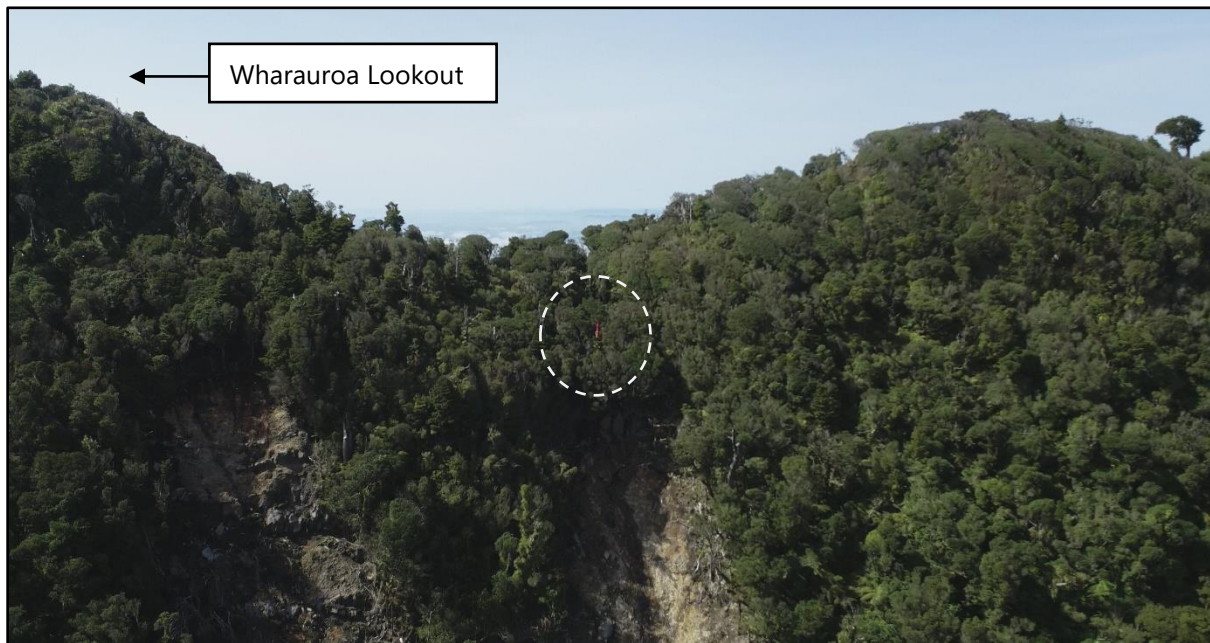
Figure 5: Accident site

- 2.39. The accident site was on Mount Pirongia on a west-facing escarpment covered by dense native forest, about 108 m southwest of Wharauoa Lookout (see Figure 5). The helicopter was sitting upright, wedged between trees below a ridge line (see Figure 6).
- 2.40. Damage to trees at the site indicated that the helicopter had fallen almost vertically through the tree canopy. All the wreckage was contained within a 15 m radius of the main fuselage.
- 2.41. The forward and aft cross-tubes of the landing-gear assembly had splayed outwards, causing the right side of the assembly to fracture in overload near the fuselage attachment fittings (see Figure 16 in Appendix 1).

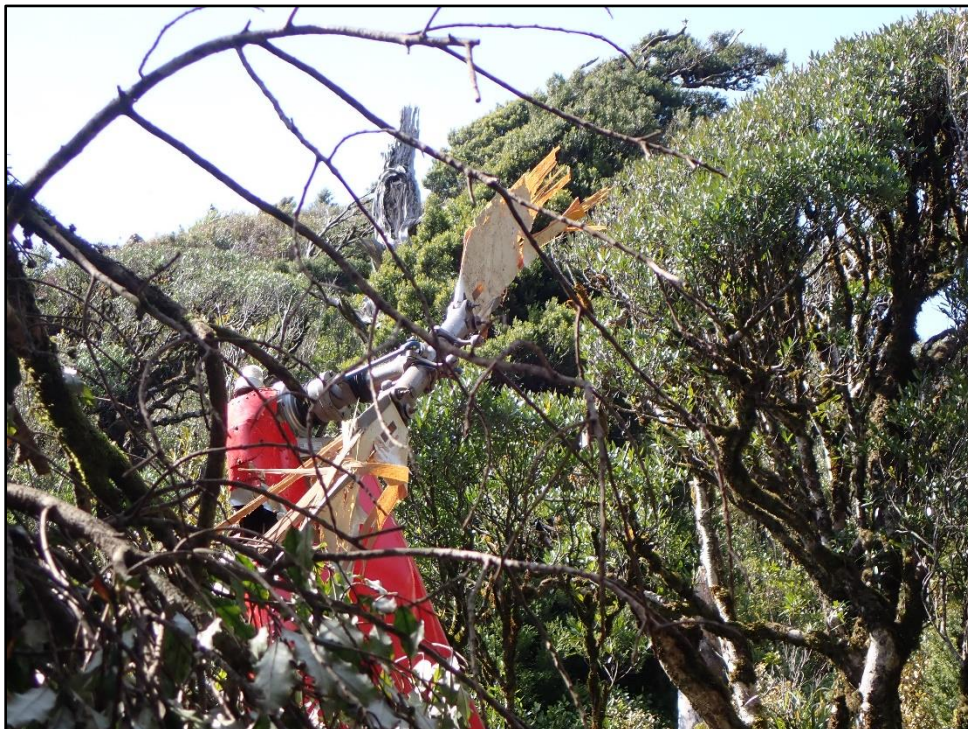
Figure 17: Tail rotor

- 2.43. Both tail rotor blades exhibited strike damage, but both were still attached to their mounting fork (see Figure 17 in Appendix 1).
- 2.44. The engine drive shafts of both engines had exhibited torsional¹⁸ failure (see Figure 18 in Appendix 1). This is consistent with the engines having continued to drive the main rotor transmission under resistance as the main rotor blades struck the surrounding trees.
