Transport Accident
Investigation
Commission

Final report

Aviation inquiry AO-2023-010
Kawasaki BK117 B-2, ZK-HHJ
Collision with terrain
Mount Pirongia
19 September 2023

April 2025

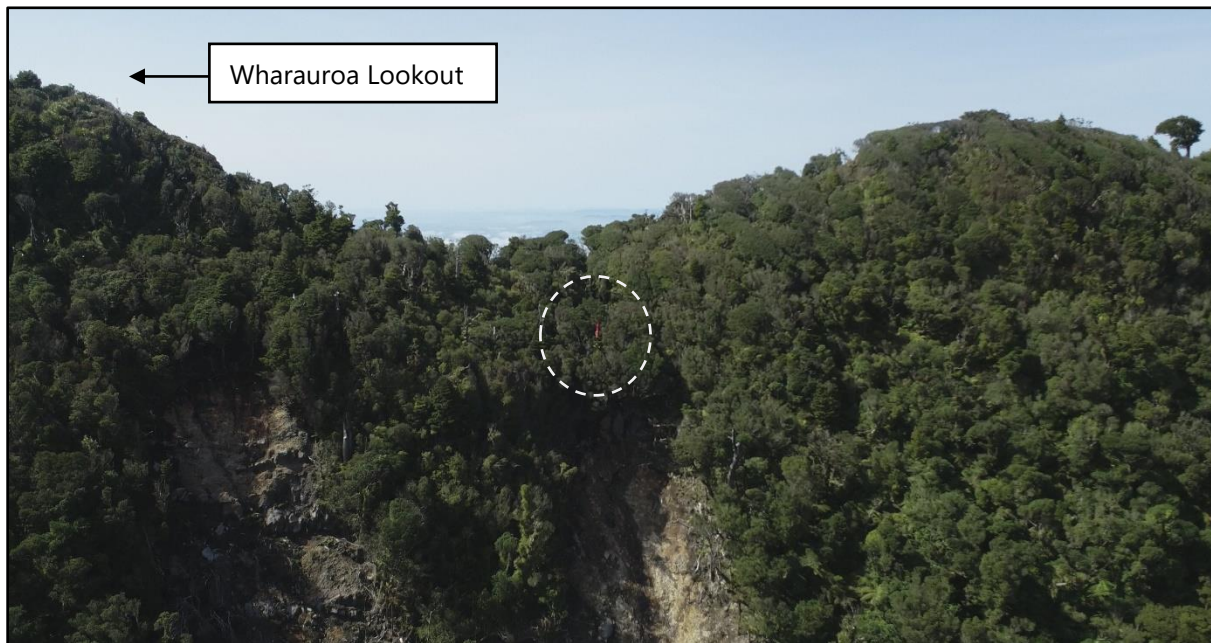
Figure 5: Accident site

- 2.39. The accident site was on Mount Pirongia on a west-facing escarpment covered by dense native forest, about 108 m southwest of Wharauoa Lookout (see Figure 5). The helicopter was sitting upright, wedged between trees below a ridge line (see Figure 6).
- 2.40. Damage to trees at the site indicated that the helicopter had fallen almost vertically through the tree canopy. All the wreckage was contained within a 15 m radius of the main fuselage.
- 2.41. The forward and aft cross-tubes of the landing-gear assembly had splayed outwards, causing the right side of the assembly to fracture in overload near the fuselage attachment fittings (see Figure 16 in Appendix 1).

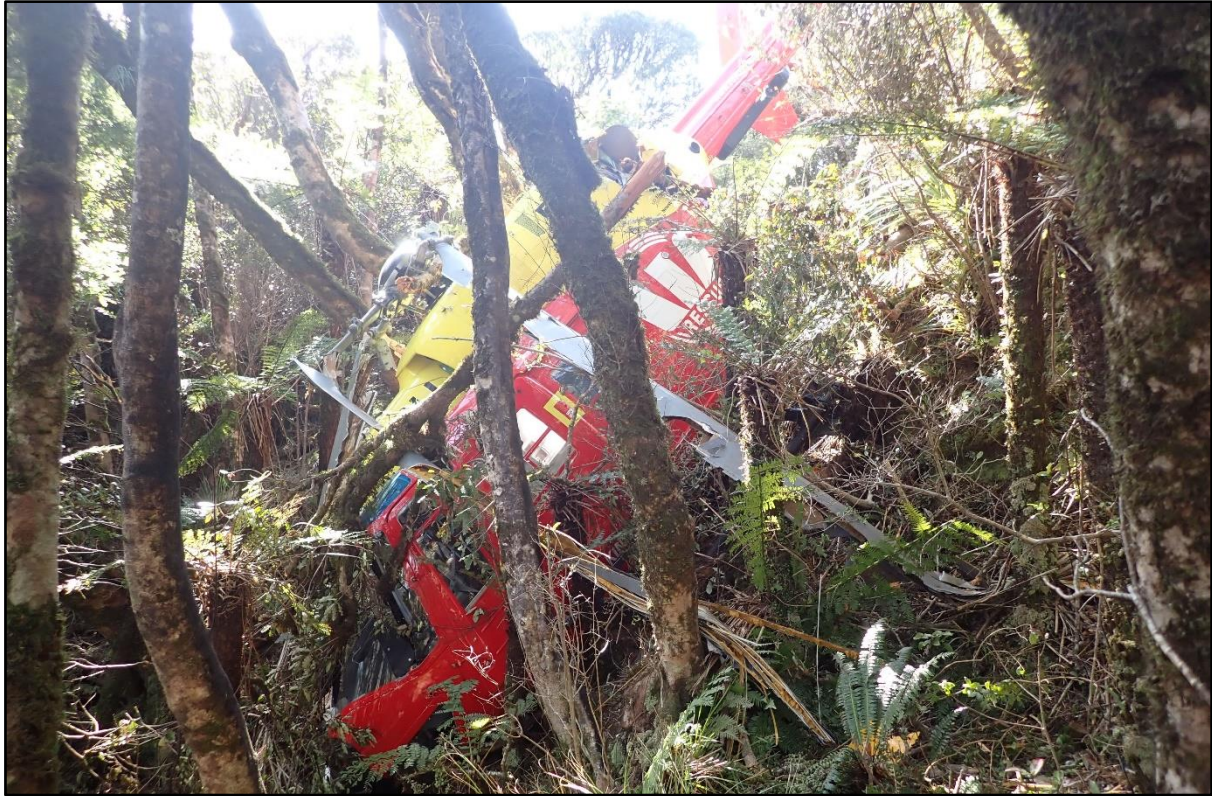
Figure 6: Accident scene

- 2.42. The markings on the trees surrounding the helicopter, and the damage to its main rotor blades, was characteristic of an impact with the blades having had high rotational energy. The outboard section of each main rotor blade was severely strike damaged. The main rotor blades had fractured outboard from the primary and secondary attachment bolts. One of the four main rotor blades had separated from the rotor head during the accident and was found lying next to the wreckage.

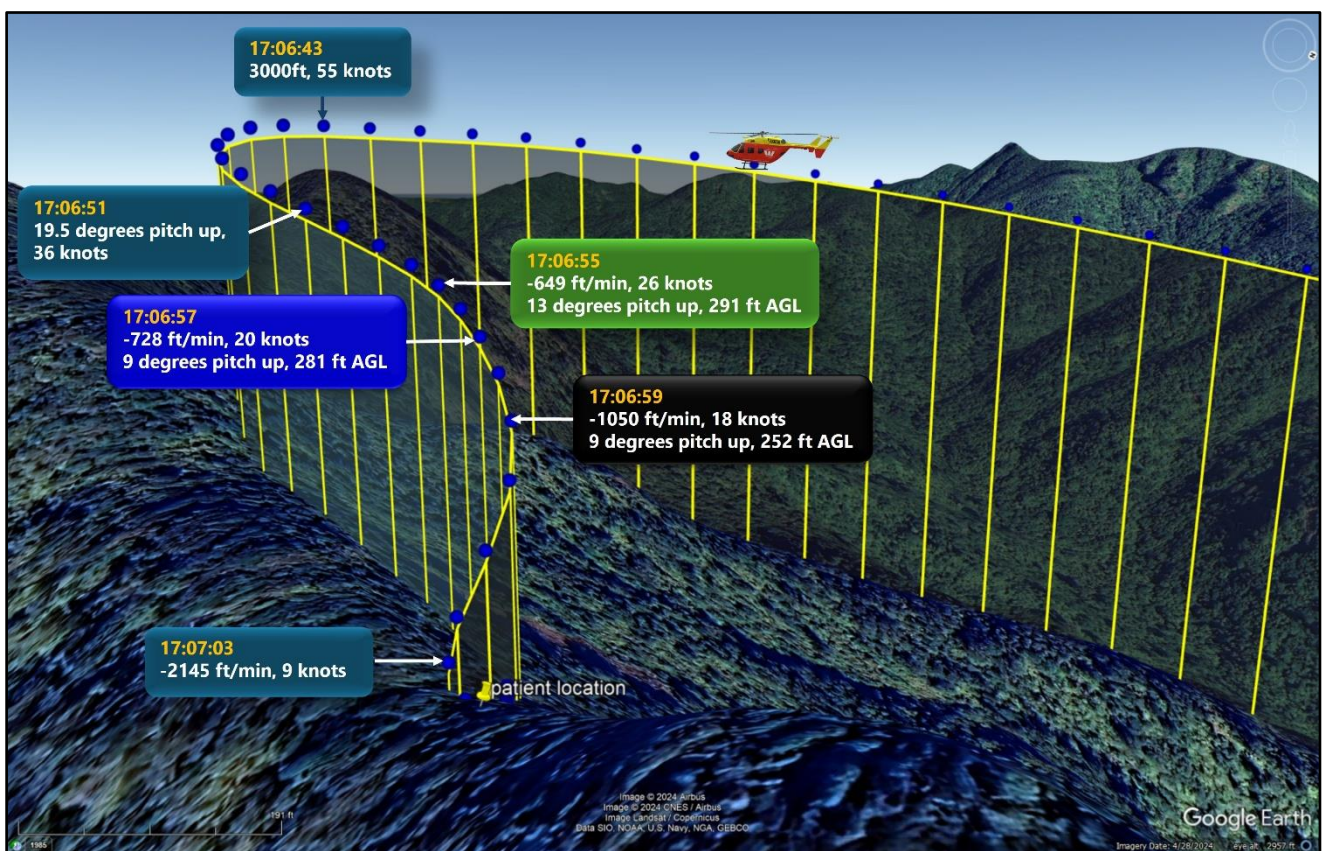
- 3.10. The helicopter's speed progressively decreased during its final approach, as depicted in Figure 11, which illustrates the helicopters trajectory. At 17:06:51 the helicopter's pitch angle reached a maximum of 19.5° (nose up). This in turn reduced the helicopter's speed and increased its rate of descent.

Figure 11: The helicopter's flight trajectory

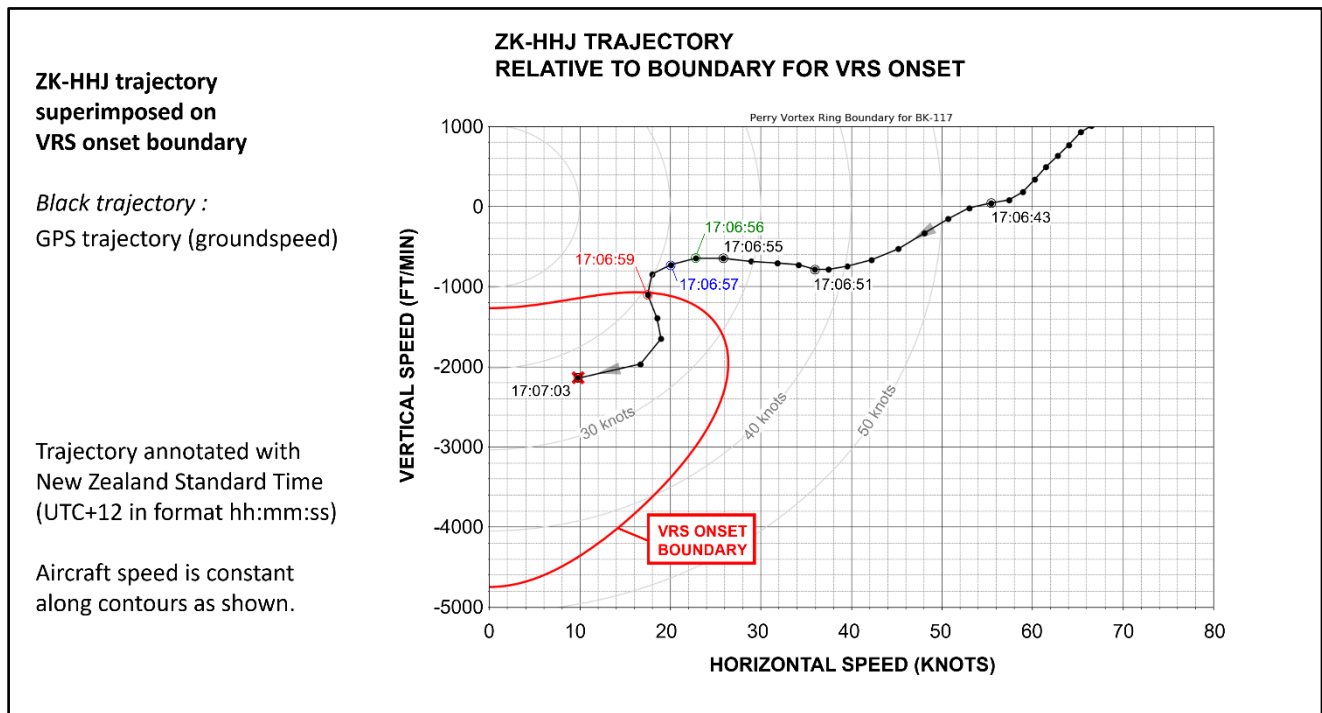
- 3.30. Figure 12 shows the location of the boundary for VRS onset on the flight envelope, as defined by mapping the location of flight conditions at which the disturbances to the wake structure are able to reach the main rotor. If the axes in this figure are interpreted as the speeds of the helicopter relative to the ground, then the figure suggests that a BK117 B-2 helicopter with the weight and geometric characteristics of the accident helicopter, when flying at the altitude of the accident site, would have encountered VRS when flying at descent rates between 1050 and 4750 ft/min if flying horizontally at speeds less than 27 kt (groundspeed). The black line shows the

horizontal speed and descent rate of the accident helicopter at various points along its final trajectory, as measured relative to the ground. According to the diagram, the helicopter will have entered VRS at 17:06:59 by crossing the onset boundary with a descent rate of 1050 ft/min and a groundspeed of 18 kt.

Figure 12: ZK-HHJ trajectory relative to boundary for VRS onset

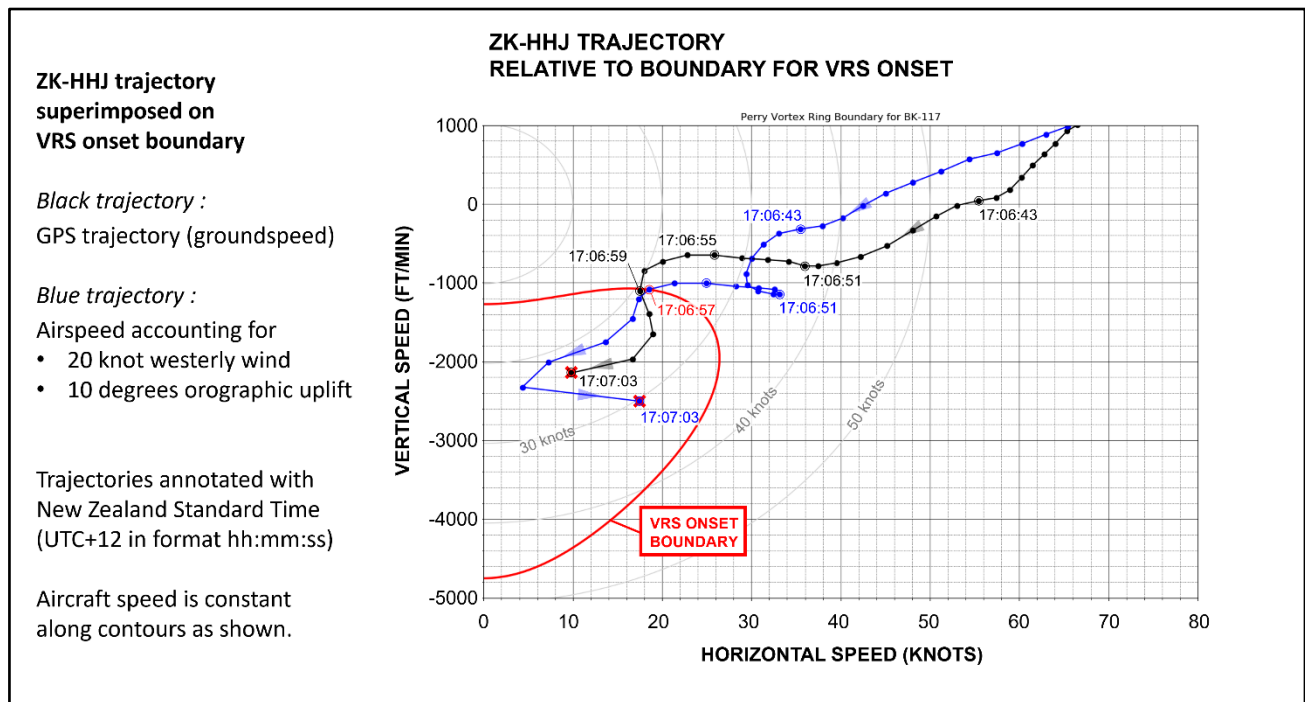
- 3.32. An analysis of the wind conditions at the time of the accident concluded that the wind speed was 20 kt, with gusts to 30 kt, from a westerly direction. The topography would have induced an upward component of wind flow relative to the helicopter's trajectory, known as orographic uplift. This upwards component of the wind would have appeared to the rotor as an increase in its effective descent rate. The blue trajectory (see Figure 13) depicts the helicopter's velocity, represented as a horizontal airspeed and descent rate, factoring in the influence of wind. This figure shows that, on accounting for the effect of the wind, the helicopter would have encountered VRS at 17:06:57, two seconds earlier than if the effects of the wind were not accounted for. By referring back to the trajectory shown in Figure 12 it can be inferred that the helicopter would have entered VRS at a substantially lower descent rate and higher forward speed (728 ft/min with a groundspeed of 20 kt) compared with the effects of the wind being omitted from the analysis.

Figure 13: ZK-HHJ trajectory, accounting for 20 kt westerly wind and 10° orographic uplift

- 3.33. An important factor was the change in the helicopter's heading around 17:06:59, causing a shift in the wind to blow from behind the helicopter (tail wind), effectively reducing the helicopter's airspeed. This shift in the relative wind contributed to the helicopter penetrating more deeply into VRS than if the heading of the helicopter had remained unchanged. As a result, the pilot would have experienced significantly exacerbated symptoms of VRS, as well as potentially greater difficulty in recovering to normal flight.

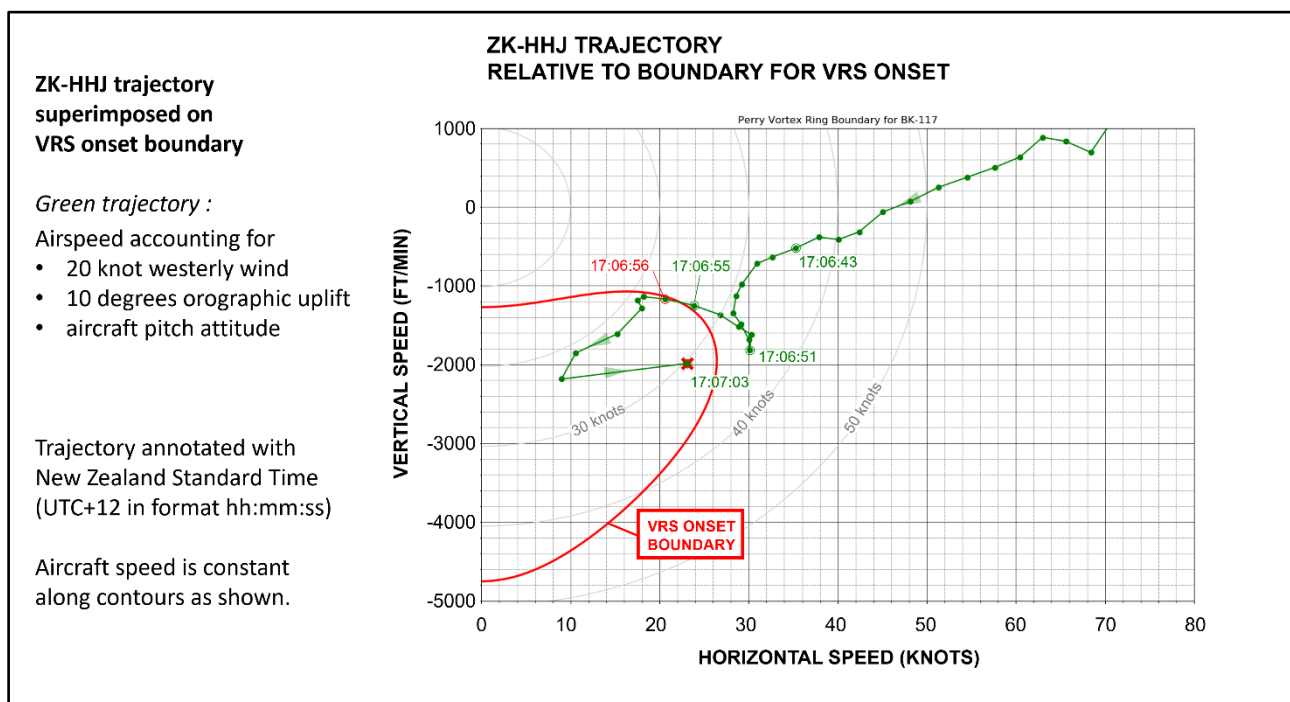
- 3.35. In Figure 14, the green trajectory denotes the airspeed and descent rate as measured relative to the helicopter's rotor, accounting for the changes in pitch attitude of the helicopter, while descending along the ridge line. The effective inclination of the rotor to the airflow was calculated by subtracting the helicopter's mast inclination angle (5°) from the helicopter's pitch attitude, as recorded by the Flightcell DZMx.

Figure 14: ZK-HHJ trajectory accounting for 20 kt westerly wind, 10° orographic uplift and pitch attitude

- 3.36. At 17:06:51 the helicopter's pitch attitude reached a maximum of 19.5°. The analysis presented in Figure 14 then shows that the helicopter would have crossed the VRS onset boundary sometime between 17:06:55 and 17:06:56, 3.5–4 seconds earlier than if the pitch attitude and wind were ignored in the analysis. Referring back to the speeds relative to the ground (the black trajectory in Figure 12), the helicopter would have entered VRS at a descent rate of 649 ft/min with a groundspeed of 25.8 kt.

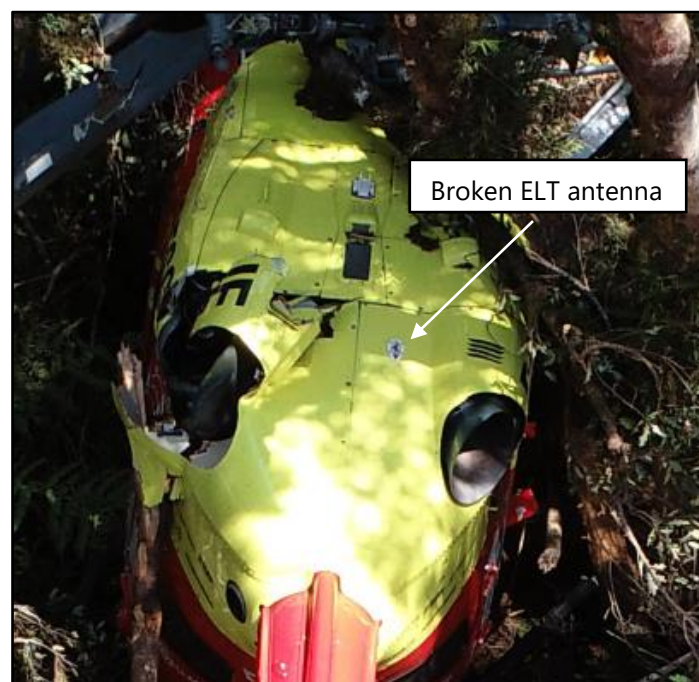
- 3.54. The ELT activated as intended, but was unable to transmit a signal because its antenna broke off during the accident sequence. As a consequence, RCCNZ did not receive a notification from the ELT.

Figure 15: broken ELT antenna after the accident sequence

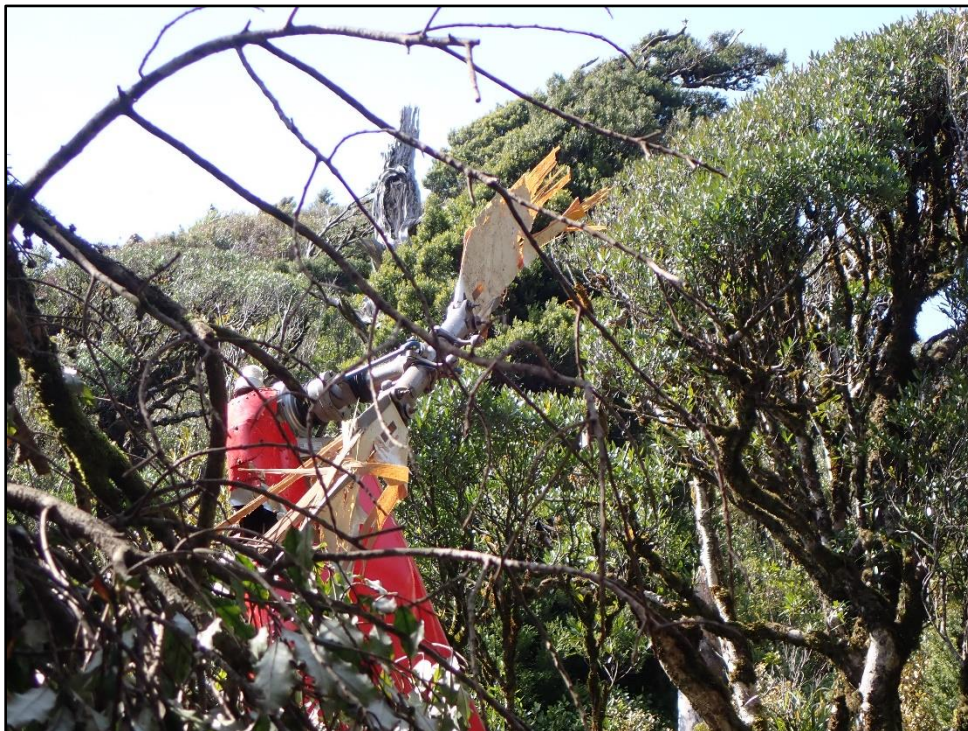
Figure 17: Tail rotor

- 2.43. Both tail rotor blades exhibited strike damage, but both were still attached to their mounting fork (see Figure 17 in Appendix 1).
- 2.44. The engine drive shafts of both engines had exhibited torsional¹⁸ failure (see Figure 18 in Appendix 1). This is consistent with the engines having continued to drive the main rotor transmission under resistance as the main rotor blades struck the surrounding trees.
