Transport Accident
Investigation
Commission

Aviation inquiry A0-2023-011

ZK-JED Beech 76 / ZK-WFS Cessna 172

Near mid-air collision

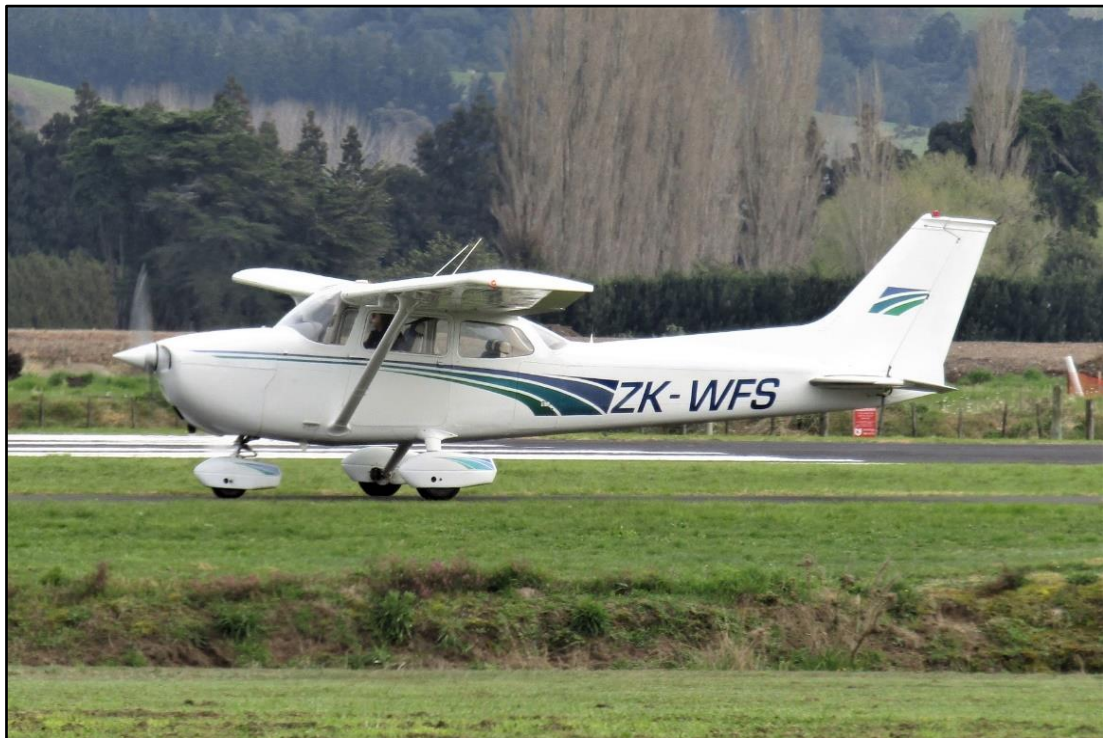
Figure 2: Cessna 172, ZK-WFS
(Credit: Mark Mabey)

- 3.36. The exterior lighting fitted to the Cessna was in accordance with CAA rules. However, the aircraft had the older-style anti-collision light with lower illumination levels. Retrofitting strobe lighting to older aircraft would potentially require new wiring and incur considerable cost. An alternative would be to replace the existing anti-collision light system with light-emitting-diode (LED) lighting. These are available for many aircraft types and use existing wiring and switches. This would increase conspicuity of the aircraft.

- 6.3. On 27 March 2025, the Commission recommended that the CAA issue guidance to promote suitable methods to increase conspicuity for aircraft flying at night. **[037/25]**
- 6.4. On 17 April 2025, CAA replied:

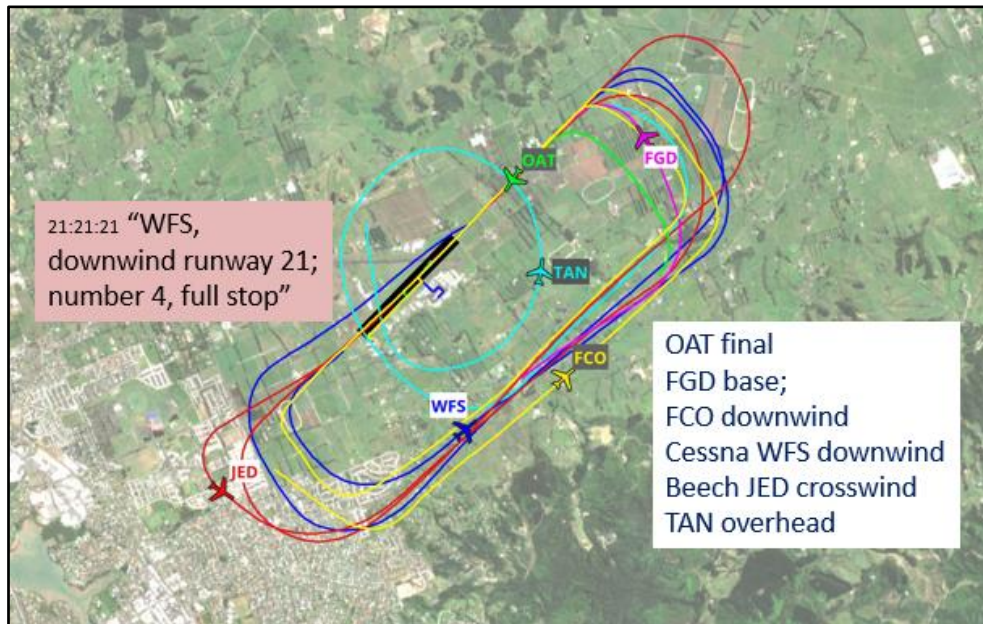
Figure 6: Aircraft sequence at 21:21:21¹³

- 2.11. At 2121 the Cessna turned downwind for their third circuit and called to say they were downwind and number 4. This sequence was correct; with OAT on final, FGD on base, and FCO downwind and in front of the Cessna (see Figure 6).

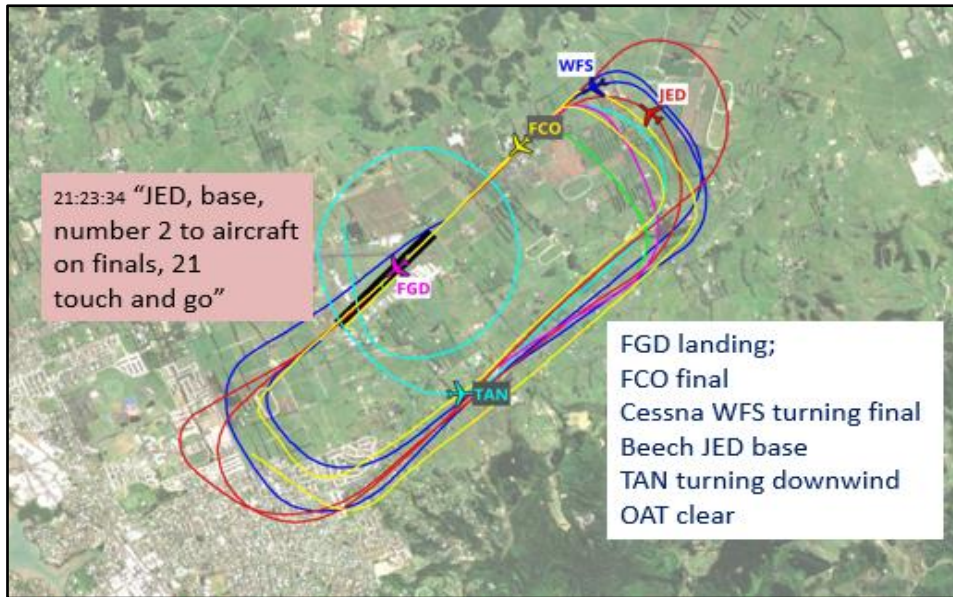
Figure 7: Aircraft sequence at 21:23:34

- 2.12. At 2122 OAT called that they were clear of the apron having completed their full-stop landing. FGD now led the sequence and was just about to make a full-stop landing and then clear the runway.
- 2.13. At 2123 the Beech called that they were on base leg, number 2 to the aircraft on final, and they intended to do a touch-and-go landing (see Figure 7). They had not made a downwind call.

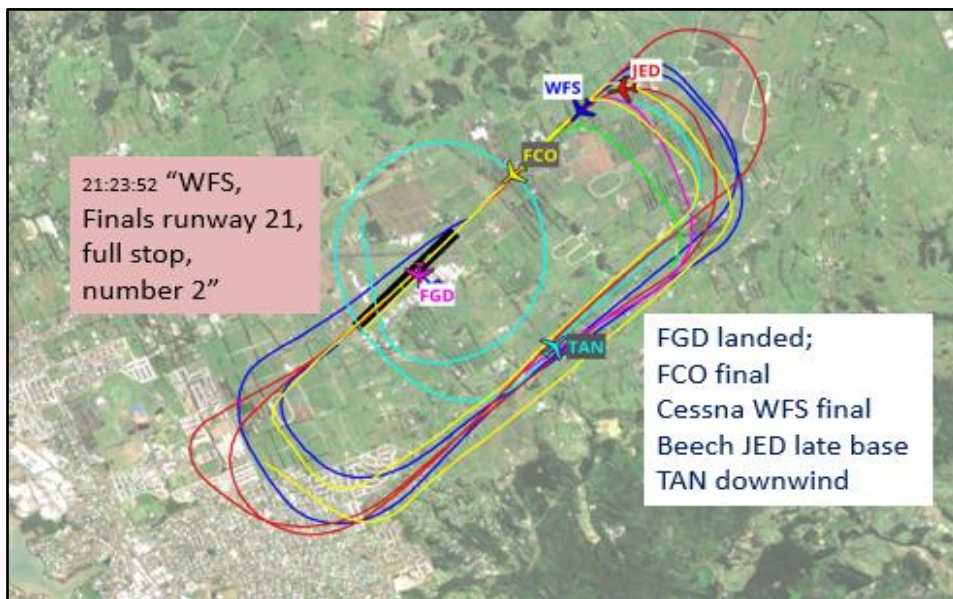
Figure 8: Aircraft sequence at 21:23:52

- 2.14. Eighteen seconds later the Cessna called that they were on final and were number 2 (see Figure 8).

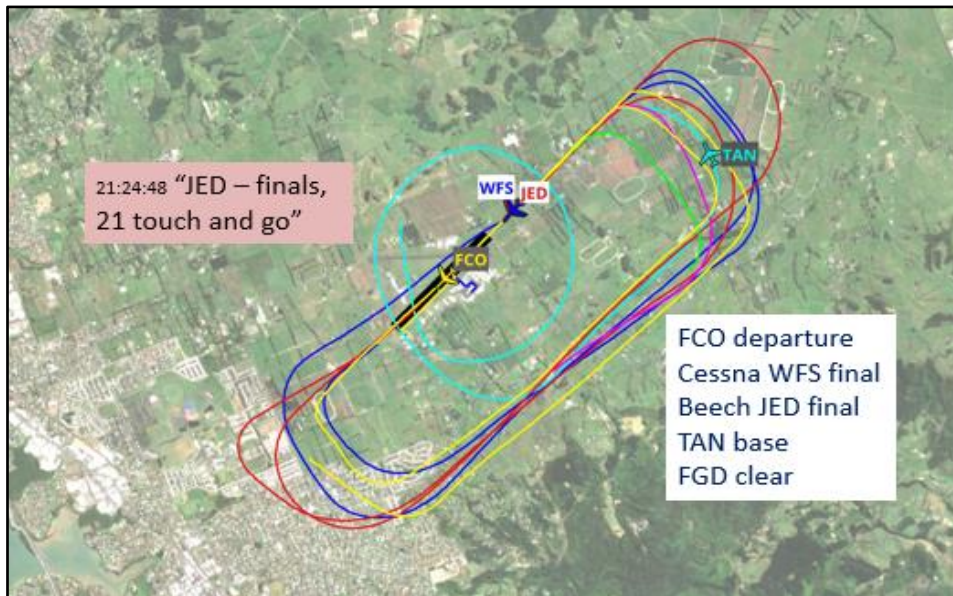
Figure 9: Aircraft sequence at 21:24:48

- 2.15. At 2124, and eight seconds after the preceding call, FCO called that they were on short final for a touch-and-go landing.
- 2.16. At 2124 the Beech called that they were on final for a touch-and-go landing (see Figure 9).

- 2.17. At 2125, and twelve seconds after the preceding call, the Cessna called that they were going around from their approach and that they had a really near-collision on short final.

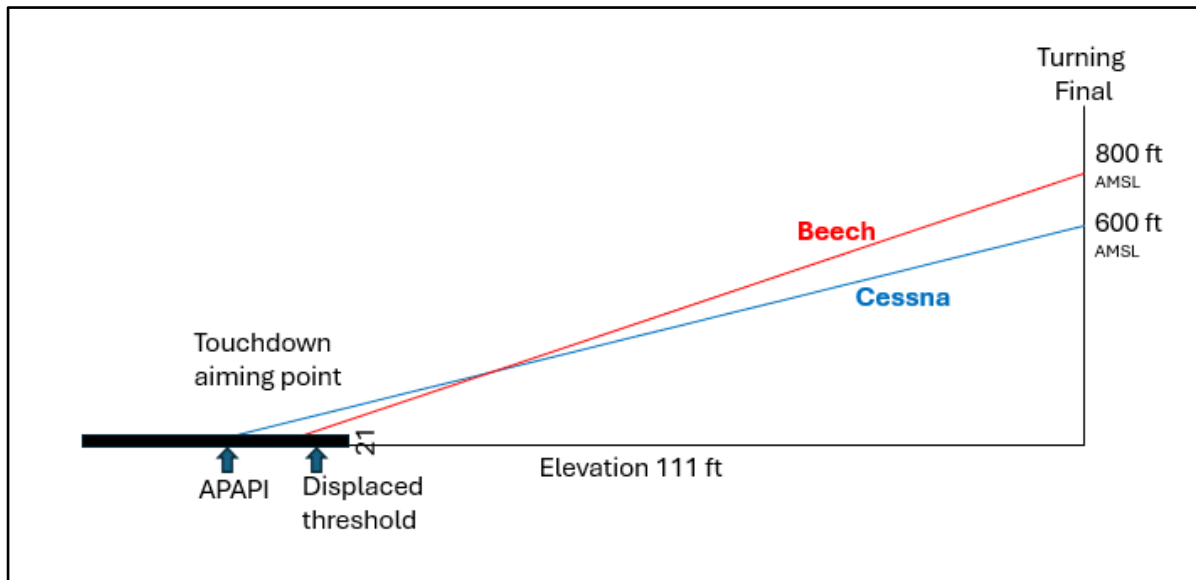
Figure 10: Vertical profiles (as reported by the pilots)

- 3.14. The projected vertical profiles of the two aircraft from turning final to the touchdown aiming point are represented in Figure 10. The data provided from ADS-B uses rounded altitude information and therefore cannot be used to calculate an accurate vertical profile, so these have been created based on the pilots' recollection.

- 3.15. The Beech 76 aircraft has a long nose and high instrument-panel coaming. While flying downwind or on base this would not restrict vision of other aircraft in the circuit, but once established on final the forward lower field of vision for the pilot flying and instructor on the Beech was restricted. The Cessna turned final at 600 ft and was following the APAPI and therefore was flying a flatter approach profile. The Beech was descending from behind the Cessna but on a steeper profile with the Cessna under their nose. Once both aircraft were lined up on the final approach to the runway, the combination of the Beech's restricted forward visibility and the lower trajectory flown by the Cessna meant that it was **very unlikely** that the pilot flying and instructor in the Beech would see the Cessna.

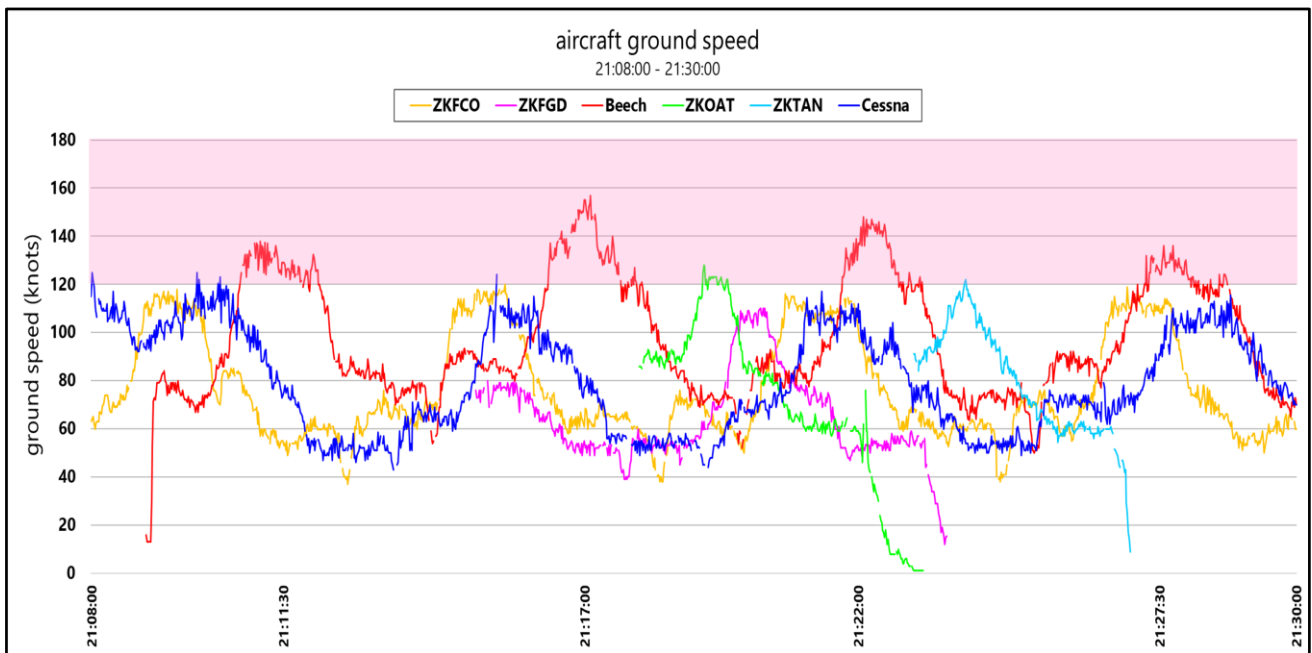
Figure 11: Ground speeds of the six aircraft in the circuit

- 3.16. Ardmore's AOM stated that airspeed was not to exceed 120 kt (or minimum safe cruising speed if greater than 120 kt). At interview, the pilot flying the Beech said that they were aware of and tried to stick to the speed limit of 120 kt. The instructor said that they planned to fly downwind at 100 kt. Figure 11 shows the ground speeds of the six aircraft in the circuit at the time of the incident. The speed of the Beech was, as expected for a twin-engined aeroplane, consistently faster than the other aeroplanes when flying in the circuit.

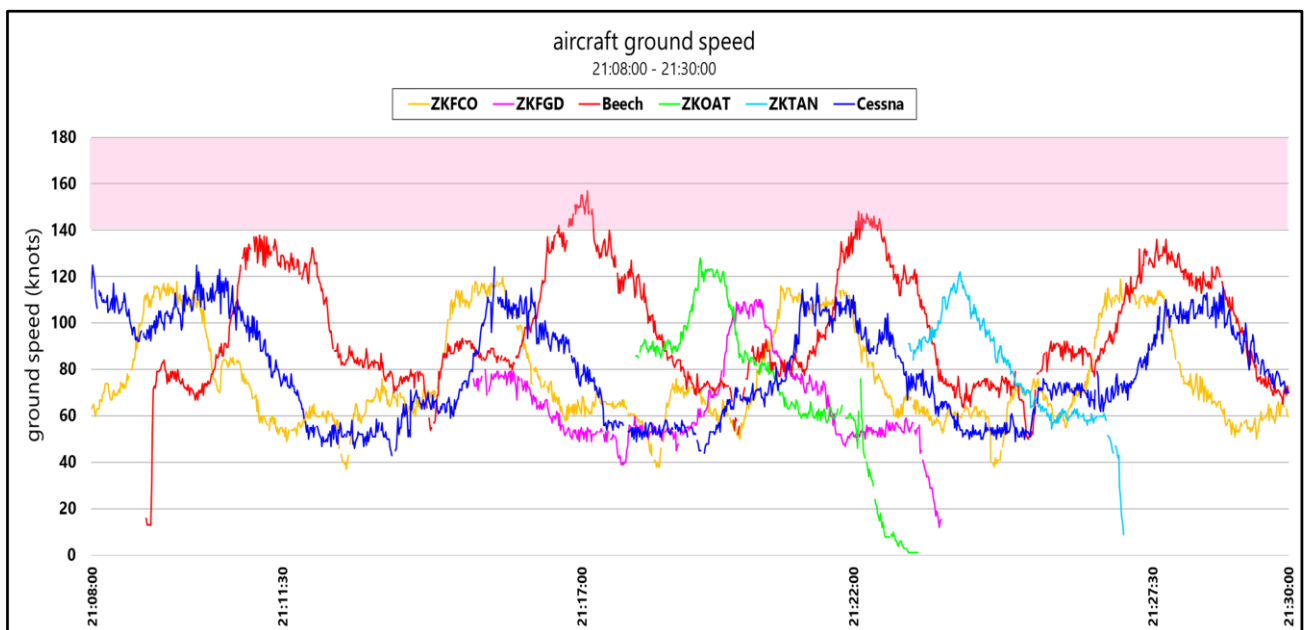
Figure 12: Aircraft ground speed (140 kt G/S limit highlighted)

3.17. It is also important to note that the data depicted in Figure 11 is calculated ground speed recorded from ADS-B. Appendix 6 details the difference between the stated speed limit as an indicated airspeed (IAS) and the speed read-outs from ADS-B that are ground speed (G/S). Effectively a limit of 120 kt IAS equates to 140 kt G/S when accounting for the wind and temperature on the evening of the incident (as calculated in Appendix 6). The pink shaded area of Figure 12 depicts the times when the Beech exceeded 140 kt, demonstrating that it was a small proportion of the flight profile.

- 3.18. The pilot of the Cessna said that they did not know that the Beech was a twin-engined aircraft and therefore faster. There was no requirement for aircraft to state their aircraft type when they make the downwind or turning final radio call. The speed variance between the Beech and the other aircraft in the circuit, rather than the instances of the Beech exceeding the circuit speed limitation, led to changes in the spacing between aircraft and therefore **likely** contributed to the occurrence.
