Transport Accident
Investigation
Commission

Final report

Aviation Inquiry AO-2019-007
Air Traffic Services Outage
30 September 2019

April 2023

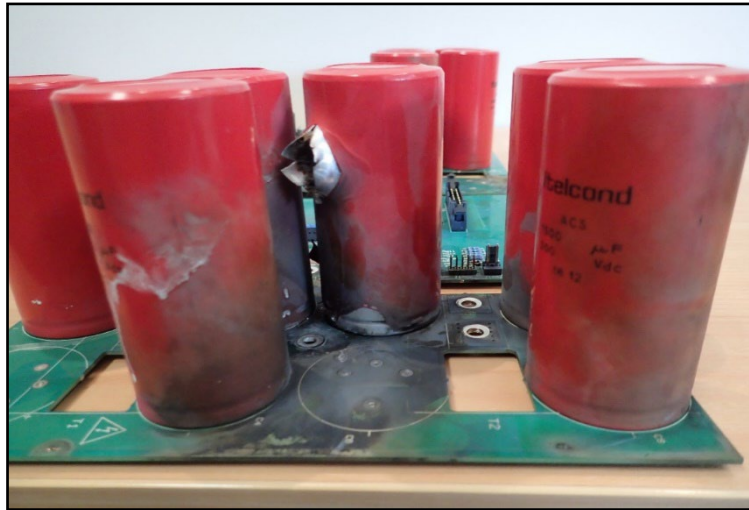
Figure 3: Failed capacitor from UPS A

- the incorrect power connection of the MPLS network equipment.
- 3.7. The initiating point for the Airways outage was the failure of a capacitor in the inverter of UPS A. The capacitor's external casing was compromised in the failure, allowing debris from inside the capacitor to be spread over surrounding circuit boards (see Figure 3) and exposed copper terminals. This debris was very conductive and created a short circuit inside the UPS cabinet.

- 3.8. These type of electrolytic power capacitors are under high electrical loads and Airways technicians were aware that they are prone to occasional premature failure. Airways had managed this risk by replacing the capacitors within the manufacturer's recommended reliable operating lifetime of six years. The capacitor that failed had been replaced 12 months before this outage.

- 3.9. The capacitor failure caused an internal problem in UPS A when the debris from the capacitor exploded within the UPS. The UPS detected the internal capacitor failure and switched to the reserve supply. However, the conductive debris from the capacitor failure created a short circuit inside the UPS.

- 3.10. The short circuit created an overload on the reserve supply, which tripped the reserve circuit breaker at the main switchboard. This removed all power to the UPS A connected loads.

- 5.10. Airways has changed its UPSs to a more robustly designed model with physically divided internal compartments. This is intended to isolate internal faults and prevent them escalating into a full UPS failure.
- 5.11. Airways has applied common wiring standards for UPS connections across all their facilities, including the Auckland and Christchurch ATMCs as well as airport towers. UPS power distribution cables are now all colour coded to distinguish the UPS they are fed from. The differentiation in colour makes it easier for technicians to identify any incorrect power connection issues.

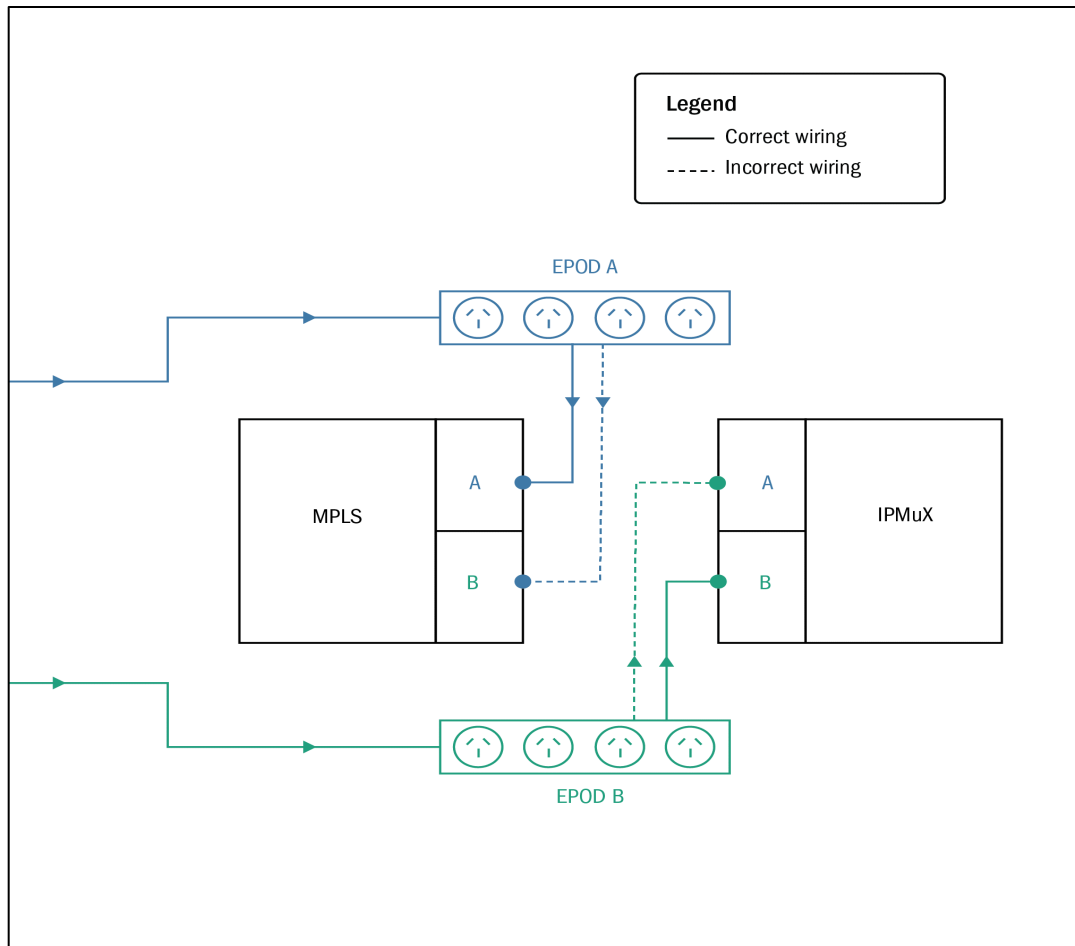
Figure 4: MPLS and IPMux incorrect power connection schematic

- 3.12. When power supply system A stopped providing power to the aeronautical telecommunications network equipment, power supply system B should have taken over. However, both power supply system connections for the MPLS equipment were plugged into UPS A electrical power outlet distribution (EPOD) (*see Figure 4*). The dashed cable from EPOD A to MPLS B indicates the incorrect power connection. The correct connection should have been from EPOD B to MPLS B, as shown in the diagram in appendix 1.

- 3.13. Therefore, when UPS A stopped providing power, the MPLS equipment experienced a complete loss of power and stopped functioning.
- 3.14. The MPLS network equipment is duplicated in a separate cabinet to provide resilience and redundancy. That separate equipment should have been operational and maintained air traffic control services. However, the incorrect connection was repeated in both cabinets, so all the MPLS network equipment lost power.

- 3.16. A second incorrect cabling issue was detected with the network equipment, although this cabling error did not contribute to the outage. Both power supply system connections for the IPMux equipment were plugged into UPS B EPOD (see Figure 4). The dashed cable from EPOD B to IPMux A indicates the incorrect power connection. The correct connection should have been from EPOD A to IPMux A, as shown in the diagram in appendix 1.

- 3.17. The MPLS and IPMux incorrect power connections had **likely** existed since installation, before the network outage in 2015.
- 3.18. At the time of the outage in 2015, Airways used black cables for all UPS power supply system connections. In 2018 they introduced a new cabling standard that ensured UPS power cables were colour coded for UPS A and UPS B. The IPMux cabinets involved with this incident at the Christchurch ATMC had not been brought up to this standard because they would become redundant after Airways relocated operations in 2023 from the Andy Heard Building to the new ATMC being built nearby.
