Transport Accident
Investigation
Commission

Final Preliminary Report **Tuhinga Whakamutunga – Mō Tēnei** **Wā**

Maritime inquiry MO-2022-206
Charter fishing vessel i-Catcher
Capsize
Goose Bay, Kaikōura, New Zealand
10 September 2022

August 2023

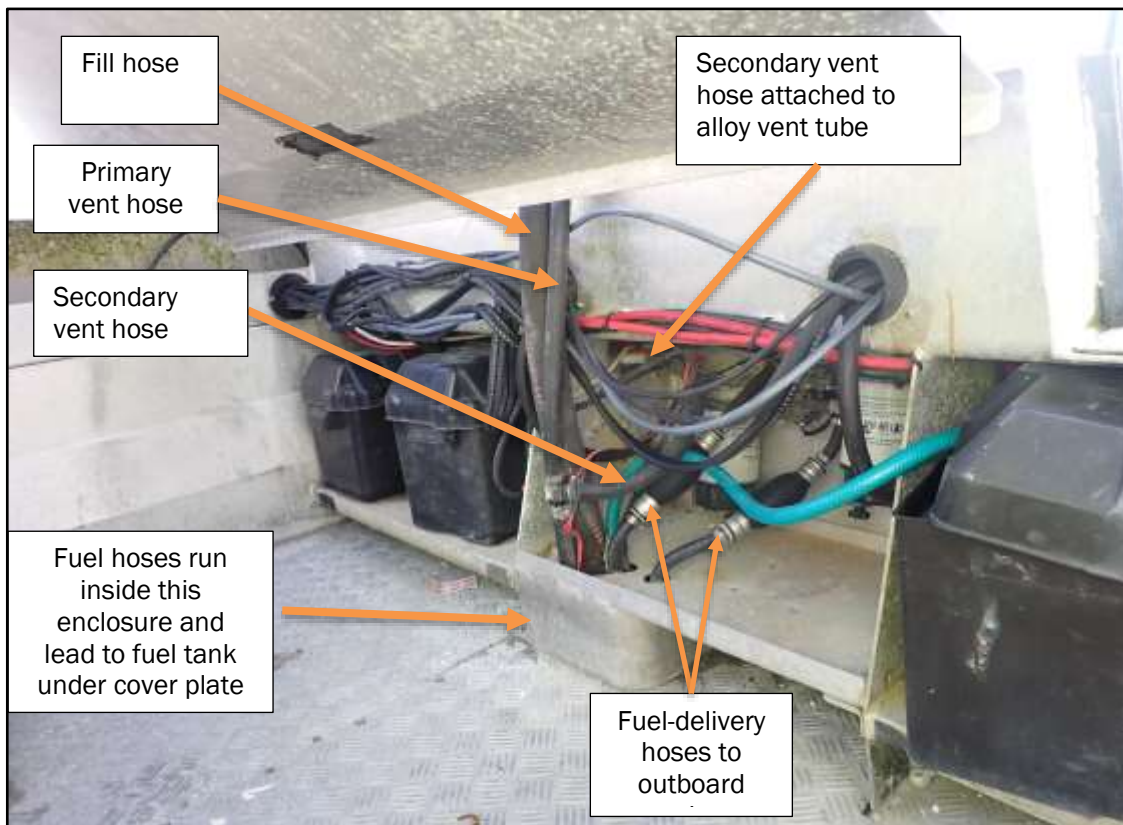
Figure 3: The *i-Catcher's* fuel system components

1.14. The fuel system on *i-Catcher* is made up of the following main components¹ (see Figure 3):

- 190-litre fixed centreline fuel tank located under the deck plate (fuel tank)
- main fuel fill hose for re-fuelling the vessel (fill hose), which connects to the fuel filler cap² and fuel tank
- the fuel-tank venting arrangement comprising three components: a primary vent hose; a secondary vent hose that branches off the primary vent hose; and an alloy vent tube attached to the secondary vent hose, which passes up through the deck of the vessel and terminates inside an alloy frame on the transom (discussed below)
- two fuel-delivery hoses, each leading to a fuel filter and one of the two outboard engines (fuel-delivery hoses).

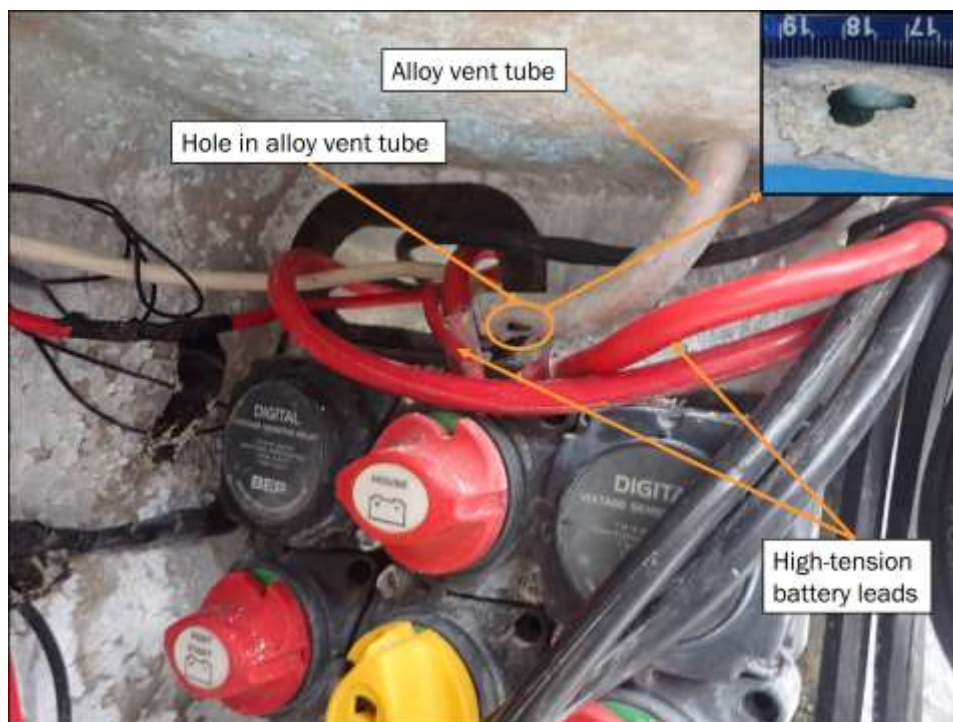
Figure 4: Hole in alloy vent tube

1.15. The Commission found a hole measuring approximately 12mm x 6mm in the alloy vent tube attached to the secondary vent hose (see Figure 4). Locating the hole required a thorough examination of the venting arrangement due to the alloy pipe being partially restricted from view.

- 1.16. This hole was a potential path for fuel to escape when filling the fuel tank or if the vessel overturned. The hole was also close to the high-tension battery leads and contact points, which presented a significant fire or explosion hazard.
- 1.17. The alloy vent tube (see Figure 4) terminated inside an alloy frame on the transom³ just forward of the swim platform (see Figure 5). A pressure test of the alloy frame revealed that it was closed-off from the atmosphere, preventing fuel vapours from venting to open air and rendering it ineffective as a fuel-tank vent (a point not identified in survey reports, as discussed below).
- 1.18. Fish Kaikoura 2011 Limited has stated to the Commission that no modifications had been made to the *i-Catcher's* fuel system since it purchased the vessel.

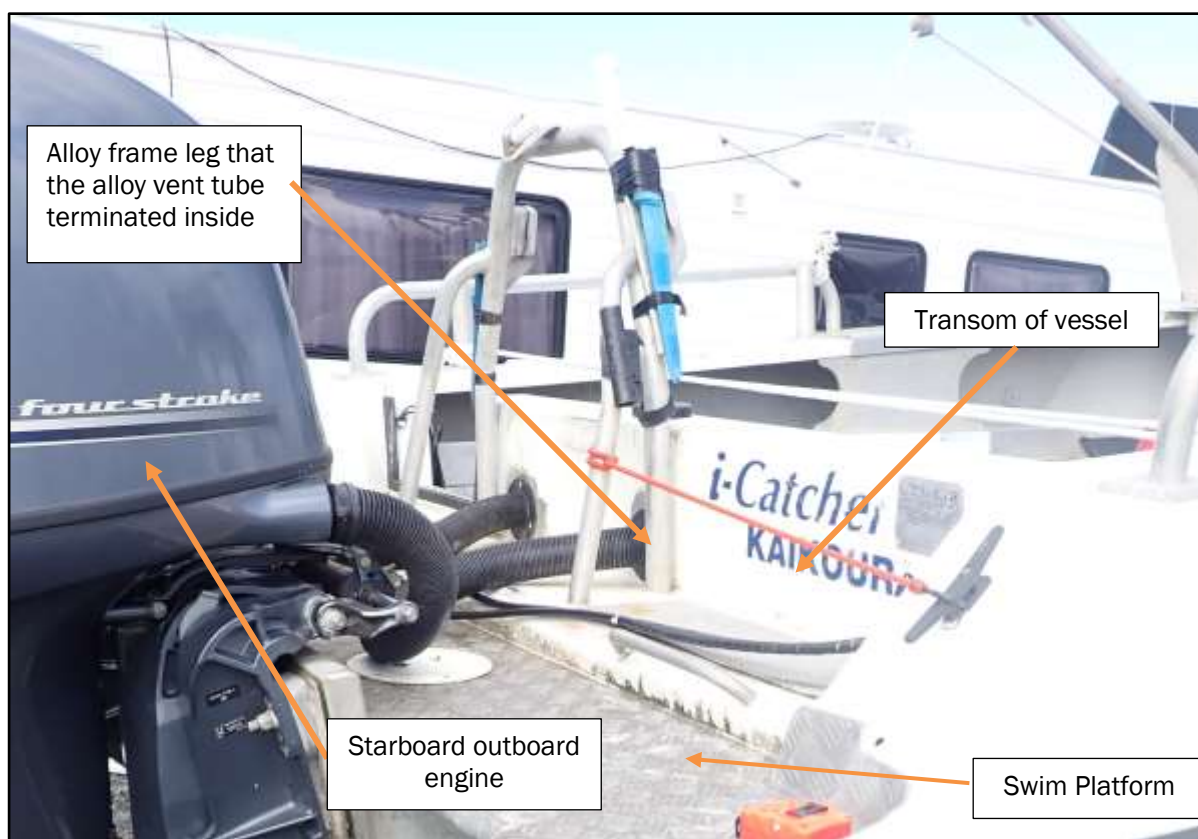
Figure 5: Stern of *i-Catcher*, identifying the alloy frame leg in which the alloy vent tube terminates.

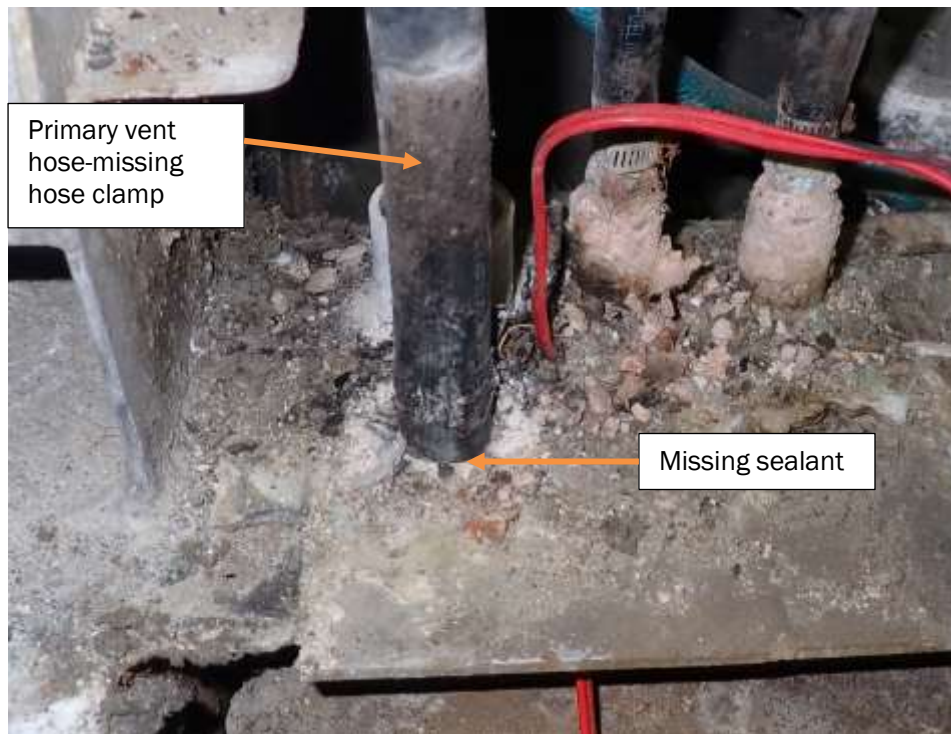
Figure 6: Primary vent hose connection to fuel tank (underneath the deck plate)

- 1.19. The vessel's fuel-delivery hoses ran from the fuel tank through two holes in a cover plate. Removal of the cover plate and the deck plate to inspect the fuel-tank connections required partial disassembly of the fuel system. Upon disassembly, the Commission found the primary vent hose was not secured with a hose clamp, a critical component to ensure a secure connection to the fuel tank (see Figure 6).
- 1.20. A sealant had been applied where the fuel and vent hoses connected to the fuel tank. The fuel tank and its fuel hoses were pressure-tested by the Commission, which revealed a leak from the base of the primary vent hose. Prior to testing, it was observed that a

portion of the sealant had broken away, leaving a section of the primary vent hose connection exposed (see Figure 6).

- 1.26. The survey reports show that no inspection of the fuel system below the deck plate (see Figure 6) had been conducted on the vessel as a part of its commercial service. Similarly, the survey reports hadn't identified that the secondary fuel tank vent was ineffective. At the time of publication of this preliminary report the Commission had not yet determined how long the hole had been in the alloy vent tube.
