Transport Accident  
Investigation  
Commission

# **Final report**

***Rail inquiry RO-2021-103***  
***Te Huia passenger service***  
***Train parting***  
***North Island Main Trunk line, Paerata***  
***19 July 2021***

**December 2022**

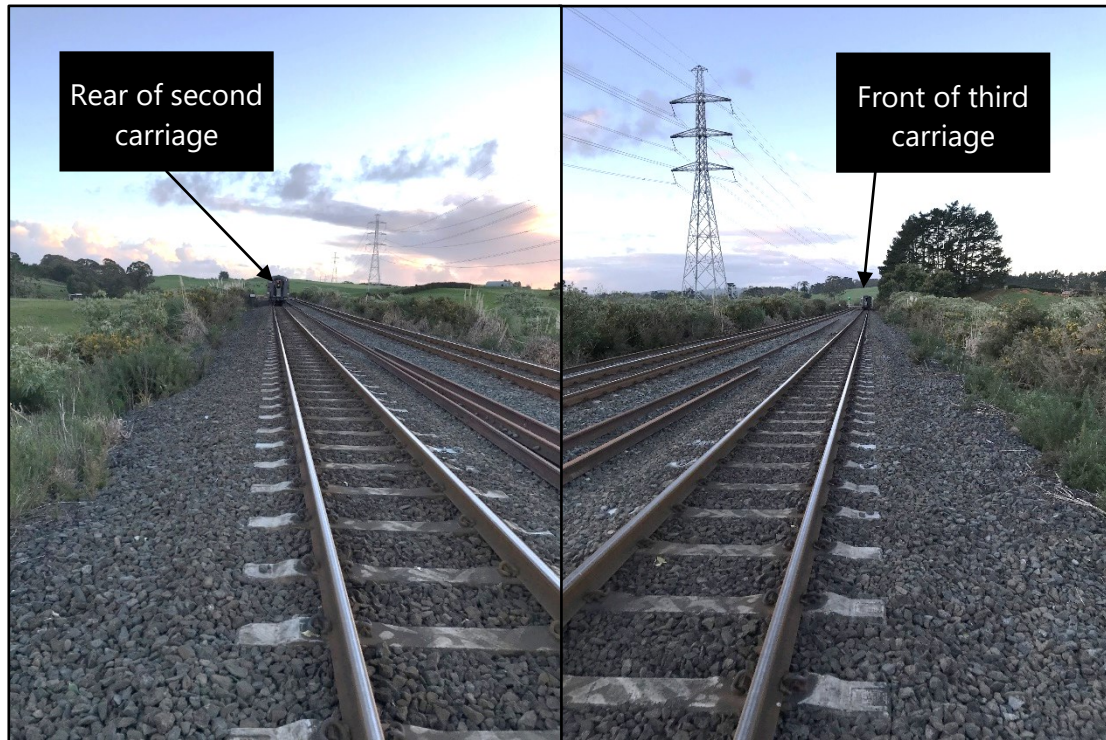
**Figure 4: Front and rear train portions after first parting**

- 2.16 Meanwhile the train attendant moved to the front of the third carriage and saw the train had parted. They immediately closed the carriage-end door and returned to the on-board café to call the train manager by mobile phone.
- 2.17 The train manager arrived at the rear of the second carriage at 1655:43 and saw that the train had parted. They immediately phoned the train attendant to confirm that all passengers in the rear portion were safe.
- 2.18 Permission from train control was requested and given for the train manager to go down to track level. They then walked along the track towards the rear portion, stopping part-way and taking the photographs presented as figure 4. Both photographs were taken from the same standing position, two seconds apart.

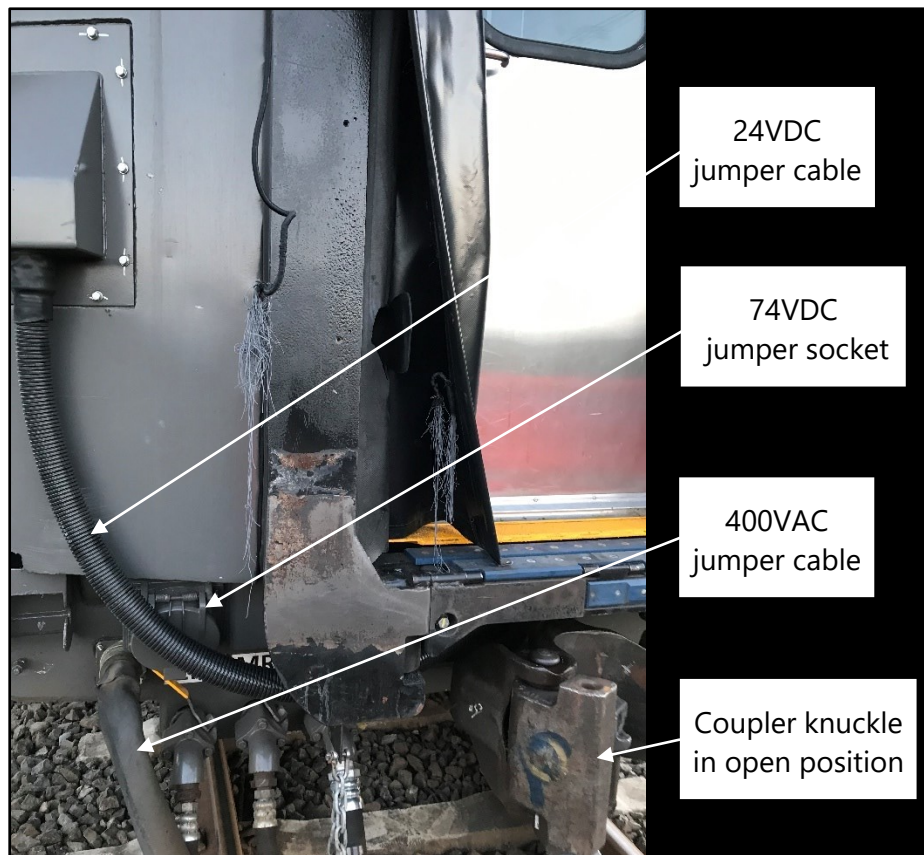
**Figure 5: Second carriage – rear end after first parting**

- 2.19 During their walk the train manager found the 27-pin 74VDC inter-carriage jumper cable<sup>10</sup> that had been between the second and third carriages and took it to the rear portion.
- 2.20 The train driver began reversing the locomotive at 1712:28, bringing the front portion back towards the rear portion by around 40 metres. They then left the locomotive cab and went to track level to meet the train manager, who had returned to the front portion.
- 2.21 At 1716:09, the train manager took a photograph of the second carriage's rear end, presented as figure 5, showing its coupler knuckle in the open position. It also shows the damaged 24VDC and 400VAC jumpers that are permanently affixed to the carriage and the socket receptacle for the 74VDC jumper.

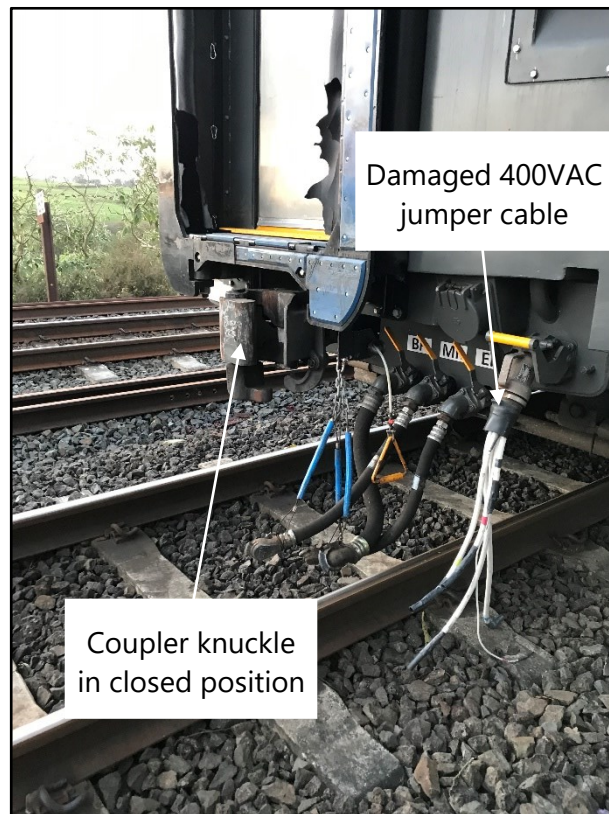
**Figure 6: Third carriage – front end after first parting**

- 2.22 The train driver returned to the locomotive and resumed reversing the front portion back to the rear portion's position. The train manager meanwhile walked back to the rear portion.
- 2.23 At 1719:50, the train manager took a photo of the third carriage's front end, presented as figure 6 and showing its coupler knuckle in the closed position. This also shows a portion of the damaged 400VAC jumper.

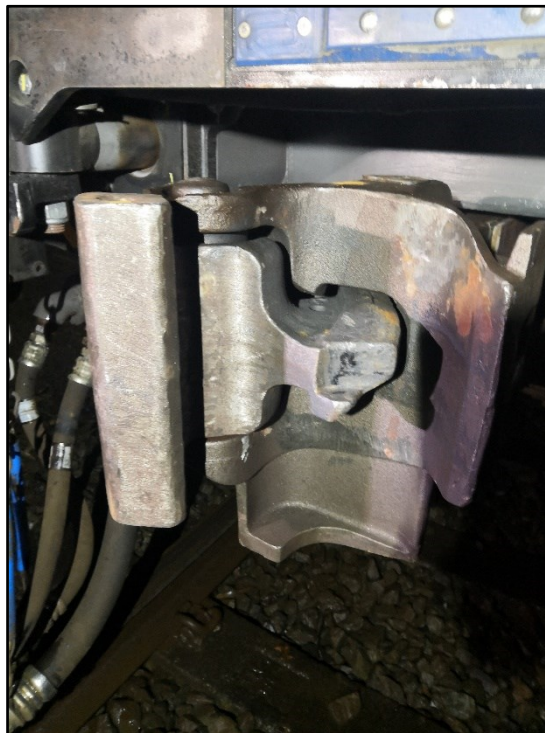
**Figure 8: Second carriage – the rear coupler in open position after second parting**

- 2.37 The mechanical manager left the front portion and went down to track level to inspect the train. They took photographs of the second carriage's coupler in its open position and the third carriage's coupler in its closed position, presented as figure 8 and figure 9.

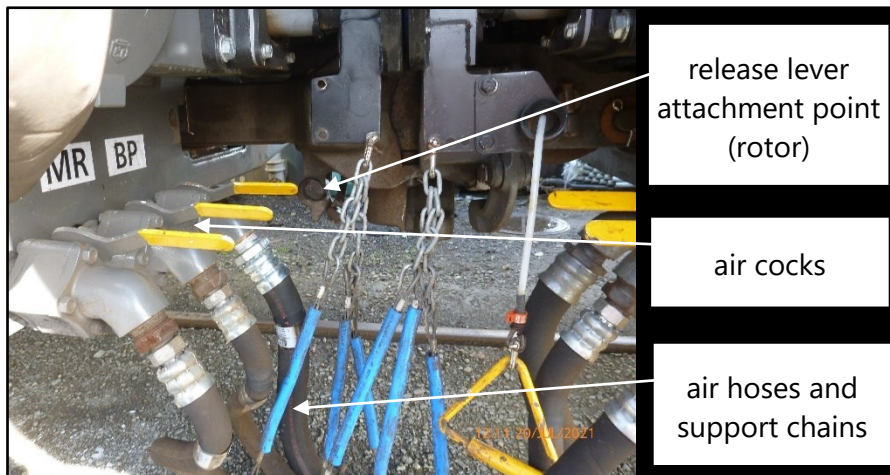
**Figure 13: A-P coupler without release lever – SR5801 No. 2 end**

- 2.59 Release levers, however, could not be fitted to No. 2 ends due to space constraints caused by inter-carriage air cocks and hoses on the B-side<sup>14</sup> of SRx carriages, as shown in Figure 13.

- 3.30 As described in paragraph 2.59, the incident coupler had not been fitted with a release lever, due to space constraints at the No. 2 end of SRx carriages. As part of its inquiry, the Commission has investigated the possible influence this omitted release lever had on the incident coupler's vulnerability to creep.
- 3.31 In a typical arrangement the release lever is supported at one end by the rotor. During creep the rotor is pulled around its axis of rotation and initially counteracted by the release lever's mass. At a certain point the release lever's centre of mass reaches a position directly above the rotor's centre of rotation (over-centre), and beyond this point the lever's mass acts to assist the creep force. Figure 28 shows this sequence, but it should be noted that loose clearances between mating parts provides a significant degree of freedom for all involved parts.

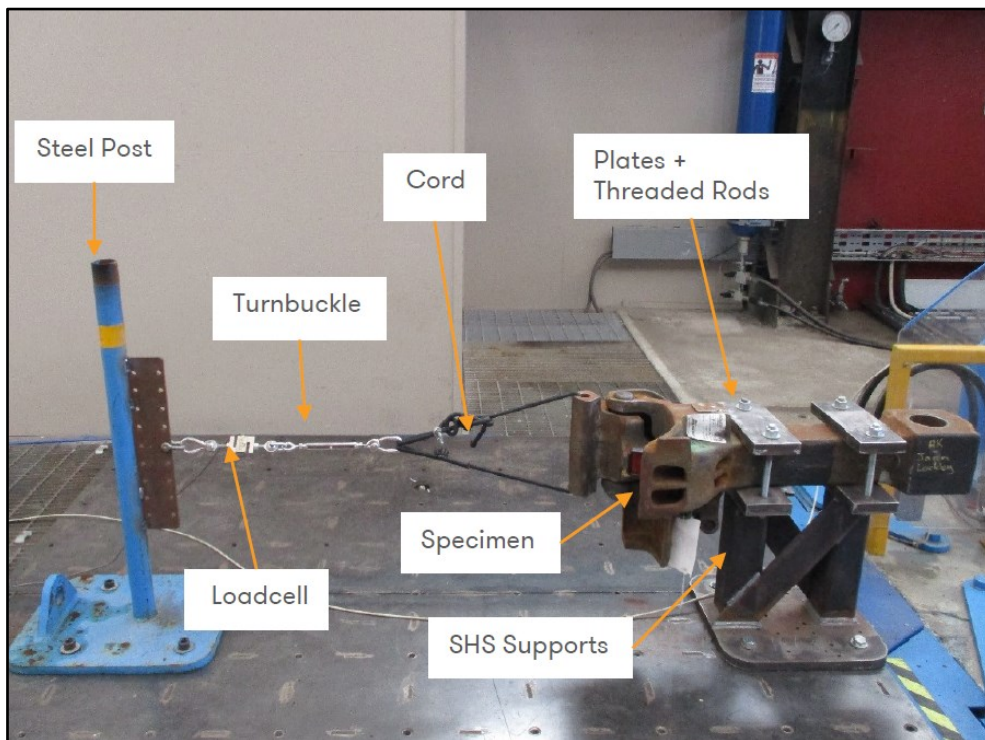
**Figure 22: Vertical shake-table test arrangement**

2.82 Following the incident, KiwiRail performed testing of an A-P coupler on a shake-table with the intent of recreating creep under controlled conditions. Commission investigators were present to witness this testing. The shake-table arrangement, shown in figure 22, included a turnbuckle to simulate draft loading on the coupler knuckle.

- 3.16 The vertical shake-table testing confirmed that an out-of-tolerance lock could fail under certain conditions, whereas the in-tolerance lock did not fail when subjected to the same and more rigorous conditions.
- 3.17 It was noted by Commission investigators that the testing involved only the A-P type coupler, and not the combination of A-P to Buckeye type couplers as was the condition present on the train at the time of the occurrence.
- 3.18 KiwiRail was asked about the significance of this and responded in part:

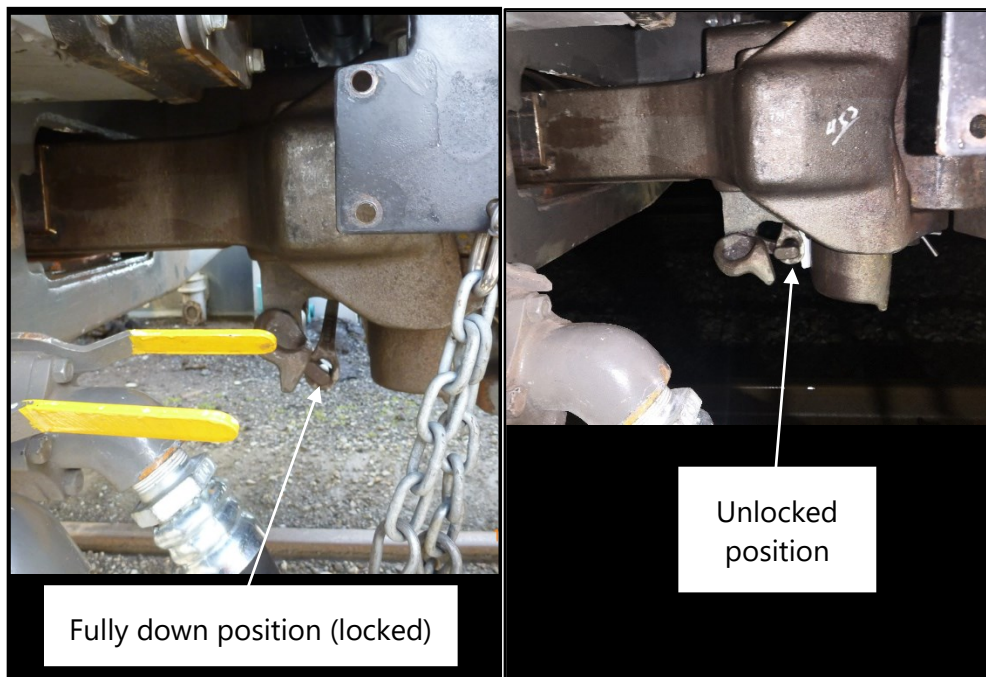
**Figure 23: Visual indication of locked and unlocked positions**

- 3.3 For the first train parting, both the train manager and train driver recalled the coupler at the rear of the train's front portion (No. 2 end of carriage SR5801) being found in its open position, and the coupler at the front of the train's rear portion (No. 1 end of carriage SRC3436) in its closed position.
- 3.4 Similarly, for the second parting, both the train manager and mechanical manager recalled couplers to be in the same state.
- 3.5 Coupling integrity for automatic knuckle couplers relies on the lock fully lowering to its locked position during coupling. A visual check is required by the person performing coupling, and in the case of the Amsted A-P coupler design this entails checking the locklift toggle is fully down and the rotor is turned fully down. This is shown in figure 23.

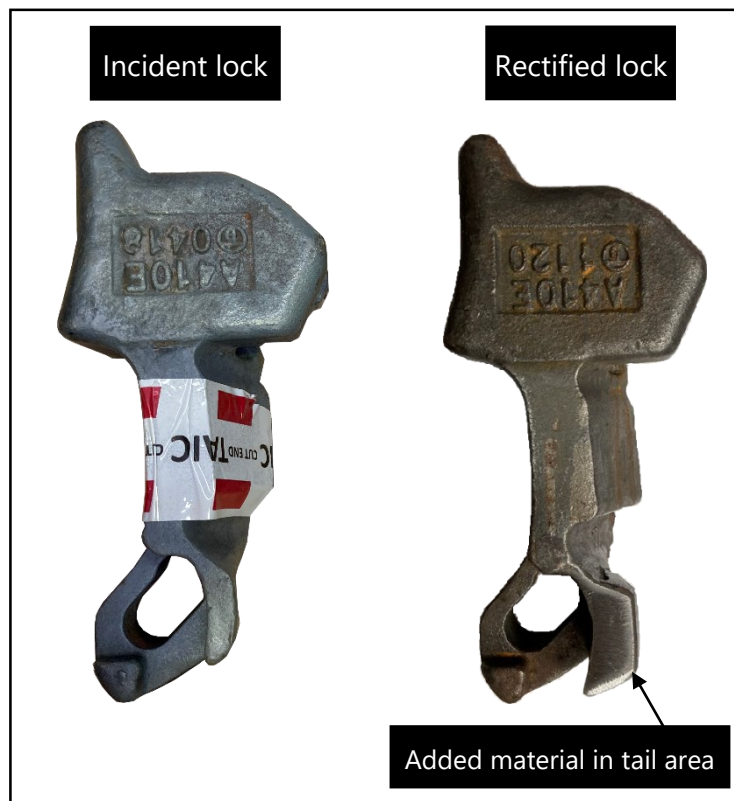
**Figure 24: Incident lock and lock modified to correct lacking material in tail area**

- 3.10 Amsted were also able to replicate failure of anti-creep testing with A-P couplers in their own stock.
- 3.11 Amsted's investigation found that a lack of material in the lock's tail portion was responsible for failing anti-creep. Figure 24 shows this lack of material, comparing the incident lock to a lock that was rectified by welding and then grinding the tail area to its design dimensions.

- 3.35 The Commission **found** this lack of material to be a result of out-of-tolerance tooling used in the lock's sand-casting process. This casting was performed by a sub-supplier, who Amsted had used to produce A-P coupler locks since 2014.

- 3.36 Initial functional checks performed in 2014 on assembled couplers with newly-sourced locks confirmed proper anti-creep operation. However, Amsted's investigation found that locks cast as early as 2017 were lacking material in the tail area, so concluded tooling wear in the period 2014 to 2017 caused the issue.

- 3.9 KiwiRail tested the three other trial Amsted A-P couplers for SRx carriages and found them to be similarly failing. Post-incident, KiwiRail removed these couplers from carriages and replaced them with Buckeye drophead couplers.

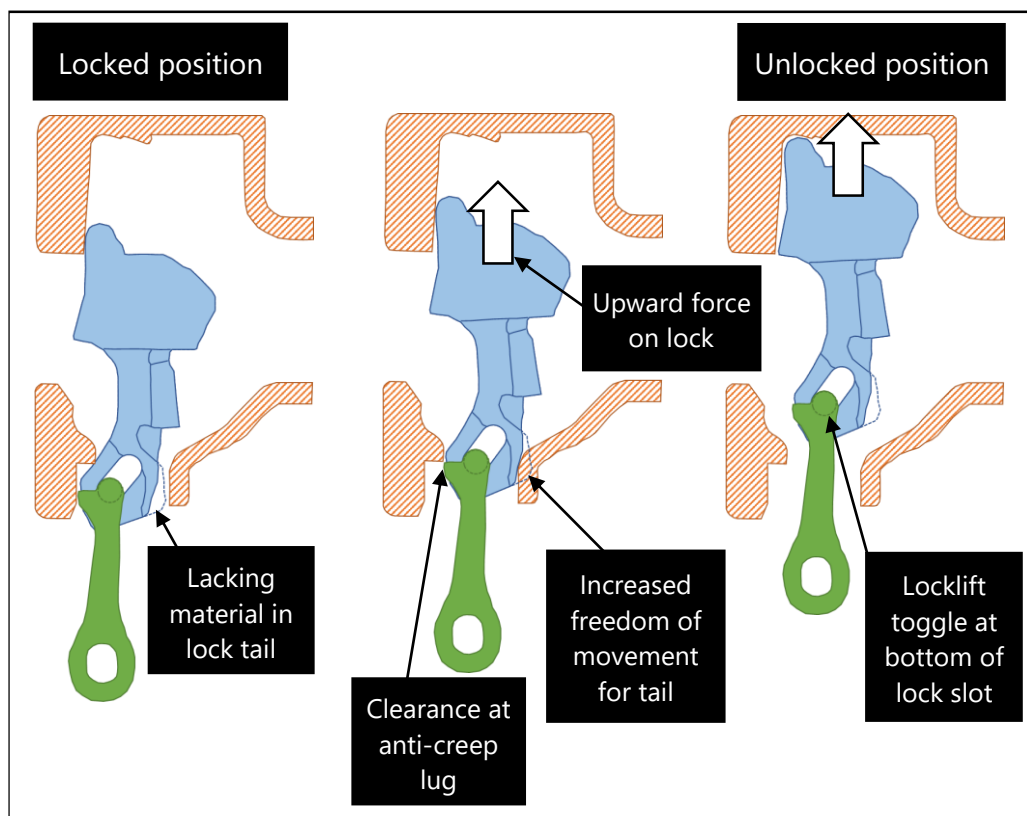
**Figure 25: Lack of material in lock tail and effect on anti-creep protection**

- 3.12 This lack of material in the lock tail area meant the mechanism had greater freedom to shift backwards before contacting the coupler body and could then clear the anti-creep lug. Figure 25 shows how this allowed the lock to move fully upwards into its unlocked position, despite the locklift toggle remaining at the bottom of the lock's slot throughout.

- 3.13 Commission investigators confirmed this finding by performing a functional anti-creep check on the incident coupler, as shown in figure 17. The incident coupler with the incident lock (figure 24, left) fitted was found to consistently fail the test. The incident coupler with a rectified lock (figure 24, right) fitted was found to consistently pass the test. All other coupler components in both test configurations were from the incident coupler, with only the lock being changed.
- 3.14 Vertical shake-table testing, as described in paragraphs 2.82 to 2.84, using an out-of-tolerance lock similar to the incident coupler's lock, was able to replicate creep to the point of knuckle opening in four of 12 tests as shown in the Table 1.

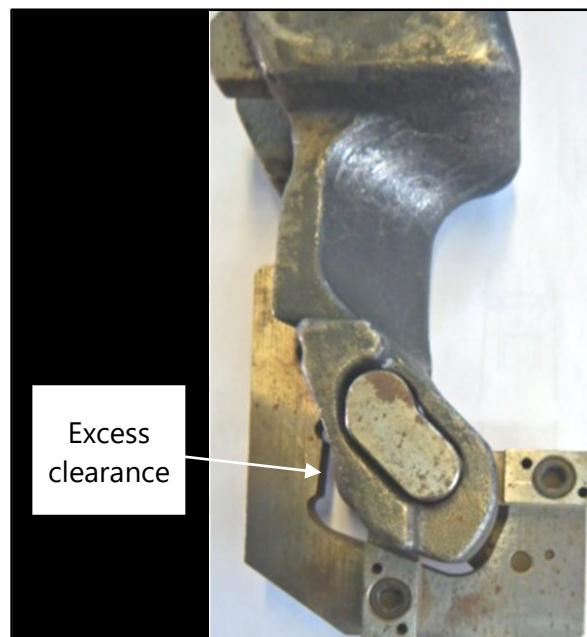
**Figure 29: Go gauge applied to out-of-tolerance lock**

- 3.39 Production checks (ie, checks performed on each lock after it is cast), undertaken by Amsted's lock sub-supplier included application of the go gauge.
- 3.40 Go gauges inspect the maximum material condition<sup>22</sup> of a part by checking whether the gauge and the part 'go' together. If a part is too big, then it will not fit the gauge and thus fails the check.
- 3.41 Production checks did not inspect parts for least material condition,<sup>23</sup> (ie, whether the part was too small). Instead, this was only checked for the first lock using shims<sup>24</sup> in conjunction with the go gauge.
- 3.42 Figure 29 shows a photo of an out-of-tolerance lock, similar to the incident lock, with the go gauge applied. Excess clearance between the gauge and the rear of the tail area is indicated.
