Transport Accident
Investigation
Commission

Final report

Rail inquiry RO-2021-105
Unintended movement resulting in locomotive
and wagon entering Picton Harbour
Picton
1 September 2021

June 2023

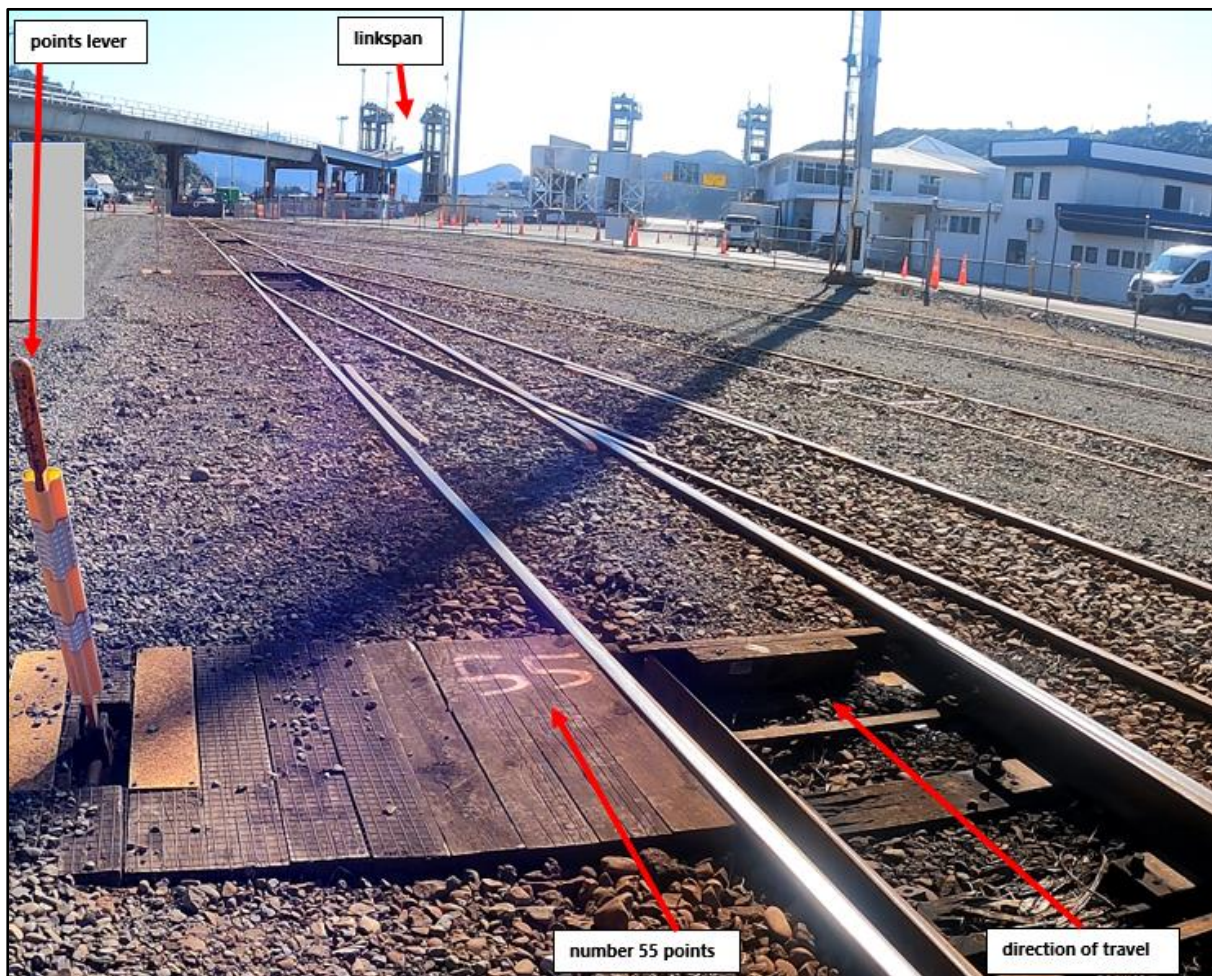
Figure 5: Number 55 points at Picton rail yard

- 2.18 When the RCO stopped the shunt locomotive to set number 55 points manually, they started walking towards the points, but it became apparent that the head wagon was fouling¹⁰ them. For the RCO to clear the fouled points, the head wagon needed to be moved approximately 30 centimetres north, towards the rail linkspan (see Figure 5).

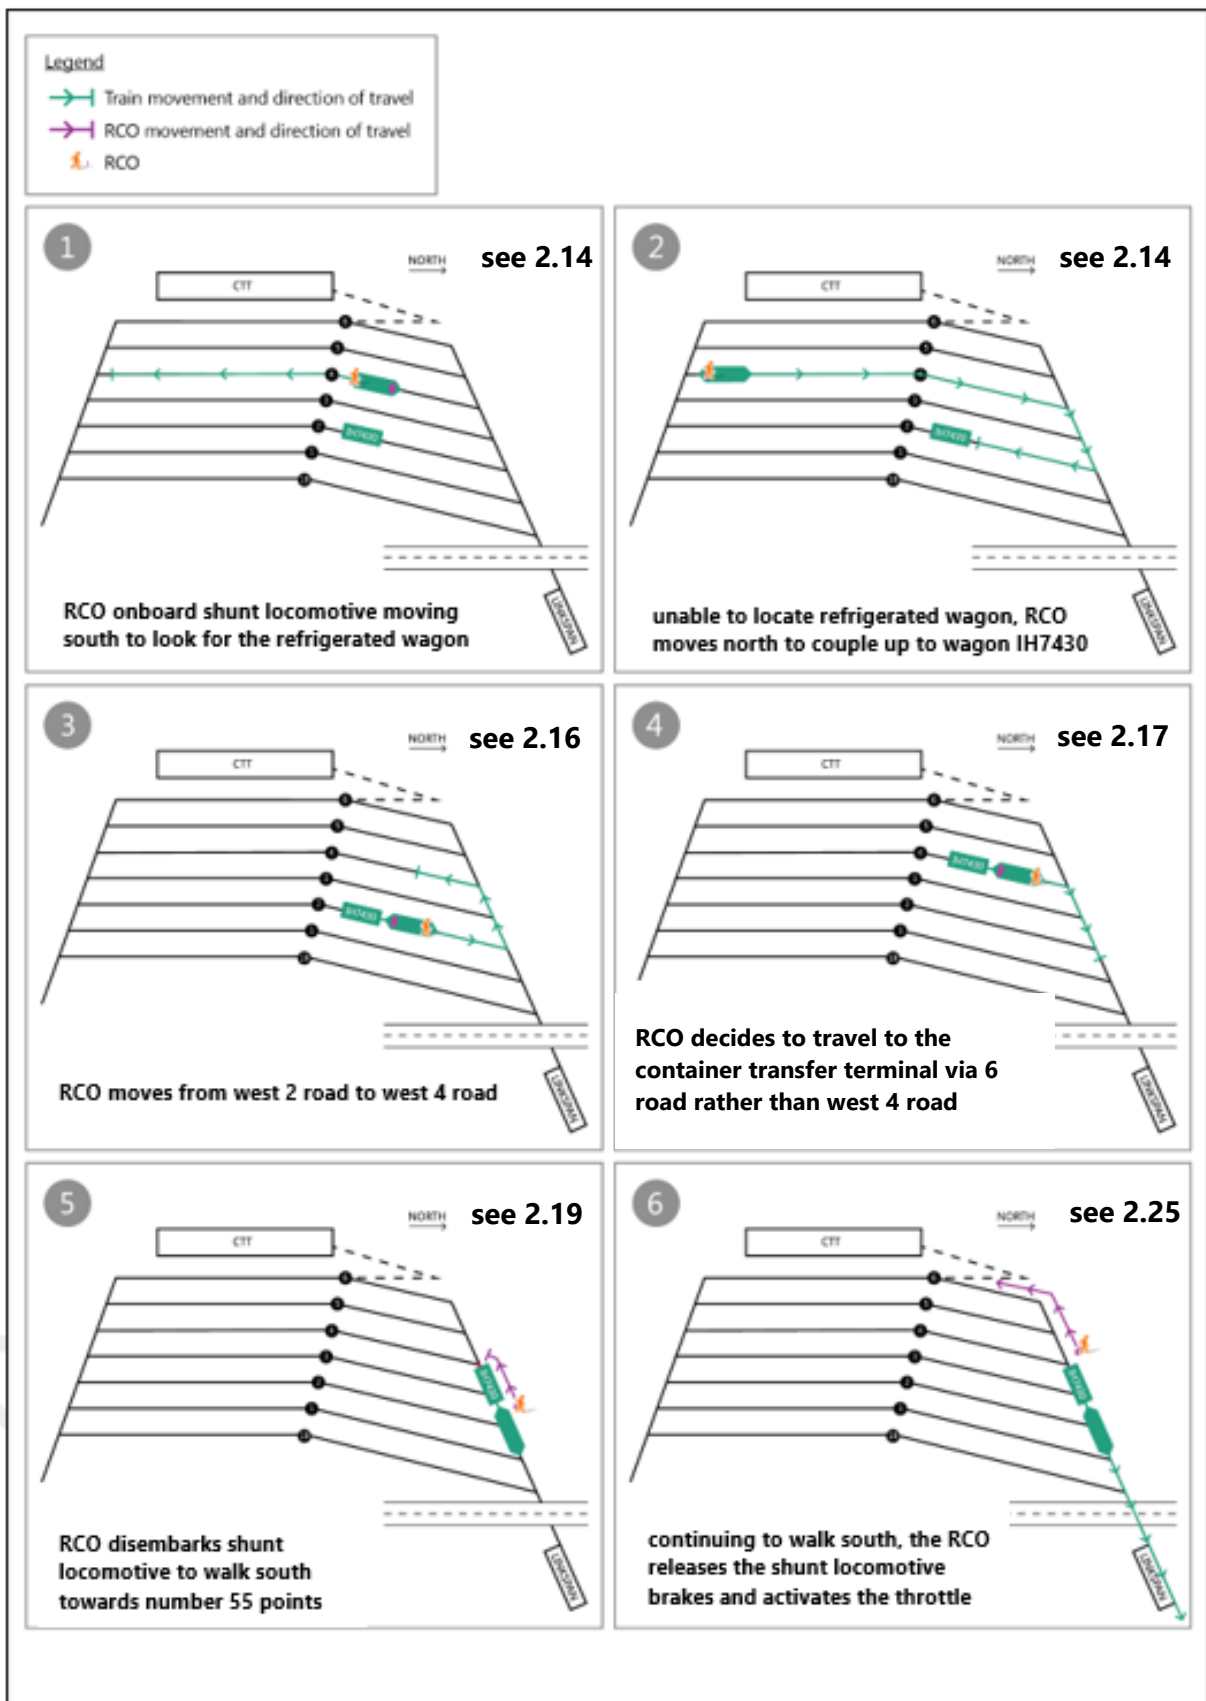
Figure 7: Timeline of events

- 2.14 The RCO positioned themselves on board the shunt locomotive and commenced moving it along west 4 road adjacent to Train 736. Unable to locate the refrigerated wagon, the RCO stopped the shunt locomotive before reversing north to locate the head wagon⁷, IH7430, instead. The head wagon was on west 2 road and was carrying two empty hazardous goods containers and needed to be taken to the container transfer terminal (CTT)⁸ (see Figure 7, pictures 1–2).

- 2.16 Initially the RCO was going to take the head wagon from west 2 road to the CTT along west 4 road, but after entering west 4 road the RCO stopped the shunt locomotive and decided it would be quicker to move to the CTT along west 6 road (see Figure 7, picture 3).

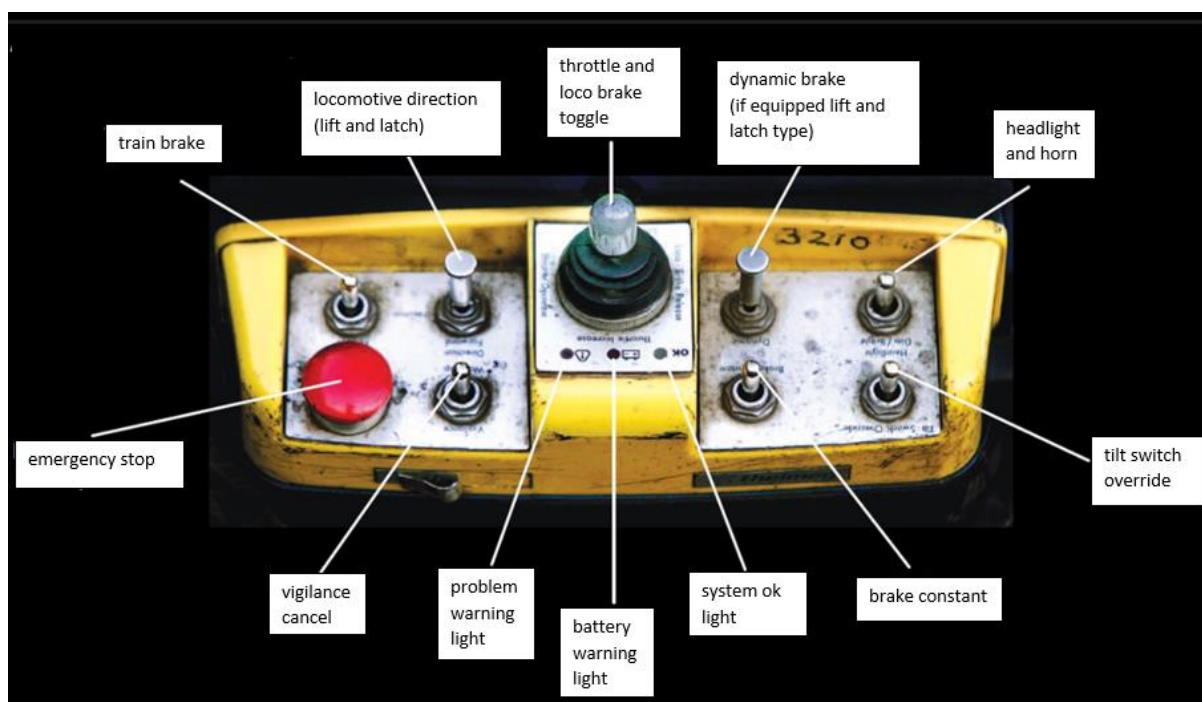
Figure 8: Arataki 1 remote-control pack layout

- 2.34 An image of the Arataki 1 remote-control pack can be seen in Figure 8. It is fitted with a vigilance system that, when turned on, sounds an audible alarm if there is no controller activity for 27 ± 1 seconds. After 34 seconds it initiates emergency braking.
- 2.35 The red mushroom emergency stop button is located on the display panel, at the right-hand side when in the harness. When the emergency stop button is pressed, the throttle returns to idle and the emergency braking is applied.

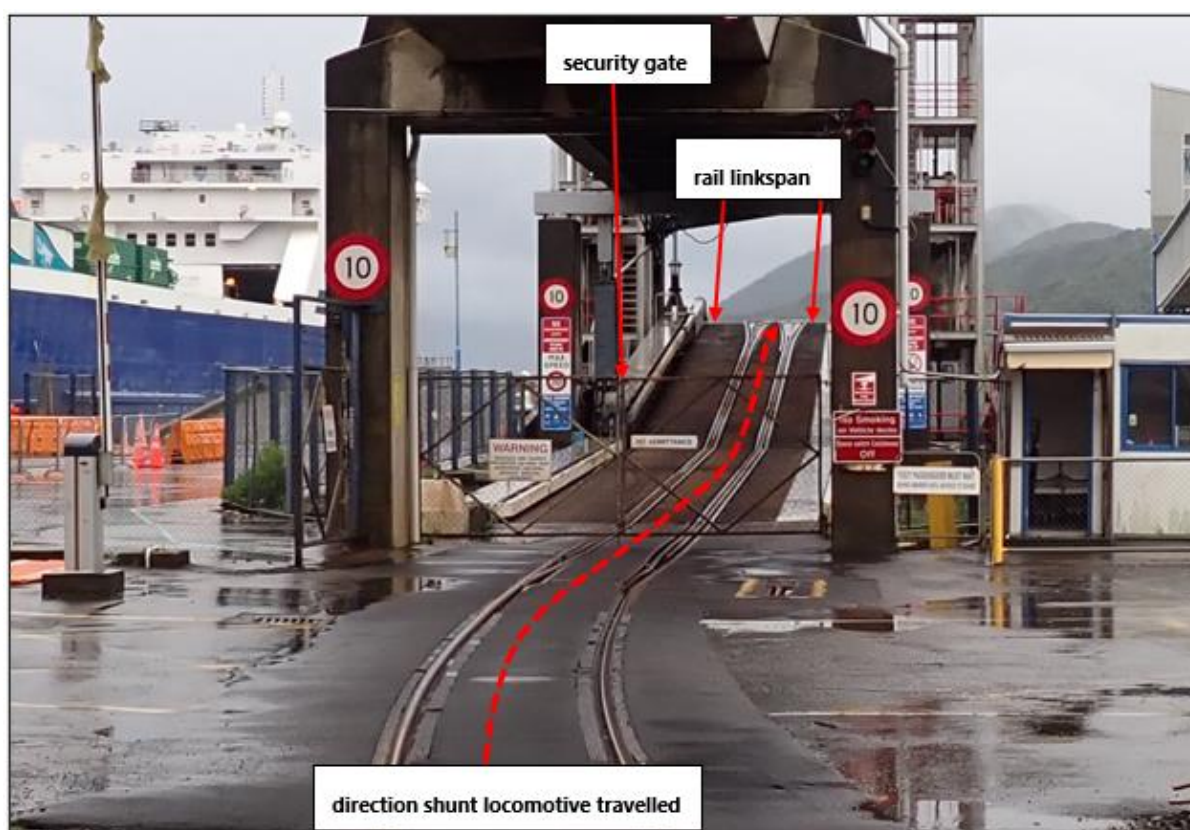
Figure 9: Picton rail linkspan

- 2.40 Due to a quick response from Port Marlborough, including from the oil spill response team who surrounded the site with spill-containment equipment and absorbent booms¹⁴, the impacts on the environment were kept to a minimum.
- 2.41 The 52-tonne locomotive and the wagon were recovered using two 300-tonne cranes. The salvage operation took three days and cost in excess of \$500,000.
- 2.42 Additionally, the weight of the locomotive travelling along the unsupported rail linkspan caused the rail linkspan to collapse and drop into the water. This in turn caused extensive damage to the rail linkspan.

- 2.61 The rail linkspan was designed to connect the rail ferry *Aratere* to the rail line at the Picton ferry terminal and facilitate the discharge and loading of rail vehicles.
- 2.62 As the rail linkspan is lowered, it locates a central pin into an eye on the stern of the vessel. This ensures that the rail tracks inside the vessel are lined up correctly with the rail tracks on the rail linkspan.
- 2.63 The rail linkspan is attached to large concrete weights by cables and pulleys on each side that allow it to be raised and lowered in a controlled manner. When it is not in use, the rail linkspan is held safely on wires and counterweights.
- 2.64 The rail linkspan is maintained by Port Marlborough.
- 2.65 The security gate was designed to restrict entry to the rail linkspan when it was not in use. The security gate was open at the time of the incident.

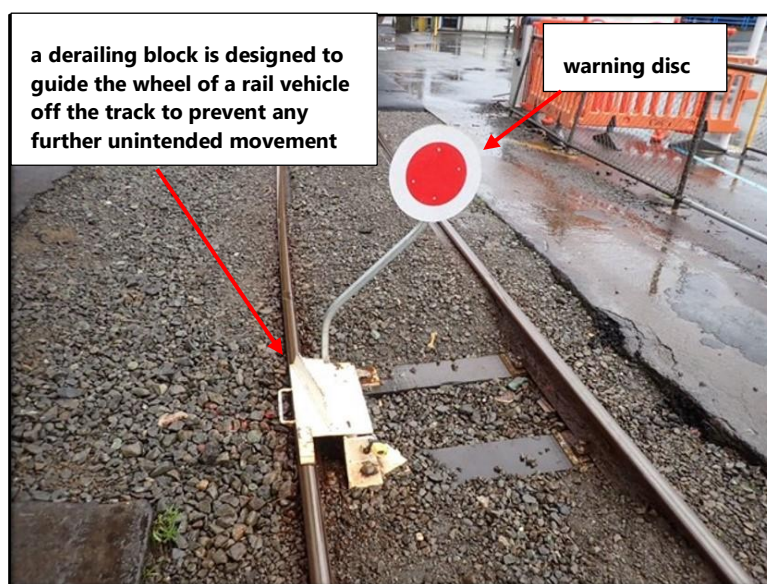
Figure 10: Derailing block fitted at Picton post-incident

- 3.44 The Commission found that there were no engineering protections in place for the rail linkspan and any Port Marlborough staff who may have been in the vicinity of the linkspan at the time of the incident.

- 3.45 Since the incident, a derailing block (see Figure 10) has been fitted to provide limited engineering protection against unintended movements entering the rail linkspan. Derailing blocks have limited effectiveness as they do not always work as intended and are reliant on rail personnel placing them in either the on or the off position.

- 3.46 The Commission welcomes the actions taken to provide protection for the rail linkspan. However, further engineering control measures would provide an enhanced level of protection for workers, and therefore the Commission has made a recommendation in Section 6 of the report to address this safety issue.

- 6.4 **On 26 April 2023, the Commission recommended that KiwiRail install a more effective engineering solution to prevent rail movements entering the Picton rail linkspan without authorisation. (005/23)**

In line with KiwiRail's response of 22 February 2023 to the draft recommendation, as part of the IREX project a preferred option has been identified for a series of automatic derailleurs that will be interlocked with the linkspan structure.
