Transport Accident
Investigation
Commission

Final report

Rail inquiry RO-2022-104
L1 shunt train and heavy goods vehicle
Level crossing collision and derailment
Whangārei
7 December 2022

March 2024

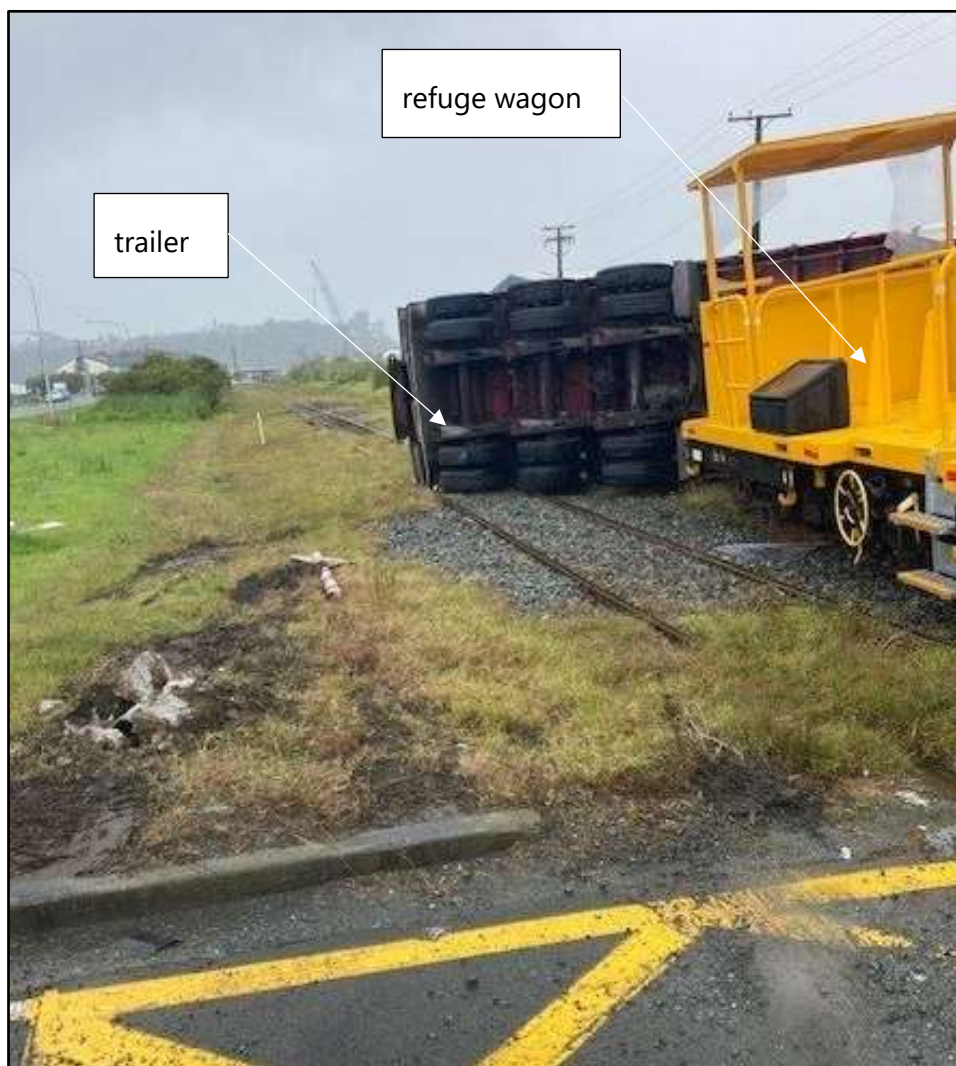
Figure 6: Truck trailer and refuge wagon after the collision

- 2.27. The train's momentum caused it to continue moving for another 16 metres (m) along the track as the refuge wagon derailed and the truck's trailer tipped over on its side (see Figures 6 and 7). At 1435:33 the train stopped.

- 2.28. Staff from a nearby business attended to the RO and called for emergency services. The RO was the only person injured; they suffered a broken collar bone and sprained wrist. The truck's trailer was extensively damaged, and the damage to the refuge wagon comprised a broken airline, damage to the protected area and a broken window.

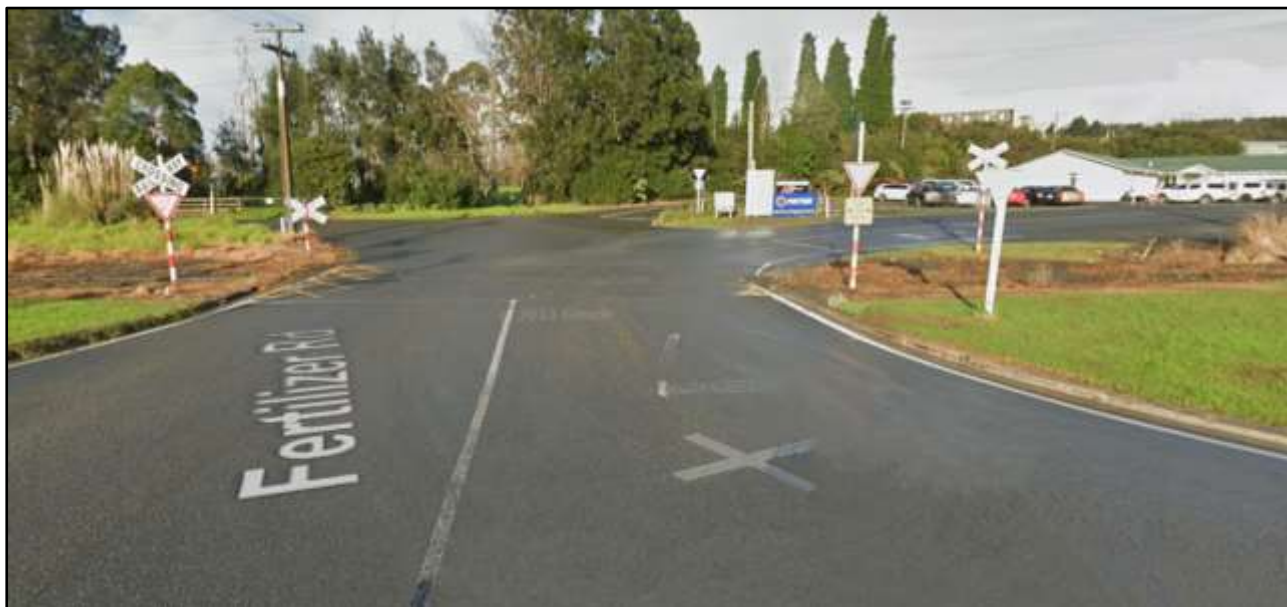
Figure 8: The Fertilizer Road level crossing

always look for trains and check that the tracks were clear of trains before crossing.³¹ There were no advance warning signs to assist road user awareness as they approached the level crossing from either direction on Port Road. Signage requirements are discussed in Section 3 of this report (see paragraph 3.26).

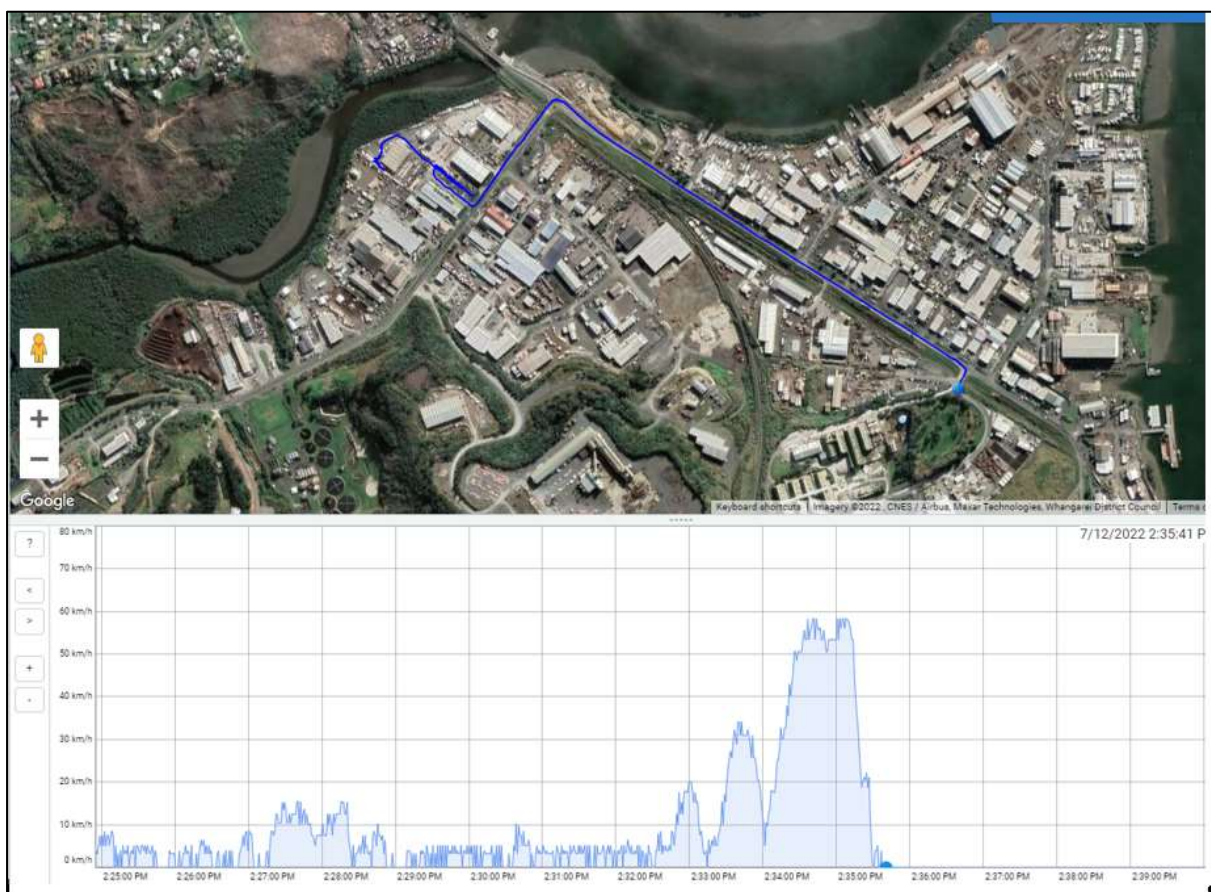
Figure 9: Tracked route and speed of the truck from Whangārei ITM to Fertilizer Road

- 3.8. Satellite tracking data showed that the driver did not stop and give way to the approaching train (see Figure 9). Information provided by the driver during the investigation supported this and it is considered **virtually certain** that the driver did not see the train, or expect to see a train, at the Fertilizer Road level crossing. The driver initially stated that they had seen the train while passing an earlier level crossing just after they had left Whangārei ITM. However, due to the position of the locomotive at the rear of the train, it is possible that the driver thought it was travelling in the opposite direction to the truck.

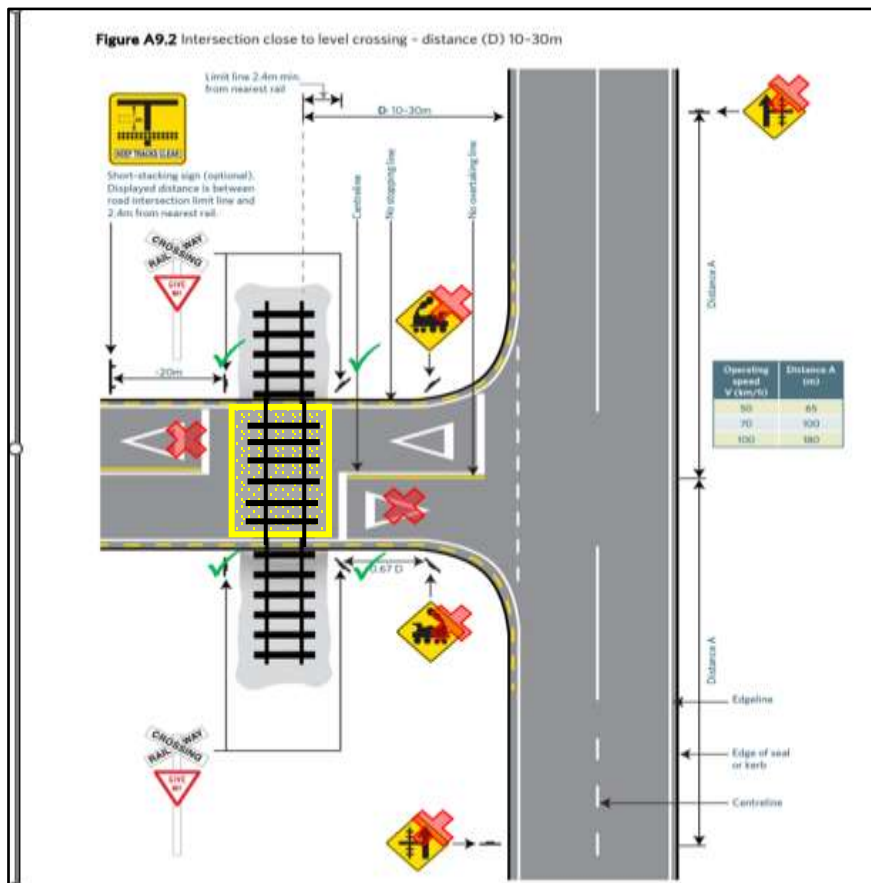
Figure 10: Figure from the TCD Manual Part 9 showing level crossing similar to Fertilizer Road, modified by TAIC (see paragraph 3.26)

- 3.26. When the signage and traffic control devices installed at the Fertilizer Road level crossing are considered in relation to those that may be expected by close adherence to the TCD Manual Part 9, it is apparent that there could be more effective protection at this level crossing. Figure 10 shows an intersection and level crossing layout similar to that where Fertilizer Road meets Port Road. The Fertilizer Road intersection is more complex than that illustrated, as three roads converge into a single access to and from Port Road. The green ticks indicate the give-way signs, with attached crossbuck signs, that were installed but not angled towards the traffic approaching from up and down Port Road. The red crosses indicate signage that should have been installed to warn drivers of the upcoming level crossing, but were not present at the time of the accident.
