Transport Accident
Investigation
Commission

Final report

Rail inquiry RO-2023-103
Safe-working irregularity
3.85 km mark Johnsonville line – tunnel 5
04 May 2023

March 2024

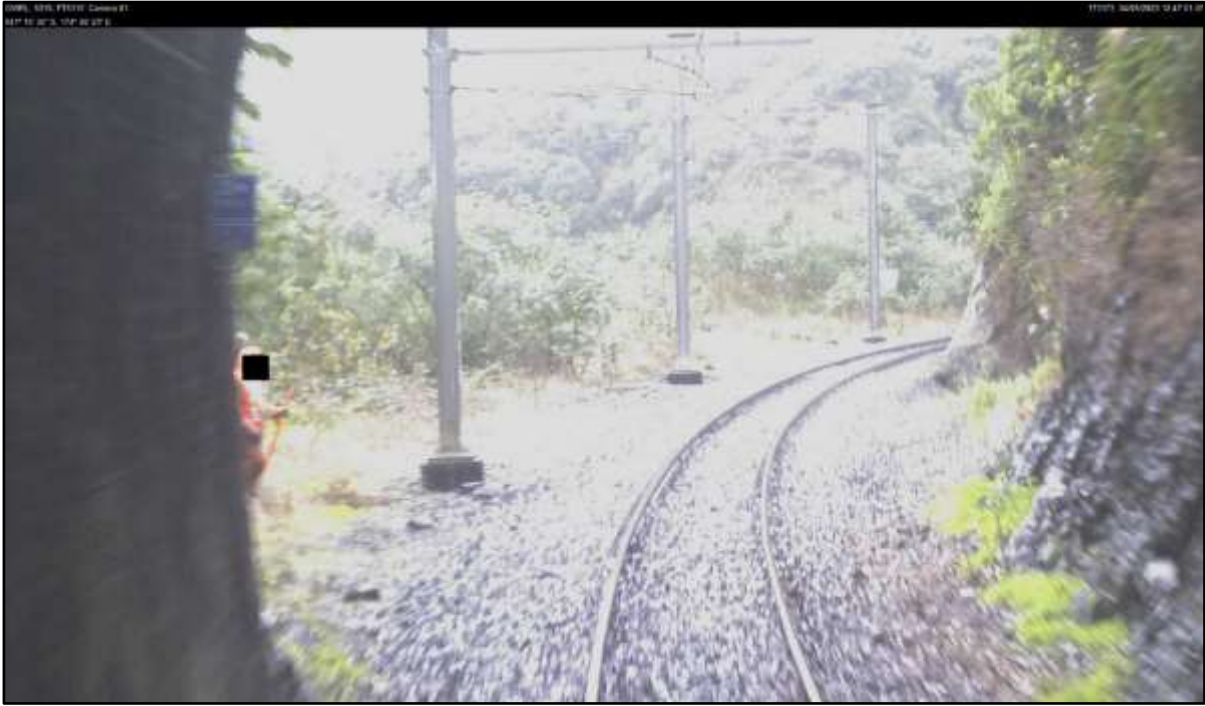
Figure 1: CCTV showing track workers coming into view as train exits tunnel 5
(Credit: Transdev, modified for anonymity by TAIC)

- 1.5. The two track workers were nearing the southern portal⁶ of the tunnel when they became aware of the Transdev passenger train entering the tunnel from the northern end. The track workers were able to exit the tunnel and move to a safe position before the train reached the southern portal.

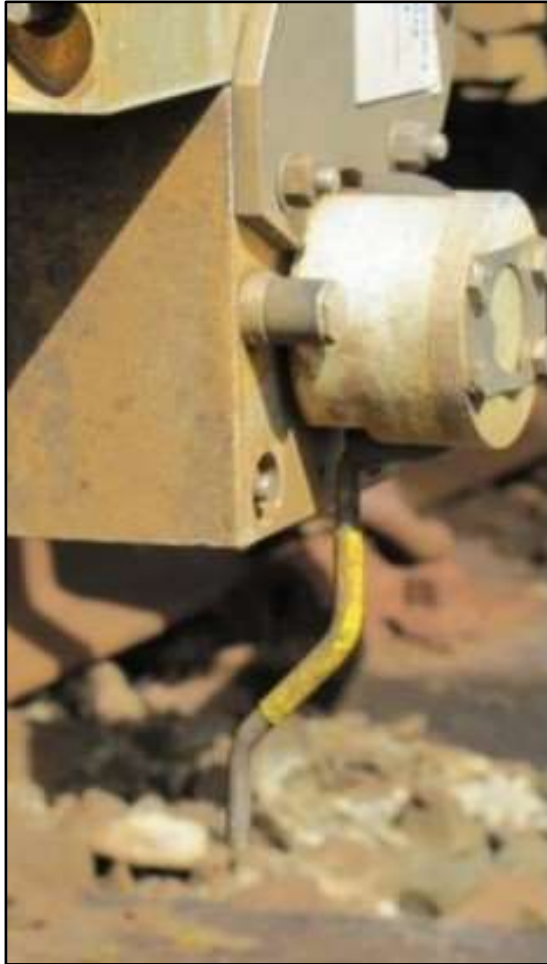
2.13. At 0538 the driver of the first northbound JVL Transdev passenger train of the morning contacted train control to advise that a train stop trip (TST)¹⁰ (see Figure 3) had been activated between tunnels 4 and 5 and gave the location as “south of tunnel 5”.

Figure 3: Train stop trip lever fitted to Transdev passenger trains

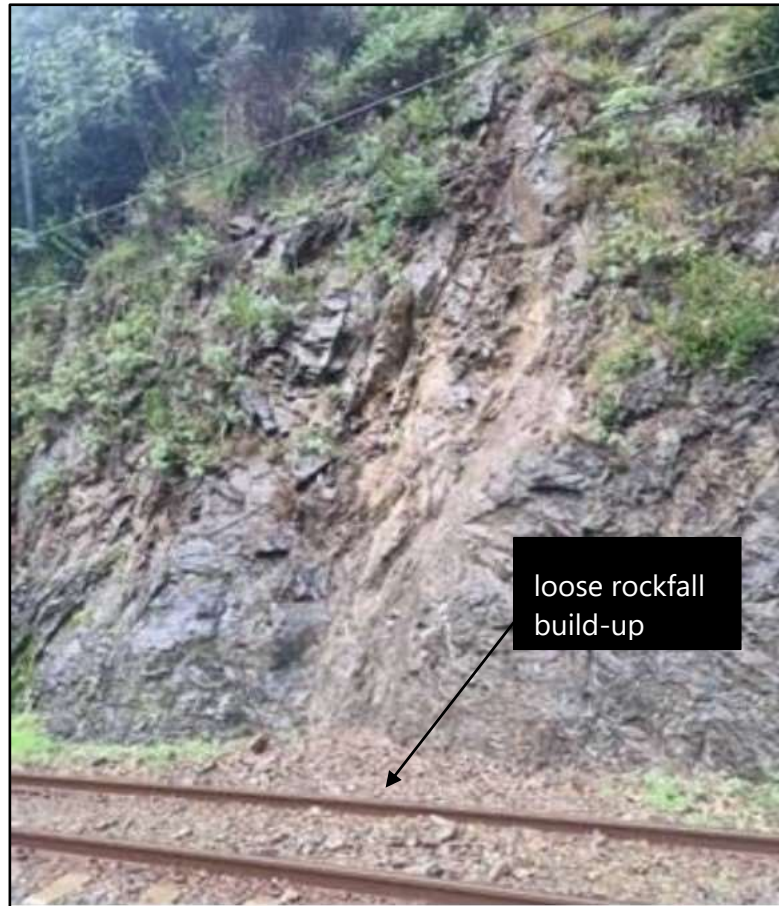
2.14. The TST location south of tunnel 5 corresponded with a build-up of loose rockfall at the 3.567km mark (see Figure 4).

Figure 4: Rockfall site at the 3.567 km mark

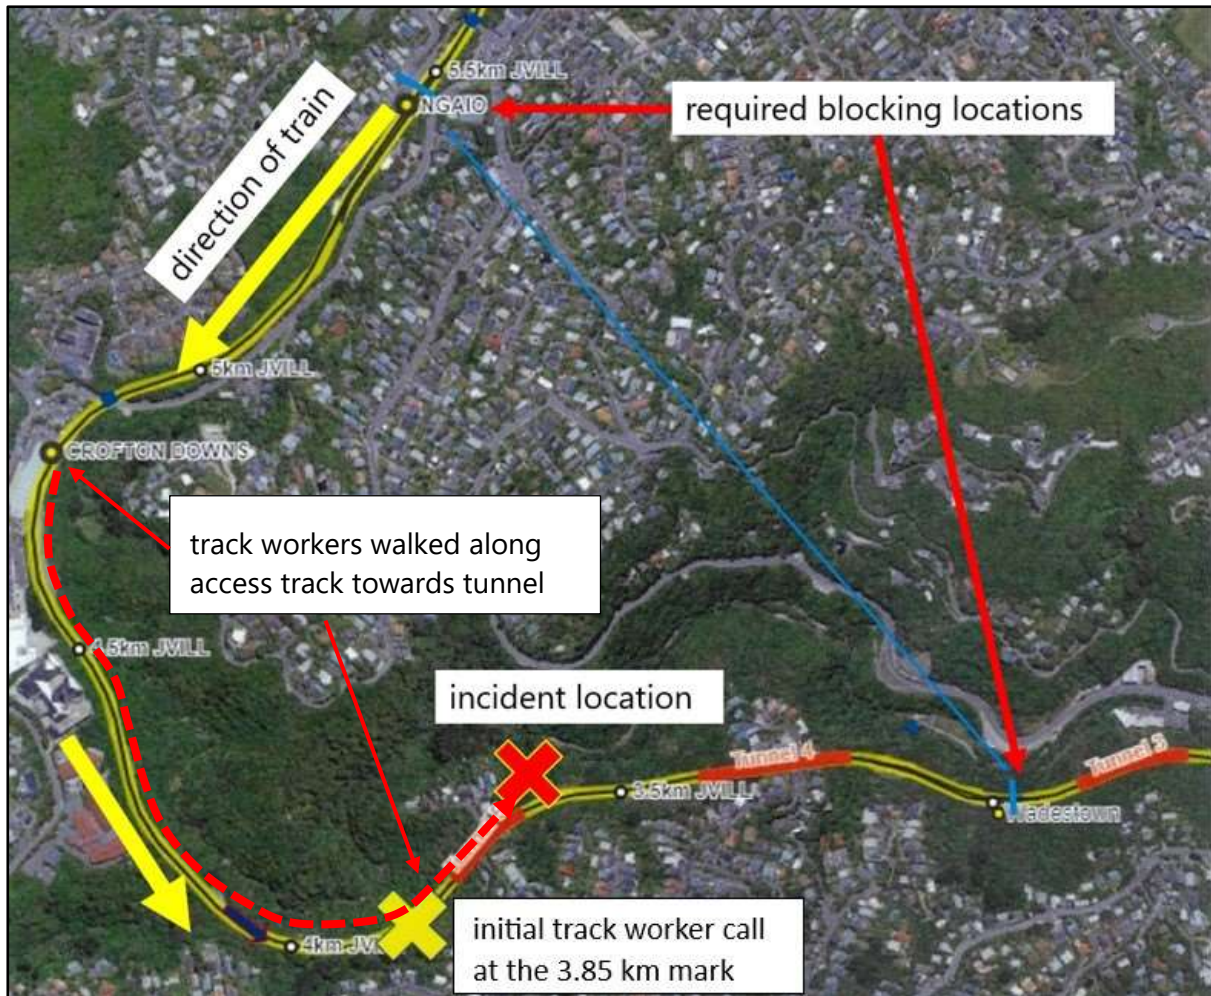
- 2.15. The TC recorded the TST activation by marking "Trip #5 tunnel sth" on the train control diagram at the same location that the slip alarm was activated the previous day, although the two alarms were in fact activated at different locations – the slip alarm at the 2.44 km mark between Wellington and Wadestown, and the TST alarm at the 3.567 km mark between Wadestown and Crofton Downs (see Figure 5).

Figure 5: Incident map

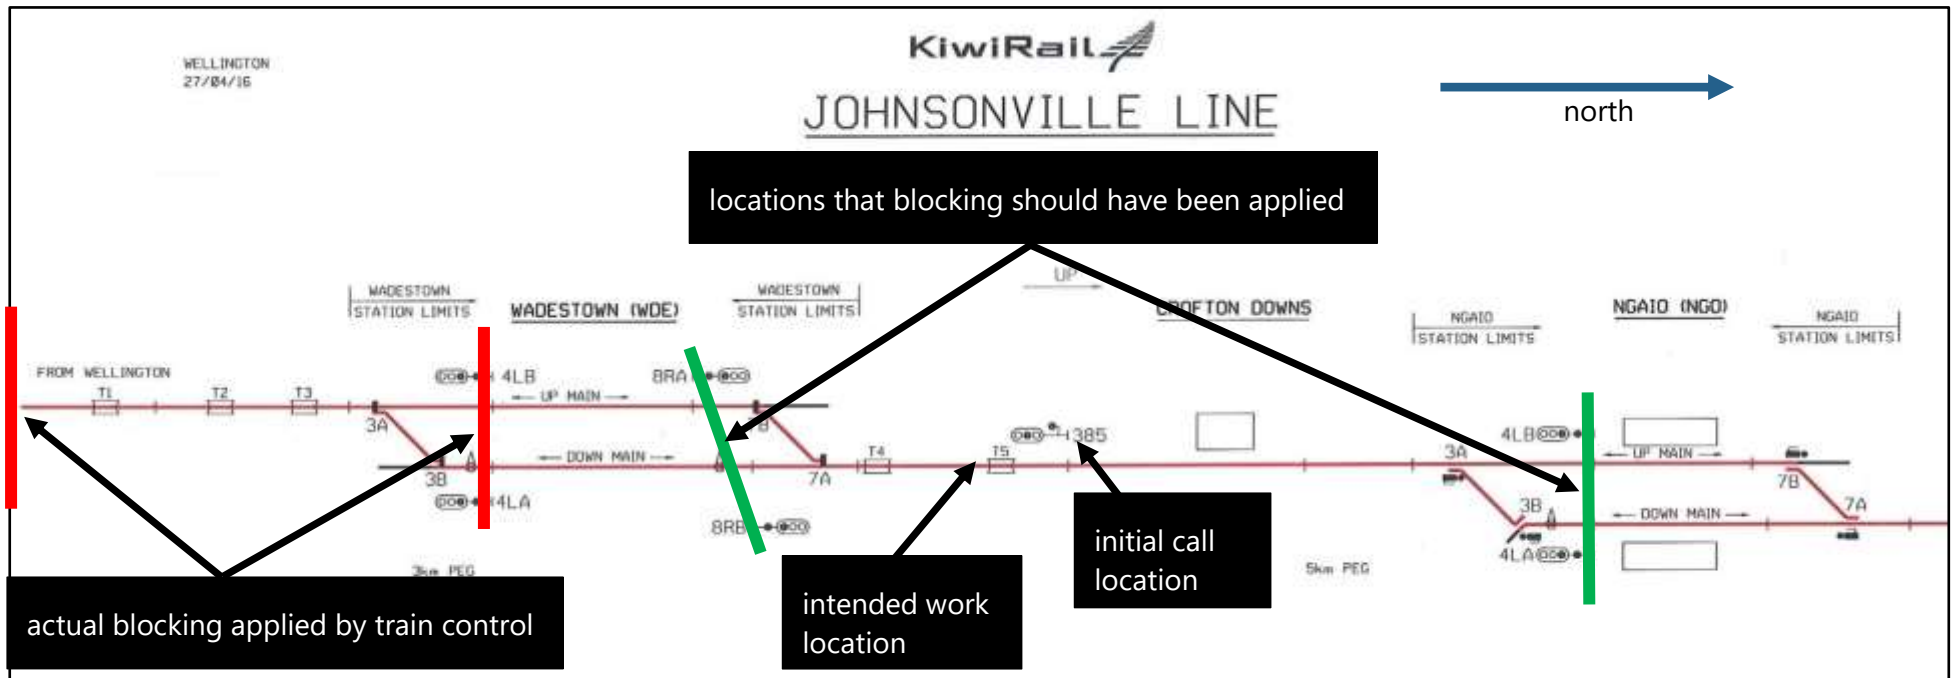
- 2.30. TW1 gave the TC the location as being at the 3.85 km mark, north of tunnel 5. This location was between Wadestown and Crofton Downs (see Figure 6).

Figure 6: Signals and Interlocking diagram (simplified and not to scale) of incident
 (Credit: KiwiRail, modified by TAIC)

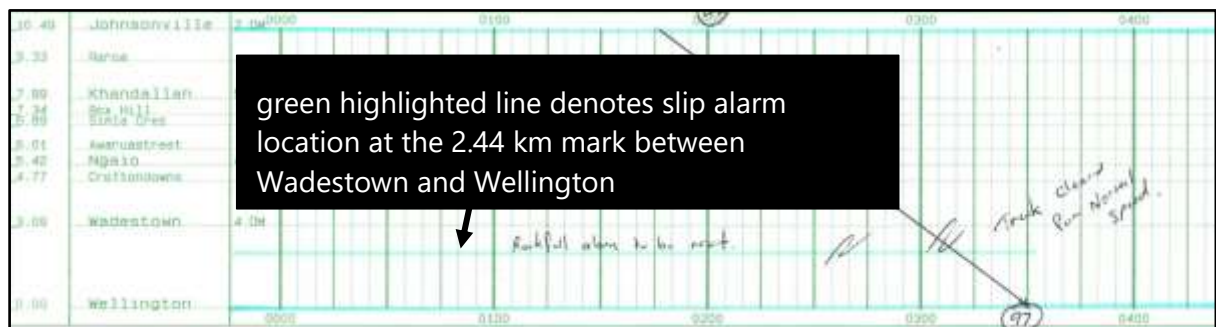
- 3.8. During the day before the incident a slip alarm had been activated at the 2.44 km mark between Wellington and Wadestown. The night-shift train controller annotated this alarm activation in green highlighter on the diagram (see Figure 8) and ruled a line from midnight until 0330. When at 0330 confirmation was received that the alarm had been reset, the night-shift train controller further annotated the diagram by crossing out the green highlighted line with black pen and writing "Track Cleared for Normal Speed", to denote that the alarm condition was no longer present.

Figure 6: Section of diagram showing the slip alarm location

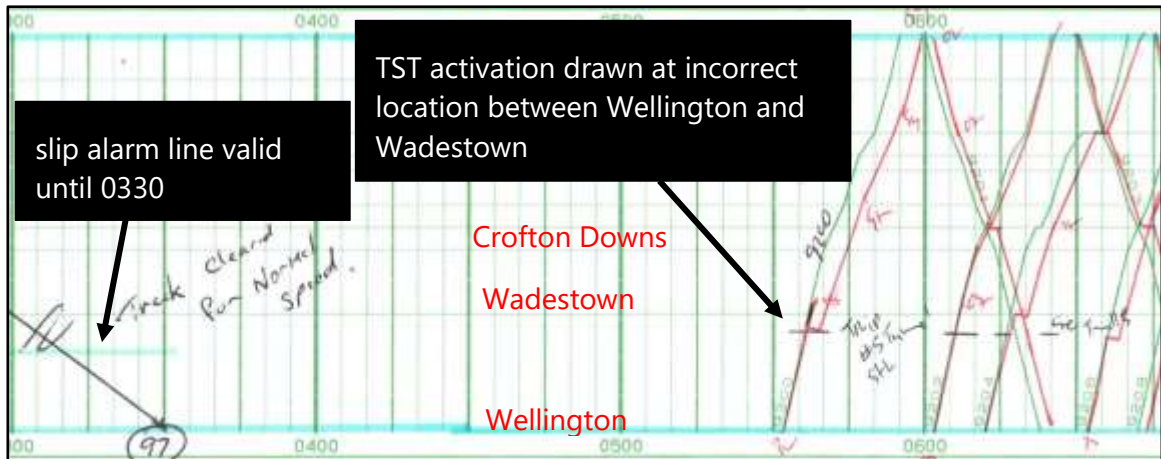
- 3.9. The TC started their shift at 0530 and was made aware during handover of the annotations on the diagram and the previous alarm activation. At that time of the morning there was little other information on the diagram as trains had not yet started running on the JVL. The TC was effectively looking at a blank diagram, except for the alarm activation and reset annotations at the 2.44 km mark.
- 3.10. Minutes after the TC started their shift, the first JVL train departed Wellington heading towards Johnsonville. At about 0538 the train driver called the TC by radio to inform them that the train had stopped due to a TST activation south of tunnel 5 (see Figure 9).

Figure 7: Diagram annotation showing the first TST activation at 0538

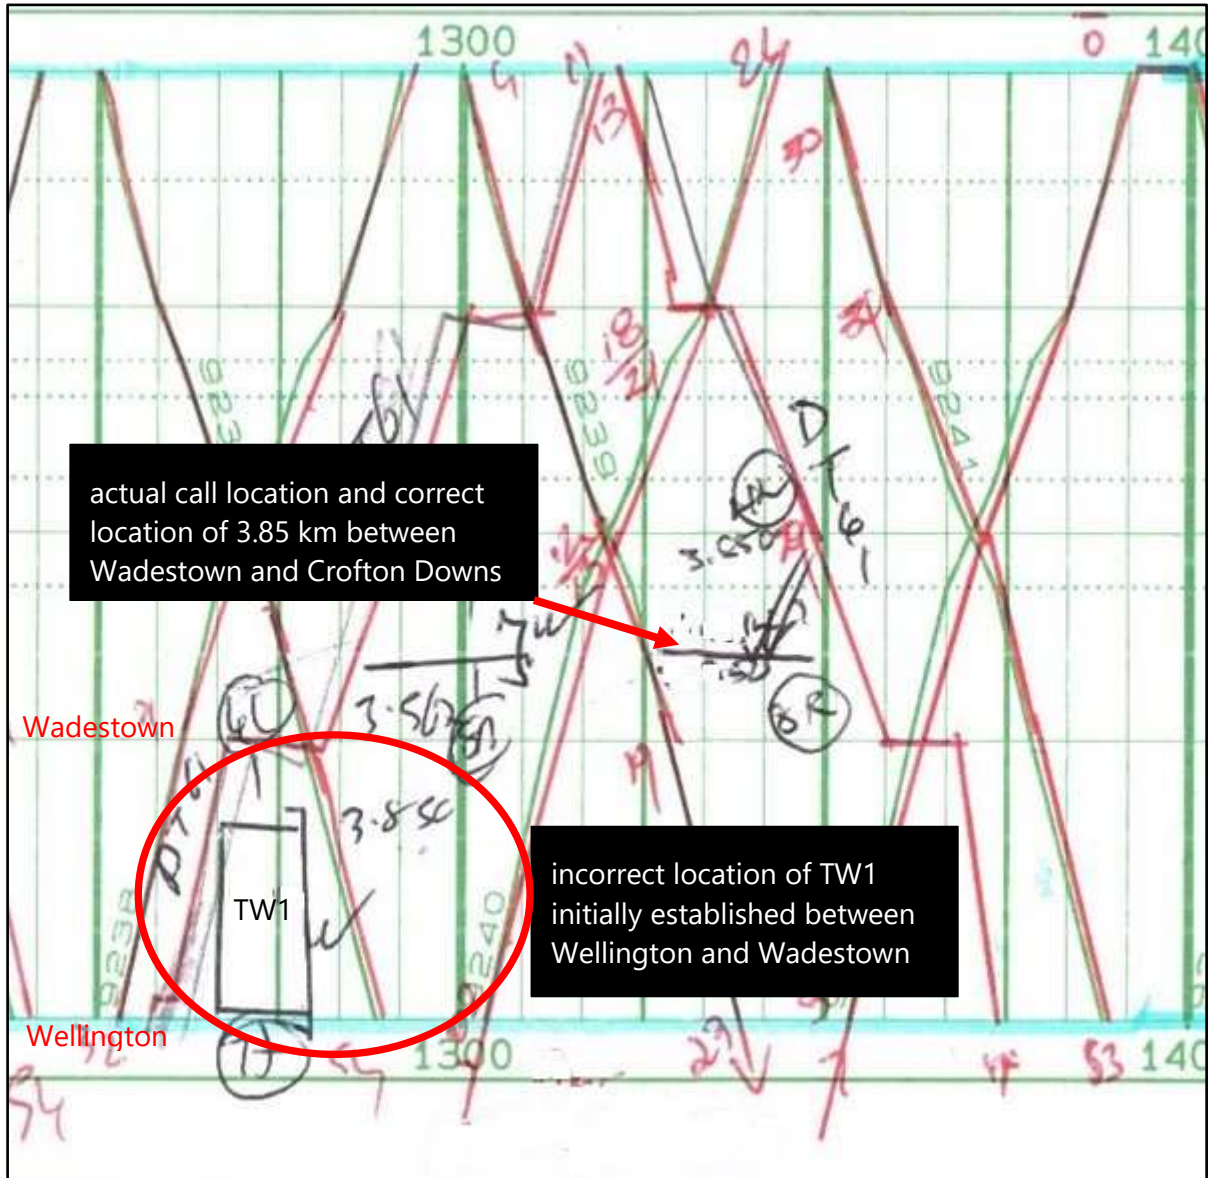
3.36. The TC advised TW1 that blocking was in place between 97 signal Wellington, and 4L signal Wadestown (see Figure 10). These locations for blocking were insufficient to protect the area the track workers were in. The TC **very likely** applied blocking to the incorrect area as they had formed an inaccurate mental model of the situation based on their earlier incorrect annotation of the TST activation location on the train control diagram.

Figure 8: TW1 location incorrectly drawn on train control diagram
 (Credit: KiwiRail, modified for anonymity by TAIC)

- 3.37. The incorrect diagram annotation **likely** led the TC to misinterpret the actual location of TW1, even though the location of “3.85 km, north of tunnel 5” was clearly stated by TW1.
- 3.38. KiwiRail’s Rail Operating Rules and Procedures, Rule 908 – Blocking stated in part:
