Summary Report

Aircraft Pacific Aerospace 750XL HB-TSA
Holder Paravia AG, Rathausstrasse 7, 6340 Baar
Owner Paravia AG, Rathausstrasse 7, 6340 Baar
Pilot Schweizer Bürger, Born 1995
License (*Private Pilot Licence Aeroplane – PPL(A)*) (*European Aviation Safety Agency – EASA*) issued by the Federal Office of Civil Aviation (FOCA)
Flying Hours
Total 594:40 h, during the last 90 days 187:49 h
...On the incident pattern 231:33 h, during the last 90 days 169:09 h
Date and time: 16 August 2018, 15:51 hr
Mode Private
Flight Rules Visual Flight Rules – VFR
Starting Point Luzern-Beromünster LSZO)
Destination Dübendorf (LSMD)
Flight Phase Take Off

Type of serious incident Loss of the right main landing gear

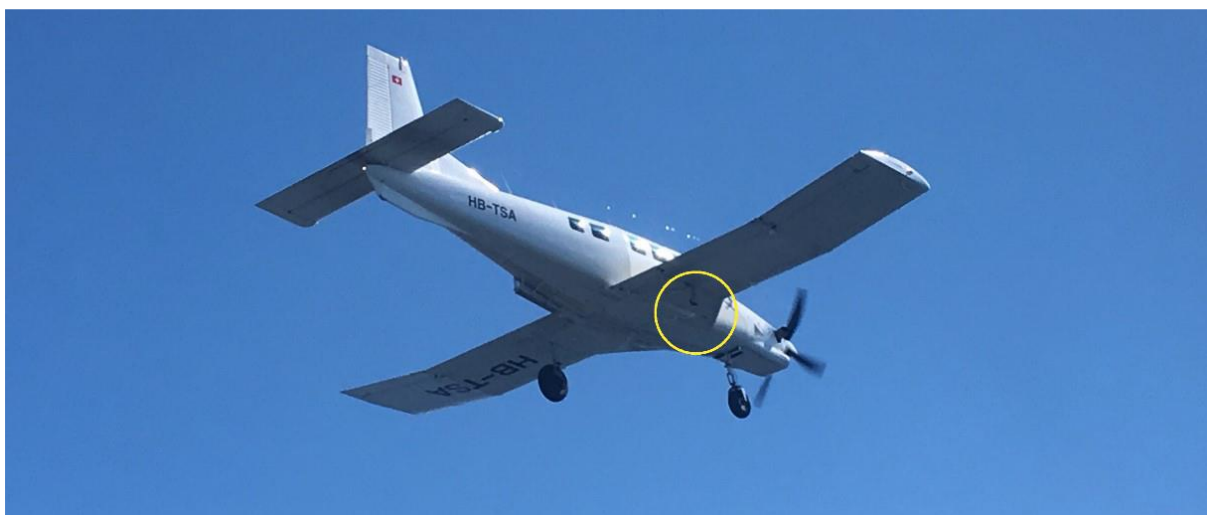
A Swiss Air Force aircraft listened to the radio traffic. It announced that emmen airfield was closed and offered to inspect the departure aircraft. After the two aircraft were merged by the air traffic control, it was confirmed that the main right landing gear was missing (see Figure 1). Together with the flight management, the pilot then decided to land at The Airfield in Dübendorf.

Figure 1: The HB-TSA with the landing gear stump without a wheel (yellow circle) after dropping the parachutists, taken from a Swiss Air Force aircraft.

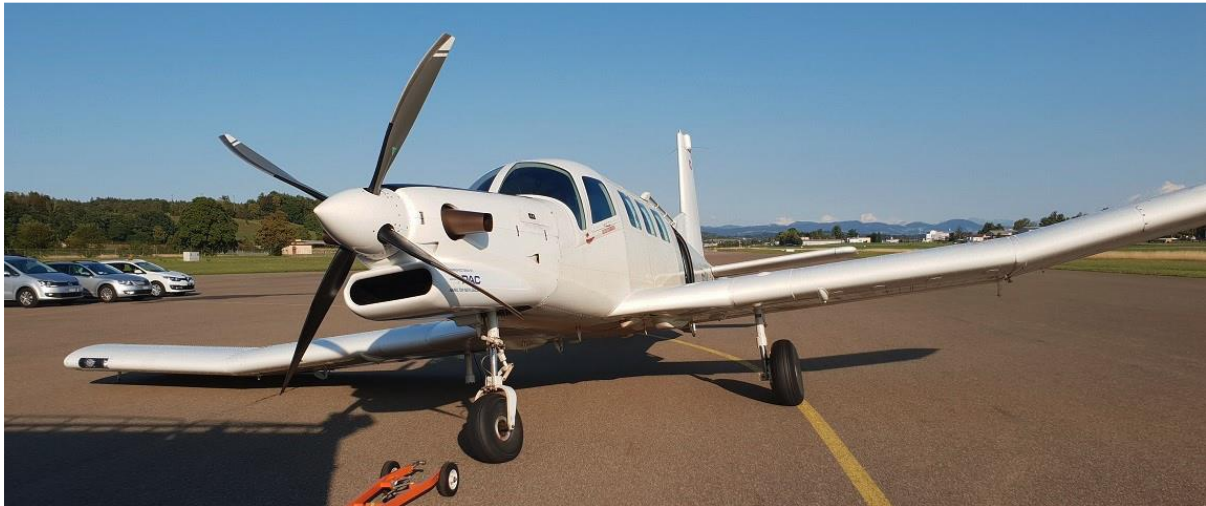
At 5 p.m., the HB-TSA took off on the runway. After lowering the right wing to the piste, it maintained its direction and came to a halt on the middle line of the piste (see Figure 2). Apart from damage in the area of the crease of the right wing and in the right landing flap, the aircraft had no other externally recognizable damage.

Figure 2: The HB-TSA after landing on runway 29 of Dübendorf airfield.

The ground contact of the right wing at full engine power and just before the necessary lifting speed was a considerable risk for the occupants. It is due to the geometry of the articulated wings and the attachments mounted below the creases that the underside of the wing hardly touched the ground, because these attachments acted as a skid, thus enabling a continuation of the take-off run and a trouble-free landing (see Abbildung 2).

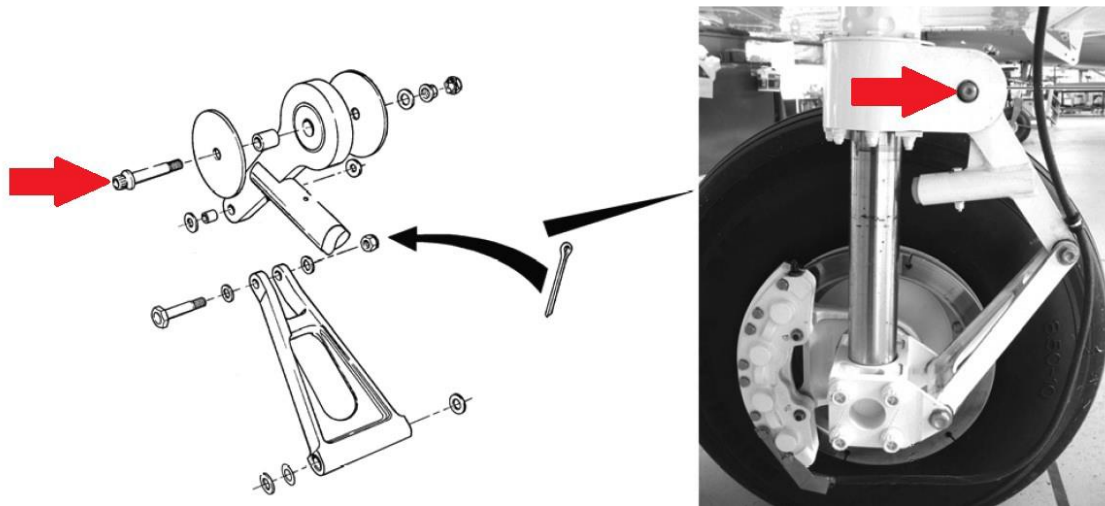
On the right main landing gear, the upper fastening bolt of the torque link (see red arrows in Figure 3) had been lost. As a result, the lower, movable part of the workleg, including the wheel, could fall out of the upper, immovable part when springing out. So-probably the lower as well as the upper part remained practically undamaged.

Figure 3: Right main landing gear leg with an exploded drawing of the torque link, whose above-right fastening bolt (red arrows) was lost (figure from the maintenance manual of the aircraft manufacturer).

The manufacturer announced an update of the Maintenance Manual (AMM) of the 750XL type in September 2019, which would improve the inspection requirement of the 300 h control, in particular the torque link of the main landing gear.

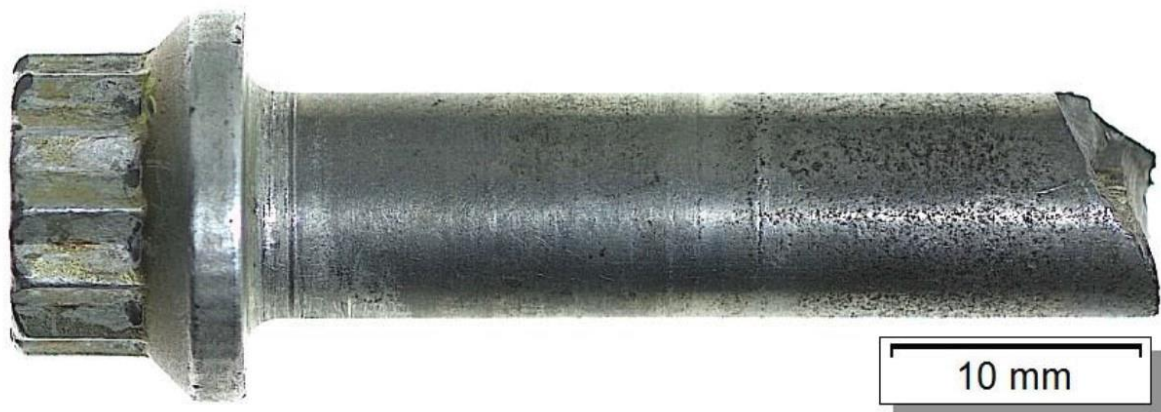
The fastening bolt could be secured on the runway of the take-off airfield. It was broken on the thread side and had strong corrosion suppreses, especially in the fracture area (see Figure 4). A trace examination concluded that the bolt had sufficient material quality, but was broken due to fatigue. The vibrational cracks leading to this fatigue fracture had been initiated by the corro-sion.

Figure 4: Broken fastening bolt with a conspicuously snarling surface in the fracture area.

The fastening bolt suffered a fatigue fracture and went away. This fatigue fracture arose from a highly advanced corrosion of this bolt. The corrosion was caused by its lack of lubrication. It must be assumed that the head of the lubricating nipple in question was torn off during tightening a long time ago and instead of a repair the remaining piece of the lubricating nipple was reworked.

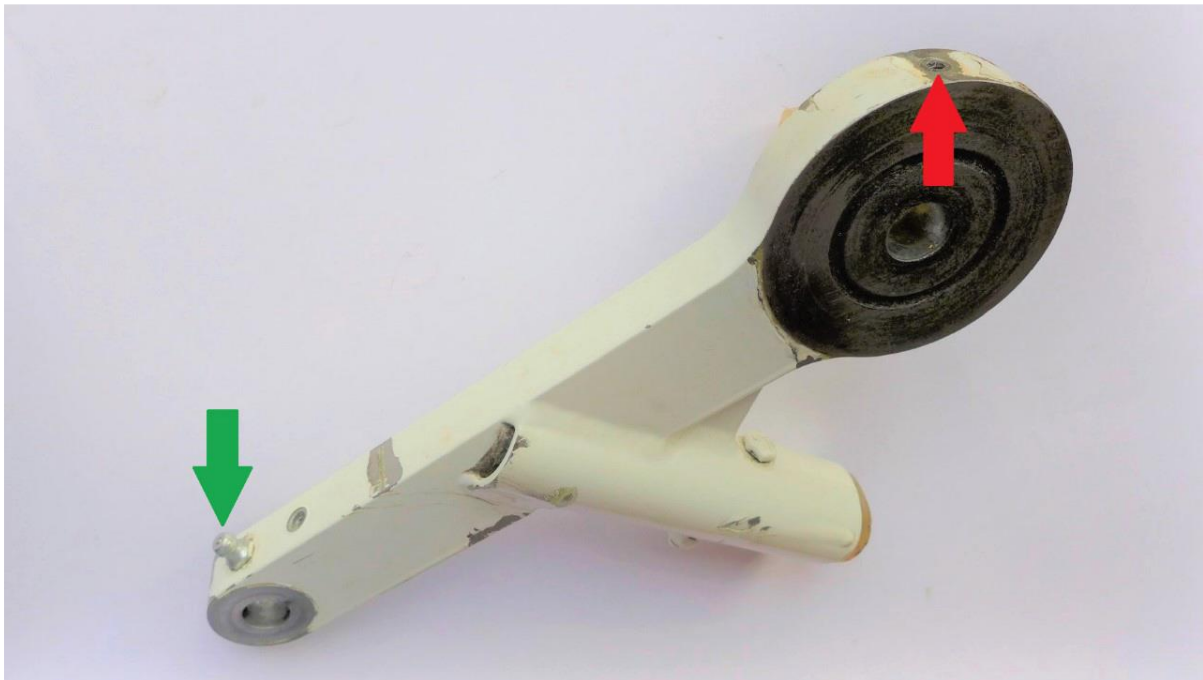
It was also found that the lubricating nipple of the affected joint was missing from the upper arm of the torque link and that this joint was in an unlubricated state. The traces found indicate that the lubricating nipple must have been broken off a long time ago and that the remaining and surviving part of the torque link must have been processed with a file (see red arrow in Figure 5).

Figure 5: Upper arm of the torque link with an intact lubricating nipple (left green arrow) and the broken and file-processed lubricating nipple of the affected joint (right red arrow).

Two months before the accident, a 300-hour check was carried out, in which the affected bolt had to be removed and inspected. Its corrosion damage was not objected to, even though these must have been caused over a long period of time. In addition, this control also included the lubrication of the affected joint, which was not possible due to the broken lubricating nipple and was also not objected to.
