Investigation Report

The Sinking of the Fishing Vessel *Insung I*

by Korean Maritime Safety Tribunal

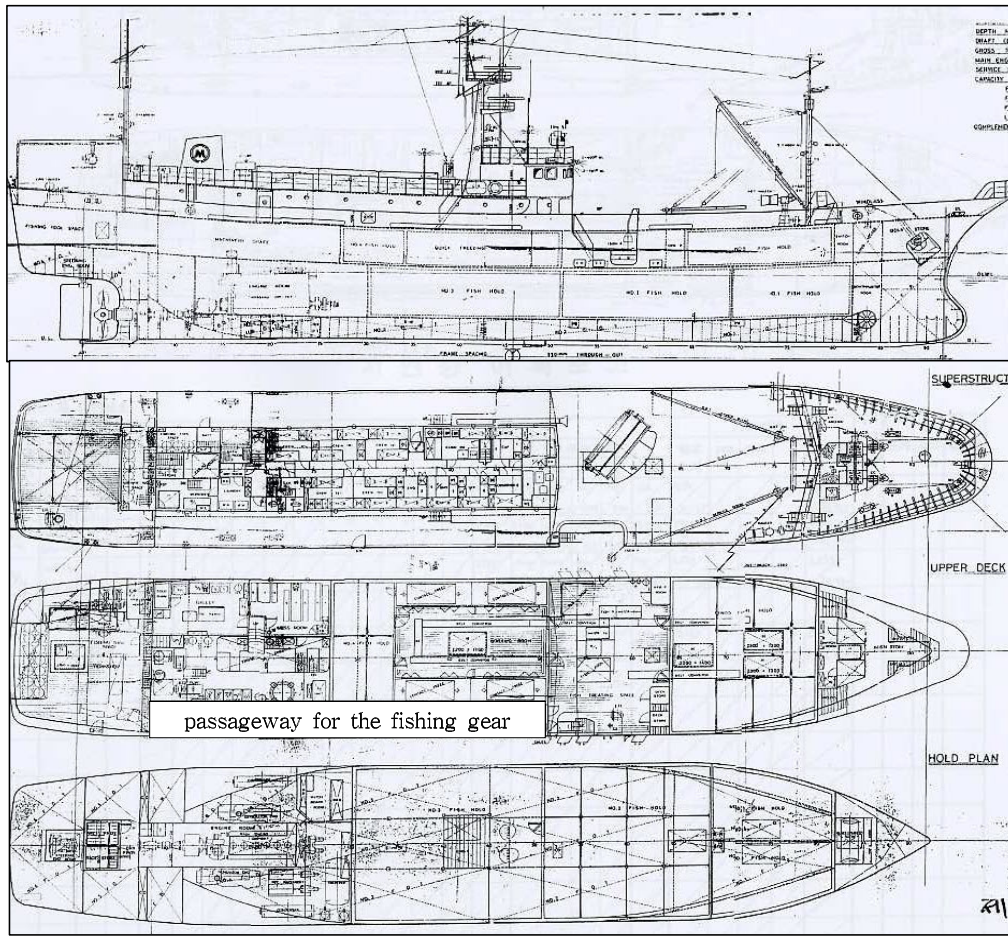
[Layouts of the Insung I]

The Insung I was a center-bridge ship. As the diagram below shows, the lower part of its upper deck consisted of a forepeak tank (FPT) at the bow, followed by fish storage areas 1, 2, and 3, an engine room, and an afterpeak tank (APT) at the stern. Below the fish storage areas and on both sides of the engine room were double bottom tanks storing ballast water.

On the upper deck were a bow deck, a front processing area (neighboring the trawling door on the starboard), a processing room, a freezer room, a cafeteria, a storage area for fishing gear at the stern, and a passageway (23.65 meter long, 2.0 meter wide) along the starboard through which the fishing gear was moved.

The superstructure housed a windlass and a derrick at the front. The crewmembers' quarters extended between the middle and the back of the deck. Above the quarters were the wheelhouse as well as a space for storing the fishing gear and sinkers.

The passageway for the fishing gear was located near the trawling door in the middle of the ship body. Because the passageway was slightly tilted to the bow of the ship by 1 to 2 degrees, seawater, once inside the ship, would have accumulated at the bow of the ship. Accordingly, the bow was installed with an electric diving pump, capable of draining 4 tons of water per hour, which was designed to start working automatically if it detected seawater around it. However, the pump at times failed to work properly. The passageway was connected to the processing room, the cafeteria, and the fish storage area at the back of the ship by opening-out doors. These doors, however, were not completely watertight. The doors on the upper deck had doorsills of about 50 centimeters in height.
