Final report MO-2016-202: Passenger ship, *Azamara Quest*, contact with Wheki Rock,
Tory Channel, 27 January 2016

Marine inquiry MO-2016-202
Passenger ship, *Azamara Quest*, contact with
Wheki Rock, Tory Channel
27 January 2016

Approved for publication: March 2018

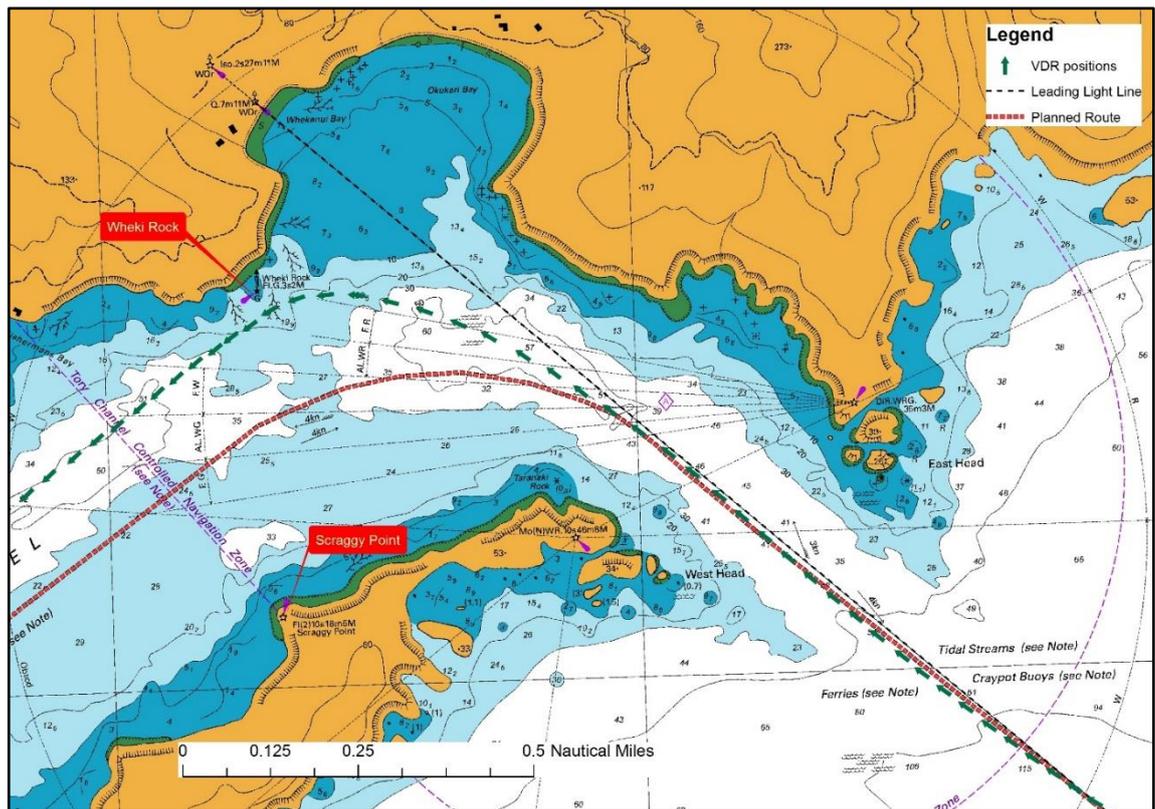
Figure 2
Voyage data recorder positions showing deviation from the planned track

- 3.2.9. The pilot initiated the turn using three degrees of port rudder, followed by successive increases to five and 10 degrees' rudder when he realised the ship was wide in the turn (to starboard of the planned track).

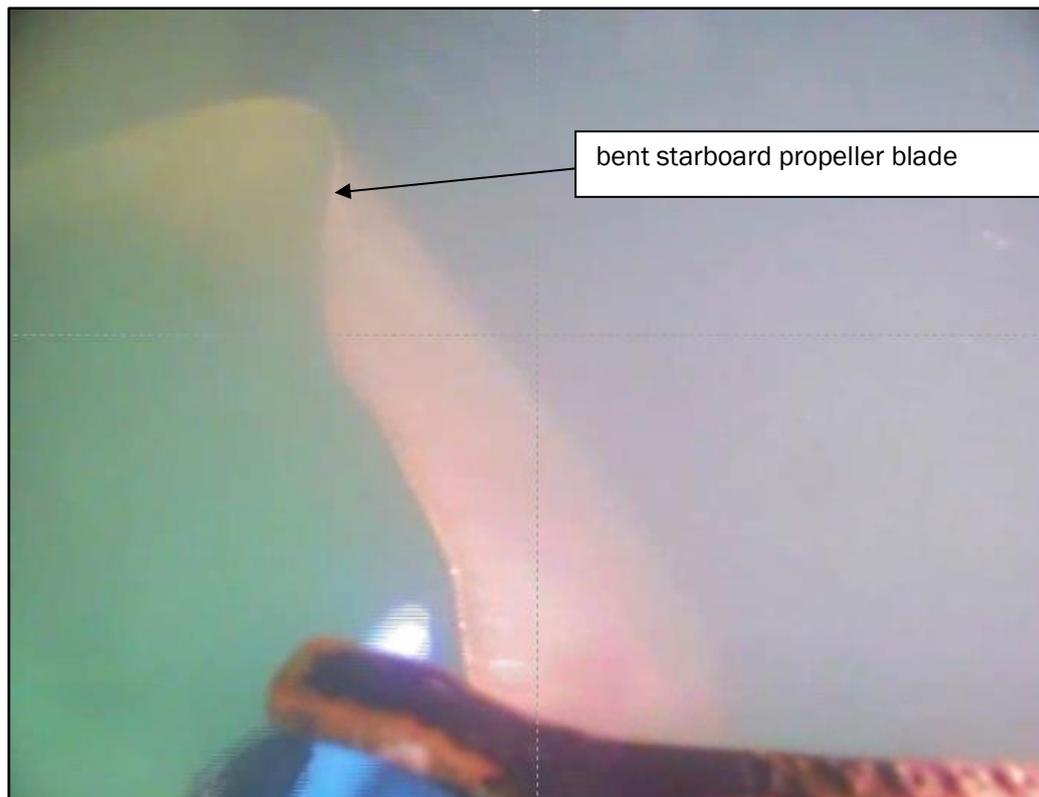
- 3.2.13. The underwater survey found damage on the starboard aft side near double-bottom tank 7804 and the starboard propeller, indicating that the ship had made contact with Wheki Rock (see Figures 3 and 4). Bending damage was observed on the starboard bilge keel and starboard propeller blades. However, there was no indication that the watertight integrity of the hull had been breached.
- 3.2.14. The *Azamara Quest* departed Picton after the classification society¹¹ had reviewed the damage report and was satisfied that the ship was safe to sail.

Figure 3
Bent starboard propeller blade

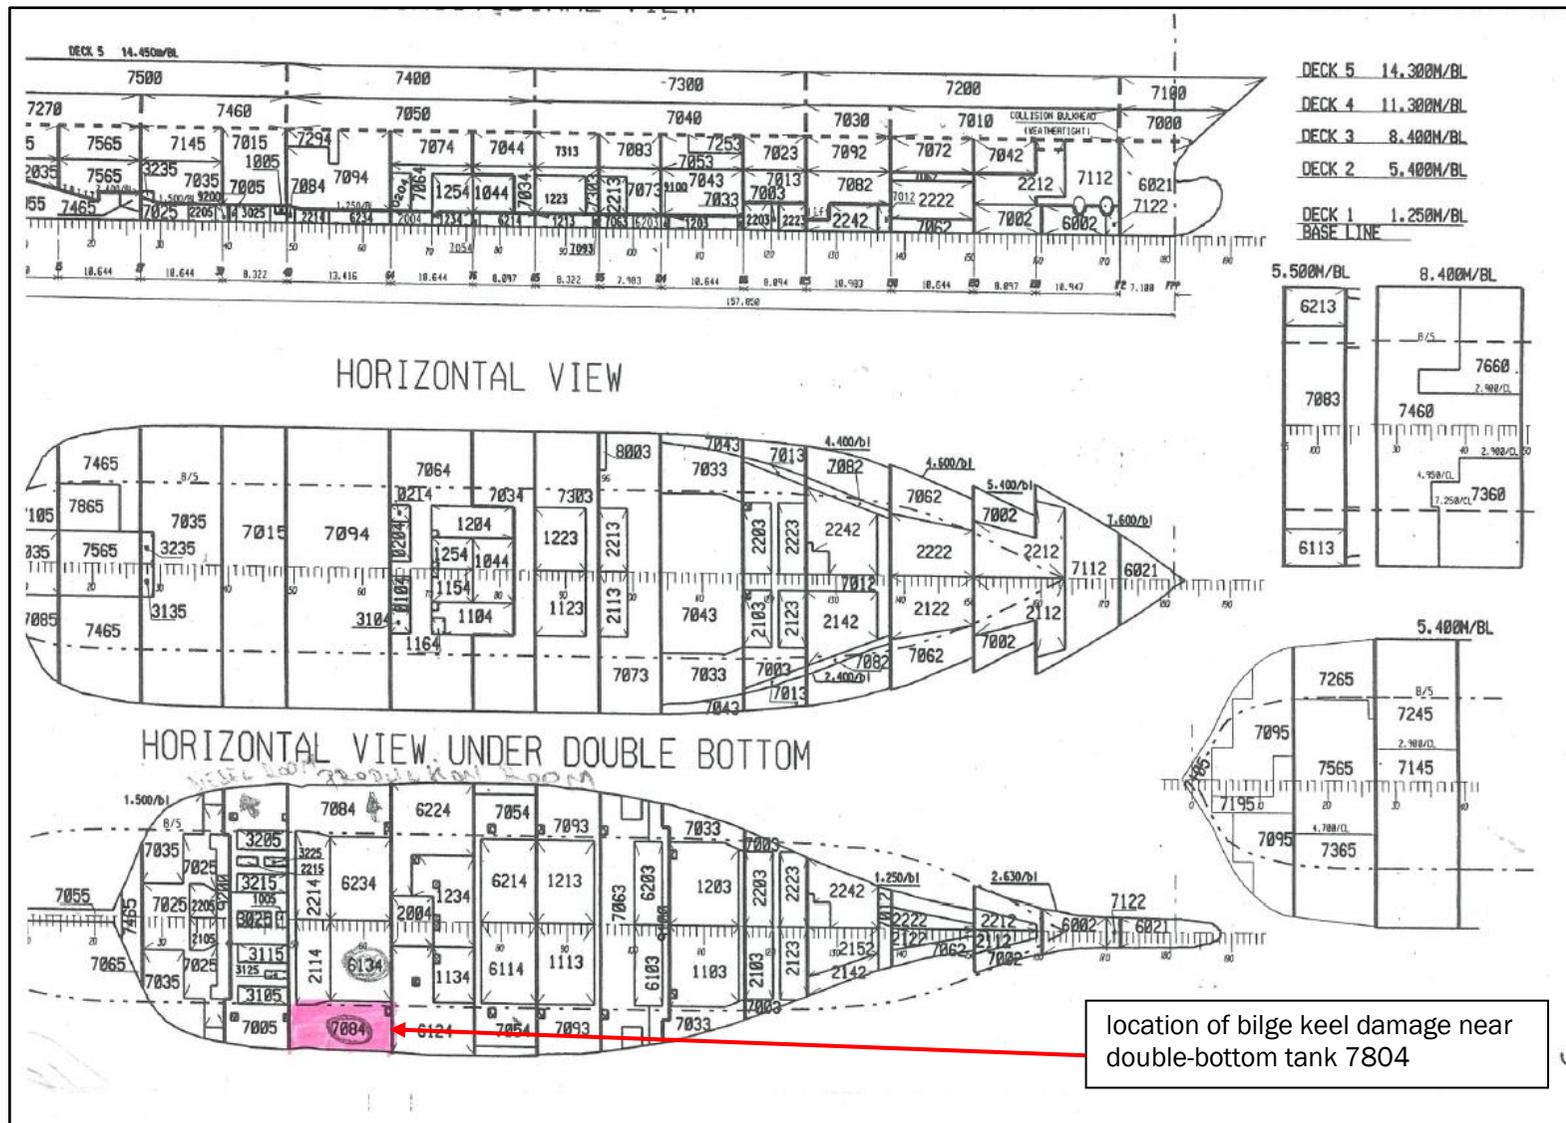
Figure 4
 Damage to bilge keel near double-bottom tank 7804

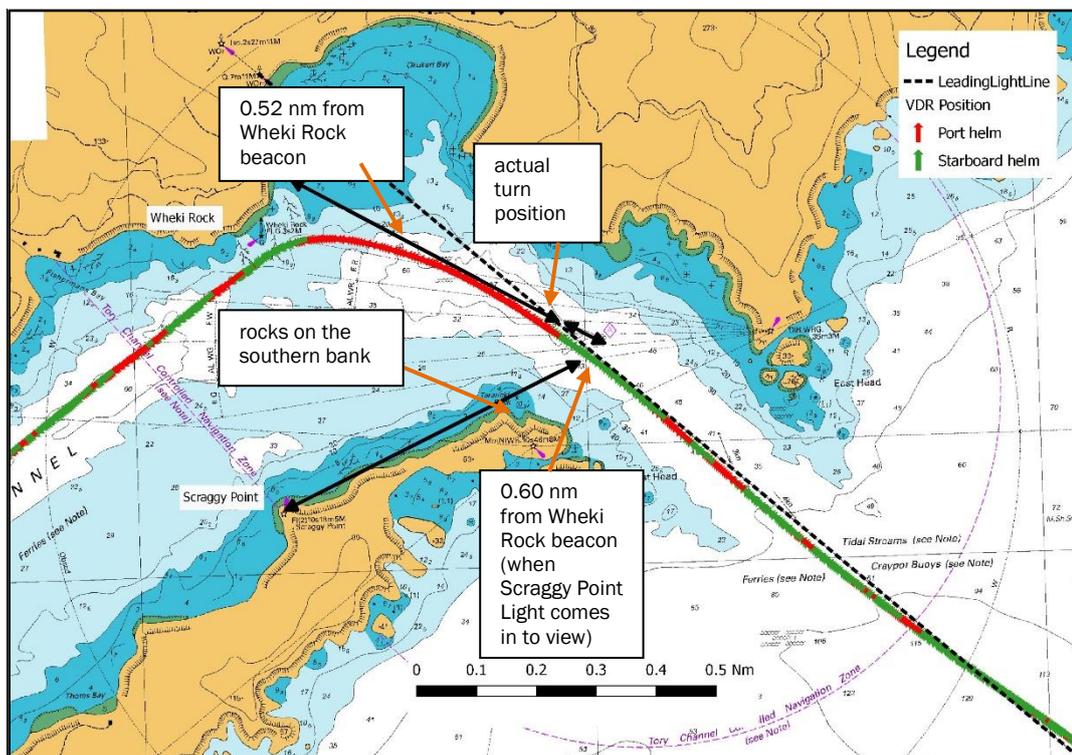
- 4.2.9. The pilot intended to commence the turn when the light on Scraggy Point light came in to sight; this was about 0.60 nautical miles from the line of Wheki Rock. However, the voyage data recorder showed that the pilot gave a port helm order about 21 seconds after Scraggy Point light came in to sight, when the bridge was about 0.52 nautical miles from Wheki Rock. This meant that the ship had advanced about 210 metres past the point where the pilot intended to start the turn. The pilot thought he had started the turn at his intended wheel-over position; he stated that it was not credible that 21 seconds could have passed without his or the master noticing that the wheel-over position had been overreached, and questioned the accuracy of the data sourced from the voyage data recorder and bridge microphones.

Figure 8
Delay in ordering the start of turn

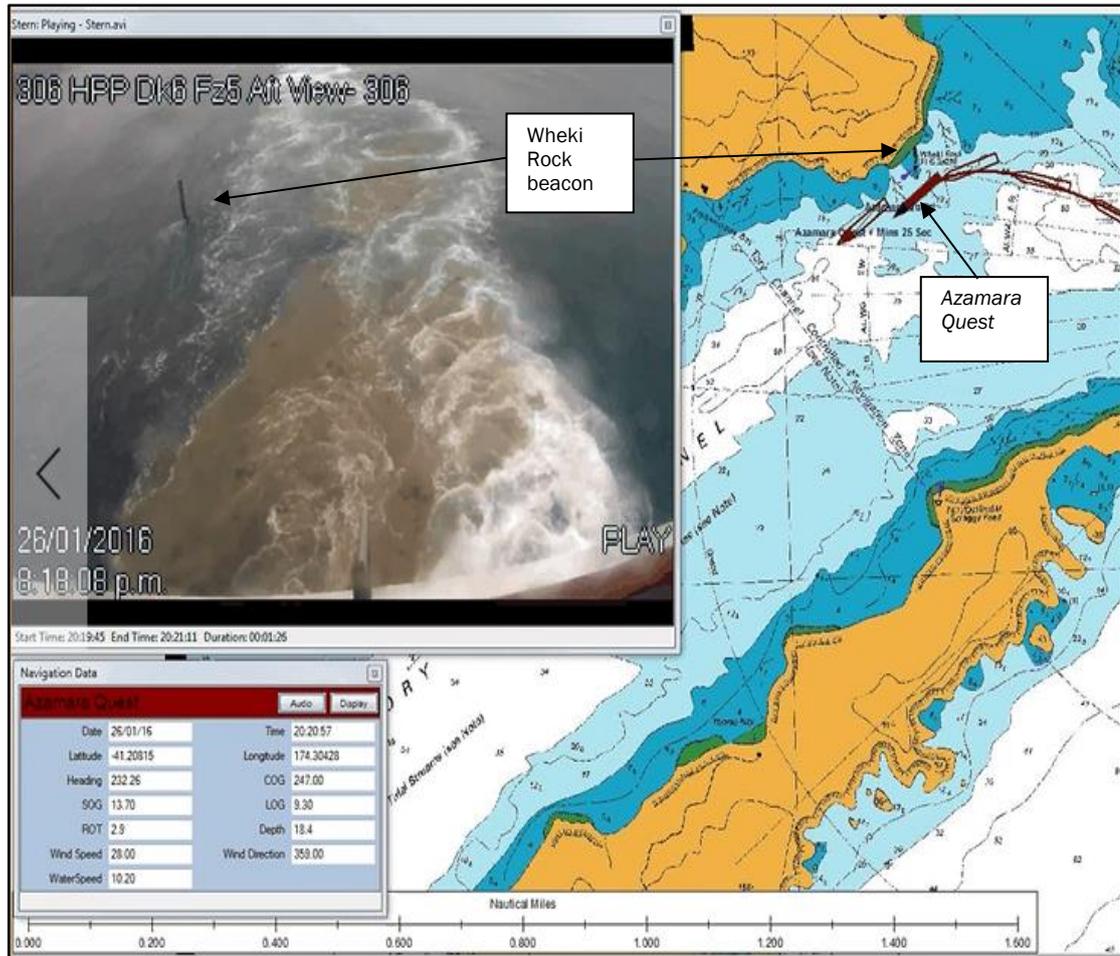
Figure 9

CCTV¹⁵ footage of the seabed coming to the surface when the *Azamara Quest* made contact with Wheki Rock

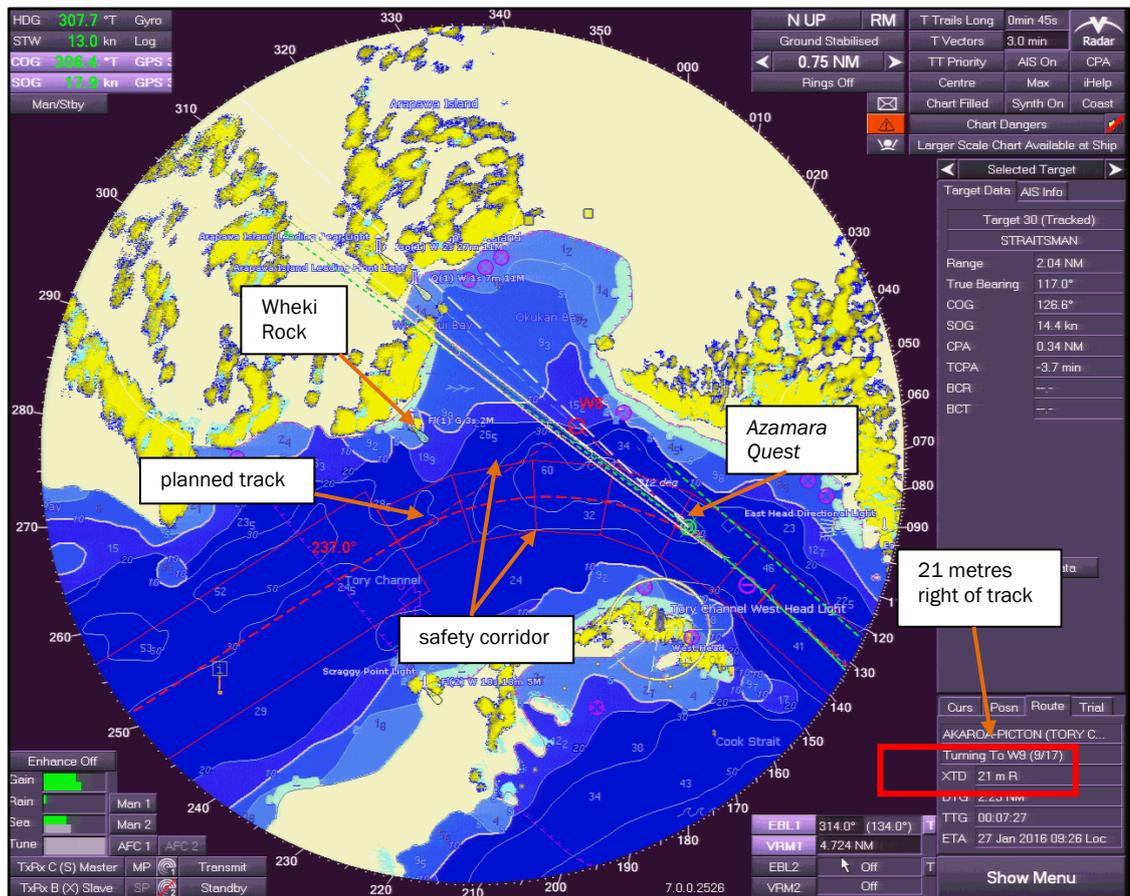
Figure 10

- 4.2.10. The master did not challenge the delay in starting the turn because that was what he was expecting based on his understanding of the pilot/master information exchange.
- 4.2.11. The pilot ordered three degrees of port rudder, expecting that it would start a “good” turn. However, at the time the ship’s heading was swinging slowly to starboard from a previous helm order and the ship was already 21 metres north of the intended track. At that point the ship’s speed over ground had increased to 17.9 knots (see Figure 10).

The Azamara Quest was 21 metres off track when the pilot ordered three degrees of port helm

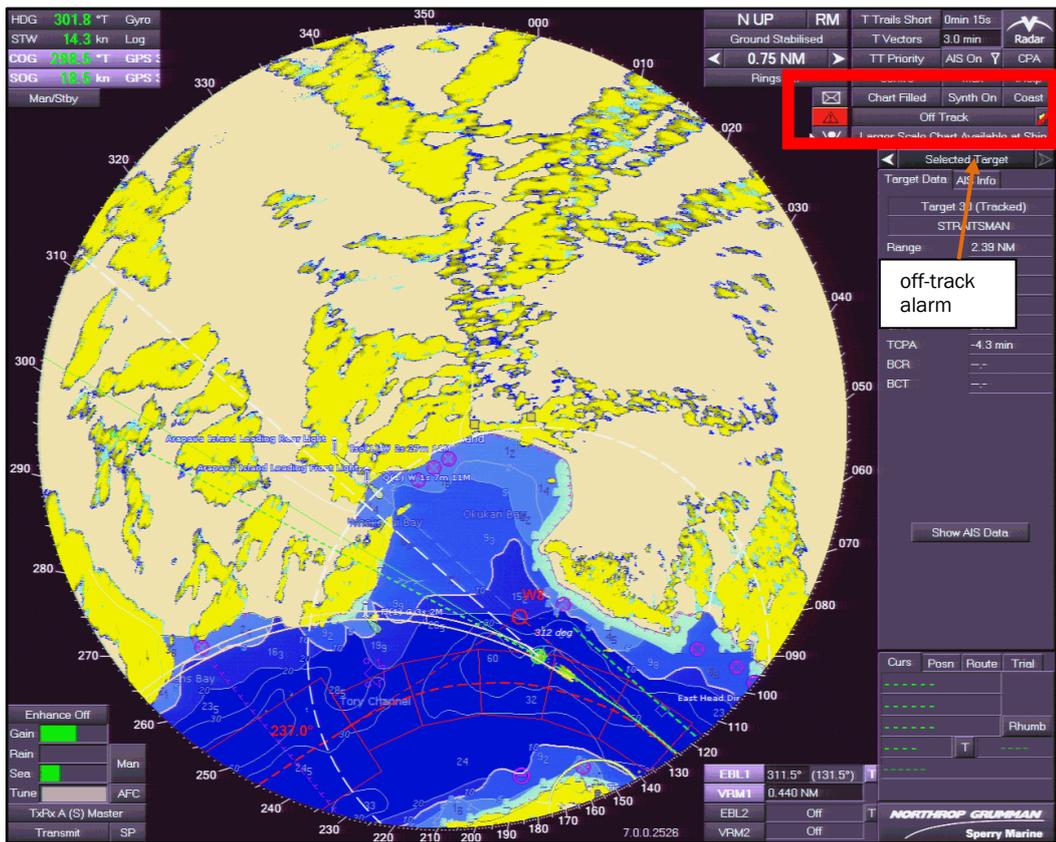
- 4.2.15. At about 0919 an off-track alarm¹⁶ flashed on the ECDIS, but this information was not brought to the attention of the master or the pilot. The alarm was a signal that the ship had departed the predefined safety corridor either side of the planned track (see Figure 10). The alarm appeared only as a visual indicator on the radar screen because its audio had been muted prior to the ship entering Tory Channel (see Figure 12). Muting alarms on an ECDIS is not considered industry good practice.

Figure 12
Off-track alarm triggered at about 0919

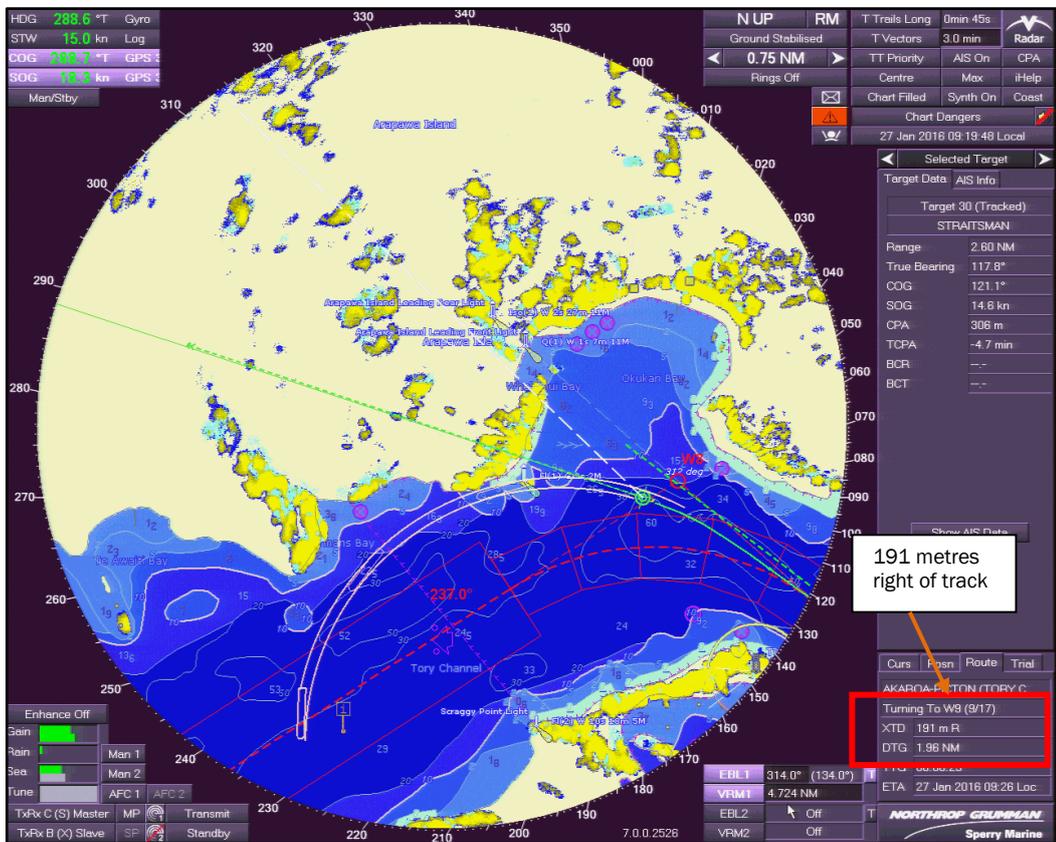
Figure 13
The Azamara Quest was 191 metres off track when the pilot ordered 20 degrees of helm

- 4.2.16. When the rudder angle was increased to 10 degrees to port, the *Azamara Quest* was 191 metres off track and the predicted path of the ship showed that it was going to pass over Wheki Rock. However, it was another 42 seconds before the rudder was increased to 20 degrees, shortly before the ship struck Wheki Rock (see Figure 13).

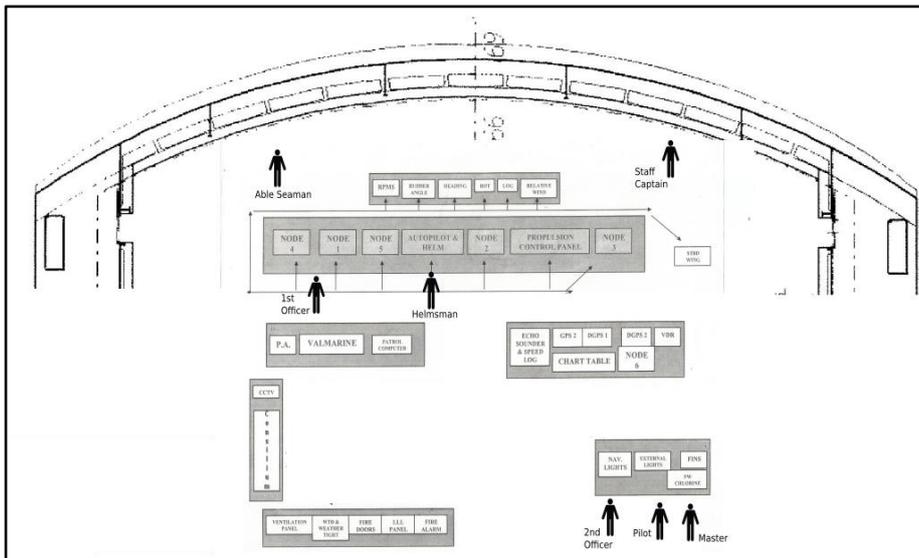
- 4.3.6. Figure 14 shows where the various members of the bridge team were standing during this exchange. The first officer was conducting the ship and was stationed on the port side of the instrument panel. The second officer was stationed near the chart table, while the staff captain was forward of the instrument panel. The helmsman and a lookout were also present on the bridge. Consequently, not all of the bridge team took part in the exchange.

Figure 14
The location of the bridge crew during the pilot/master information exchange

- 4.3.7. The standard of communication among the bridge team was a departure from good bridge resource management practice and also represented a missed opportunity to ensure that everyone was sharing the same mental model of how the ship would transit Tory Channel.
