Final report MO-2017-203: Burst nitrogen cylinder causing fatality,  
passenger cruise ship *Emerald Princess*, 9 February 2017

Marine inquiry MO-2017-203  
Burst nitrogen cylinder causing fatality,  
passenger cruise ship *Emerald Princess*,  
9 February 2017

Approved for publication: November 2018

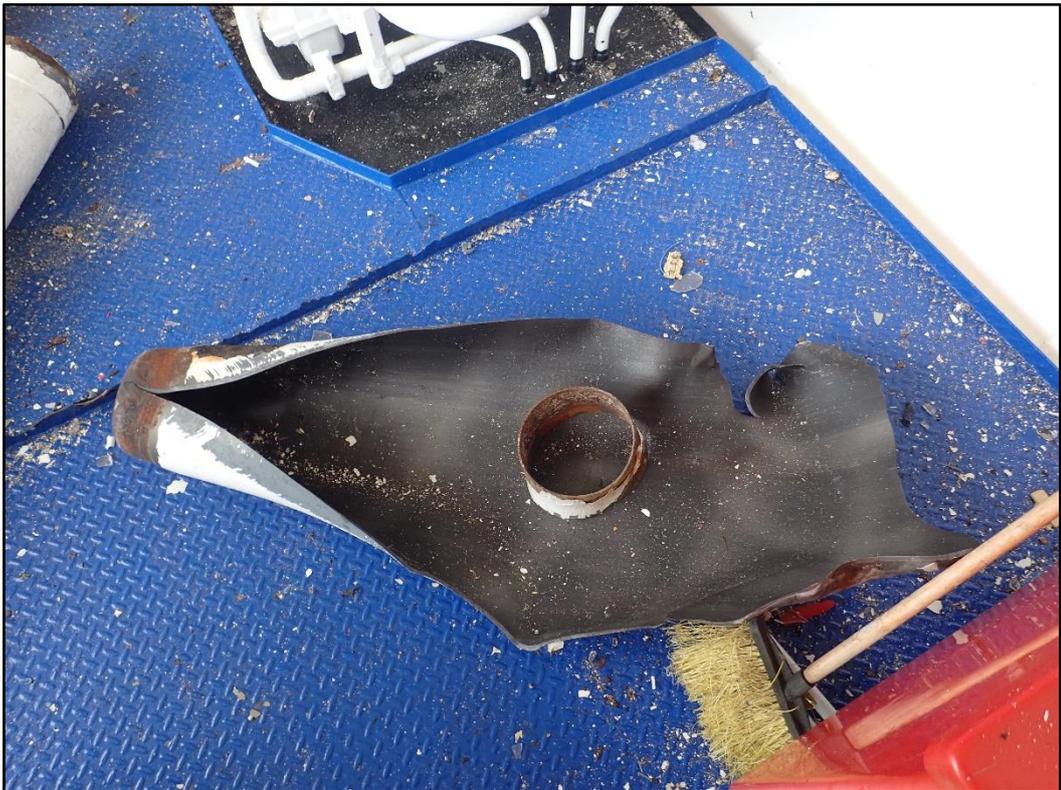
Figure 5  
Failed nitrogen cylinder

- 1.3. The Transport Accident Investigation Commission (Commission) **found** that the nitrogen cylinder burst at below its normal working pressure because severe external corrosion had reduced the wall thickness to about 30% of its original thickness.

- 3.5.3. A visual examination of the failed cylinder showed that the failure was typical of an over-pressure burst. A single split had occurred along the length of the cylinder and the cylinder head was missing.

- 3.5.4. The burst nitrogen cylinder had suffered significant corrosion at the point of failure, which was situated approximately 150 millimetres (mm) below where the steel securing band had clamped the cylinder within its frame. The corrosion had developed on the outside of the cylinder. The internal surface was clear of corrosion. Corrosion had reduced the thickness of the cylinder wall by about 70% at the point of failure (from 4.8 mm to about 1.5 mm). A second area of corrosion was noted near to the bottom of the cylinder and a third area where the protective coating had been scraped away to observe the cylinder's identification details.

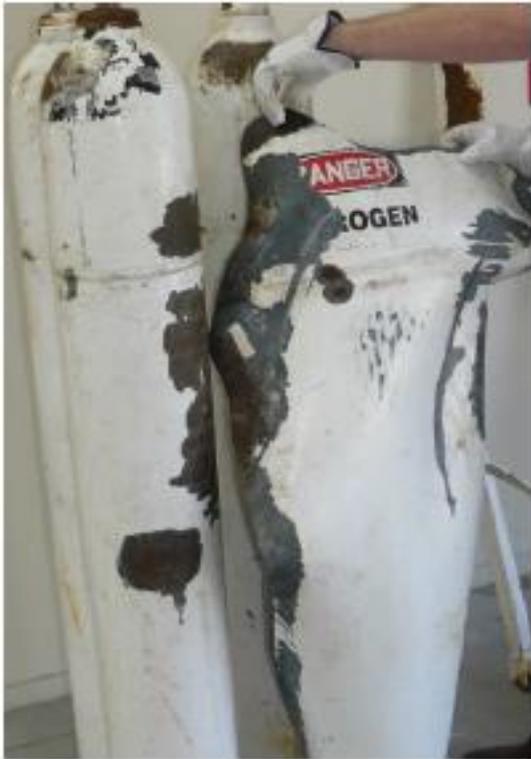
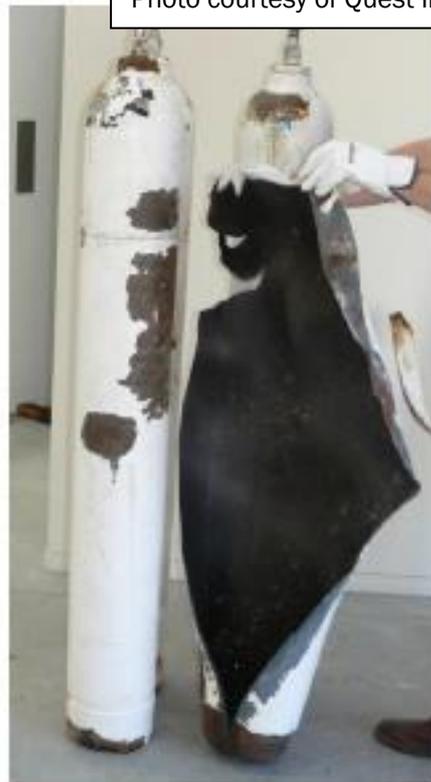
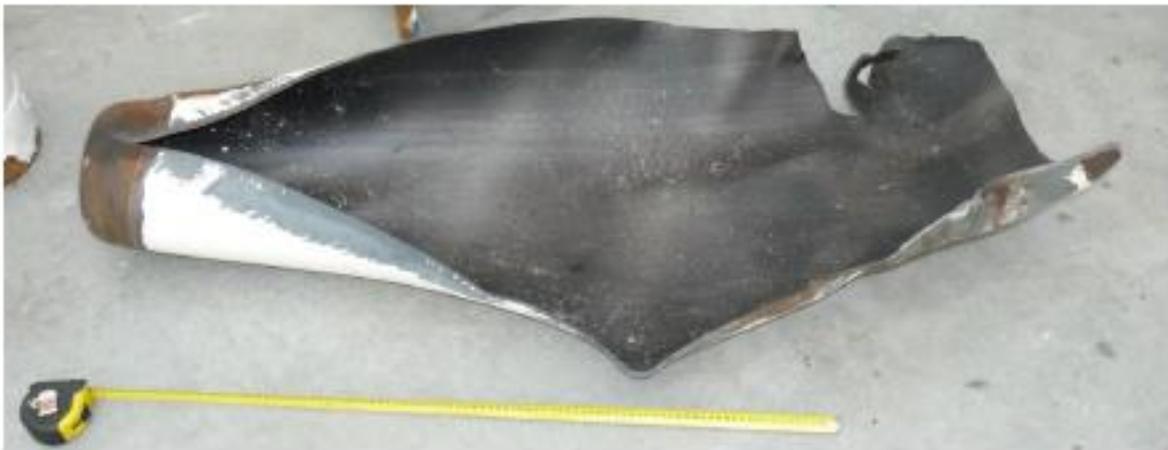
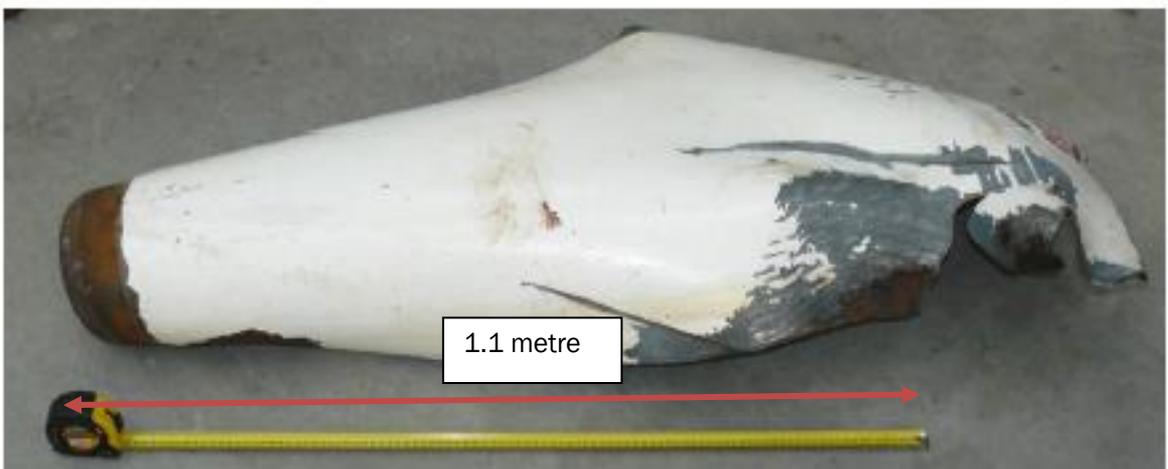
Figure 9  
Initiation of the failure (1.1 metre from the base of the cylinder)

Examination of the fracture revealed that the fracture had initiated at a region of corrosion that was about 1.1m from the original base of the cylinder

Failure had passed through the middle of the region of corrosion.

The fracture surface of the failure was typical of overload. There was no evidence of fatigue or any other pre-existing defect being present.

- 4.2.1. The cylinder burst because a region of severe corrosion reduced the cylinder wall thickness from about 4.81 mm to 1.45 mm and significantly compromised the cylinder's ability to withstand internal pressure. As a result, the cylinder suffered an overpressure burst while the crew attempted to raise the nitrogen pressure from 160 bar to its normal working pressure of 200 bar.

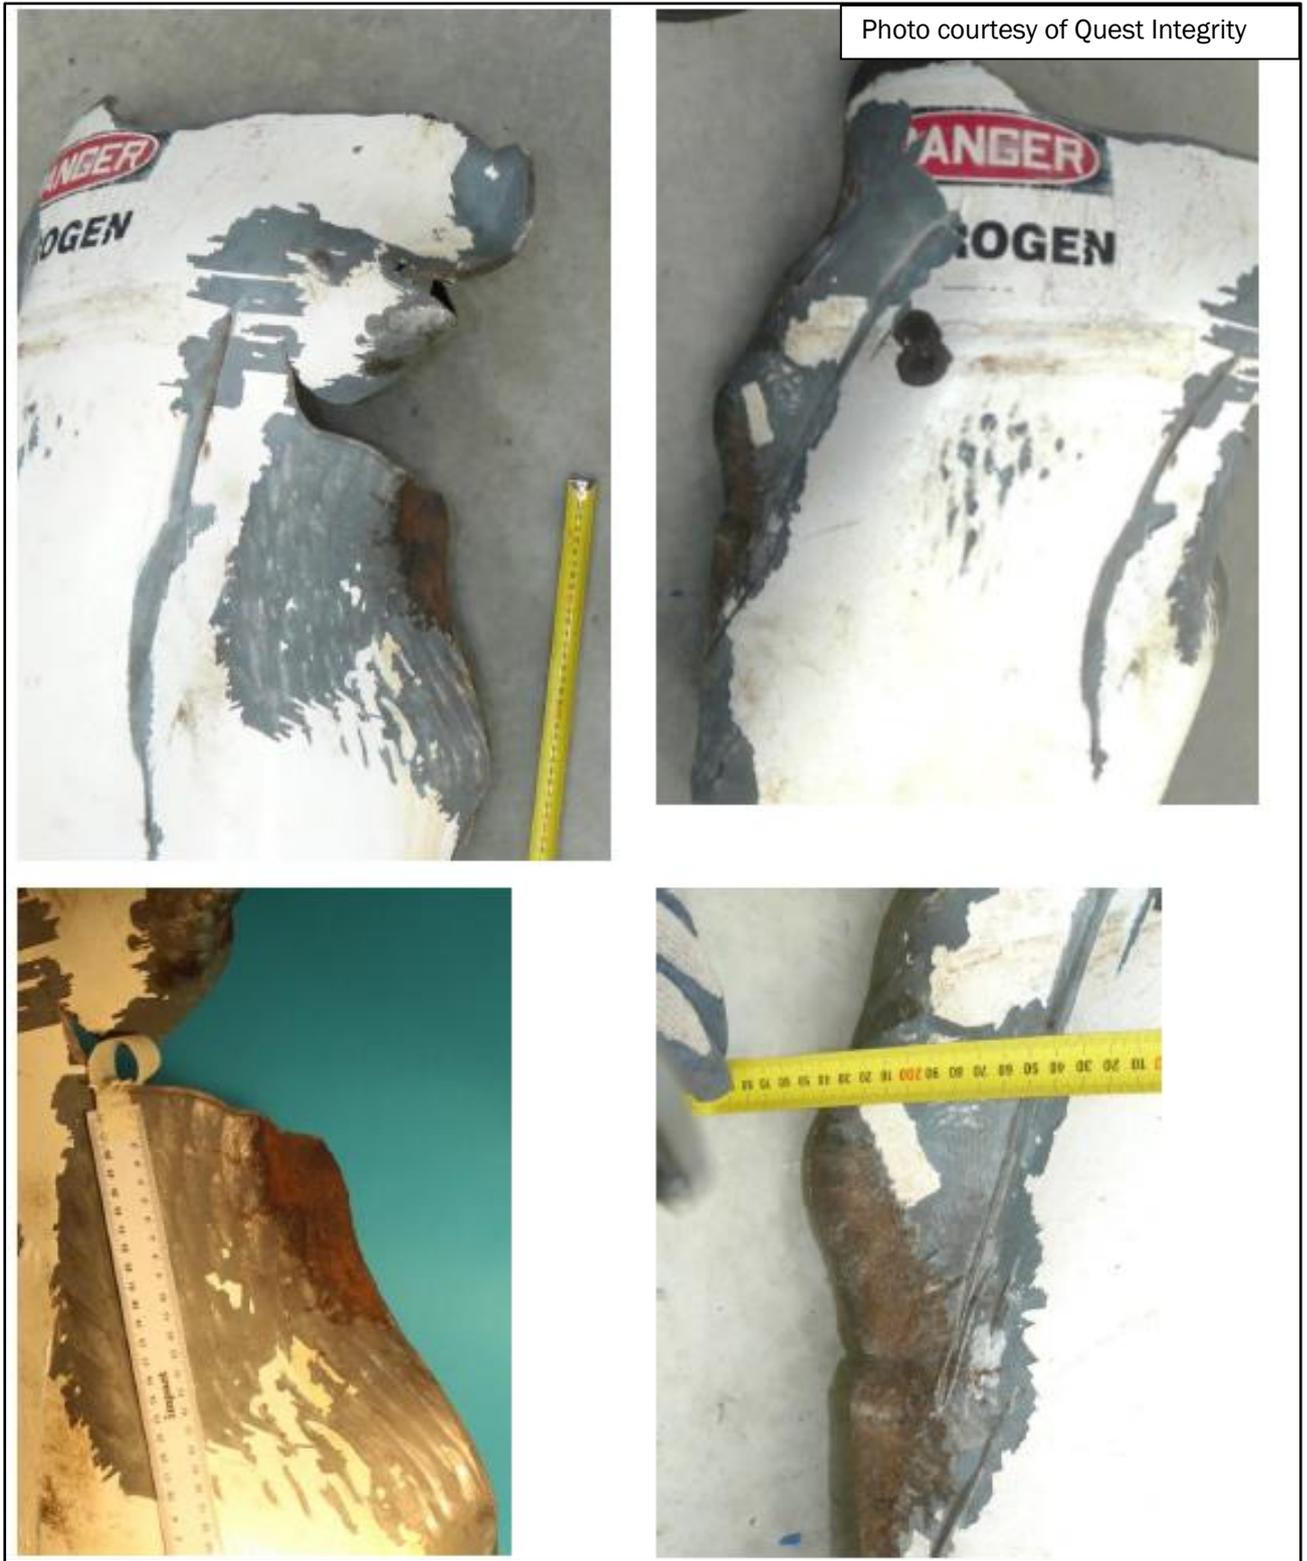
Figure 10  
Area of corrosion at the area of initiation of failure

The majority of corrosion product had been lost from the surface

Minimum 1.45mm to 1.56 i.e. both sides of the failure

Away from the corrosion the cylinder was 5.35mm to 5.9mm thick i.e. thicker than the minimum specified of 4.81mm

The paint had spalled off the surface. This is indication that the underlying steel had been strained

Away from the corroded area the fracture was typical of ductile overload.

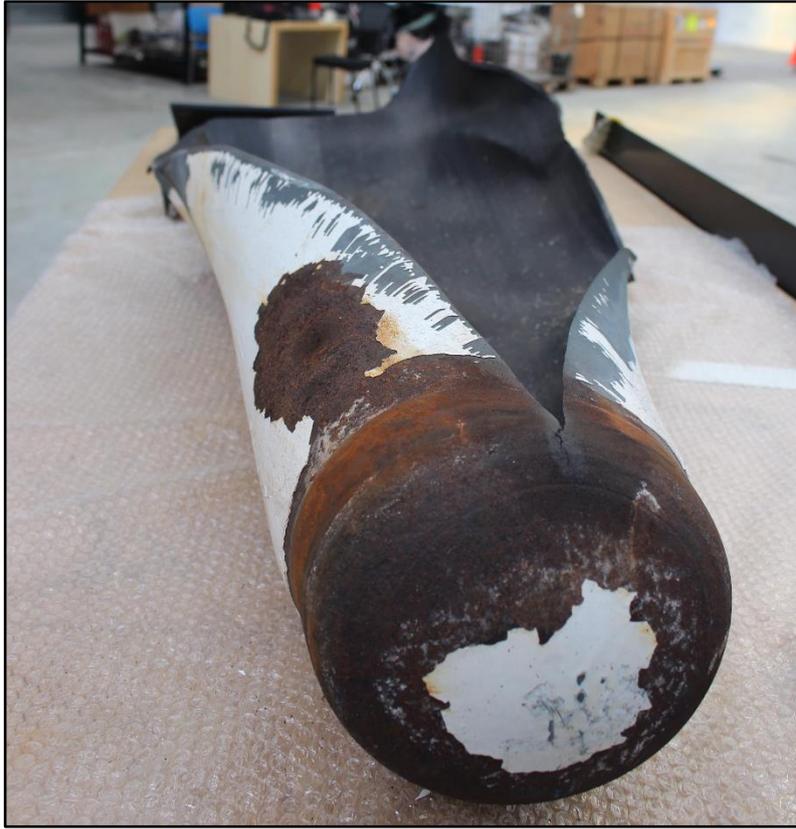
Figure 11  
Area of corrosion near the bottom of the failed cylinder

An area of corrosion was also present on the cylinder near the base and directly below the main area of corrosion where the failure initiated.

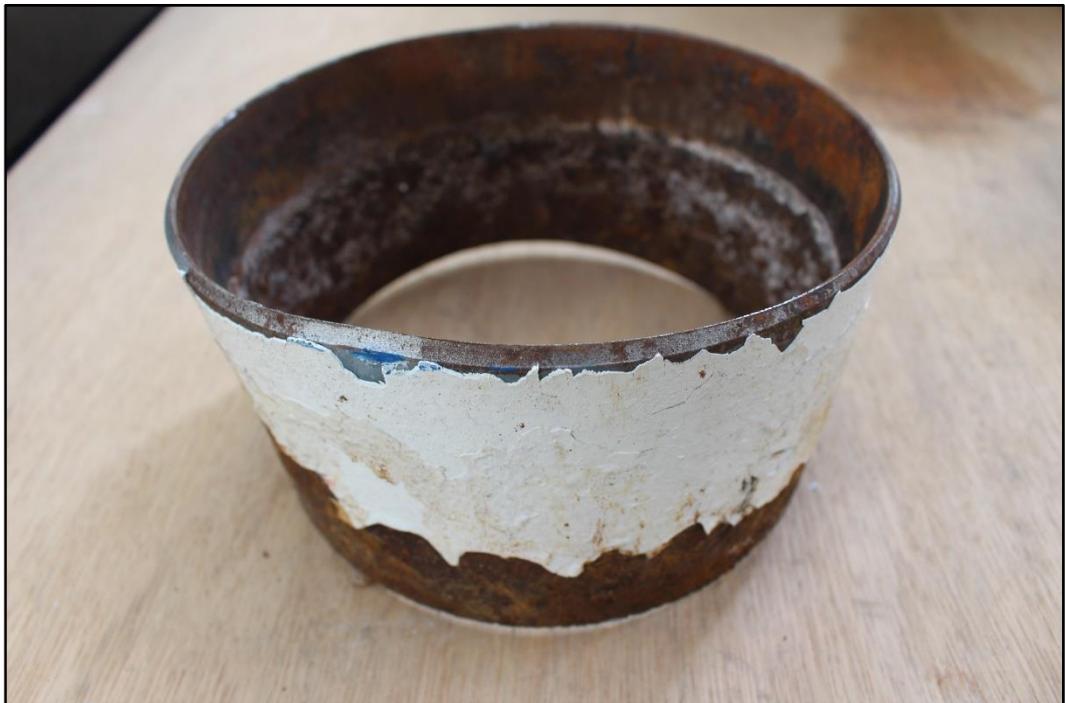
Figure 12  
Foot from failed cylinder

The foot of the failed cylinder was found separated from the cylinder. Examination of this and the base of the cylinder showed they were both corroded and a significant amount of paint was missing.

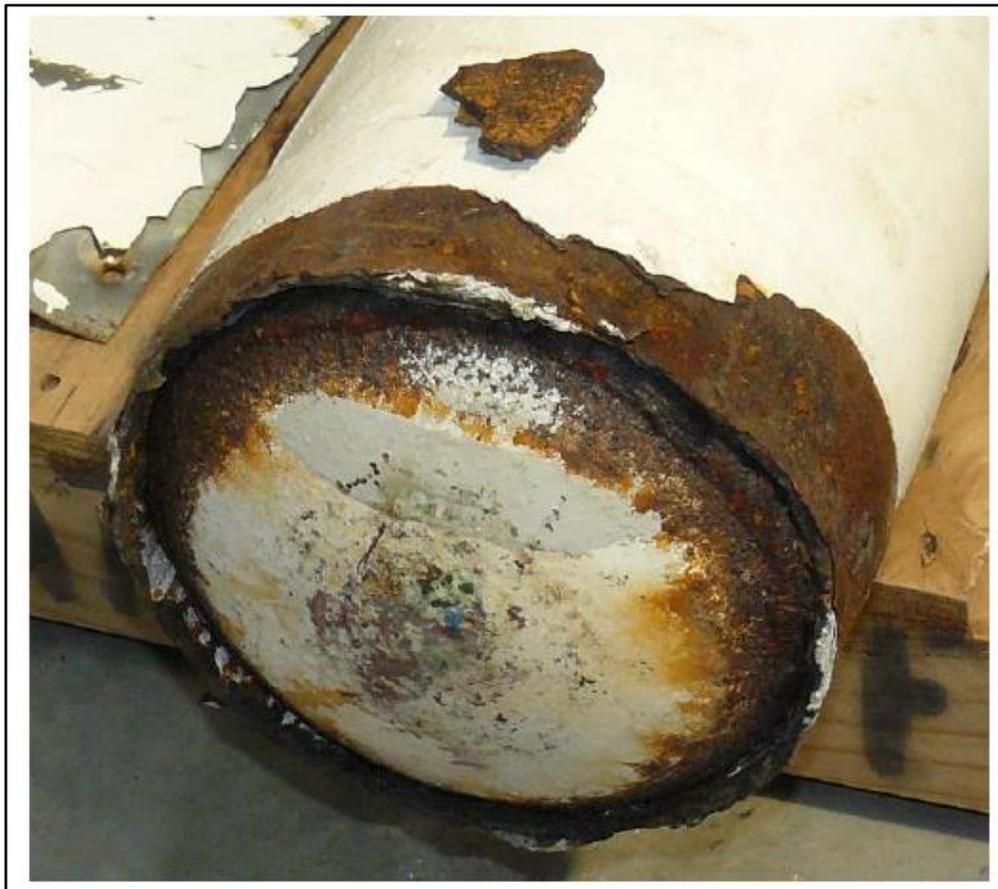
**Figure 13**  
Extreme corrosion at the base of the randomly selected cylinder under the foot ring

3.5.6. The metallurgist inspected a randomly selected cylinder from the *Emerald Princess* and found the base of the cylinder extremely corroded.

Examination of the intact cylinder revealed that extreme corrosion was present on the base of the cylinder in the region of the foot ring.

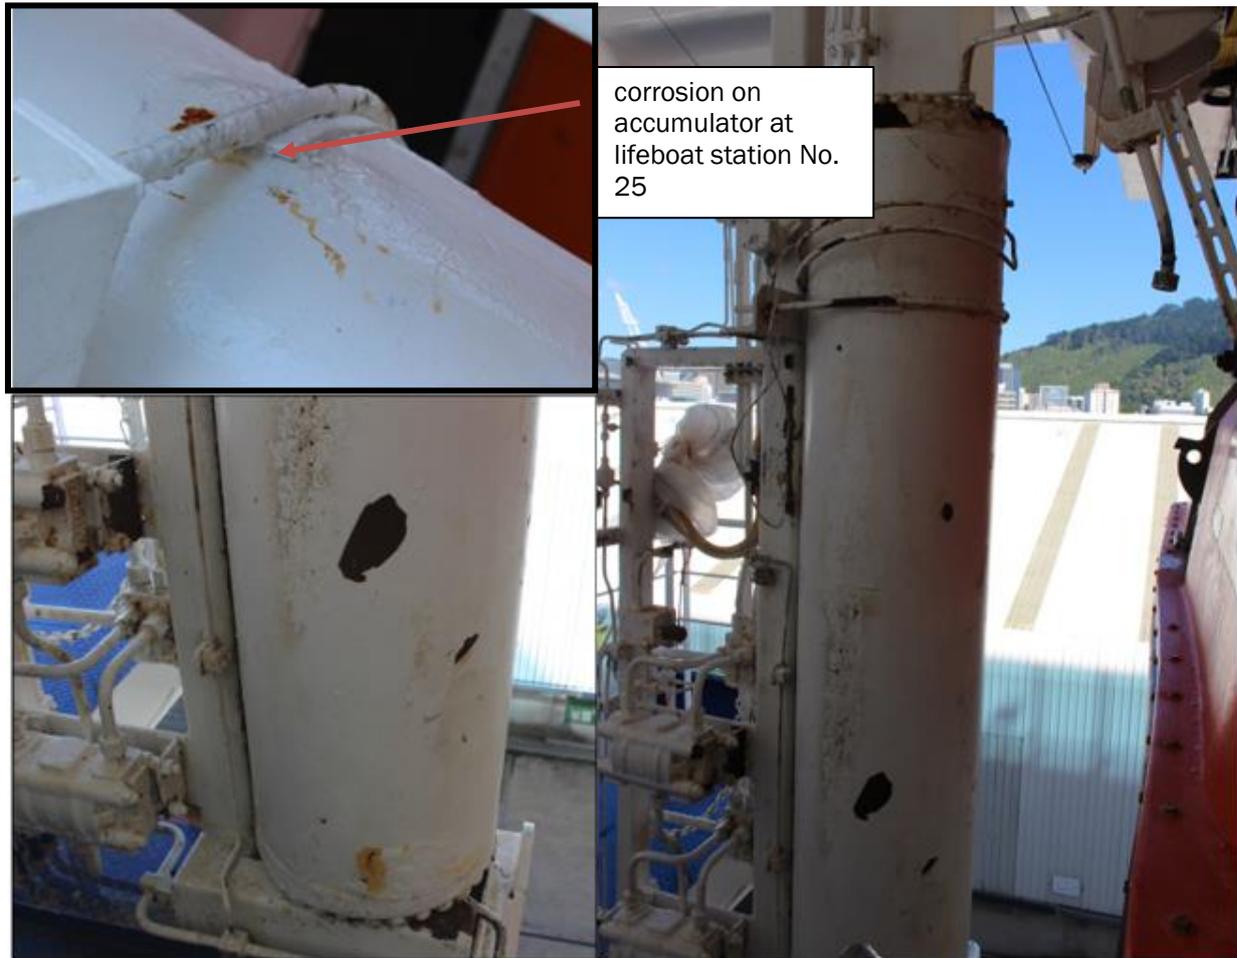
Figure 14  
Corrosion on accumulator

3.5.8. The hydraulic accumulator is part of the stored energy system. It is a pressure storage reservoir in which a hydraulic fluid is held under pressure by nitrogen gas. The metallurgist observed significant corrosion on at least two accumulators whilst on board the *Emerald Princess*.

The surface of pressure vessel that houses the hydraulic oil/air piston at lifeboat station 25 was obviously bulged as result of the build-up of corrosion products under the paint and under the support strap. The depth of corrosion was unknown.

The surface of the pressure vessel that houses the hydraulic oil/air piston at lifeboat station 24 [the station where the failure occurred] was obviously severely bulged as a result of the build-up of corrosion products under the paint. The depth of corrosion was unknown.

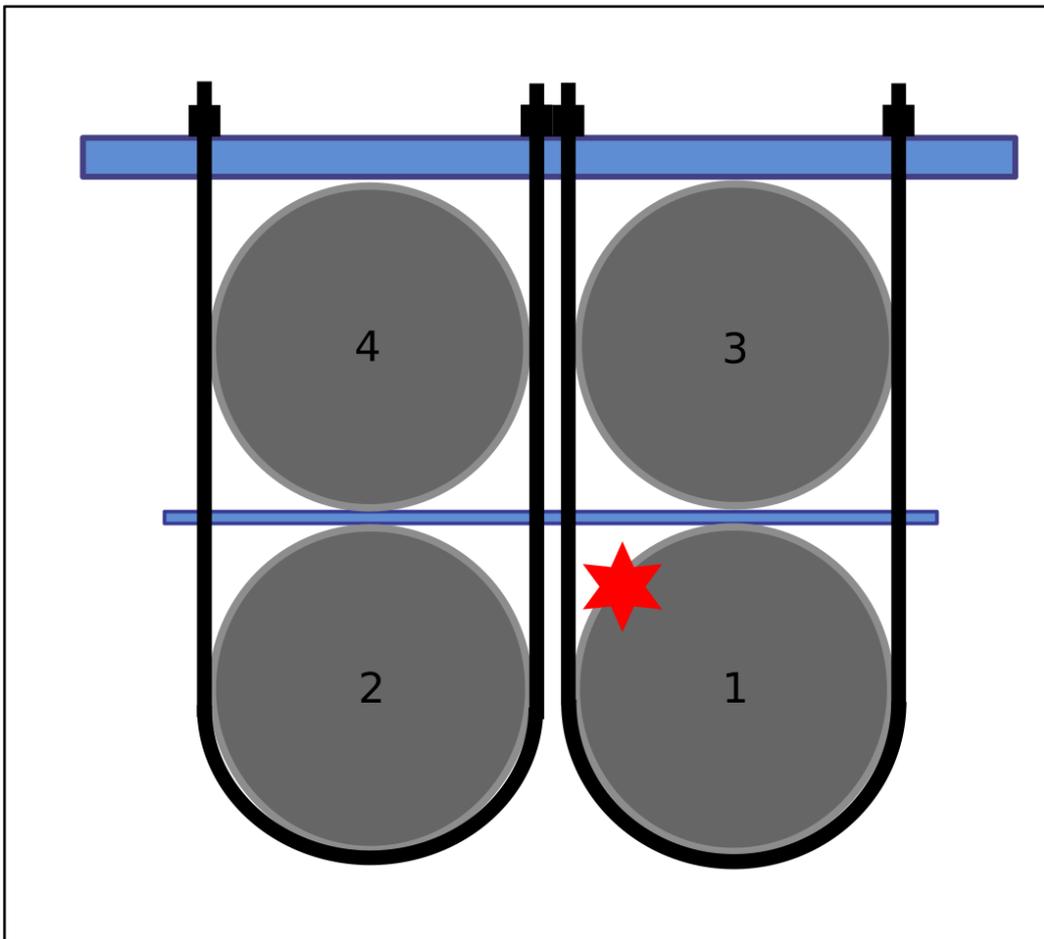
Figure 15  
Location of burst on failed cylinder

- 4.2.2. There is no clear evidence as to why this particular cylinder was so heavily corroded in the area where the failure started. The adjacent cylinders in the frame were not heavily corroded. Corrosion can be initiated by a number of factors. Mechanical damage to the protective coating in a saltwater environment is a common cause. Seawater being trapped against a steel surface can accelerate corrosion. The straps that retained the bottles in the frame is a place where seawater could have become trapped. They could also have initiated mechanical damage to the protective coating. However, as Figure 15 shows, the location where the worst corrosion occurred was not where the straps were in contact with the bottles.

- 4.2.3. There was no evidence of any pre-existing crack occurring before the failure. The source of the leak in the system that the crew were trying to remedy was never found.
