Final report MO-2017-205: Multipurpose container vessel *Kokopo Chief*,  
cargo hold fire, 23 September 2017

Marine inquiry MO-2017-205  
Multipurpose container vessel *Kokopo Chief*

Cargo hold fire

23 September 2017

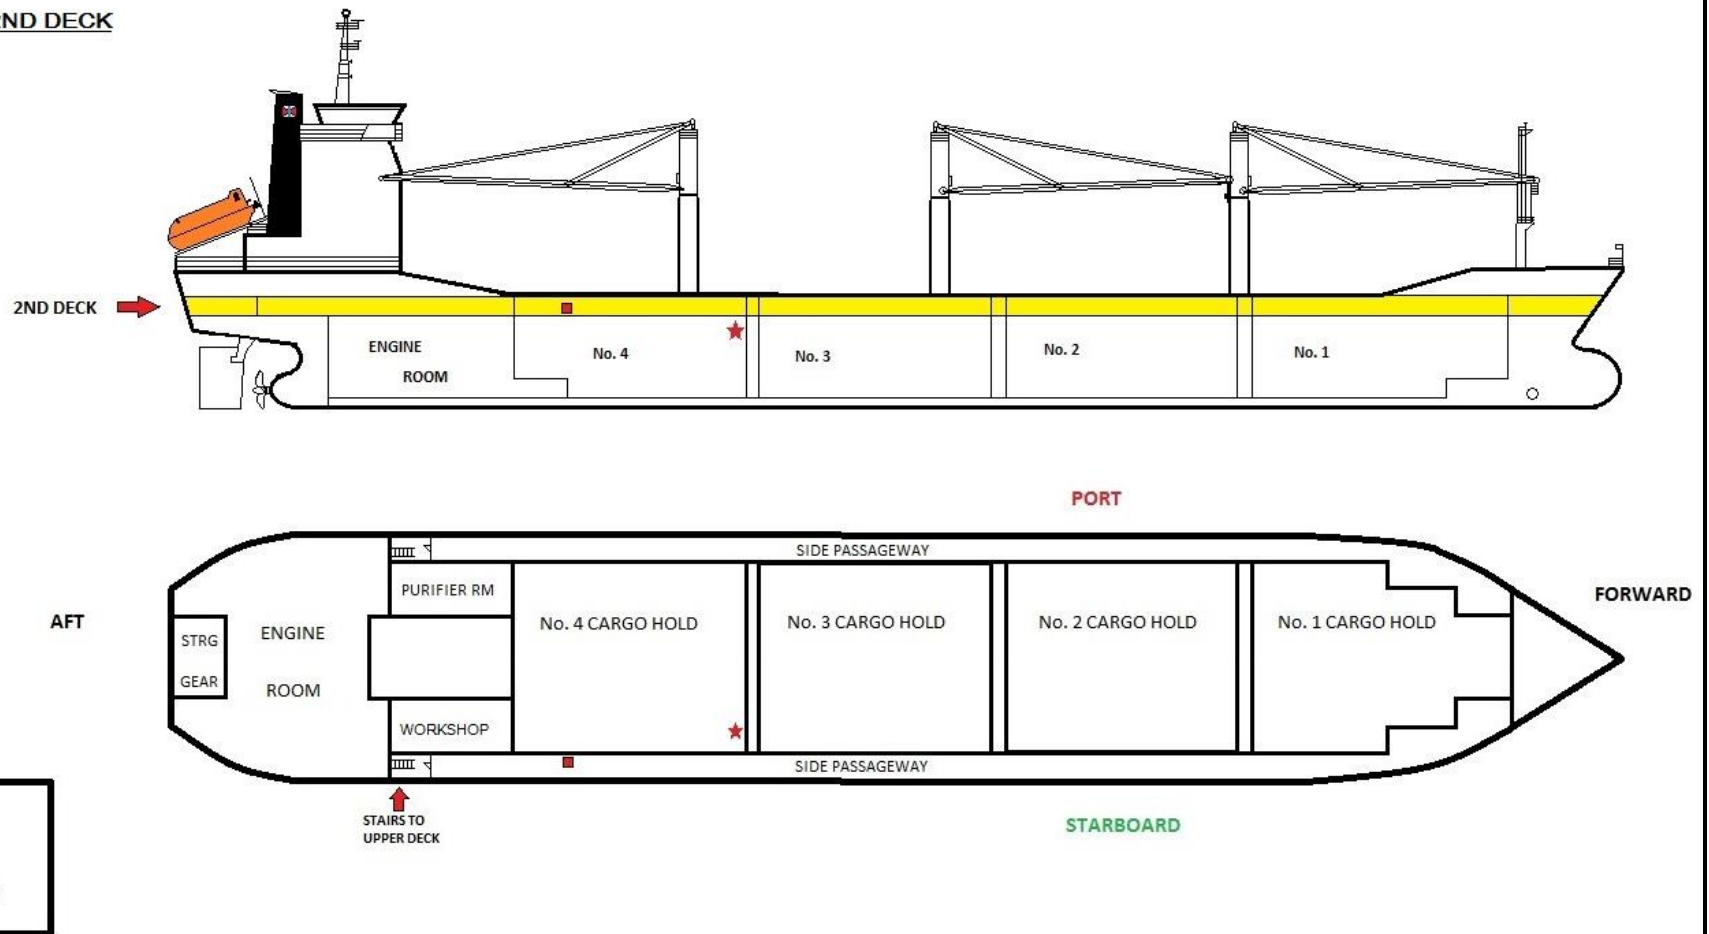
Figure 1  
Location of fire and access hatch

- 3.2.8. The chief officer and the fourth officer went to the starboard-side under-deck passageway, where there was an access hatch to number 4 cargo hold (see Figure 1). They lifted the lid of the access hatch and smelled burning, so immediately closed the lid. They reported to the bridge that there was a fire and that it was not a false alarm.

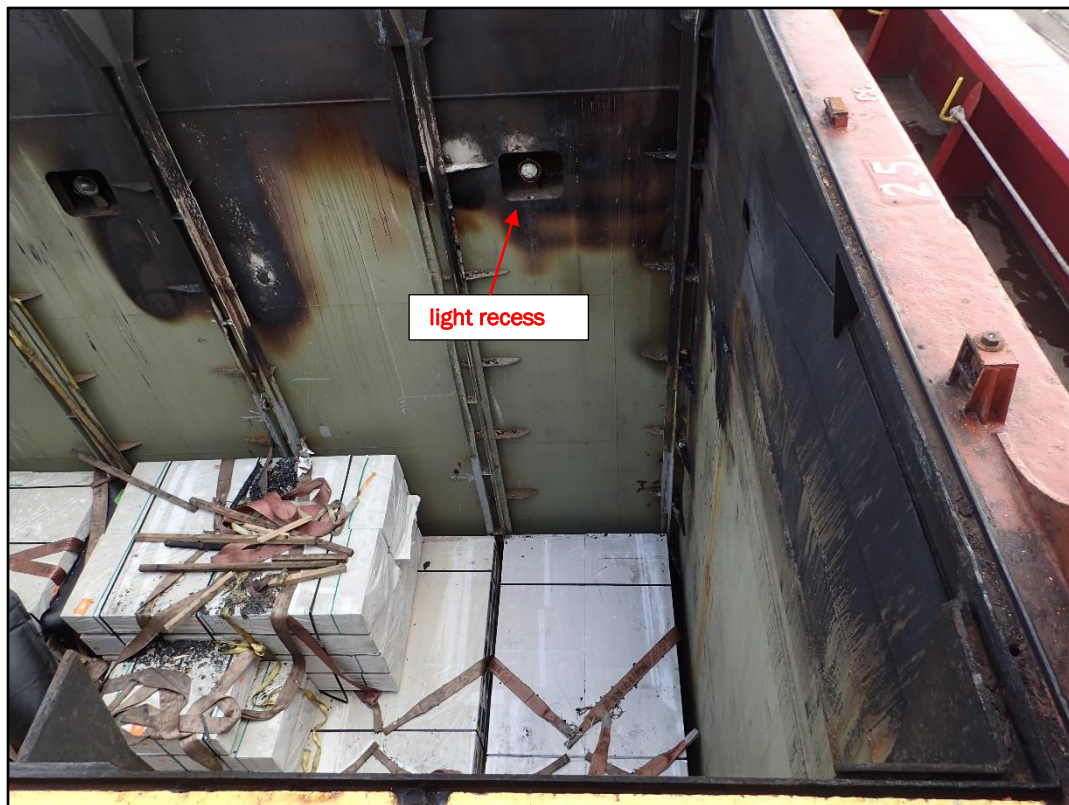
Figure 2  
Remaining timber stowed in number 4 cargo hold after damaged timber had been removed

- 3.3.1. The timber loaded into number 4 cargo hold consisted of 43 packs of sawn radiata pine<sup>12</sup>. The timber packs at the origin of the fire contained individually wrapped, kiln-dried, H4<sup>13</sup> treated posts, 90 millimetres (mm) by 90mm. Each pack had an outer wrapping of woven plastic sheeting.
- 3.3.2. Safety data sheets were reviewed for several brands of treated radiata pine. They all recommended avoiding heat and ignition sources when storing and handling treated pine and its products.
- 3.3.3. The damaged timber was removed to the extent necessary to confirm the fire was out. Figure 2 shows the state of the cargo hold once the timber packs had been removed. The worst of the smoke and heat damage on the forward bulkhead of the cargo hold indicated that the seat of the fire was in the vicinity of the recessed cargo hold light.

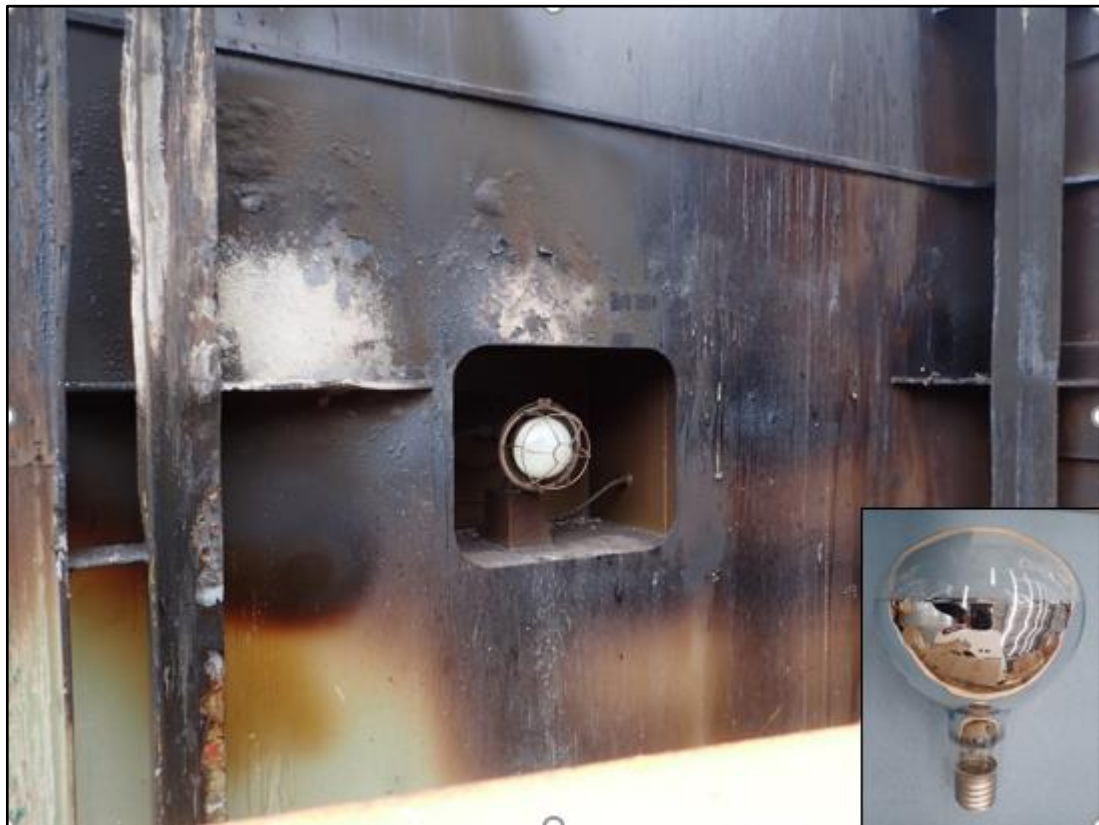
**Figure 3**  
Cargo hold light in recess (inset, the reflector lamp)

- 3.3.4. The cargo hold lights were fitted with Matsuda 500-watt (W) reflector lamps. They were each housed in a protective cage and recessed into the cargo hold bulkhead so that they would not be damaged during cargo operations (see Figure 3).

- 3.3.5. The face of the lamp was 40 mm away from the inside of the protective cage and the protective cage was set in 5 mm from the edge of the recess.

- 3.3.6. The Lloyd's Register requirements for ships' lighting equipment stated that "lamp holders are to be constructed of flame retarding non-hygroscopic materials" and that "lighting fittings are to be so arranged as to prevent temperature rises which overheat or damage surrounding materials"<sup>14</sup>. Technically, the lighting installations on board the *Kokopo Chief* complied with these rules. However, the choice of lamp and cargo stowage are beyond the scope of these rules.

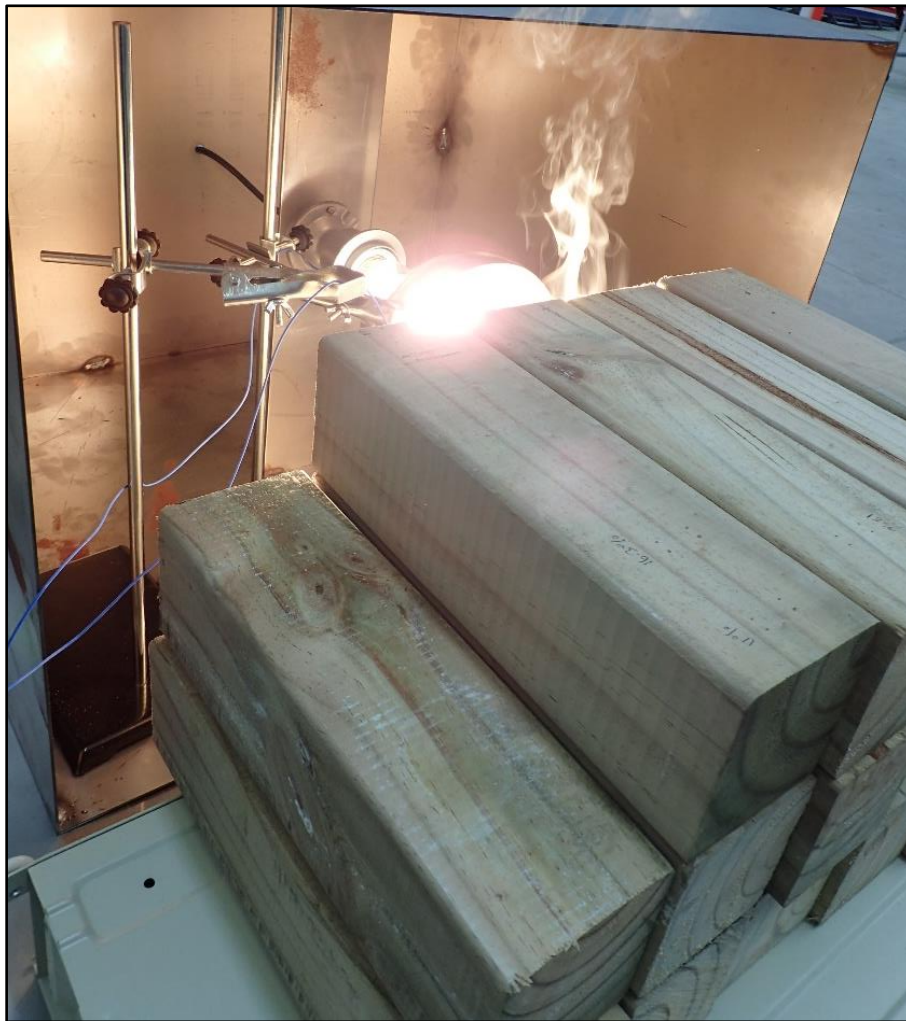
Figure 4  
Lamp test set-up

- 3.3.10. Because there was no data available for a 500 W reflector lamp, the Commission carried out tests<sup>17</sup> to measure the temperature of a Matsuda 500 W reflector lamp when operated under conditions similar to those on board. A steel box was fabricated with dimensions matching those of the light recess in the cargo hold (600 mm x 700 mm x 525 mm). Thermocouples<sup>18</sup> were used to measure the temperatures at the centre of the lamp's face and at the surface of the timber opposite the lamp. A stack of H4 treated, dry radiata pine was placed 50 mm from the opening to the box and the lamp was switched on (see Figure 4).

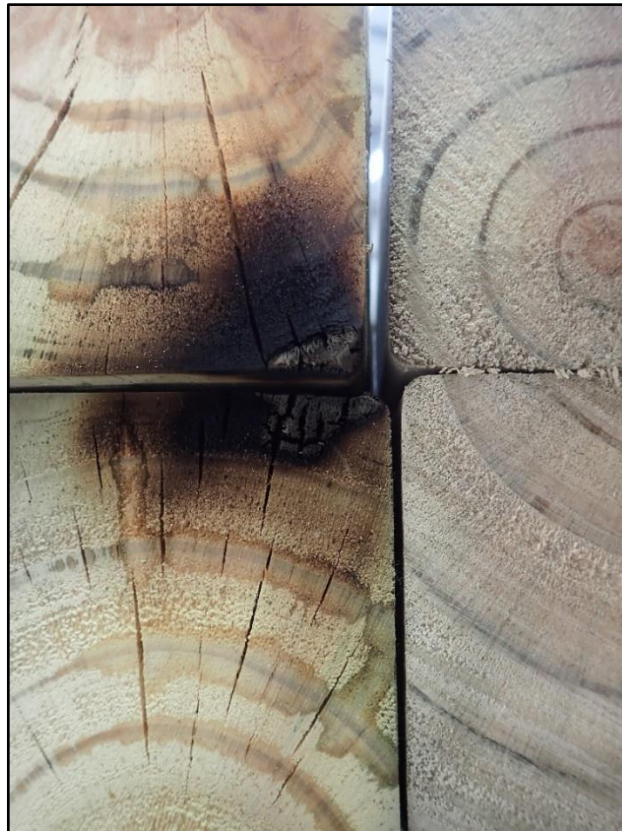
- 3.3.11. Before the lamp reached a maximum temperature, the test had to be stopped because the timber had already started to smoulder<sup>19</sup> (see Figures 4 and 5). At the time that smoke was first seen the temperature of the lamp was 155 °C (degrees Celsius) and the temperature at the surface of the timber was 114 °C. The temperature of the lamp continued to rise and was 208 °C when the test was stopped (see Figure 6).

Figure 5  
Photograph taken after three minutes' exposure to the lamp

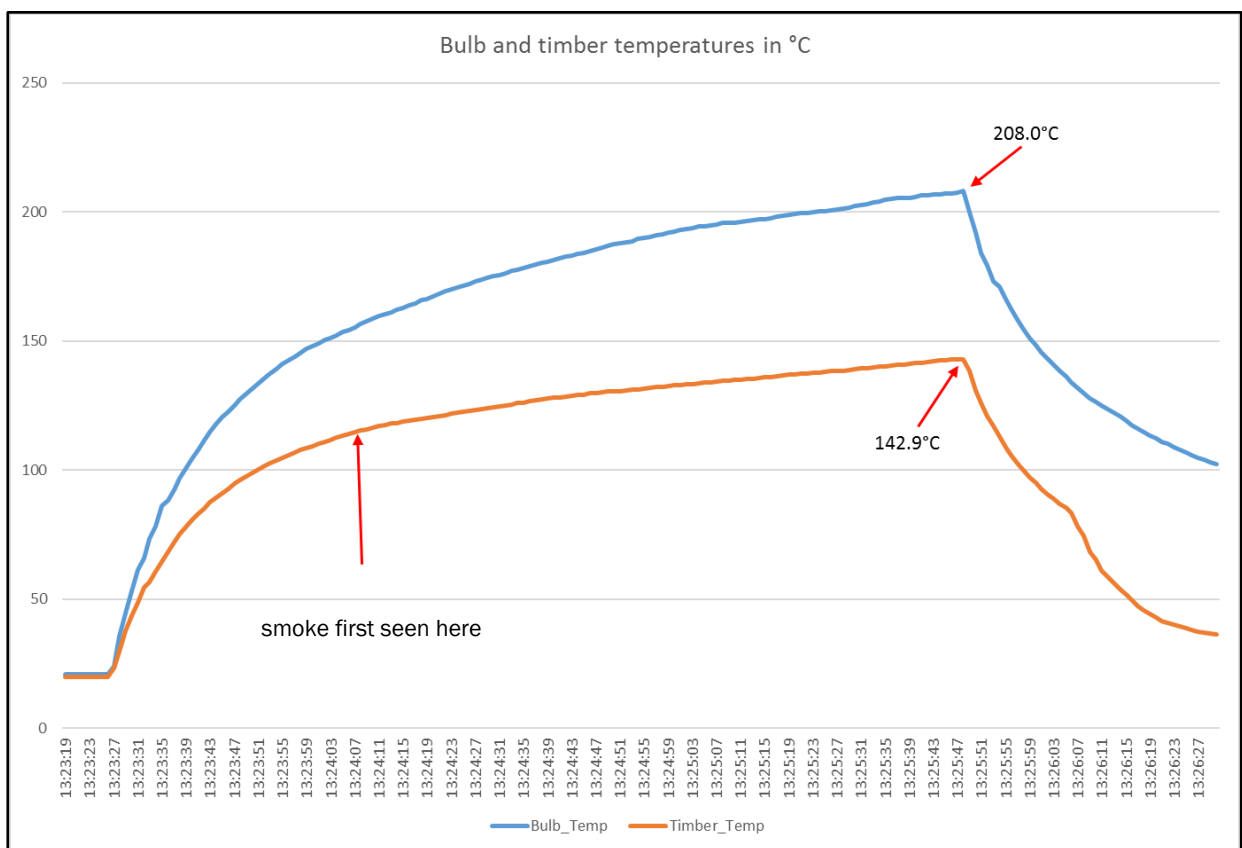
Figure 6  
Graph showing temperatures recorded by test thermocouples

- 3.3.12. With no obstruction across the opening to the box, the lamp reached a maximum temperature of 191°C and remained at 188-190°C. It was found that placing the timber across the opening restricted the airflow around the lamp and prevented heat dissipation. The lamp reached a higher temperature and the heat was concentrated onto a focused point on the timber, where the smouldering commenced.

- 3.3.13. Several tests were run. However, when timber was placed at the opening to the steel box the tests had to be ceased after three to four minutes for safety reasons. Consequently, the maximum temperature the lamp would have reached could not be determined. The maximum temperature recorded was 216°C and rising.

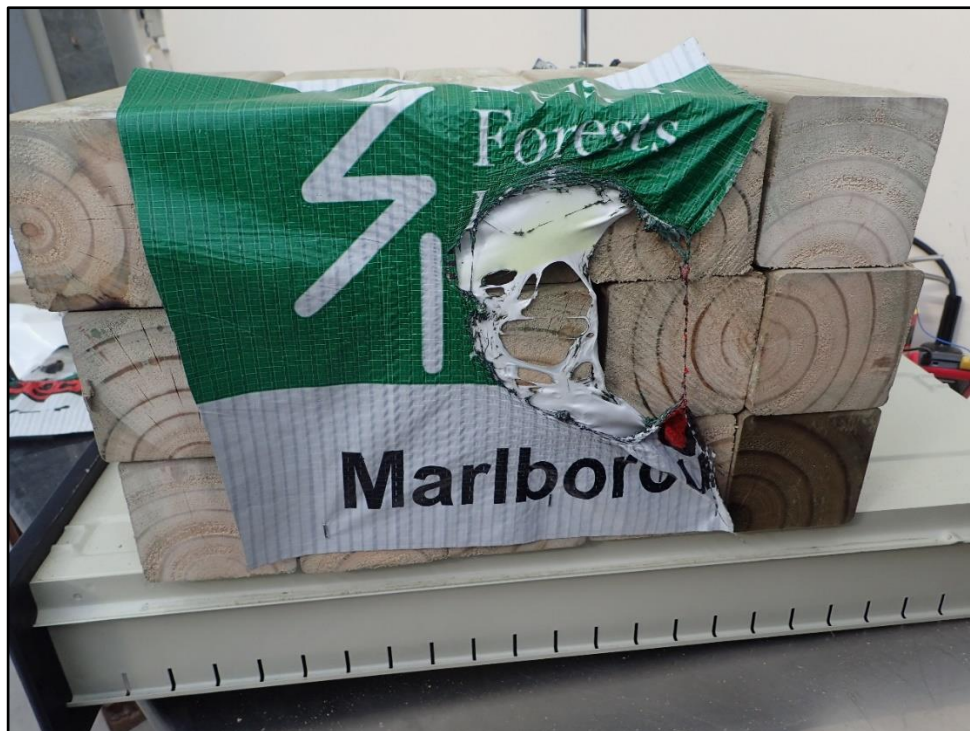
- 3.3.14. Samples of the plastic used by the sawmill<sup>20</sup> to wrap its timber products were secured over the test timber. The plastic was found to melt, but not ignite, and left the timber exposed to the hot lamp (see Figure 7). The plastic wrapping was not considered an accelerant. In fact, in the tests the wrapping delayed the start of the timber combustion for about 30 seconds.

**Figure 7**  
Plastic wrapping after two minutes, 20 seconds of exposure to the ship's lamp

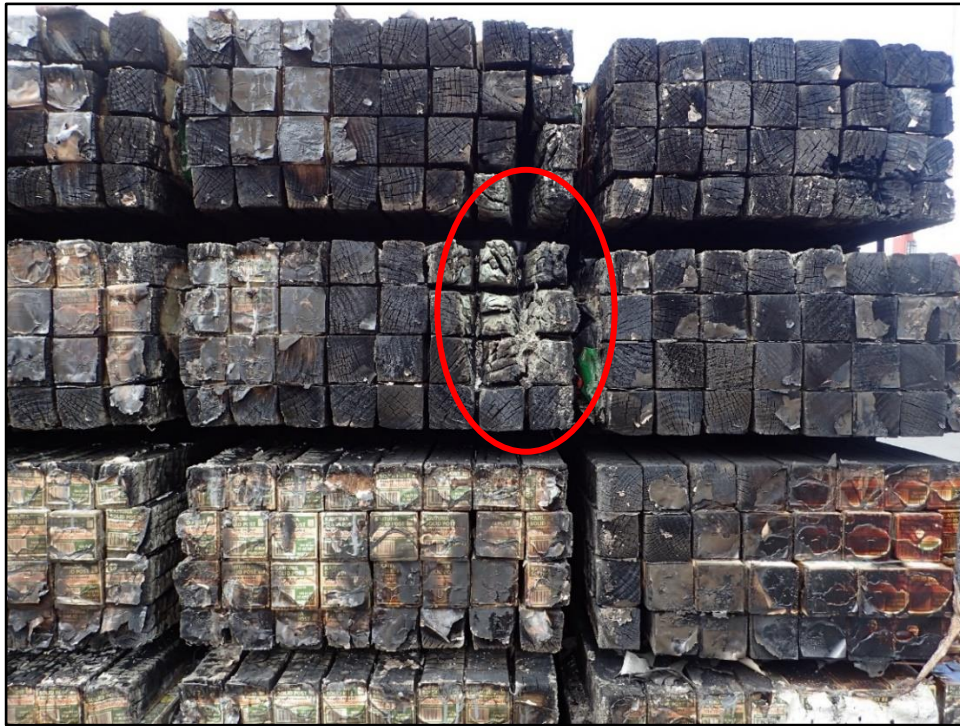
Figure 9  
Timber packet showing origin of fire

- 4.2.1. The burn pattern on the timber cargo adjacent to the cargo hold light was a strong indication that the heat generated by the reflector lamp was the cause of the fire. The only other potential sources of heat found in the cargo hold were two old cigarette butts found in the hold. However, both were found at the opposite end of the hold to the fire location. One had been well stubbed out and the other had been discarded behind a cell guide<sup>21</sup> and could not have come into contact with any cargo.

- 4.2.4. The deep scorching of the timber that was stowed directly opposite the 500 W lamp showed that enough heat was radiated from the light to melt the plastic wrapping and cause the exposed timber to smoulder (see Figures 9 and 10). This timber was estimated to have been loaded as close as 45-50 mm from the face of the lamp. Over time the plastic wrap melted to expose the timber ends, which became hot enough to start a smouldering fire.

- 5.1. The fire was caused by heat radiating from an incandescent cargo hold lamp that set fire to packs of timber that had been stowed within 45-50 mm of the lamp.

- 4.2.8. Another measure that can be taken to mitigate the risk of similar fires is having procedures in place for ensuring that cargo hold lighting systems are turned off (and, if necessary, isolated) at an appropriate time before a loading operation creates the hazard. In this case, the lights could have been switched off and/or isolated as soon as the timber packs were placed over the lighting recess.
