Transport Accident
Investigation
Commission

Final Report

Marine Inquiry MO-2018-202
Accommodation fire on board
Fishing trawler Dong Won 701
Timaru
9 April 2018

December 2019

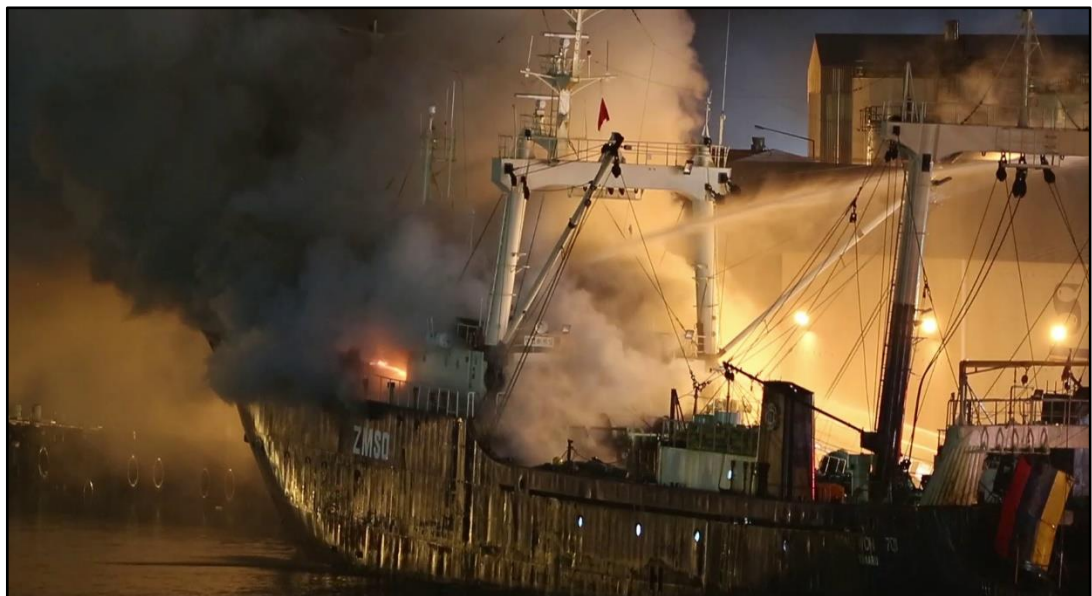
Figure 3: The *Dong Won 701* on fire

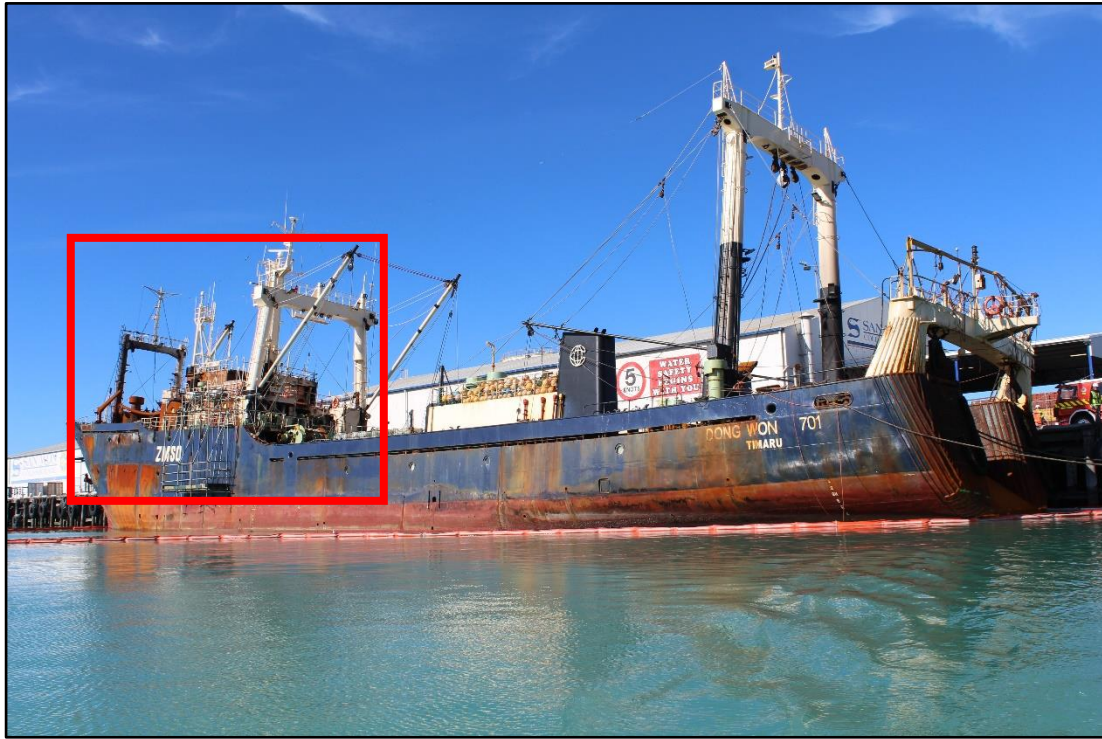
- 2.25. The following is an overview of the damage caused by the fire. A FENZ fire investigation report in Appendix 1 provides a more detailed description of the damage. The vessel suffered fire and heat damage to areas forward of the main winches on the upper deck, as shown in Figure 6.

Figure 6: Area affected by fire marked in red

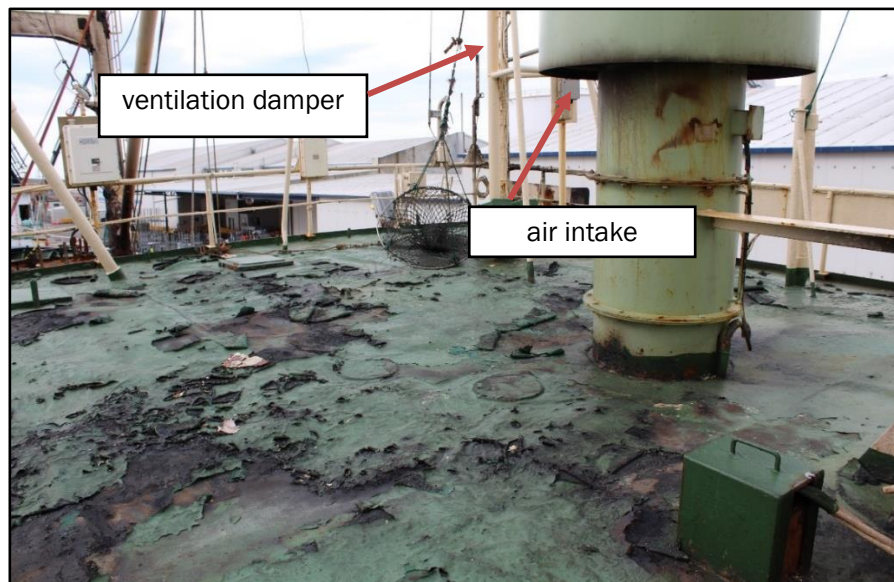
- 2.26. The accommodation superstructure and area forward of the superstructure suffered severe heat damage and buckled in several areas. The rear of the superstructure was less affected: the protective paint was still relatively intact and there was no buckling of the upper deck.
- 2.27. A ventilation damper¹⁰ located above the bridge was found in the open position.

Figure 7: Ventilation damper on top of the bridge

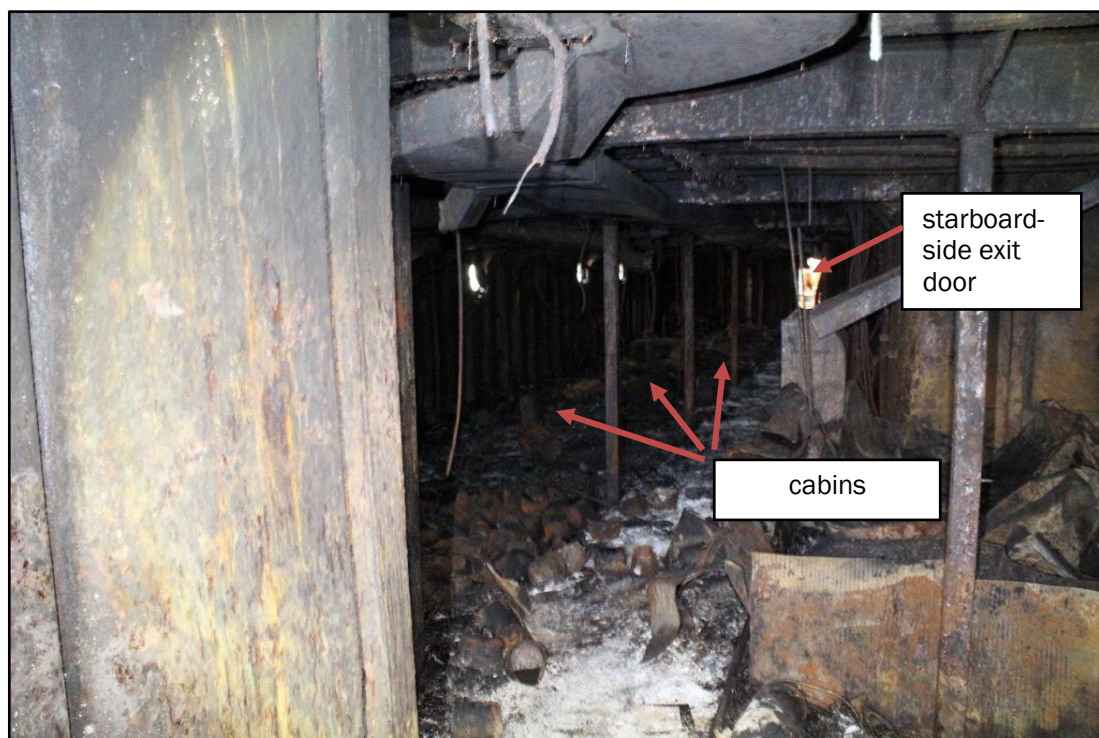
2.28. All cabins located on the port and starboard sides of the officers' deck were destroyed by the fire (see Figure 8 and Figure 9). The first engineer's cabin suffered the most fire damage. The severity of the damage reduced with the distance away from the first engineer's cabin.

Figure 8: Fire damage to cabins on the officers' deck

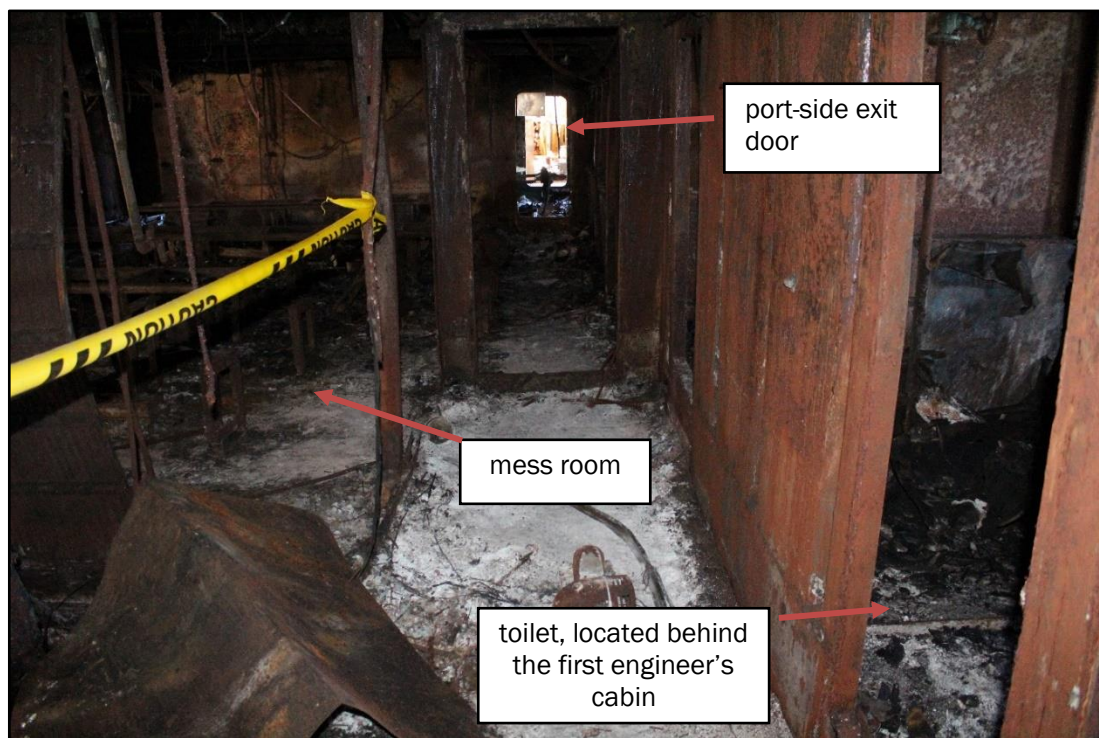
Figure 9: Fire damage to the officers' deck, port side

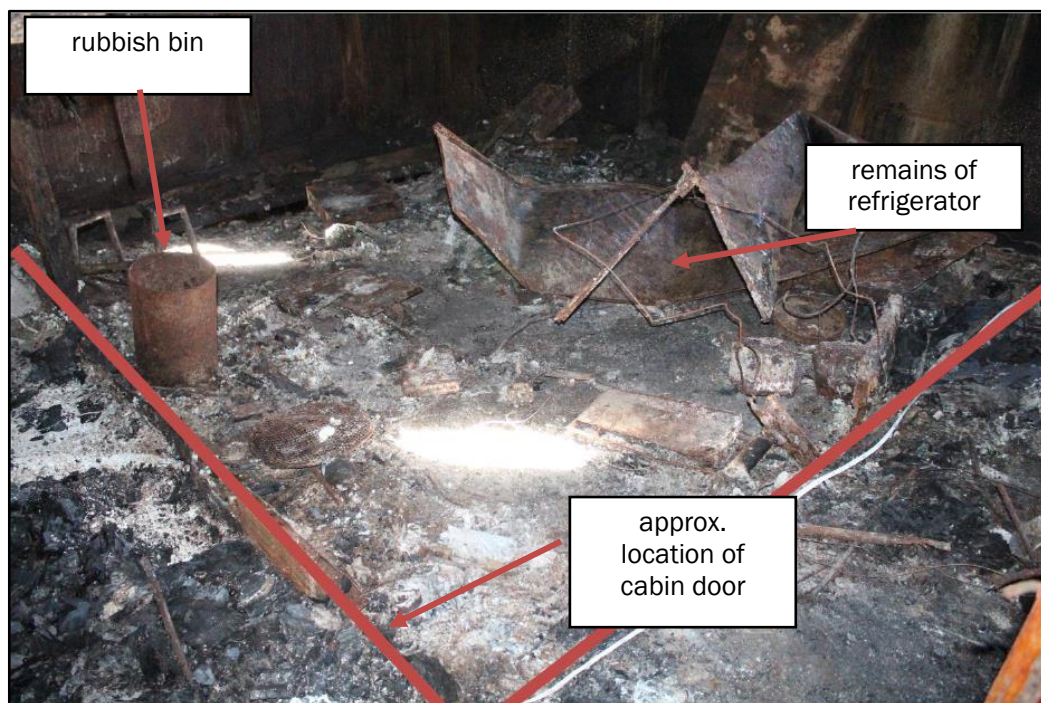
Figure 10: Fire damage to first engineer's cabin

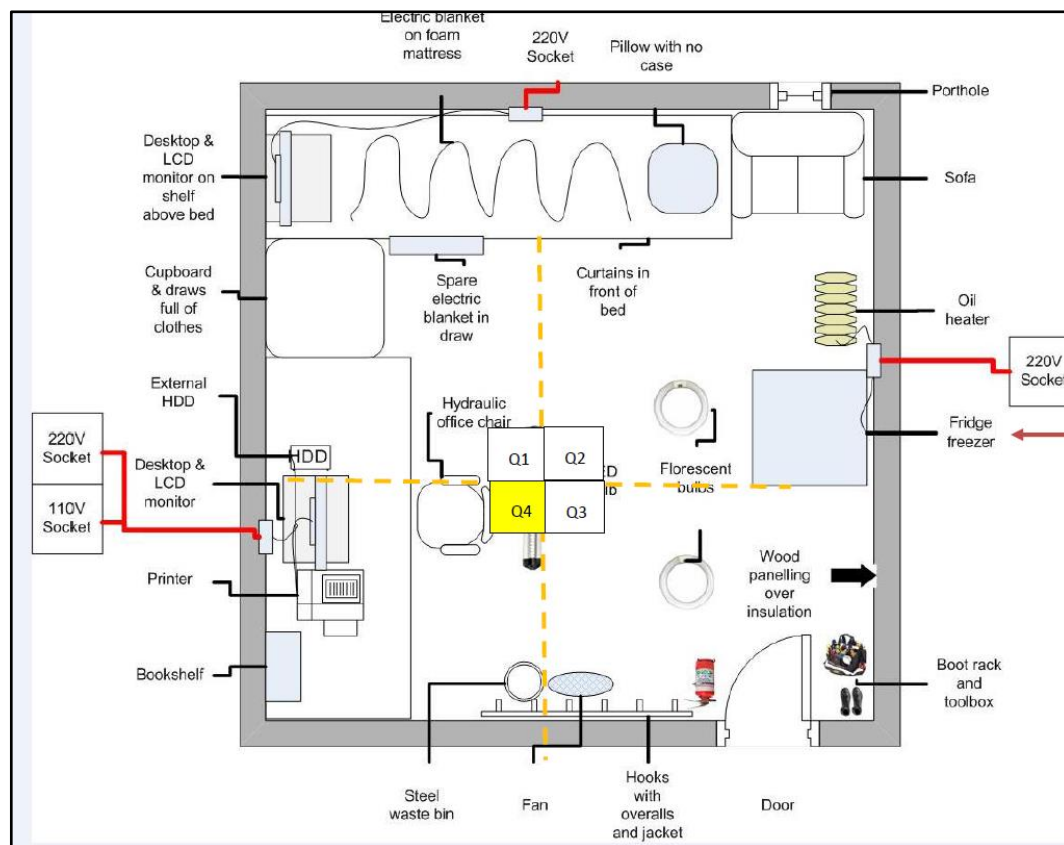
- 3.7. The point of origin was considered to be at or just above the floor level beside the rubbish bin, next to the first officer's desk. The burn patterns on the ceiling and the warping of the steel plate where the cabin bulkheads¹³ were fastened supported this conclusion, as did the accounts of those who entered the cabin during the initial firefighting effort.

Figure 11: Plan layout drawing of first engineer's cabin

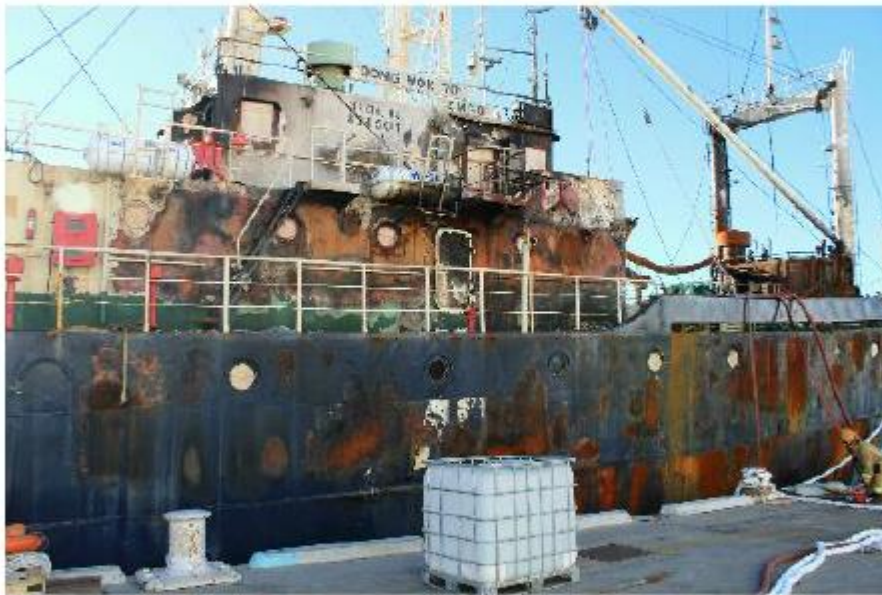
An external examination of the vessel was carried out which revealed obvious signs of fire and heat damage to almost the entire front half. Oxidization of the steel hull on both port and starboard sides was proof of this. (Refer to photo 4).

Photo 4: Shows the oxidisation on the superstructure and hull that is a result of excessive heat.

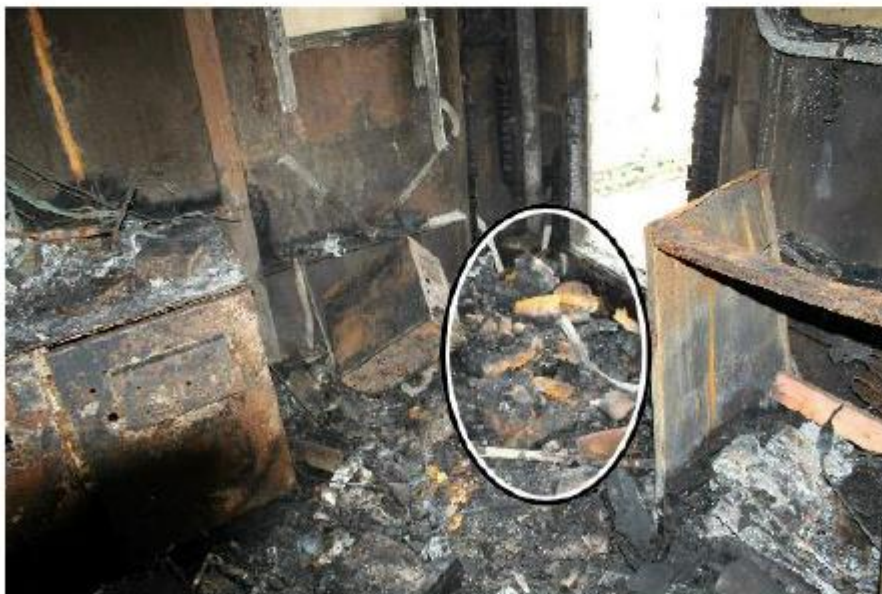
burning and oxidization of the steel around the windows at the front of the area to have less fire debris left on the port side compared with the starboard side. This aligned to the warping of the gunnel in front of the bridge. There was a large rectangle hole in the floor that had obviously been engineered into the floor. It was more to the port side of the area and was the ladder that provided access between levels. I did not identify anything in the debris that could have been a door or hatch to shut the ladder off from the lower level. (Refer photo 7). The rear starboard corner of the Bridge was less damaged than the rest of the area. I noticed parts of the wooden flooring were still in place along with timber framing that lined the steel structure and polystyrene that was used as cladding between the hardboard walls and the steel structure. (Refer to photo 8).

Photo 8: The circle shows the wall cladding and remaining floor at the rear entrance on the starboard side of the bridge.

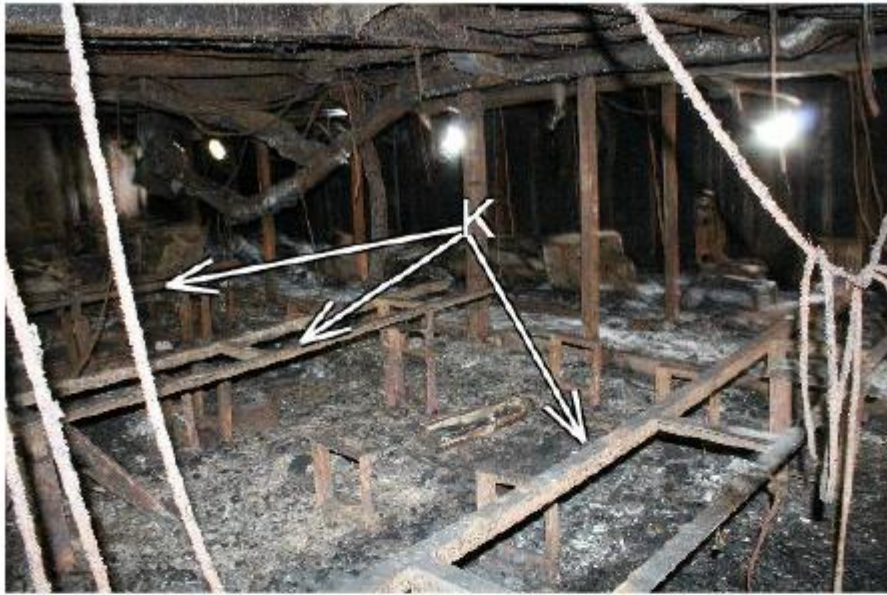
I entered this area through the galley door at the rear on the port side. I noticed a chair in the galley that was only partially burnt. Galley appliances such as a wok and deep fryer were also only partially damaged. I noticed the ceiling lining was hanging from the roof at the rear of the galley. I then inspected the dining area and found all wall, floor and ceiling linings were gone. The dining tables were steel frames. I could clearly make out the passageway due to the lack of debris and identified the steel plate that protruded vertically from the floor where the internal wall was fastened too. (Refer to photo 9).

Photo 9: 'K' shows the steel frames that were the dining tables.

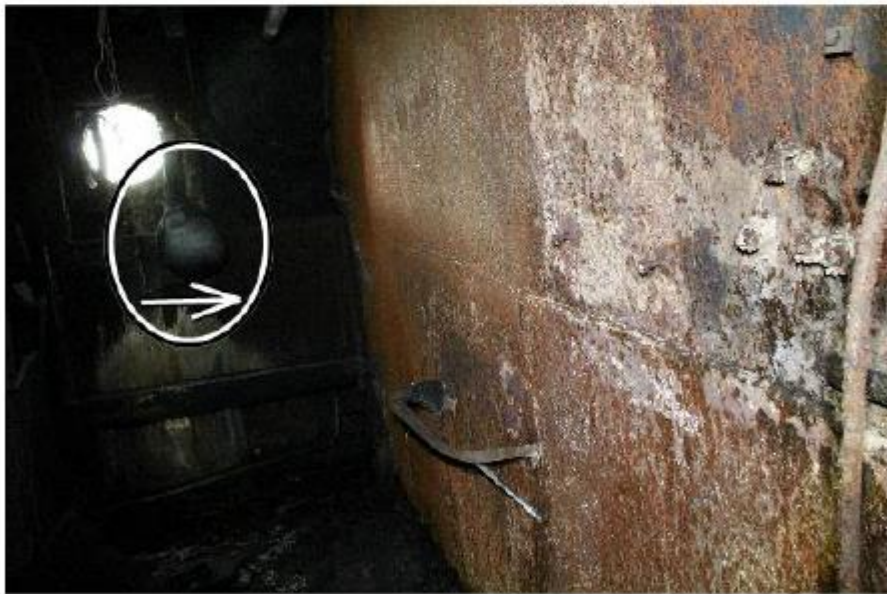
I inspected the two cabins on the port side as I moved toward the front of the ship. Both had similar damage with the exception of the forward-facing steel wall in the second cabin. This wall had been subjected to intense heat. This was indicated by the oxidization of a section of wall. The rest of the room still had the remains of wall linings attached to the walls. There was a cover hanging from the port hole that had moved toward the forward-facing wall due to this being the hottest area. (Refer to photo 10).

Photo 10: The circle identifies the cover over the port hole and the arrow shows the gravitation towards the heat.

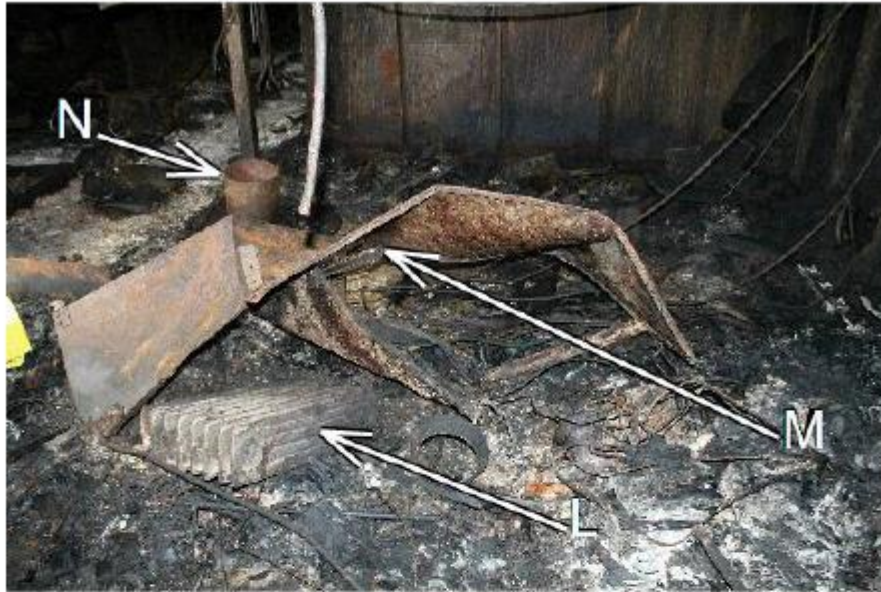
Photo 11: Shows the first engineer's cabin looking to the rear of it. 'M' identifies the fridge. Note the way it has collapsed. 'L' identifies the oil column heater. 'N' identifies the rubbish bin.

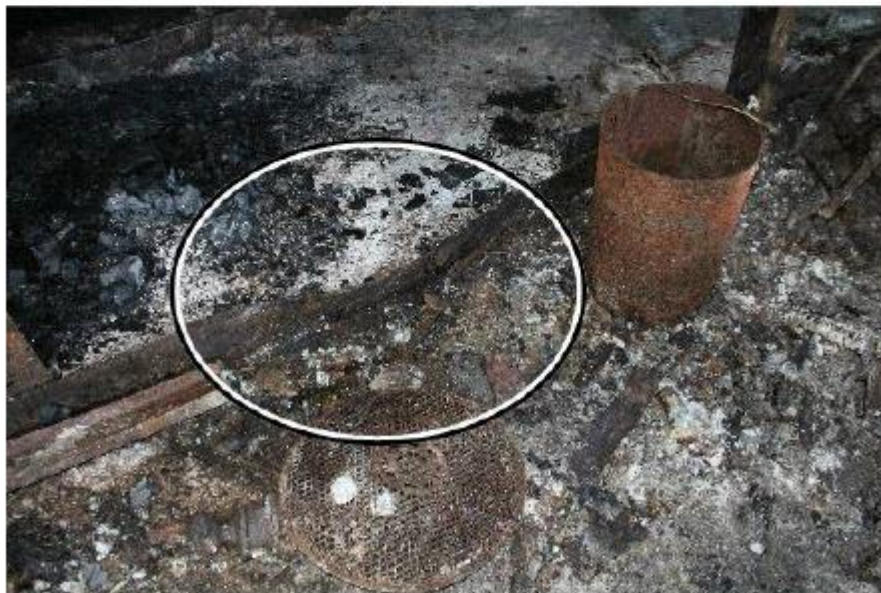
I returned to the First Engineer's cabin and examined the area. I found the remains of a fridge that had collapsed toward the starboard side of the room. Underneath this was an oil column heater. The fridge would have been positioned against the wall between the first engineer's cabin and cabin 1. (Refer photo 11). Working my way to the rear of the cabin from this point I identified a rubbish bin on the starboard side and the metal cover from an electric blower fan beside it. I noticed the steel plate that protruded vertically from the floor where the hardboard wall had warped extensively due to heat at this point. (Refer to photo 12).

Photo 12: The circle shows the warped steel plate.

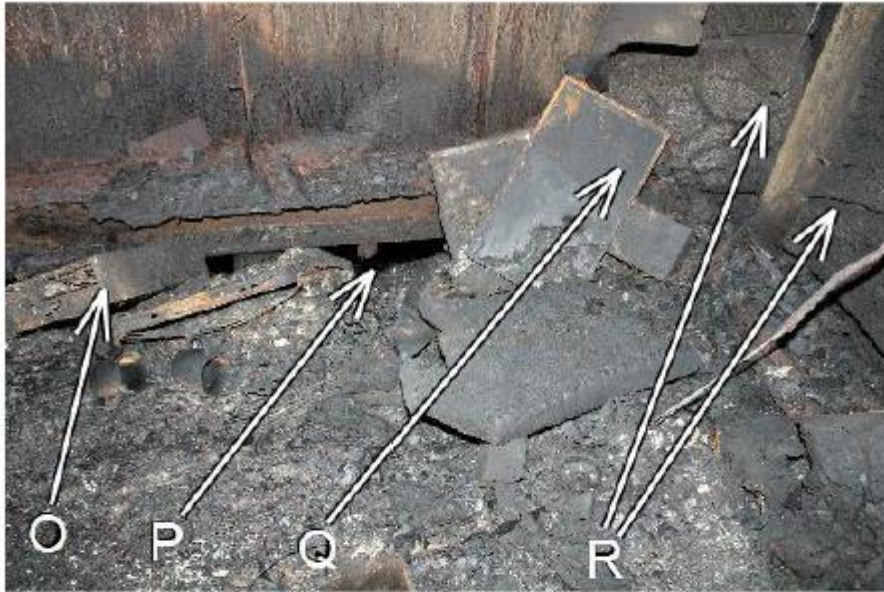
I moved to the rear of the cabin and found the remains of a computer, printer and monitor on the floor against the rear wall. I noticed a hole in the floor where it had separated from the wall. It was approximately two metres long and 150 mm wide at its widest point. (Refer photo 13). The bottom section of the wall and the floor that joined it were extremely rusted and corroded. I noticed there was polystyrene insulation along the port side wall and the burn patterns on the steel were not as pronounced as those on the rear wall and the roof.

Photo 13: 'O' identifies the computer. 'P' identifies the hole at the bottom of the rear wall. 'Q' identifies the computer monitor and 'R' shows the remaining cladding on the port side wall.

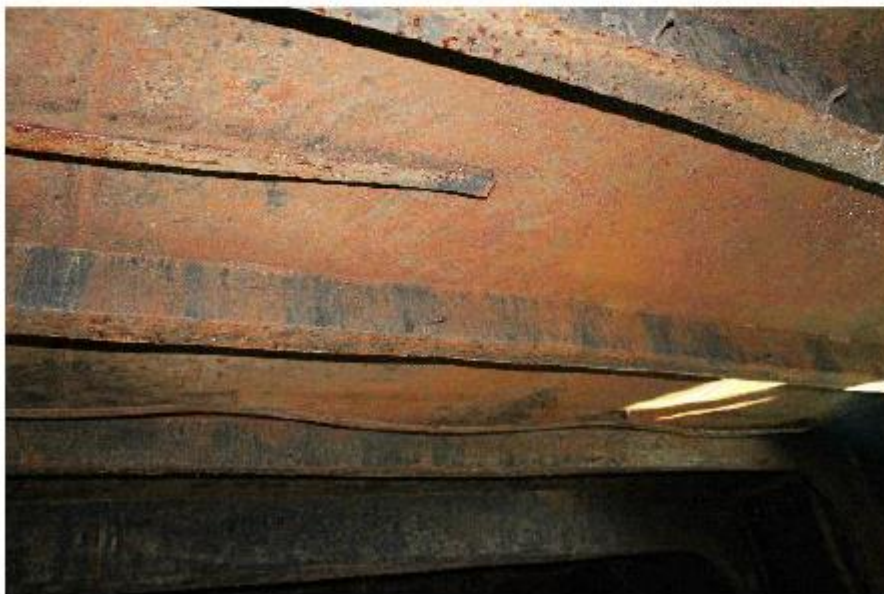
The burn patterns that showed the area that sustained the most intense heat were those on the ceiling. (Refer to photo 14). They were more intense in a strip across the cabin (port to starboard) in a line between the port hole and rubbish bin. I identified a number of green glass bottles on the floor against the port side wall. The tops of the bottles had distorted and were pointing toward the direction of the most heat. They were indicating across the cabin toward where the rubbish bin was positioned.

Photo 14: Shows the burn pattern on the ceiling in a line between the porthole and the rubbish bin.

The point of origin was considered to be at or just above floor level beside the rubbish bin. Indications of this were the burn patterns on the ceiling, the position of the of the fridge, the warping of the steel plate that had the cabin wall fastened to it and the witness statement that identified fire in the wall just above floor level.

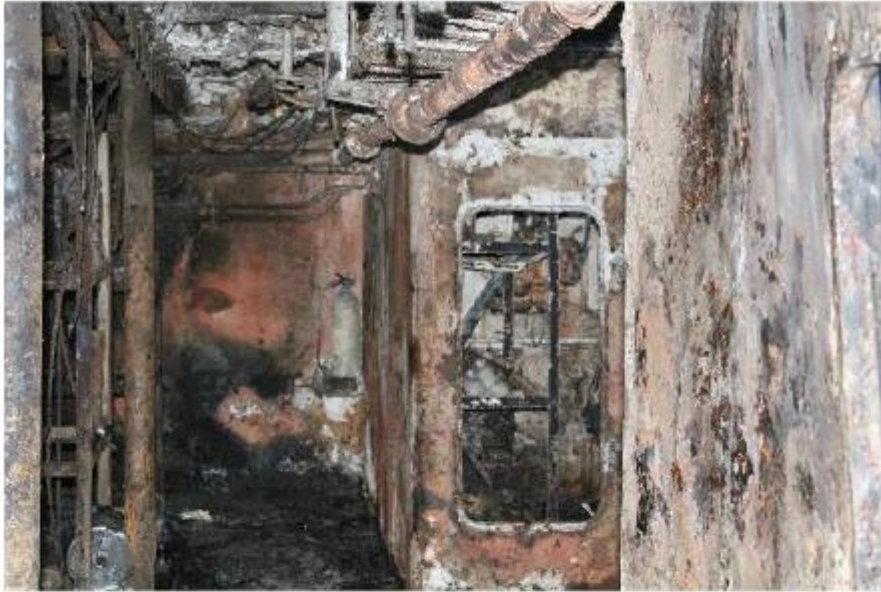
While the walls, floors and ceiling linings of the cabins in this area were destroyed there was clearly less fire intensity. Indicators that identified this were even burn patterns with no obvious fire travel indicators as found on other levels and a considerable amount of cladding and paint remaining on the walls. (Refer to photo 15).

Photo 15: Shows the remaining paint on the walls of the Seamen's Living Quarters.

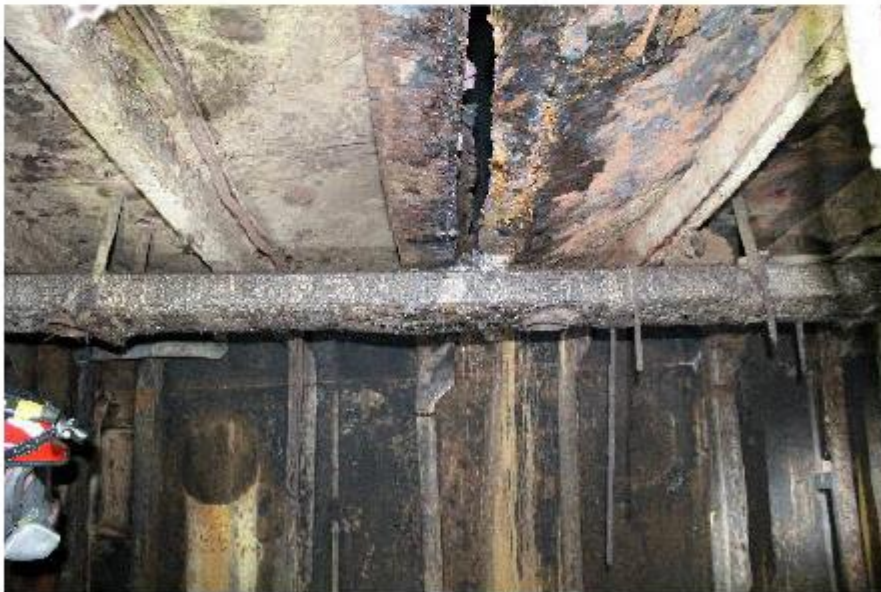
I examined the area below the First Engineer's cabin. While the ceiling below this cabin showed more indication it had sustained heating for longer than the rest of the area it was not to the degree of the patterns on the ceiling in the First Engineer's cabin. I then examined the separation in the ceiling. As above, in the First Engineer's cabin I observed excessive rust and corrosion. I did not consider this to show any indication of fire travel between levels. (Refer to photo 16).

Photo 16: Shows the corrosion around the separation between the wall and ceiling in the Seamen's Living Quarters.
