Transport Accident
Investigation
Commission

Final report

Marine inquiry MO-2018-205

***Fatality on board the factory trawler San Granit
14 November 2018***

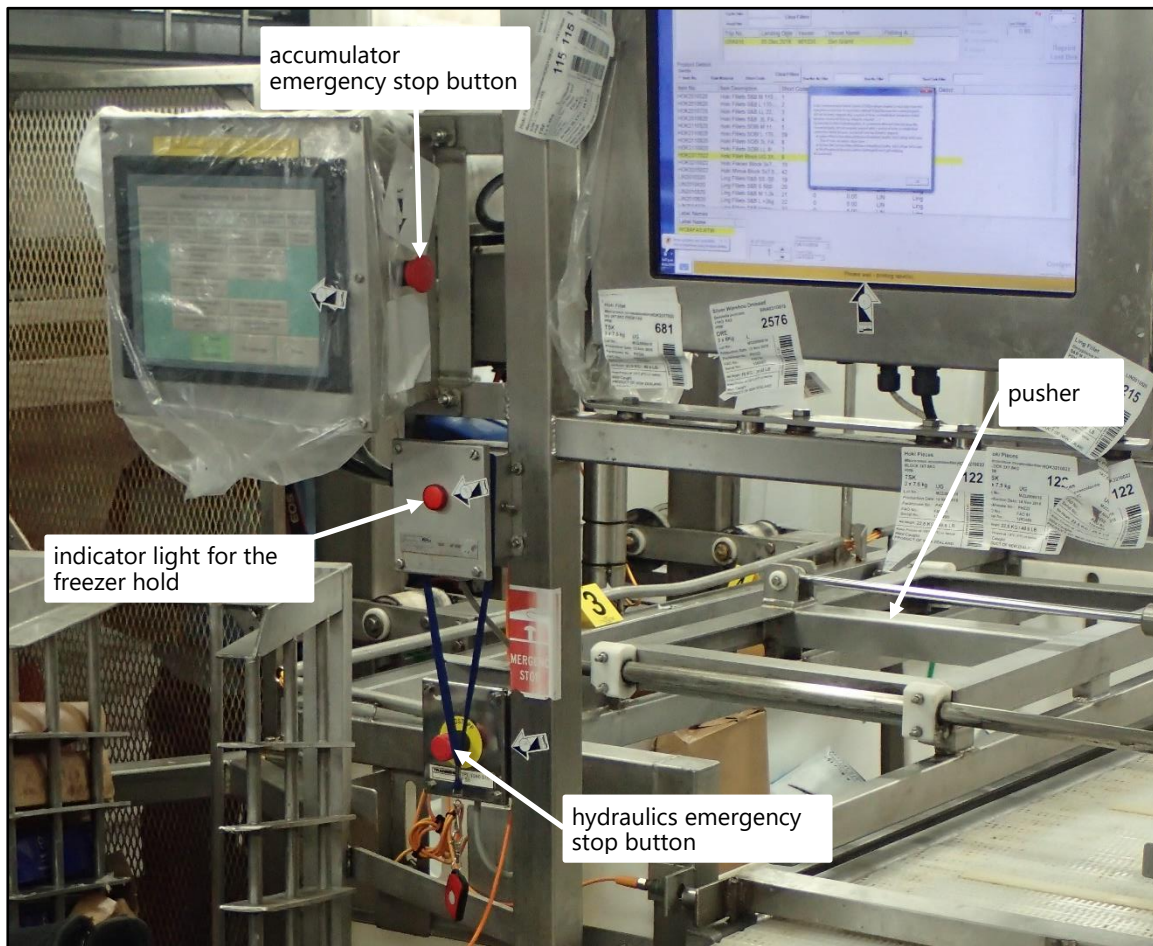
Figure 6: Control screens and emergency stops at the weighing and packing station

- 3.15. It had been noted in EH&S meetings that there was confusion surrounding the emergency stops in the factory, particularly on which emergency stops serviced which system, due to their not being properly labelled. The investigation found that only the emergency stop on the operator's touch screen and the emergency stop button on the side of the touch screen (see Figure 6) cut the power to the accumulator.

- 3.16. Post-accident recovery actions required the operation of the accumulator, and as a result the status of the emergency stops at the time of the accident could not be determined. Attempts to recreate the accident scenario showed it was very likely that the freezerman did not operate the accumulator emergency stop. This recreation, together with interviews conducted in the course of the investigation, identified some confusion among crew on which emergency stop serviced which system. The investigation found, through interviews with the crew and the recreation of the accident, that the confusion identified in the EH&S meetings was likely the result of poor awareness of the emergency stop configuration that had been passed on through training. While it was unlikely that this issue contributed to the accident, crew could potentially access running machinery after pressing an incorrect emergency stop.

- 6.4. **On 25 March 2020 the Commission recommended that the Chief Executive of Sanford Limited implement training for the crew on the configuration of the emergency stops to avoid confusion on which emergency stop services which system. This will reduce the likelihood of crew accessing running machinery after pressing incorrect emergency stops. (002/20)**

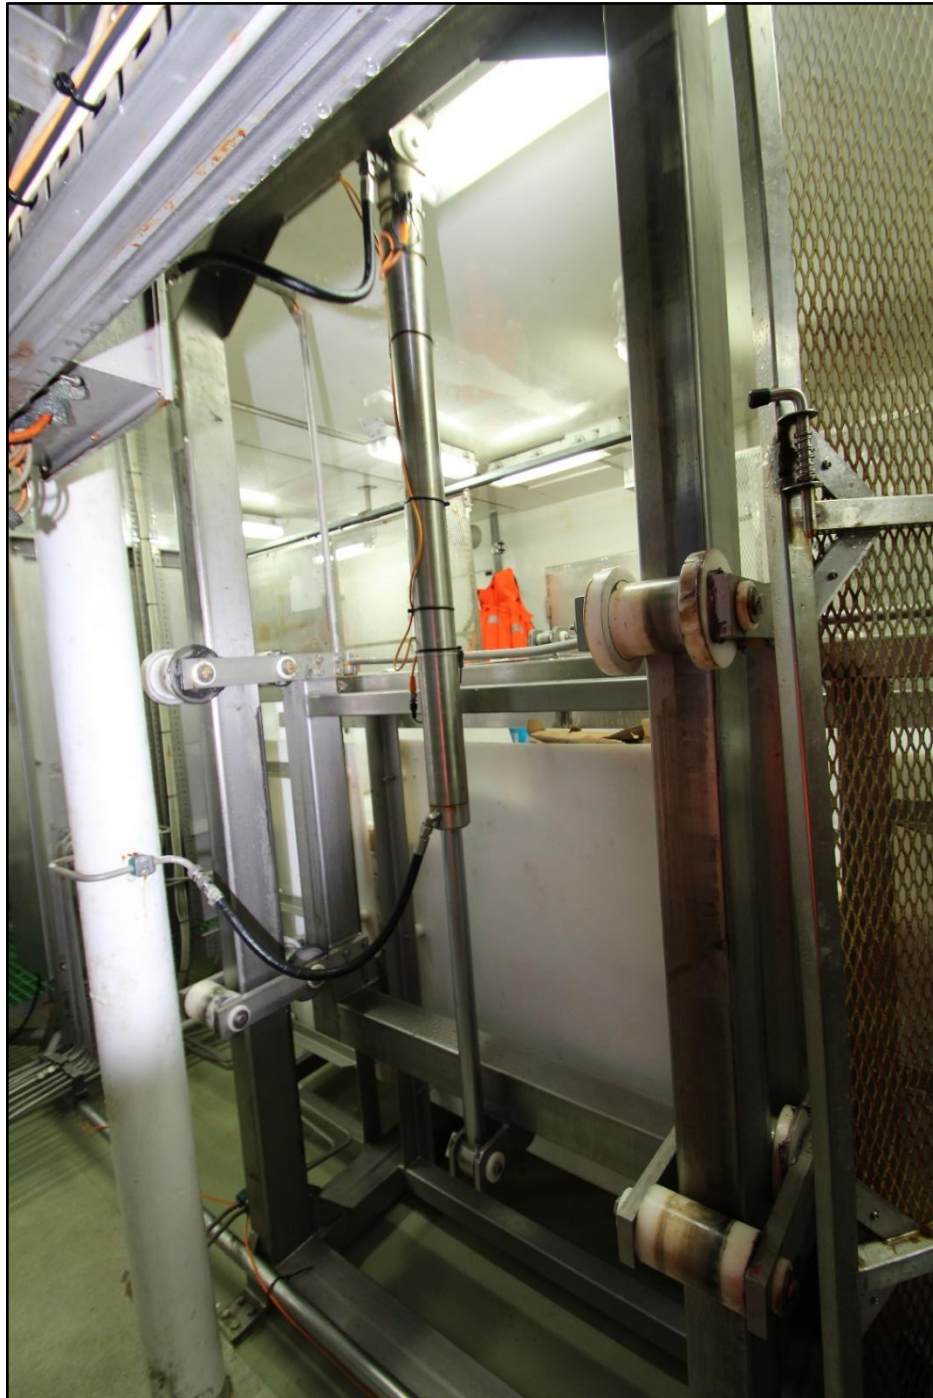
Figure 7: Hydraulic ram at the back of the accumulator, which moves the floor up and down (credit: Maritime New Zealand)

- 3.6. The accumulator was found to have been operating in automatic mode at the time of the accident. In this mode, when the hydraulic ram that raised and lowered the floor of the accumulator was activated, the attached framework (see Figure 9) would lower. It was therefore likely that the hydraulic ram was activated by the freezerman triggering a sensor. This then lowered the attached framework and trapped the freezerman between the static and moveable sections of the framework.

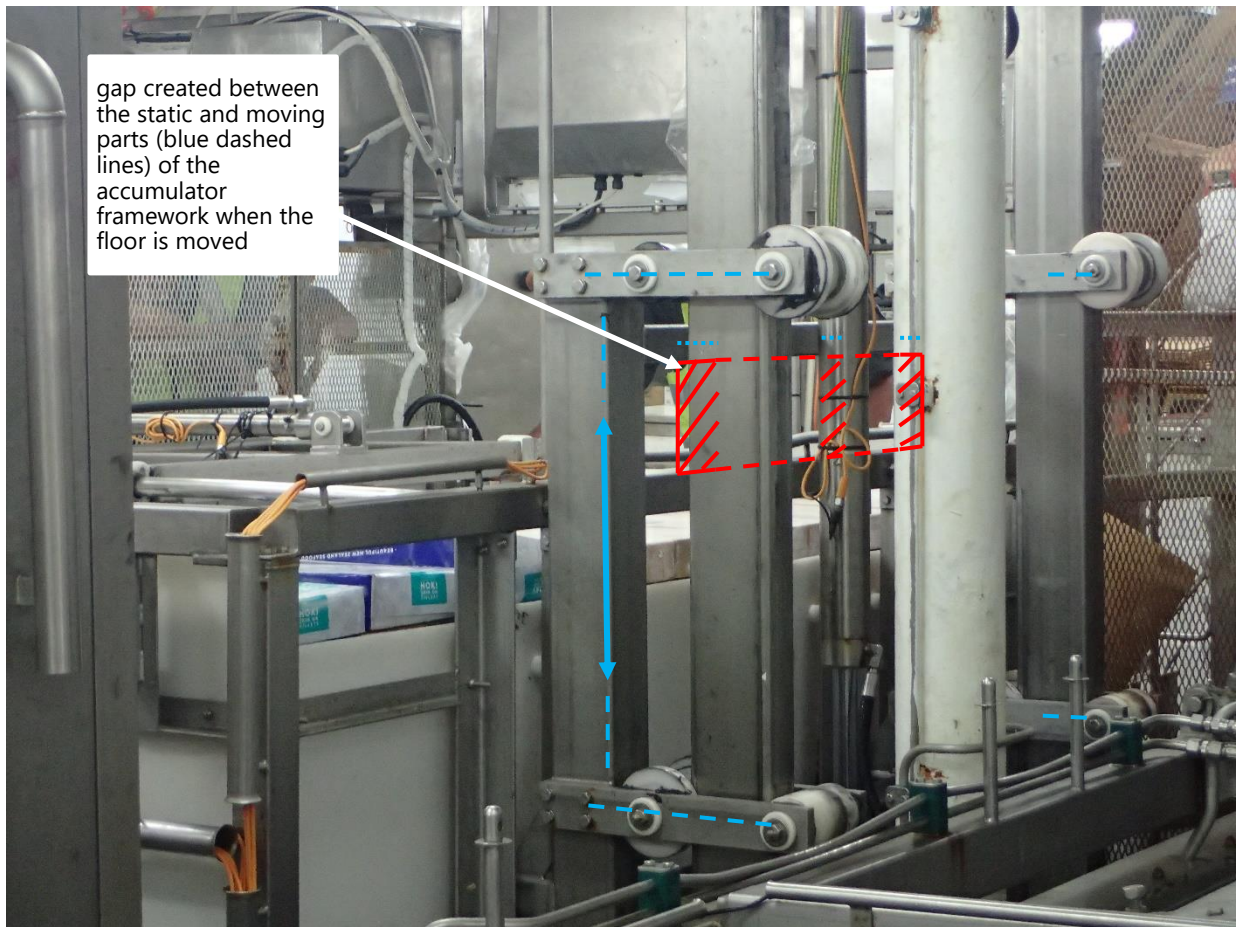
Figure 9: View of the accumulator showing the area where the freezerman was entrapped

- 3.5. The freezerman was found trapped in a position that showed it was very likely they were reaching into the accumulator when the accident occurred. It is about as likely as not that the freezerman reached into the accumulator attempting to clear a box of frozen product that had become misaligned.
