Transport Accident
Investigation
Commission

Final Report

***Marine inquiry MO-2019-201
Jet boat Discovery 2
contact with Skippers Canyon wall
23 February 2019***

December 2019

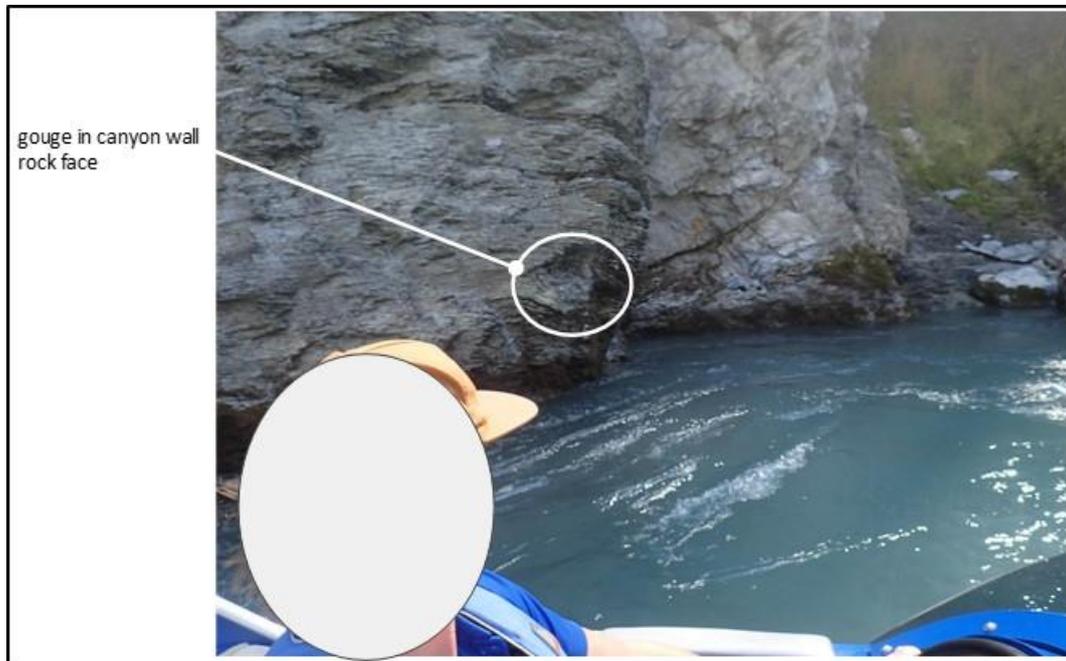
Figure 5: Photo showing location of the *Discovery 2*'s impact with the canyon wall

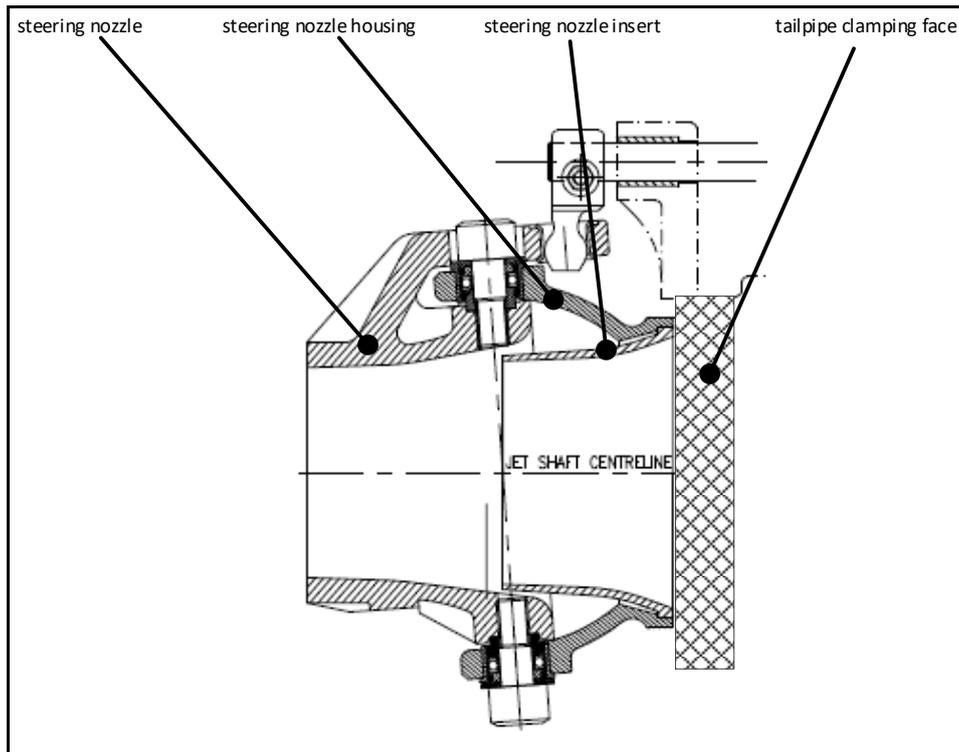
Figure 11: Steering nozzle assembly showing insert

- 3.31. The nozzle assembly described in section 2 included an insert into the nozzle. The failure analysis found that the insert was not fitting flush with the bearing face of the nozzle housing and was proud by up to 0.23 millimetres. The clamping arrangement between the steering nozzle and the tailpipe was therefore not optimal and may have contributed to fatigue in the stud-bolts.

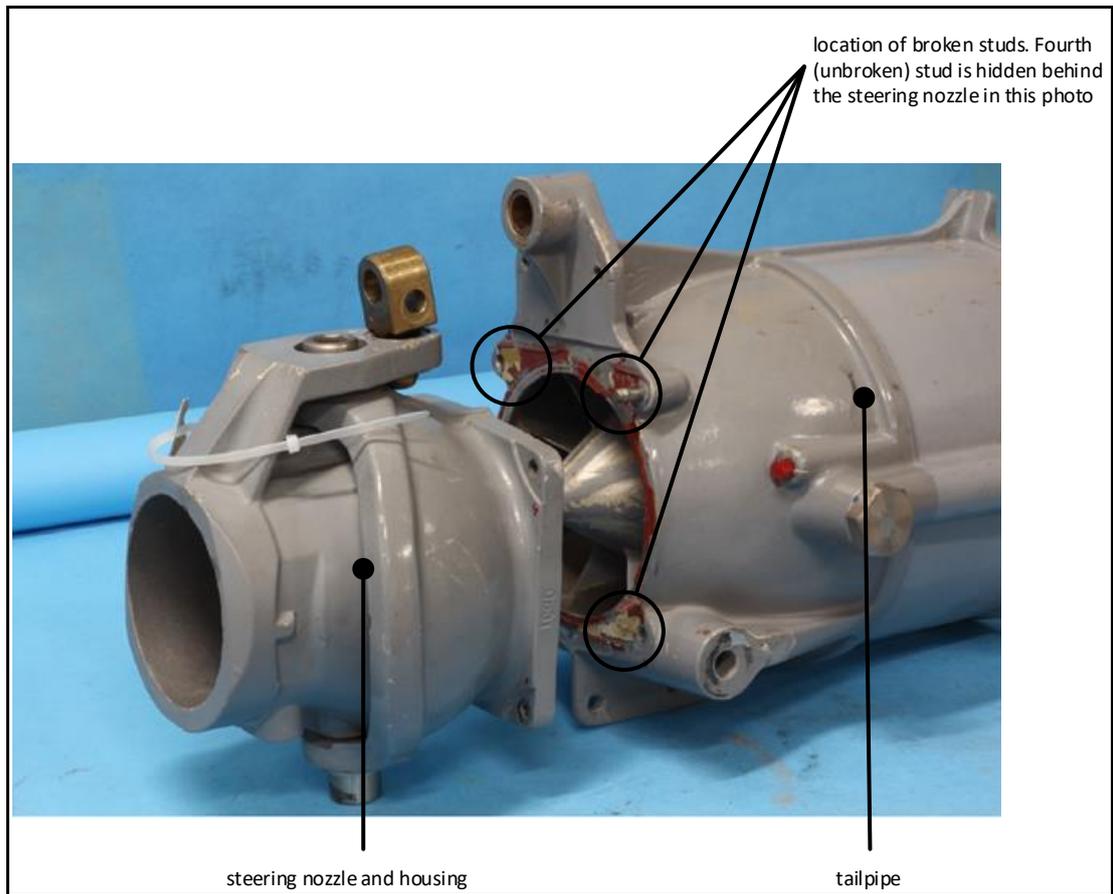
- 2.42. The consultant's report found, in part:
- the jet nozzle failed on the Discovery 2 as a result of fatigue cracking of three of the four stud-bolts holding the nozzle housing on to the tailpipe (shown in Figure 12)

- the fatigue cracking had begun within about the previous 200 hours of operation
 - the major cause of the fatigue cracking is considered to be a lack of adequate torque when the nuts were last tightened on the stud-bolts

- this led to insufficient pre-tension on one or more of the stud-bolts, in turn resulting in excessive cyclic loads being applied to the stud-bolts, resulting in the observed fatigue failures

- a liquid sealant had been applied to the joint, and was found to be up to 0.1 millimeters thick. If the stud-bolts had been tightened to specification the sealant should have been extruded from the contact face.

Figure 12: Photo showing the separated steering nozzle and tailpipe, and broken stud-bolts

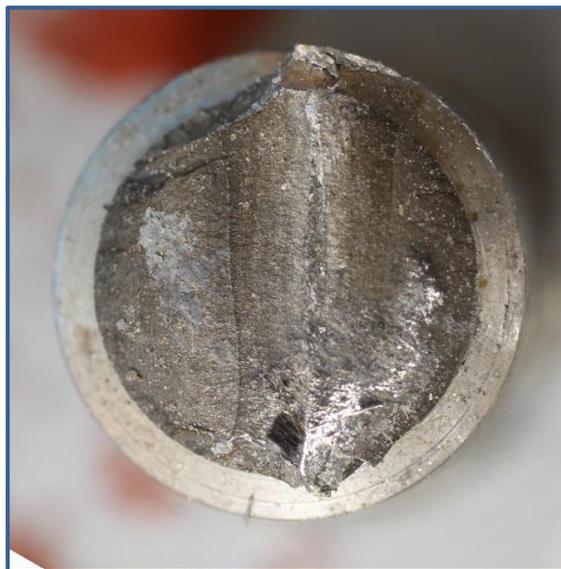
Figure 13: Fatigue fracture surface of a stud-bolt from the Discovery 2

- 3.7. The failure analysis conducted on the broken stud-bolts found they had failed due to fatigue cracking. A close examination of the fracture faces (Figure 13) showed that the fatigue cracking was consistent with low pre-tension in the stud-bolt.

- 3.8. The failure analysis report concluded that the stud-bolts had fractured due to fatigue cracking caused by insufficient torque being applied to the nuts and therefore inadequate pre-tension in the stud-bolts.

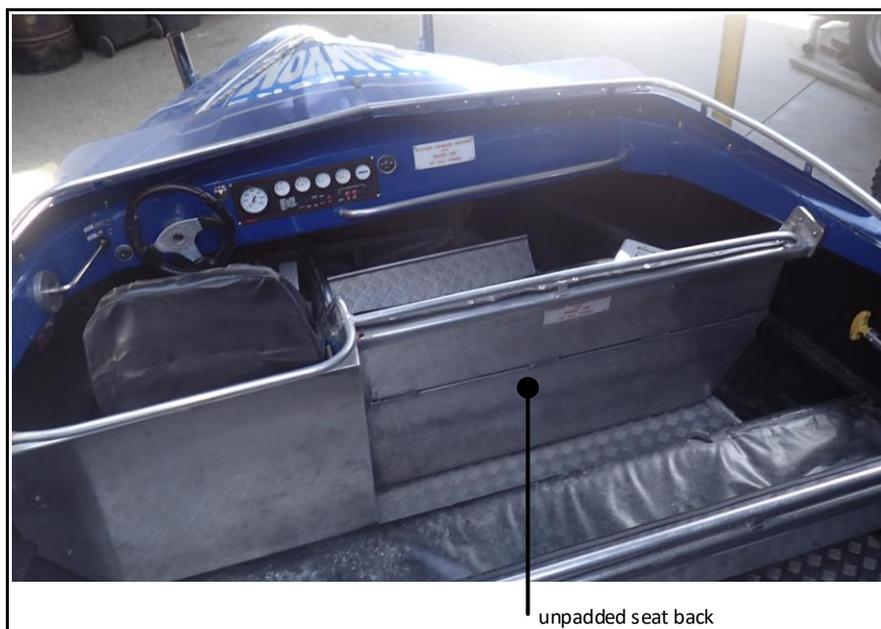
- 3.38. Other recovery risk controls laid out in Part 82 are handholds for passengers, padding to cushion contact between them and the boat, and no "projections and sharp edges" that could harm passengers. The *Discovery 2* was free of projections and sharp edges. However, it is likely that some injuries were aggravated when passengers were thrown into the unpadded seat backs in front of them, as shown in Figure 14.

Figure 14: Interior of the Discovery 2
