Transport Accident
Investigation
Commission

Marine inquiry MO-2019-203

Bulk log carrier *Coresky OL*

**Crew fatality during cargo-securing operation,
Eastland Port, Gisborne**

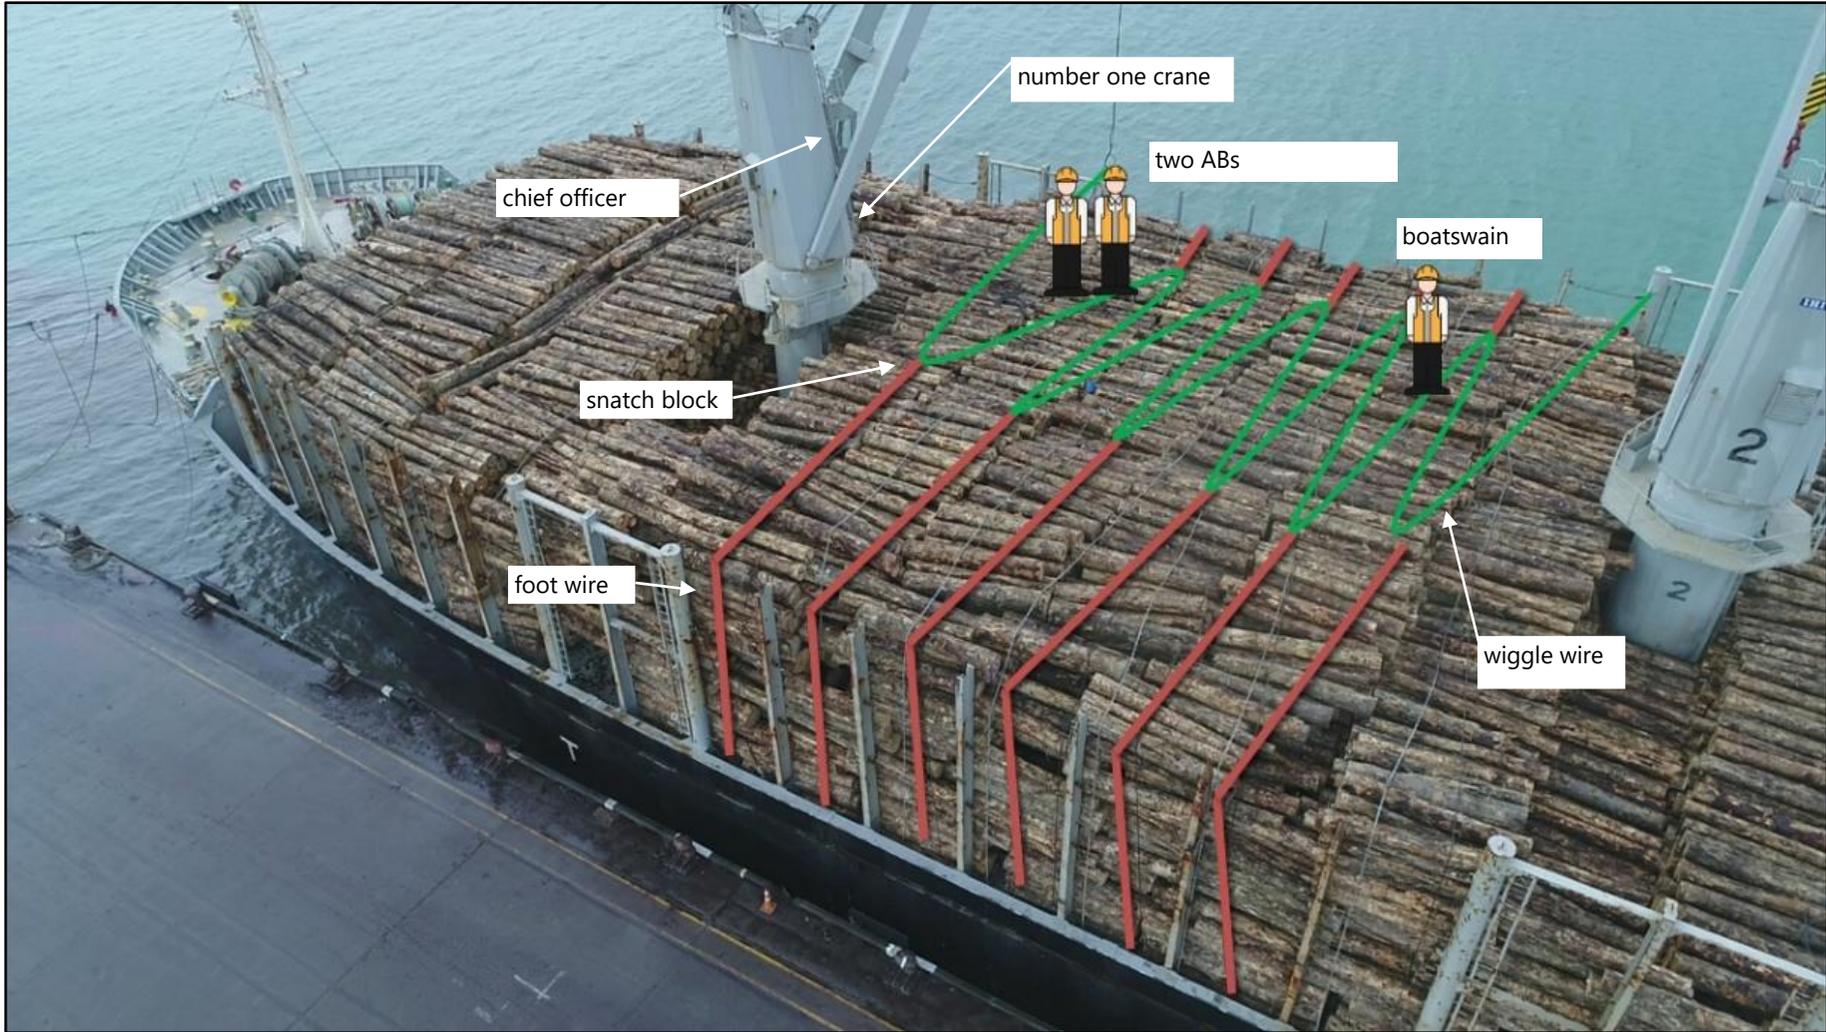
**Figure 3: Diagram of the accident site
(Credit: Eastland Port)**

- 2.9 At about 0140 the chief officer commenced heaving⁹ on the wiggle wire. At this time the boatswain was walking away from the number one crane and had their back to the chief officer. The boatswain then turned around and signalled to the chief officer to stop heaving.

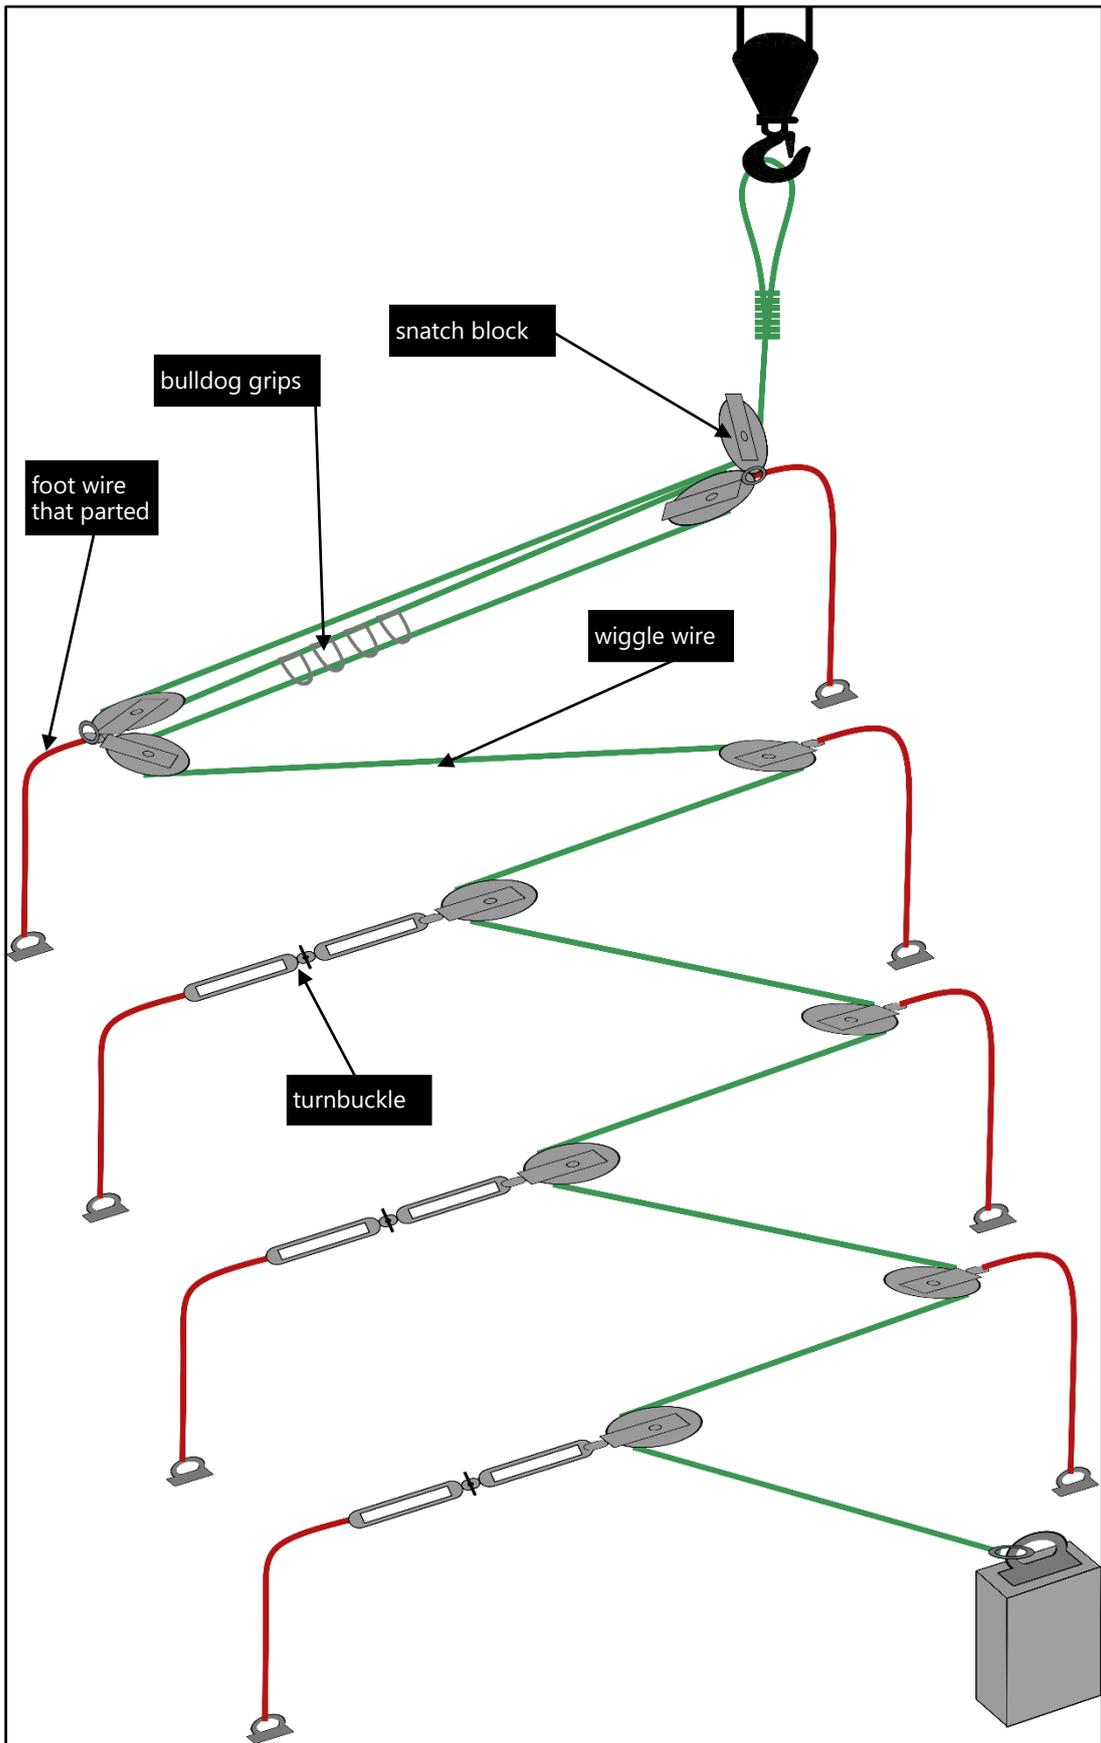
Figure 4: Simplified securing layout as described in the vessel's cargo securing manual

- 2.27 When the vessel was on passage, the turnbuckles were to be used to tighten the wiggle wires further if movement of the deck logs had created slack.

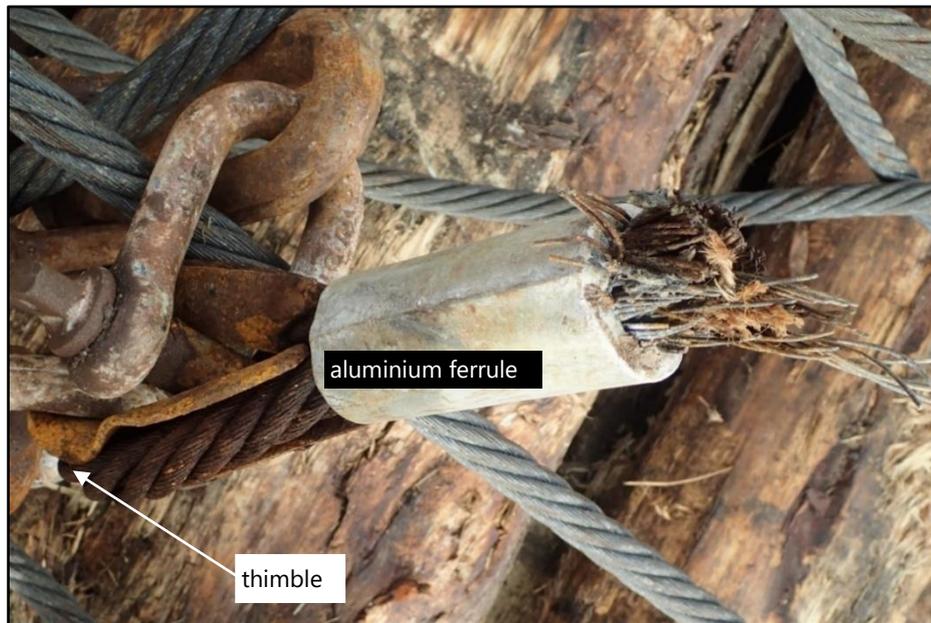
The failure of the rope most likely occurred as a result of overload. The failed wires exhibited necking and a cup and cone fracture face that is typical of this type of failure.

Although some corrosion had occurred it is considered unlikely that corrosion of the rope was the primary cause of the failure.
- 3.8 The elements of the failure mechanism described by the engineer can be seen in Figure 7, and the relevant section of the report is contained in Appendix 1.

Figure 6: Photograph of the parted wire rope after the accident

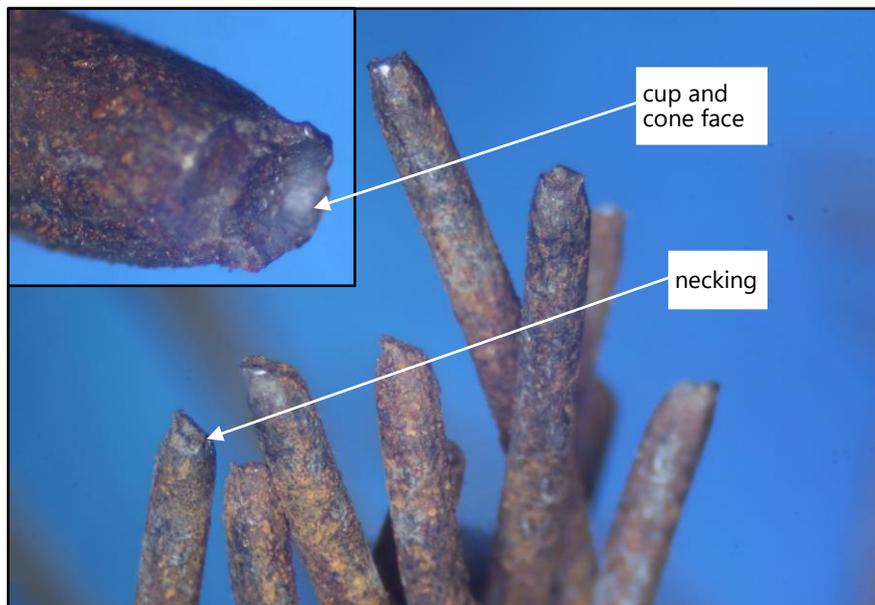
Figure 7: Macro photograph of the failed foot wire showing reduction (necking) and cup and cone failure face

- All of the broken wires that could be examined appeared to have failed via tensile ductile overload. There was diameter reduction near the failure area (necking) and a 'cup and cone' type failure face, see Figure 9. The degree of necking seen adjacent to the failures was relatively high indicating that there was no significant embrittlement of the material.

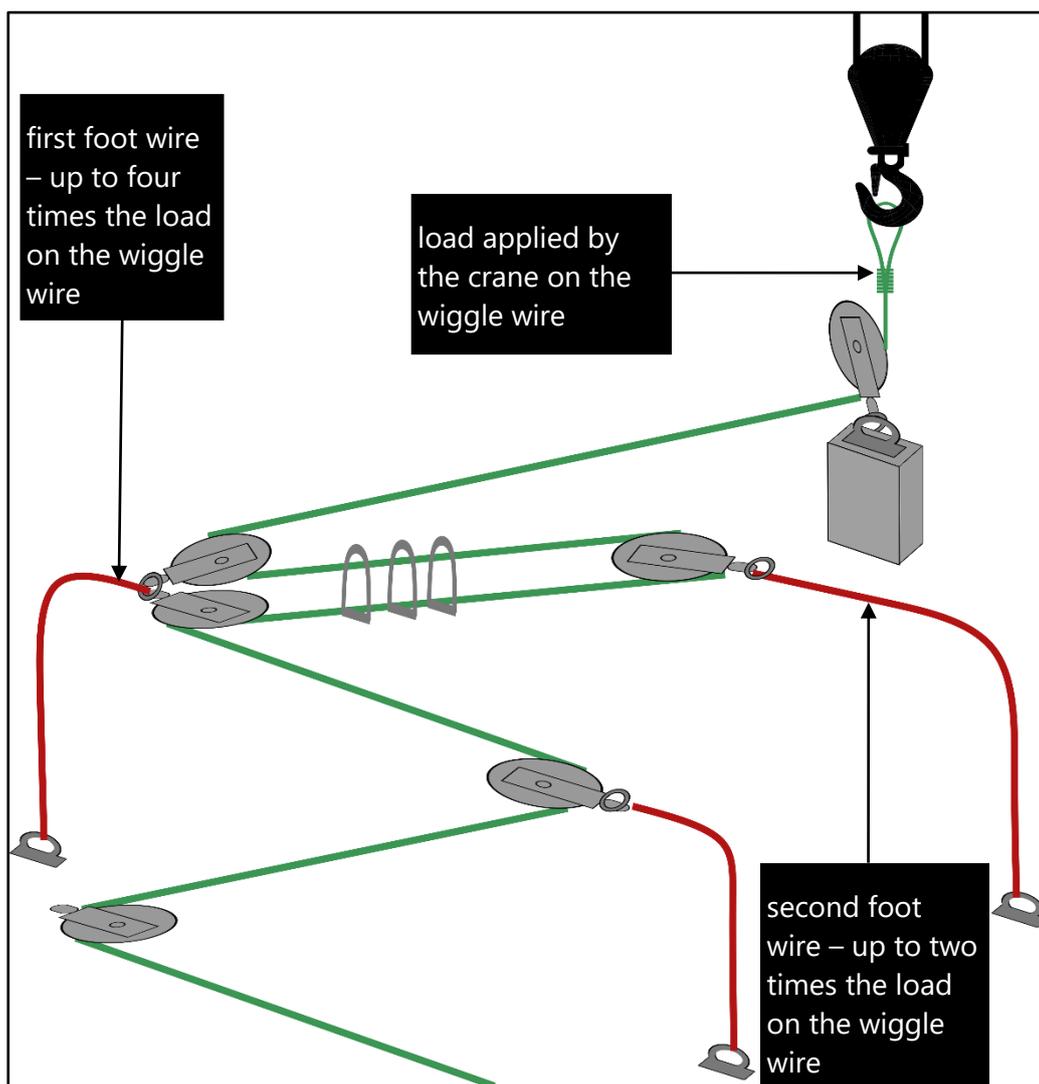
Figure 8: Diagram showing the configuration of the blocks on the day of the accident

- 4.3 The failure of the foot wire occurred as a result of overload.
- 4.4 The load being applied by the crane when multiplied by the configuration of the blocks was sufficient to overload the foot wire.

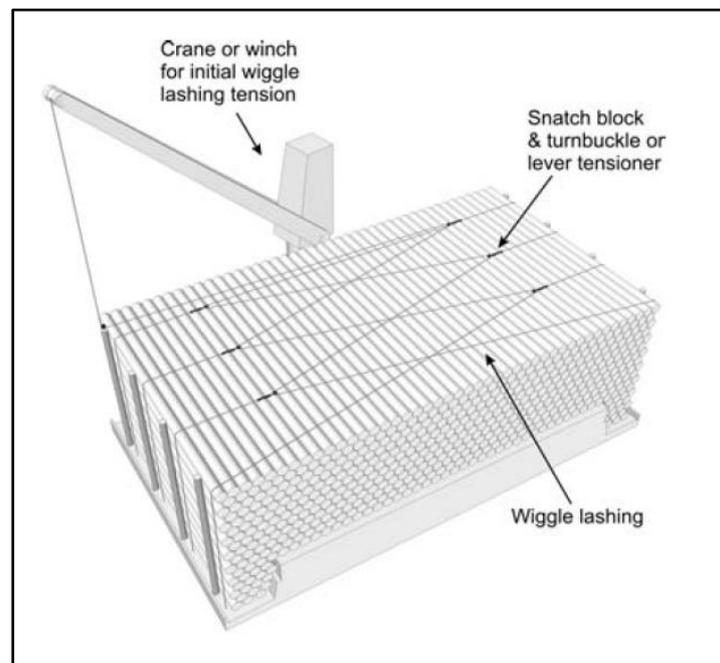
Figure 9: Extract from the 2011 Code of Safe Practice for Ships Carrying Timber Deck Cargoes

3.22 An extract from the 2011 edition of the code, explaining the arrangement for wiggle wires, is shown in Figure 9.

3.23 The explicit reference to apply only the initial tension would have provided the crew with the guidance necessary to minimise the likelihood of inadvertent overload and reinforce the need to use turnbuckles, which would have allowed the crew to better assess the amount of tension throughout the securing system.
