Transport Accident  
Investigation  
Commission

***Marine inquiry MO-2020-201***

***Collision between bulk carrier Rose Harmony and  
fishing vessel Leila Jo***

***12 January 2020***

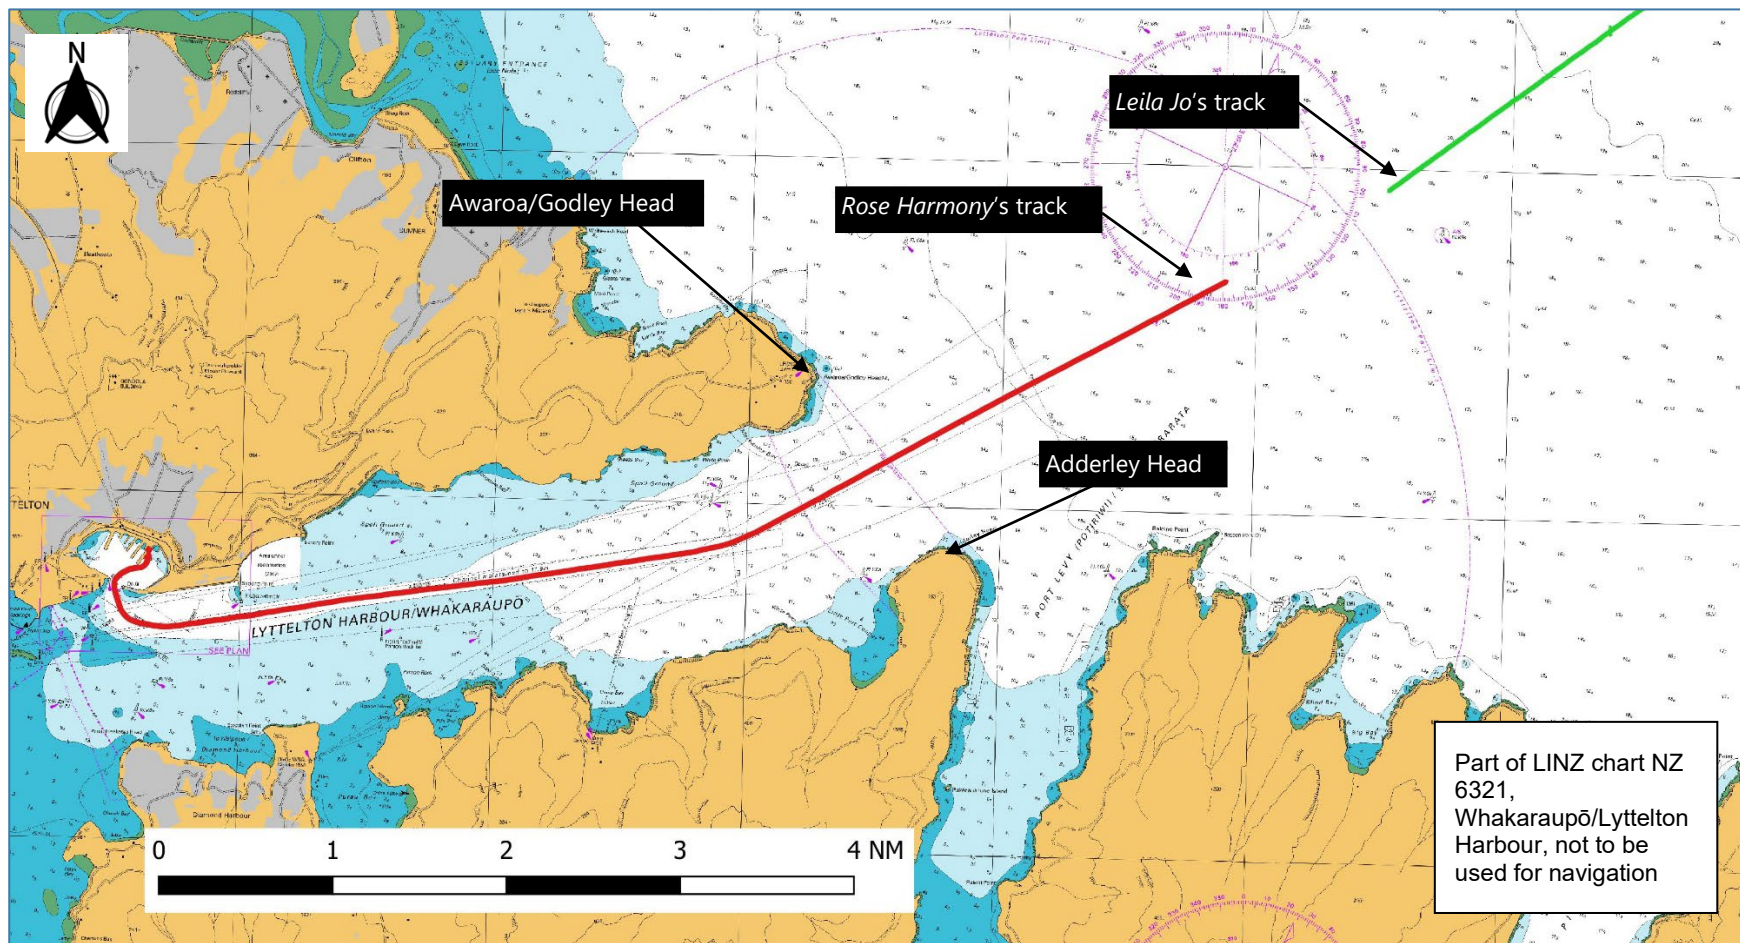
**Figure 4: The *Rose Harmony*'s track from voyage data recorder and the *Leila Jo*'s from chart plotter up to 2256**

- 2.22. At 2254 the passengers and the master were discussing the electronic chart display information system. The *Leila Jo* was 1.5 NM away; neither vessel had altered course.

- 2.23. At 2256 the third officer informed the master that the *Leila Jo*'s closest point of approach would be 0.047 NM.

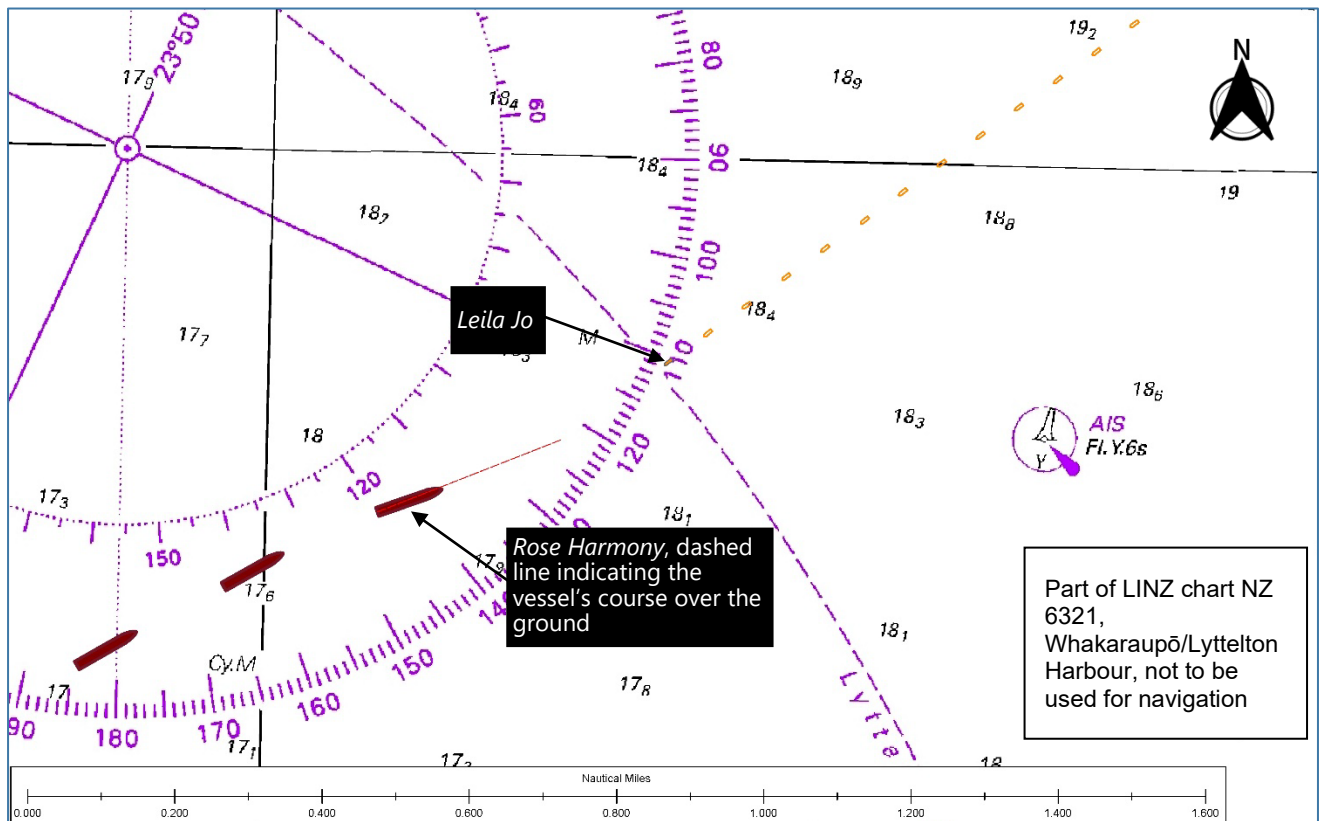
**Figure 5: Vessel positions, shapes to scale, at 2258**

2.24. At 2258 the third officer informed the master that the fishing vessel's course over the ground was 230°. The master first confirmed with the helmsman that the *Rose Harmony* was on a course of 060°, then ordered the helmsman to alter course 10° to starboard to avoid a collision.

2.25. At 2258.30 the third officer informed the master that the bow crossing range was 0.089 NM. At this point the master ordered hard starboard and sounded one continuous long blast on the vessel's whistle.

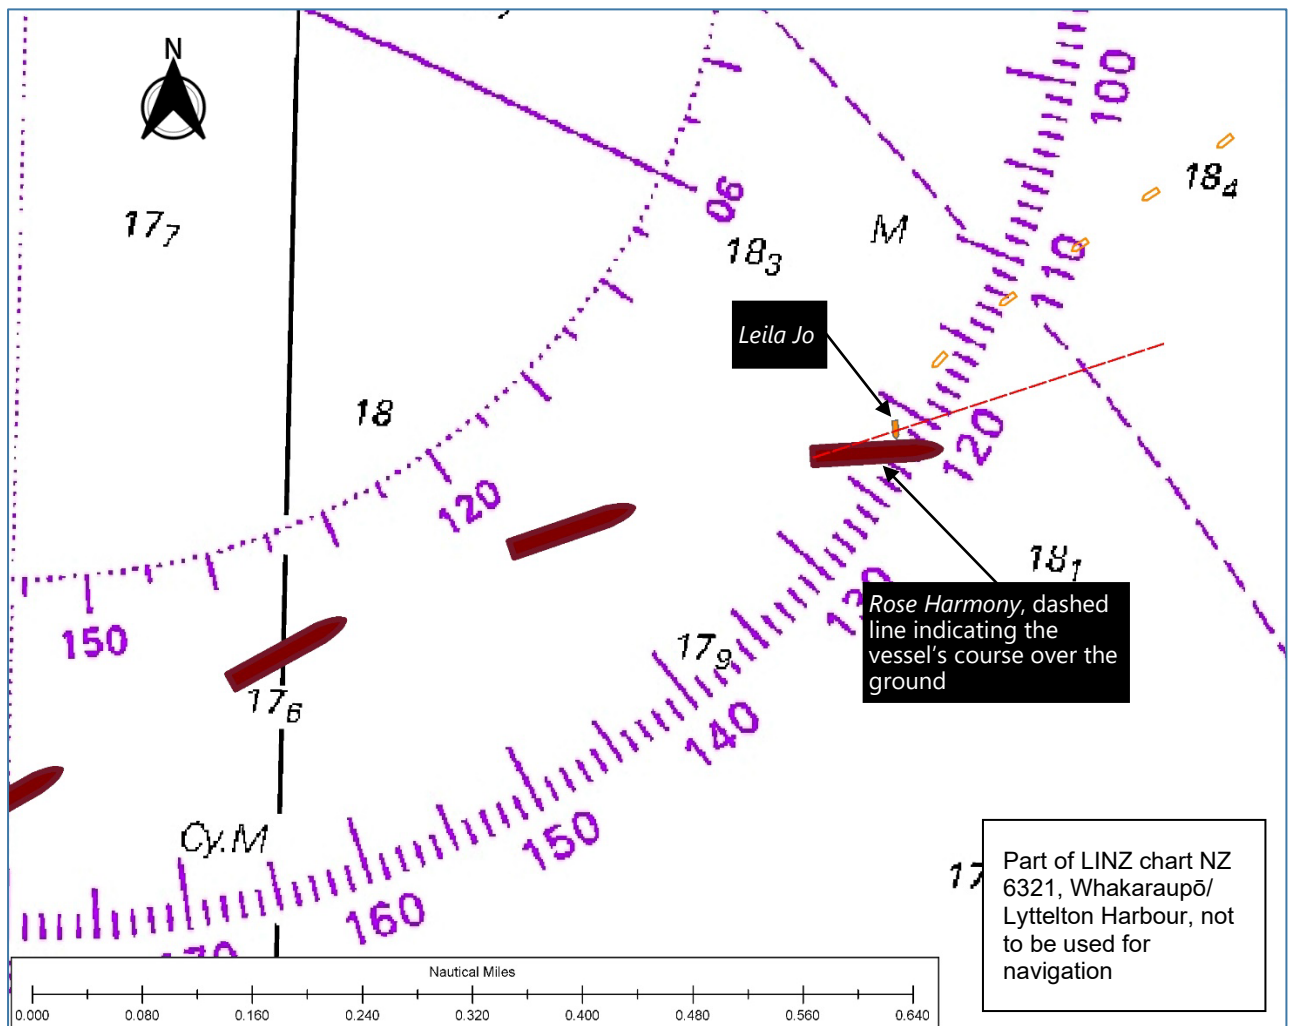
**Figure 6: 2259, vessel positions at the point of collision**

2.26. At 2259 the *Leila Jo* and the *Rose Harmony* collided.

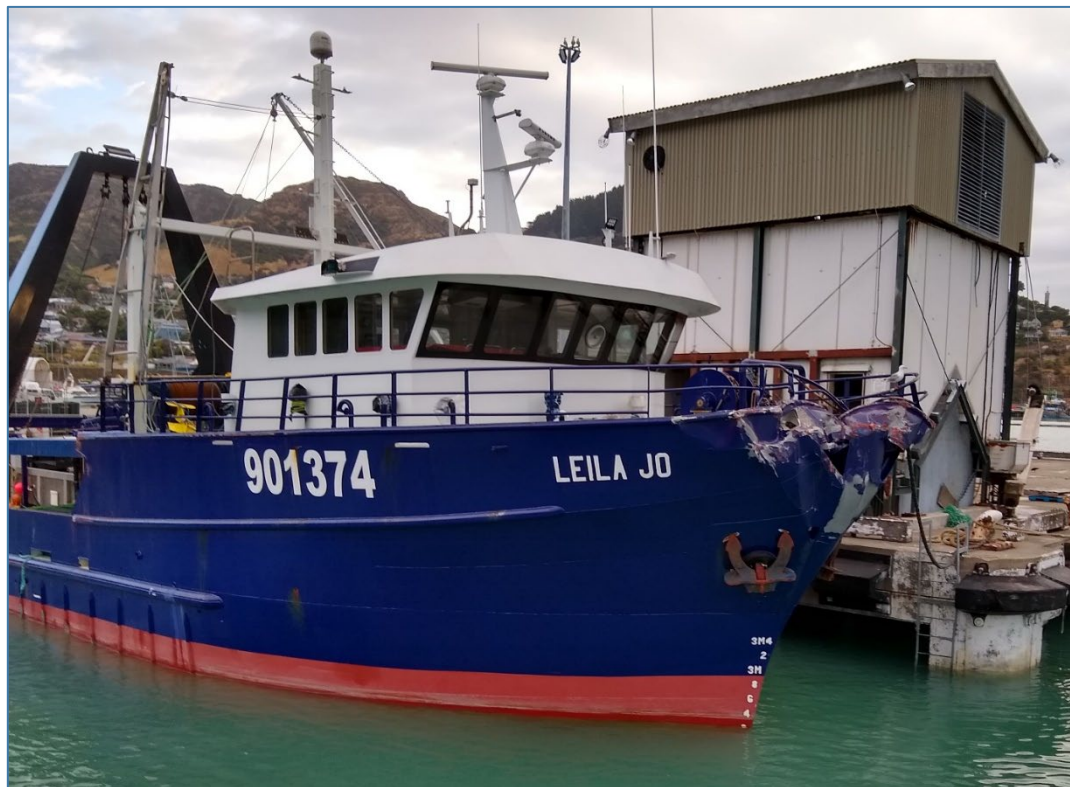
**Figure 7: Post-accident photograph of damage to *Leila Jo***  
(Credit: Archie Laird)

- 2.27. The *Leila Jo*'s crew mustered and gathered lifejackets and started to prepare their life raft. The crew then carried out a damage assessment. The crew found there was no significant damage to the boat. The bow of the *Leila Jo* was damaged, but the crew found no ingress of water or fuel egress.

- 2.32. Following the collision the *Leila Jo* was surveyed by a marine engineer, who assessed the vessel as “having cosmetic damage and had not lost watertight integrity”<sup>13</sup>. The engineer also stated there was no need to take the vessel out of service.

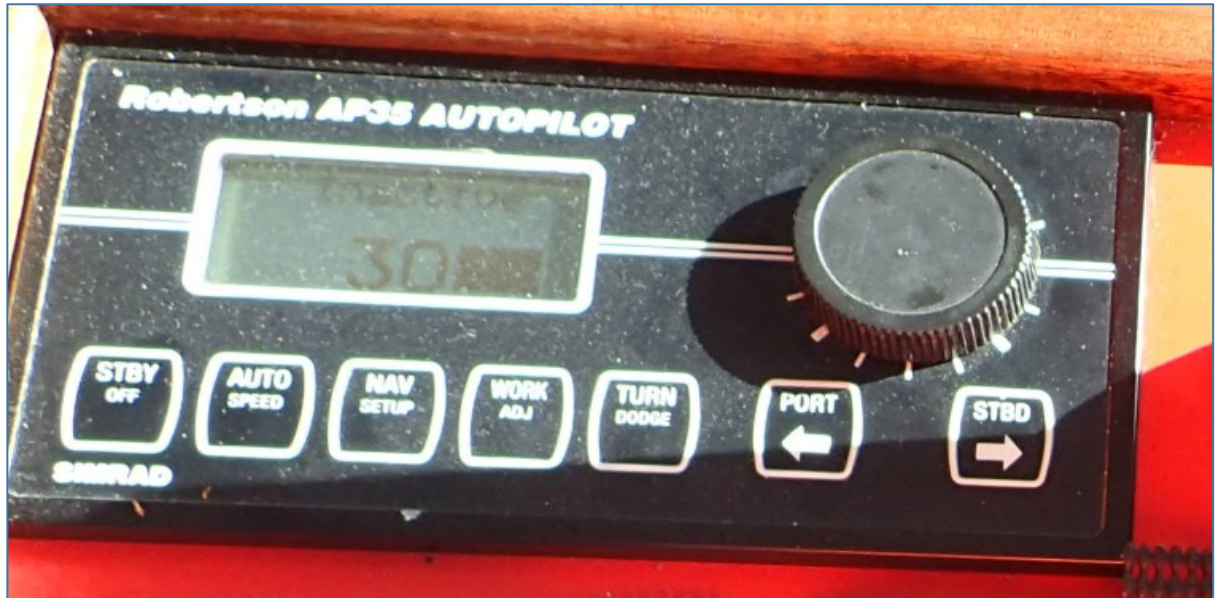
**Figure 8: Autopilot interface on the *Leila Jo***

- 2.36. The *Leila Jo* was fitted with a Robertson AP35 autopilot, which could maintain a course by automatically making alterations to the rudder. Course alterations under autopilot mode could be made either incrementally, by repeatedly pushing port or starboard buttons, or more rapidly by rotating a course command knob (see Figure 8). A disengagement of the autopilot (as performed by the standby button) transferred the control to manual steering.

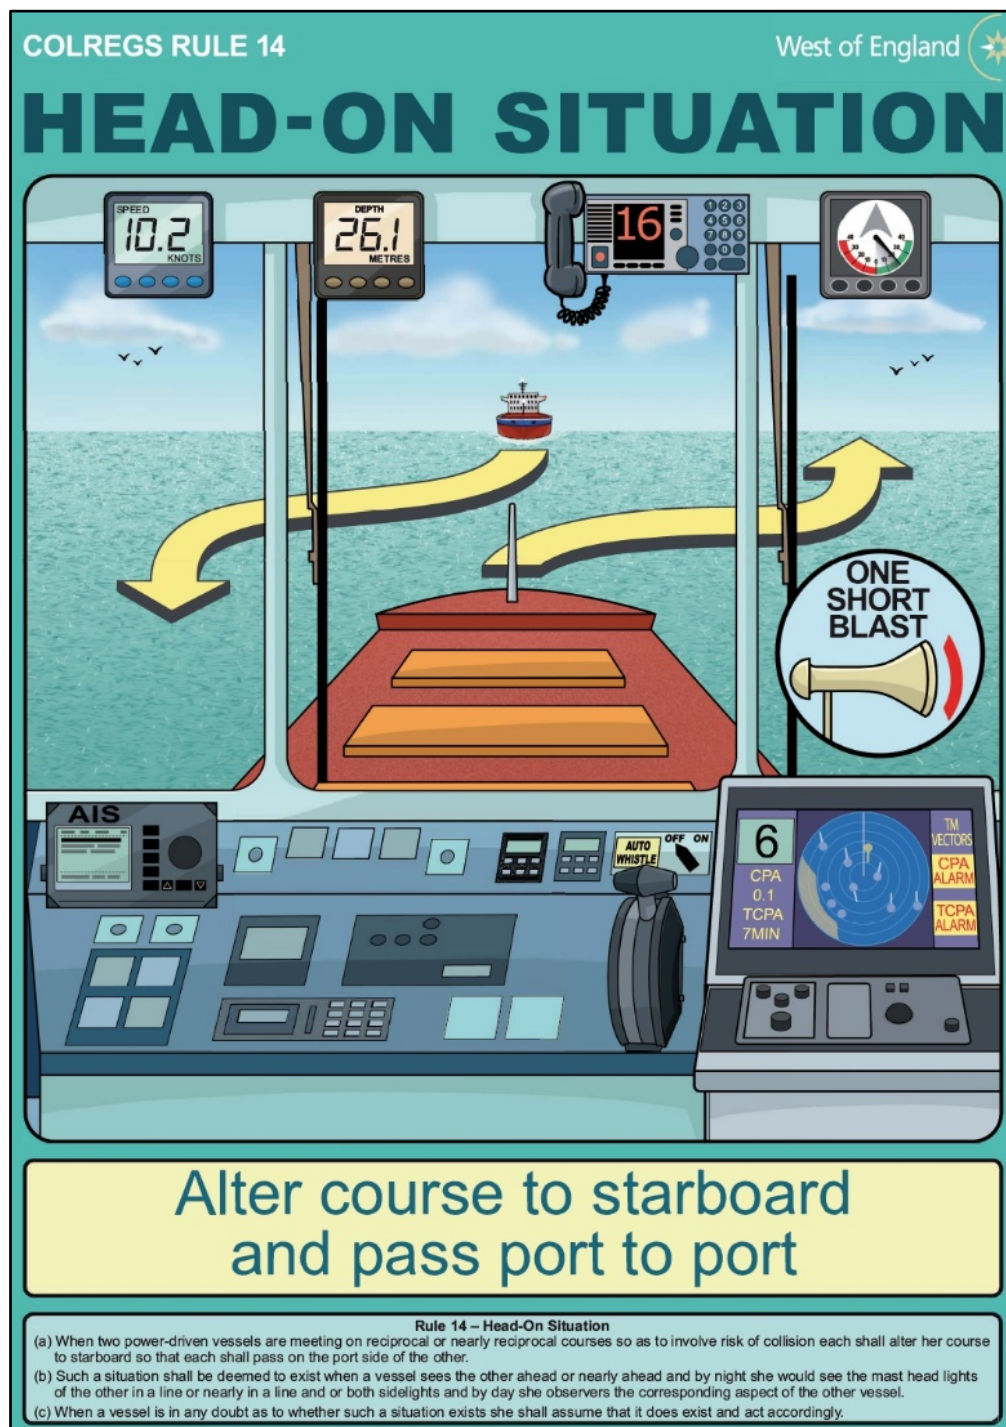
**Figure 9: COLREGs Rule 14: Head-on situation**  
(Credit: West of England Protection and Indemnity provider)

alter course to starboard so that each passed on the port side of the other<sup>18</sup> (see Figure 9).

- 3.9. The meeting of these two vessels was not a complex situation. Each vessel was equipped with appropriate radar equipment capable of detecting the other and there was ample sea room for each to manoeuvre as required by the rules.

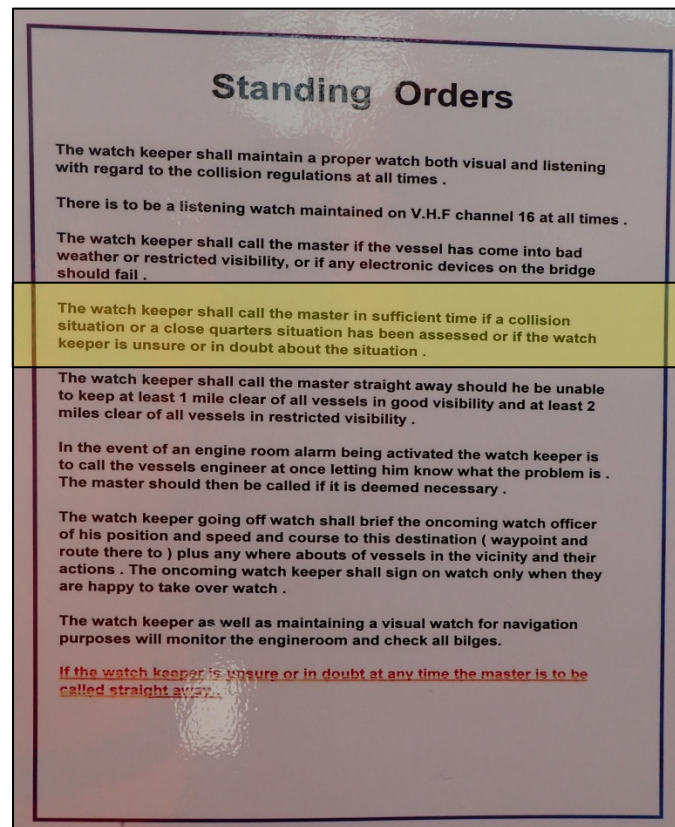
**Figure 10: Annotated photograph showing the *Leila Jo* Standing Orders for skippers**

- 3.33. The owner of the *Leila Jo* (Pegasus Fishing) also operated four other fishing vessels. It was common practice for skippers to be the only certified watchkeepers when the vessels were going on trips for multiple days. When it was necessary for the skipper of a vessel to rest, a deckhand was required to keep the navigation watch.
- 3.34. On board the *Leila Jo* the deckhands knew that if they were unsure about anything when they were keeping a navigational watch, they were to wake the skipper immediately. This was defined in the vessel's Standing Orders, which were posted in the wheelhouse (see Figure 10).

- 3.39. The Commission has recommended that the owner enhance its training system so as to upskill deckhands in watchkeeping practices that meets the minimum requirements of Maritime Rules Part 31 and adequately reduces the risk of accidents and incidents resulting from poor watchkeeping practices.
