Transport Accident
Investigation
Commission

Marine inquiry MO-2020-201

***Collision between bulk carrier Rose Harmony and
fishing vessel Leila Jo***

Off Lyttelton

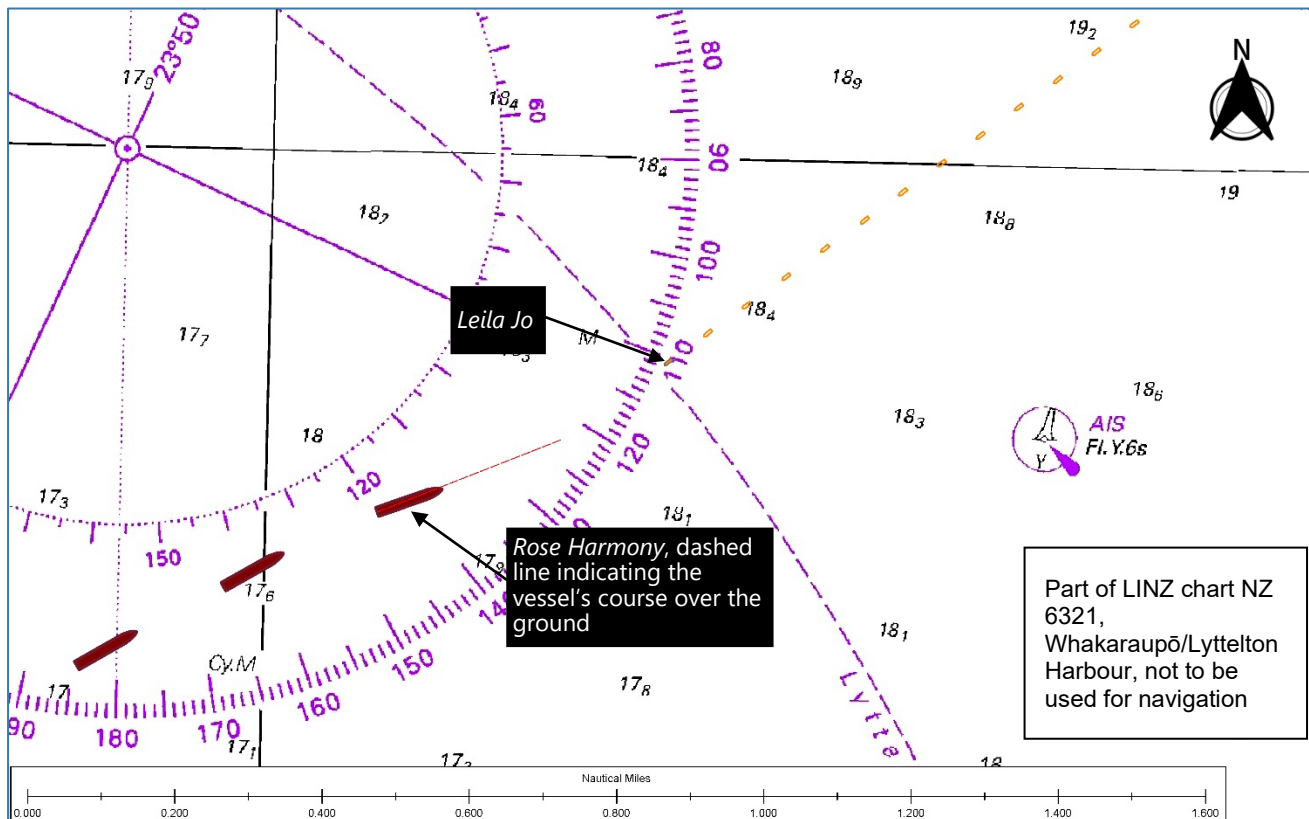
Figure 5: Vessel positions, shapes to scale, at 2258

2.24. At 2258 the third officer informed the master that the fishing vessel's course over the ground was 230°. The master first confirmed with the helmsman that the *Rose Harmony* was on a course of 060°, then ordered the helmsman to alter course 10° to starboard to avoid a collision.

2.25. At 2258.30 the third officer informed the master that the bow crossing range was 0.089 NM. At this point the master ordered hard starboard and sounded one continuous long blast on the vessel's whistle.

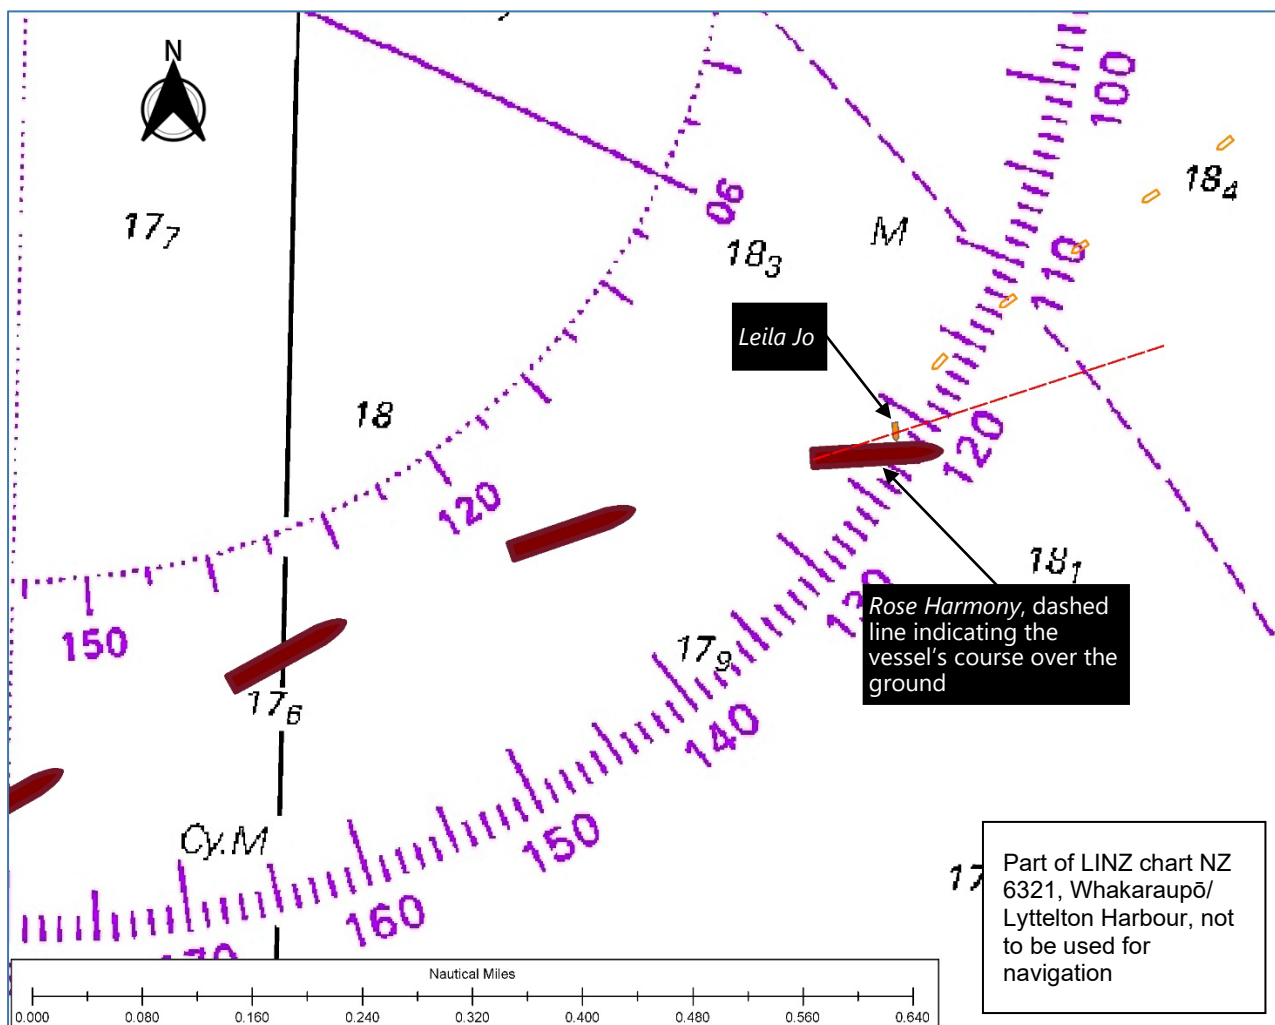
Figure 6: 2259, vessel positions at the point of collision

2.26. At 2259 the *Leila Jo* and the *Rose Harmony* collided.

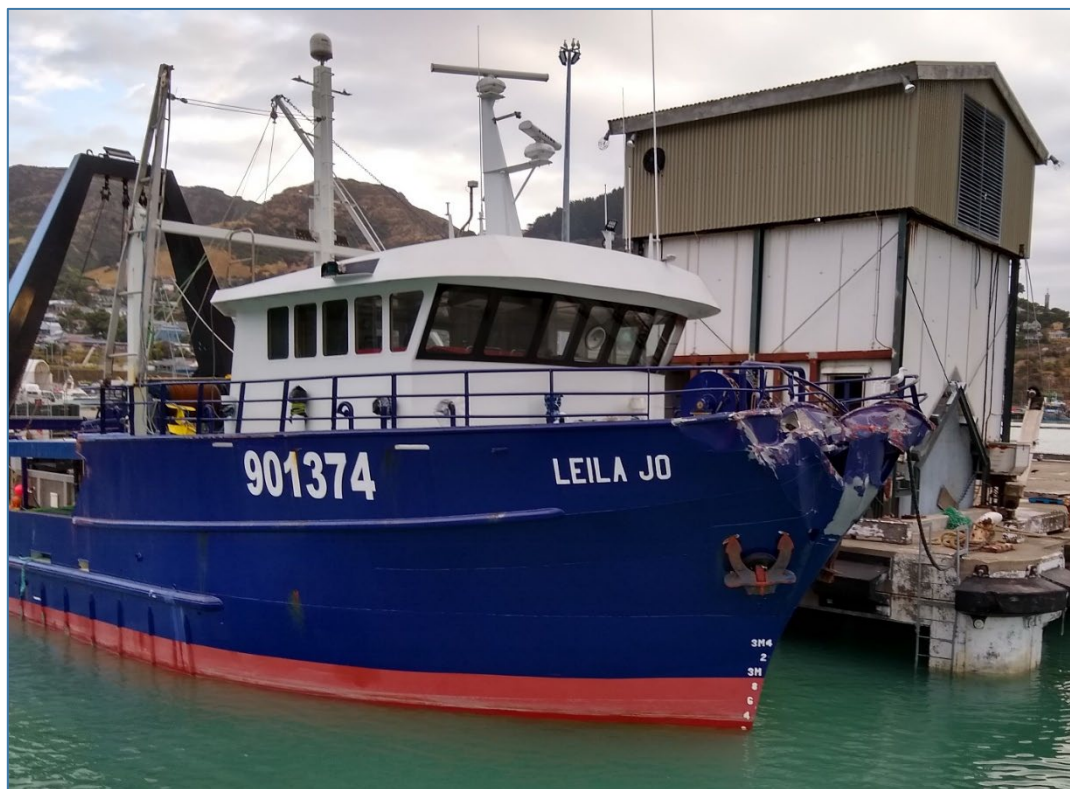
Figure 7: Post-accident photograph of damage to *Leila Jo*
(Credit: Archie Laird)

- 2.27. The *Leila Jo*'s crew mustered and gathered lifejackets and started to prepare their life raft. The crew then carried out a damage assessment. The crew found there was no significant damage to the boat. The bow of the *Leila Jo* was damaged, but the crew found no ingress of water or fuel egress.

- 2.32. Following the collision the *Leila Jo* was surveyed by a marine engineer, who assessed the vessel as “having cosmetic damage and had not lost watertight integrity”¹³. The engineer also stated there was no need to take the vessel out of service.
