# Final Report

***Marine inquiry MO-2020-202***

***Bulk log carrier Funing***

***Loss of manoeuvrability while leaving port***

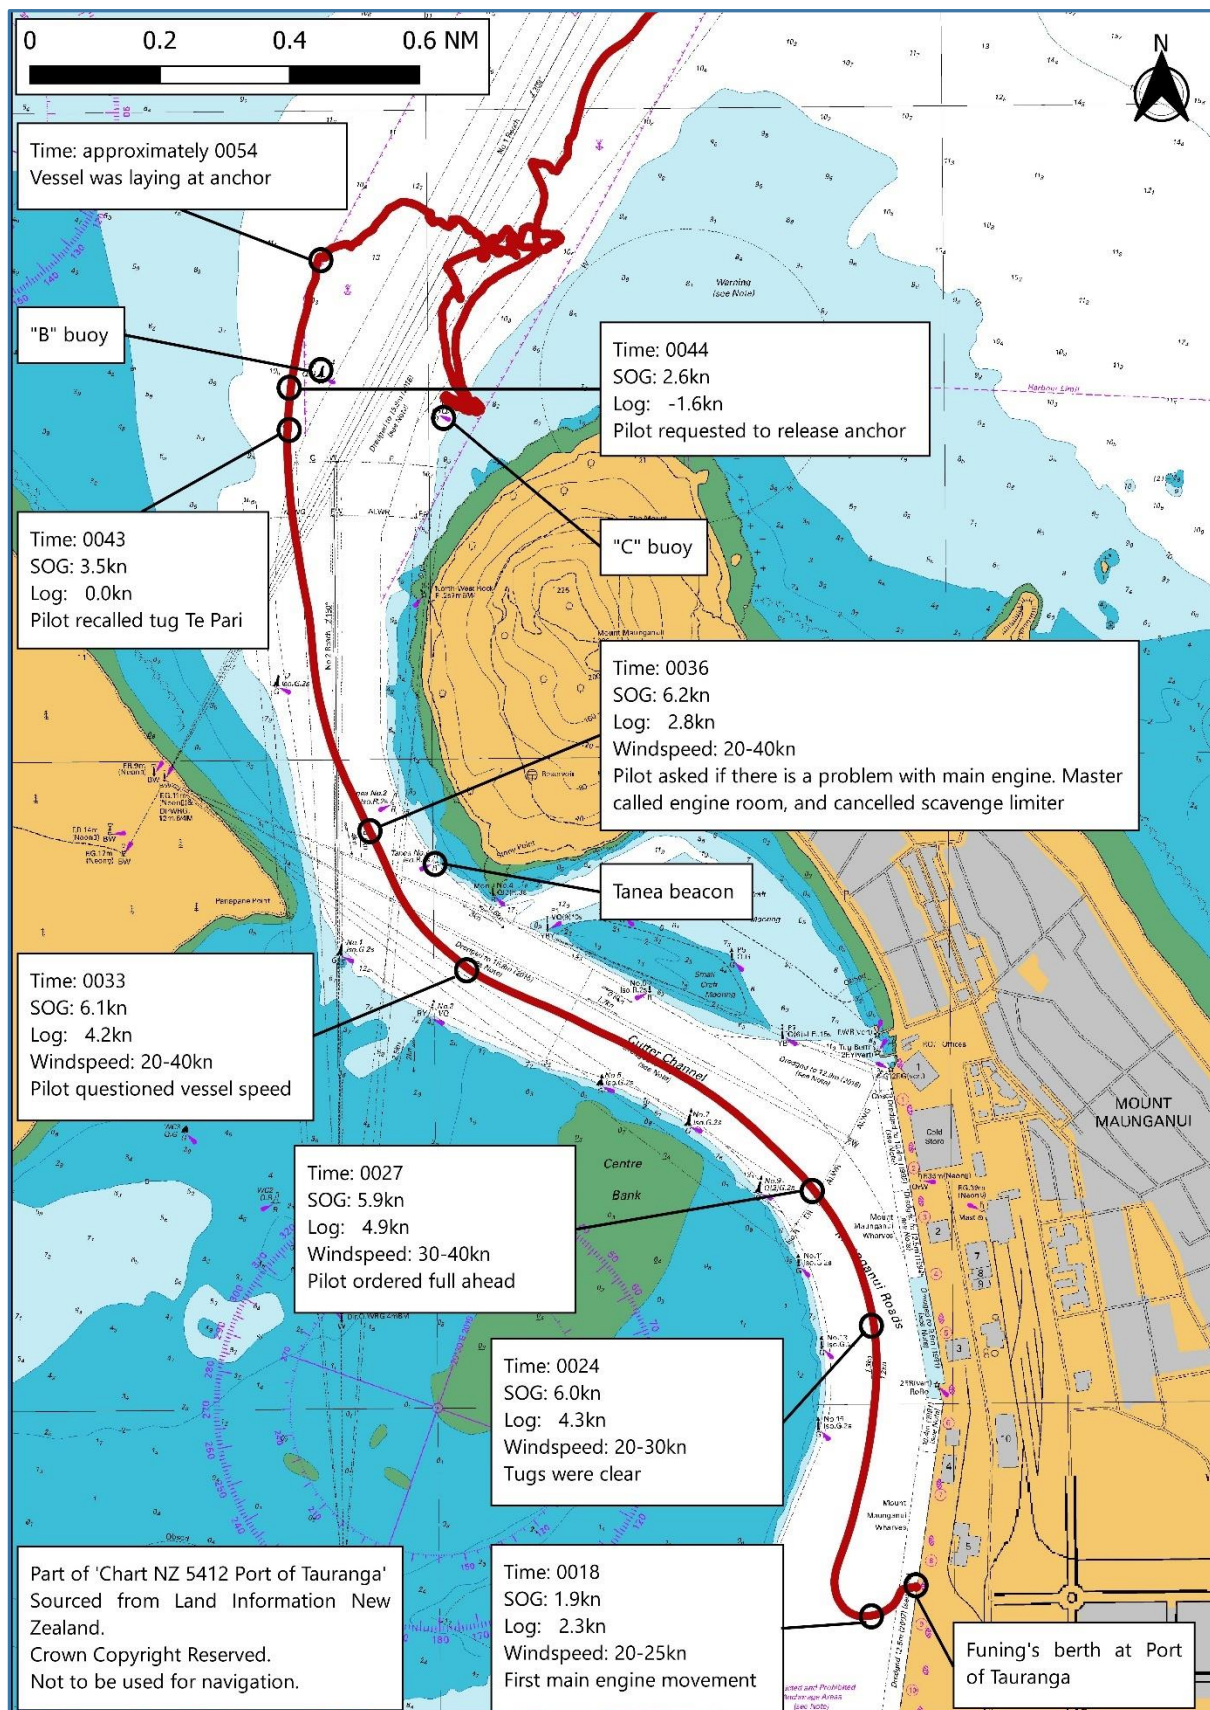
**Figure 3: Excerpt from Chart NZ-5412 Port of Tauranga showing the approximate track of the *Funing* as it departed Port of Tauranga**

- 2.14 Tugs were secured at about 0006, and all mooring lines were let go and clear at about 0018.
- 2.15 As shown in Figure 3, the first main engine movement was at 0018, and the quantity piston failure alarm for number two cylinder was triggered immediately.

- 2.16 Over the next three minutes the pilot ordered dead slow ahead, slow ahead and half ahead.
- 2.17 At 0024 the tugs were let go, and at 0027 the pilot ordered full ahead and the telegraph<sup>5</sup> was set to full ahead (68 rpm [revolutions per minute]). The chief engineer noted that the main engine speed was not increasing above 48 rpm (this point is discussed further in section 3). The vessel's speed through the water was about 4.3 knots.

- 2.28 The *Funing's* port quarter lay very close to 'C' buoy, so the tug *Sir Robert* was used to try to drag the stern into deeper water. Due to the environmental conditions the line parted. The pilot made the decision for the vessel to remain in position, lying to both anchors, and wait for the tide to turn.

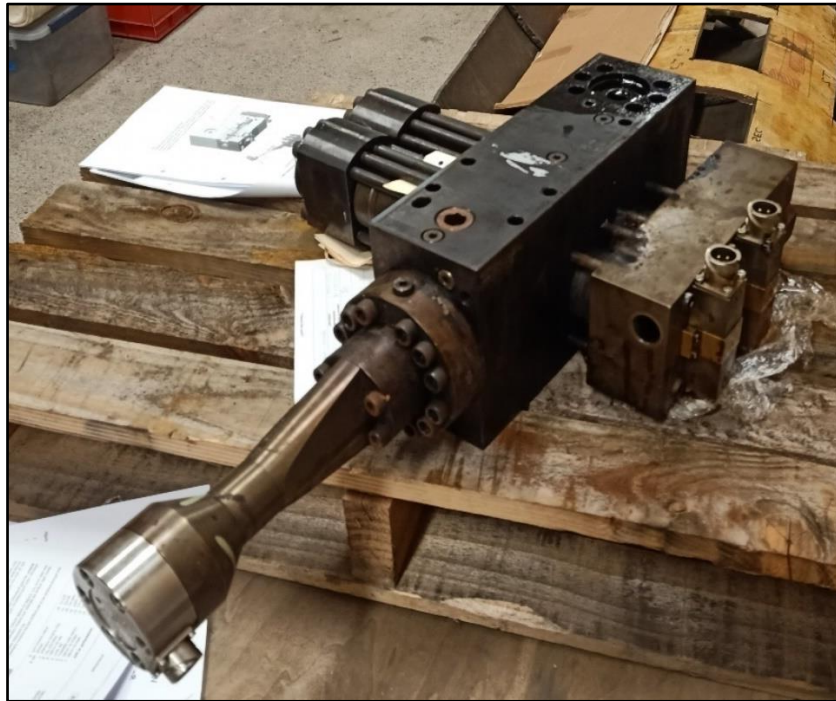
**Figure 5: The ICU removed from the *Funing***

- 2.46 The defective ICU removed from the *Funing* had accumulated 24,586.6 hours of service.
- 2.47 One of the onboard maintenance tasks was to monitor any 'leakage' within the ICU. Leakage is a normal operating feature of an ICU.

2.87 During pre-departure checks of the main engine, a fault was identified on the injection quantity piston for number two engine cylinder, which had failed. It is very likely that the injection control valve was unable to move because it had become seized with coking debris that had entered the system and interfered with the operation of the valves.

2.89 After the accident, when the vessel was laying at anchor, engineers replaced the ICU with a new unit. Replacing the ICU resolved the fault.

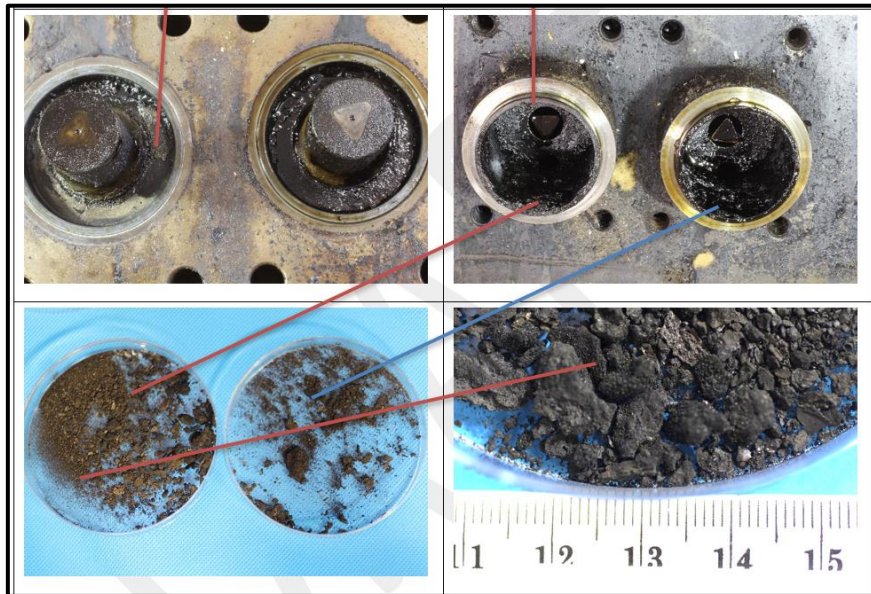
- 2.92 The examination of the ICU was conducted at the Quest Integrity laboratory in Wellington, New Zealand. The draft report and its findings were discussed with a technical representative from Wärtsilä.
- 2.93 The examination found that in the ICU the rail valves<sup>11</sup> were operational, and one of the two injection control valves had seized, very likely due to coking debris entering the system. Figure 15 shows the coking debris found in the cavity on the fuel oil side of the servo piston<sup>12</sup>.

**Figure 14: Coking debris found in the cavity on the fuel oil side of the servo piston**

- 3.43 As discussed in sections 2 and 3 of this report, the coking deposits within the ICU occurred because of fuel leakage. The leakage was likely a result of two things associated with low-sulphur fuels:

- 3.45 As general guidance, Wärtsilä states that leakage rates of above 12 litres per hour while using low-sulphur fuel are an indication that the ICU is worn. When the Commission inspected the ICU, coking debris was found, which indicated excessive leakage. However, it is not clear why there was a disparity between the daily and monthly leakage measurements recorded on board and the coking found in the ICU.

- 3.55 In this case the ICU malfunctioned far short of its estimated lifetime service hours, and this was very likely due to coking caused by oil leakage.

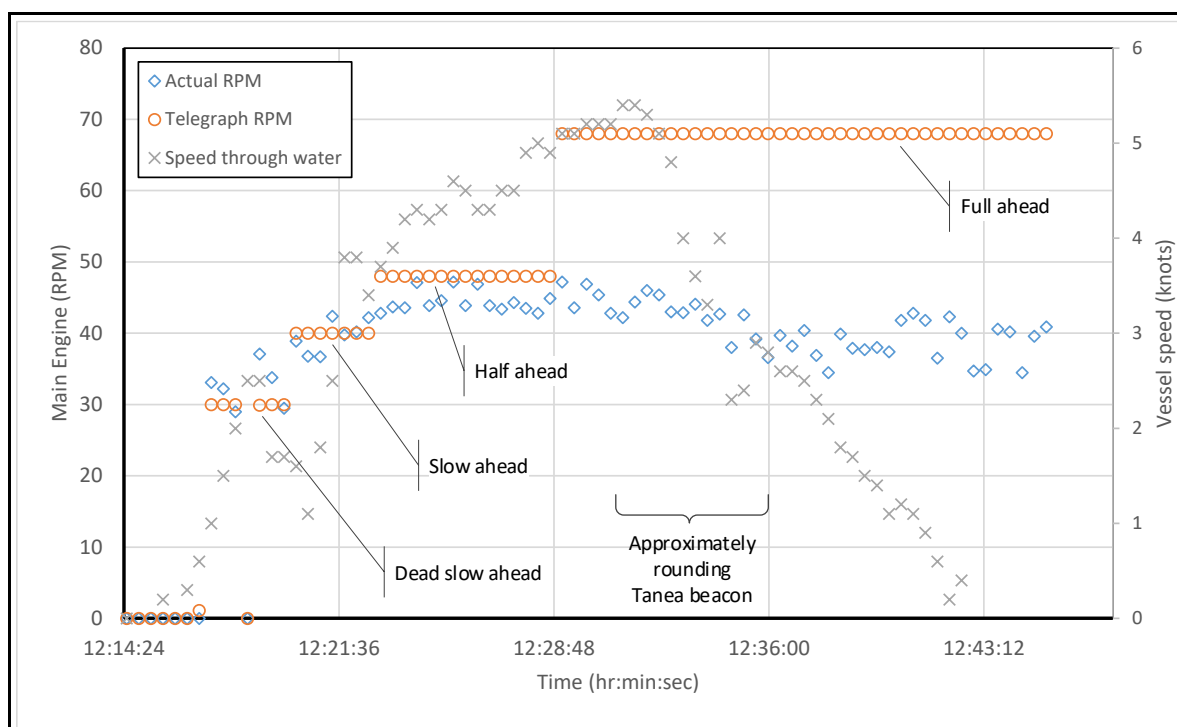
**Figure 15: Main engine RPM as the vessel departed Port of Tauranga**

- 3.28 Due to the reduced power of the malfunctioning main engine, the increased drag due to vessel speed and the adverse environmental conditions, the *Funing* did not consistently reach half ahead rpm when commanded by the telegraph.
- 3.29 When the *Funing* rounded Tanea beacon it was more exposed to the head sea and wind. The combination of reduced main engine power and adverse environmental conditions further reduced the vessel's rate of acceleration and its ability to increase speed. As a result, its manoeuvring characteristics were significantly diminished and ultimately overcome by the increasing environmental effect, and the vessel's speed through the water was reduced to near zero knots.

- 3.38 The vessel was unable to increase speed because the power produced by the main engine was unable to overcome the vessel's drag induced by environmental conditions.

- 3.39 The primary reason for the vessel being unable to develop sufficient propulsive power was that number two cylinder of the main engine was not firing as a result of a malfunction of number two cylinder's injection control unit. It is possible that other factors, such as hull fouling, propeller fouling<sup>15</sup> and changes in the normal operating conditions of the vessel, further contributed to the main engine's inability to generate sufficient propulsive power to manoeuvre the vessel safely.
