Transport Accident
Investigation
Commission

Final report

Marine inquiry MO-2021-201
Jet boat KJet 8
Loss of control
Shotover River, Queenstown
21 March 2021

May 2022

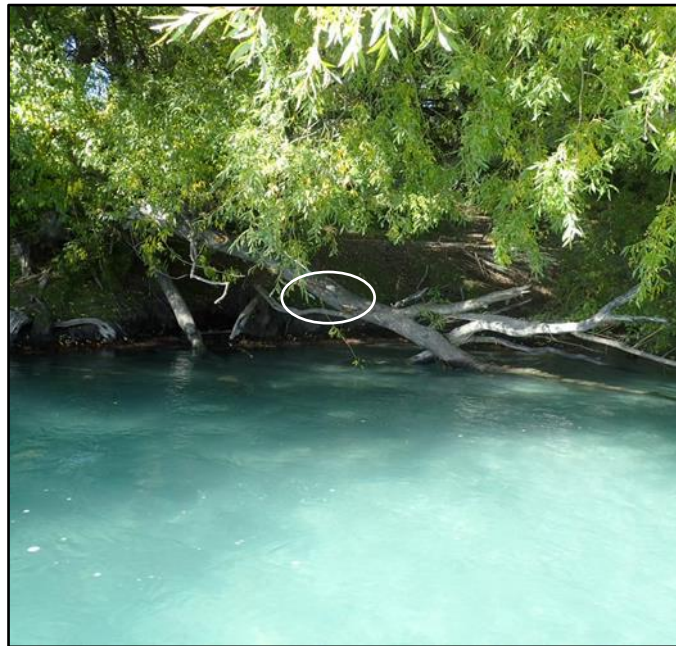
Figure 5: Point of impact with trees lining the riverbank

2.25 The accident occurred on the return leg of the journey, travelling downstream approaching a right-hand bend. Figure 5 shows the point of impact with the tree branch situated on the left-hand bank. The jet boat suffered minor structural damage.

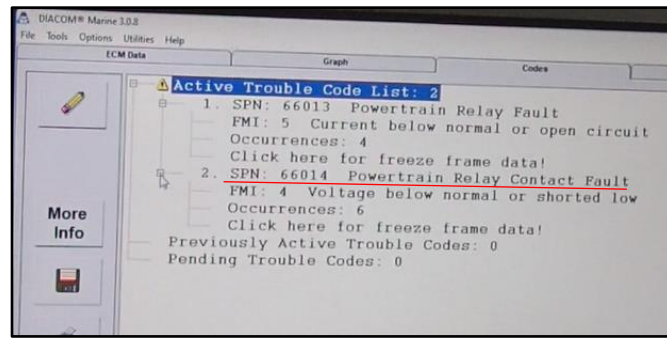
Figure 7: Diagnostic read out from the main engine

- 2.35 The information from the diagnostic read out provided engineers and investigators with a focal point from which to systematically try to identify the cause of engine failure. During examination of the engine, its components and the powertrain, it was found that deliberate movement of the wiring loom connected to the main engine fuse box (figure 8) caused the powertrain relay to activate.

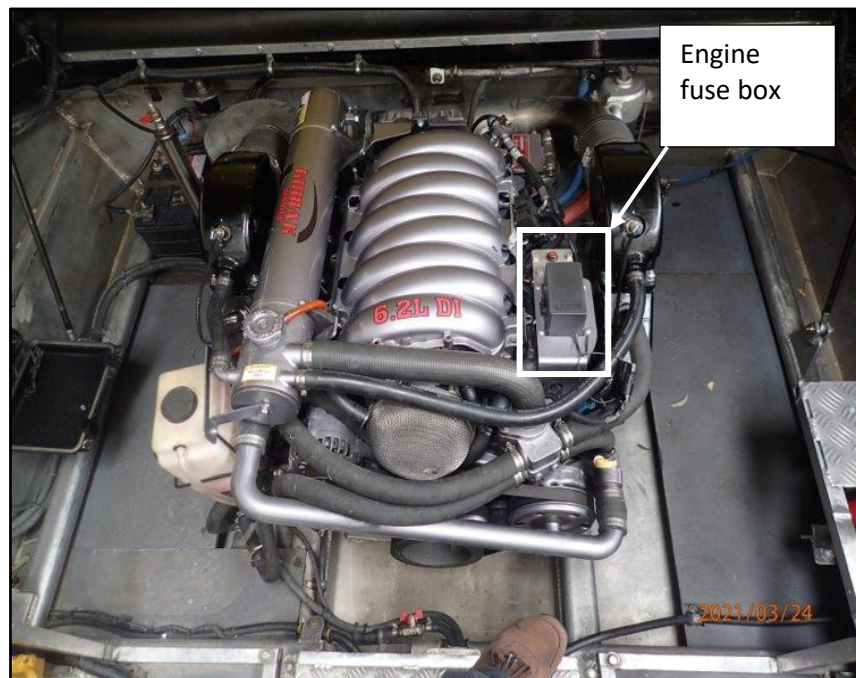
Figure 8: Location of fuse box

- 2.36 Closer inspection of the fuse box found that a 20 ampere fuse protecting the engine powertrain relays had failed. The fuse and the connections into the main fuse box were replaced, the engine was retested and it operated successfully.

- 2.42 The fuse box fitted to *KJet 8* was of a design commonly used in the automotive industry where wiring looms are generally secured to prevent significant vibration occurring on the wiring. When *KJet 8*'s engine was marinised the fuse box was installed on a bracket bolted to the engine without any vibration dampening. Without vibration

dampening the fuse box was subject to vibrations from the engine, which could lead to fatigue loading on the fuse box assembly. Wires were bent into place after they were fitted into the fuse box.

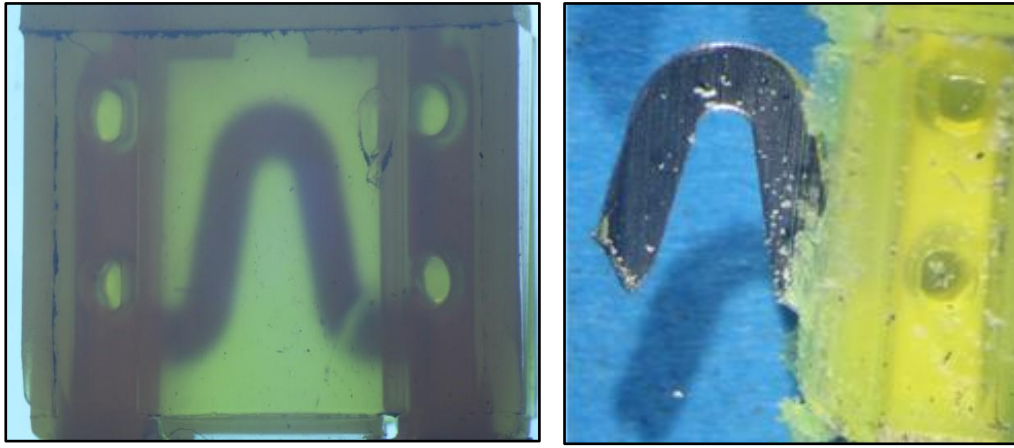
Figure 9: Condition of the failed fuse removed from *KJet 8*

- 2.39 There was significant evidence to show that the fuse did not fail as a result of electrical overload as shown in figure 10. Extensive melting did not occur, the fuse section was not distorted, and failure did not occur in the normal mid-point position of the fuse (figure 9).

- 2.40 It was considered **very likely** that the fuse failed primarily because of bending fatigue due to flexing caused by an unsupported connecting wire. Evidence to support this hypothesis included: lack of gross distortion, a flat fracture face, failure occurring at the end of the radius where there was a stress concentration, the design of the fuse box, and stiff connecting wires allowing a rotation of about 10 degrees.

- 2.41 The fuse was made from zinc, which provided reasonable corrosion resistance, low melting point, good electrical conductivity and relatively low cost. Zinc is not a good structural material. It is hard and brittle and will be highly prone to fatigue failures at room temperature. It is therefore important that the wires connecting to a fuse box should not be able to transfer cyclic loading to the fuse, which would lead to fatigue.

- The fuse in KJet 08 probably failed as a result of mechanical fatigue as a result of the connecting wiring flexing due to resonant vibration. This resulted in wear/damage to the fuse support hole and a straight flat fracture at the location most prone to bending fatigue.

- The fuse in KJet 08 did not fail as a result of electrical overload.
- The fuse in KJet 08 did not fail as a result of a mechanical overload, i.e. it did not fail as a result of the accident.

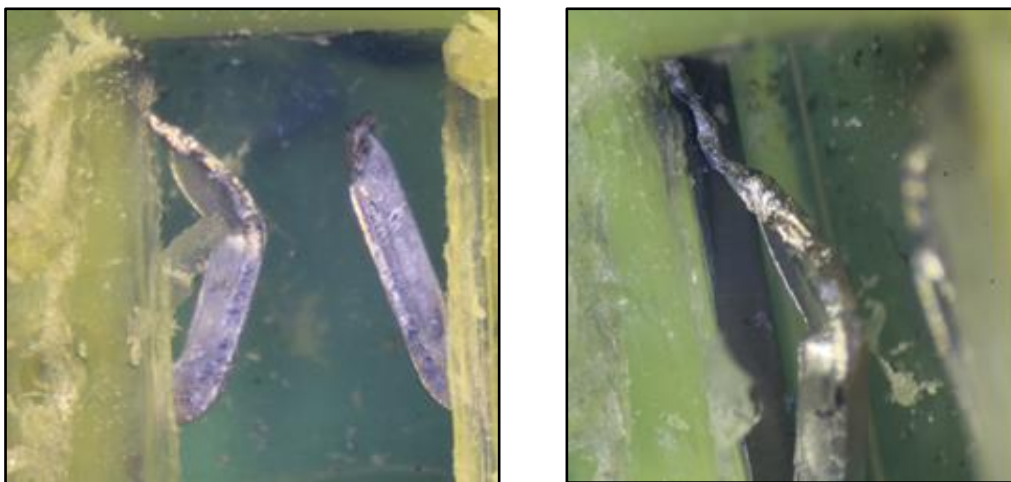
Figure 10: Example of the condition of a similar fuse deliberately failed through electrical overload

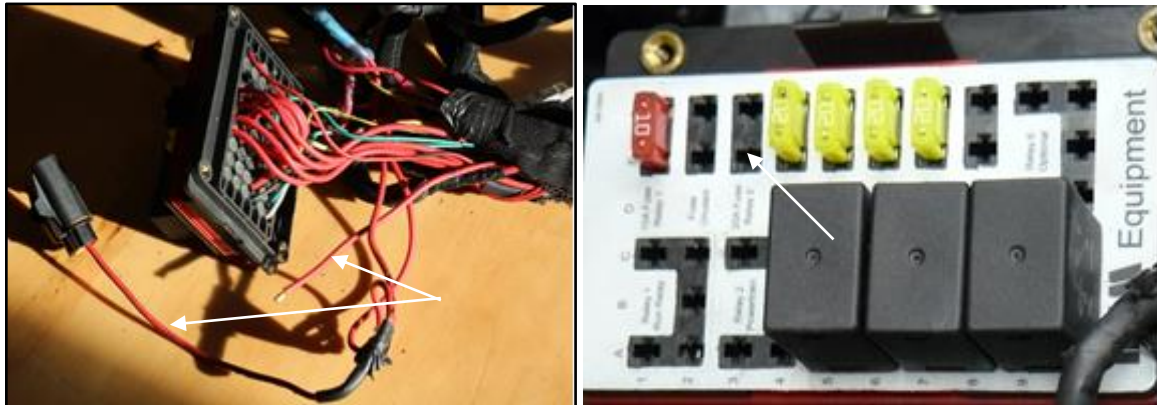
Figure 11: Left – wiring loom at the rear of the fuse box from KJet 8 showing the two wires that had been attached to the failed fuse. Right – fuse box where the failed fuse had been located

- 2.43 If the resonant frequency⁵ of a wire assembly is close to one of the engine's vibrational frequencies, resonance will occur that could result in significant vibrational movement and increased risk of failure of the weak points, such as a fuse. In this case it is considered **probable** that the wire to the failed fuse had a longer unsupported length than the other wires (figure 11), which likely resulted in excessive vibration contributing to the mechanical failure of the fuse.

- The fuse box/wiring assembly/support structure was not ideal to prevent failure as a consequence of the following:
 - a) The fuse box will have seen significant vibration as it was mounted in a stiff bracket that was directly bolted to the engine in the jet boat.

- b) Unsupported wiring could flex backward and forward as a result of resonance.
 - c) The fuse box was not ideal in that the flexure of the wires could introduce significant torsional movement on the legs of the fuses and the fuses were made of zinc. Ideally it should not be possible for the movement of the wires to cause any movement in the legs of the fuses.

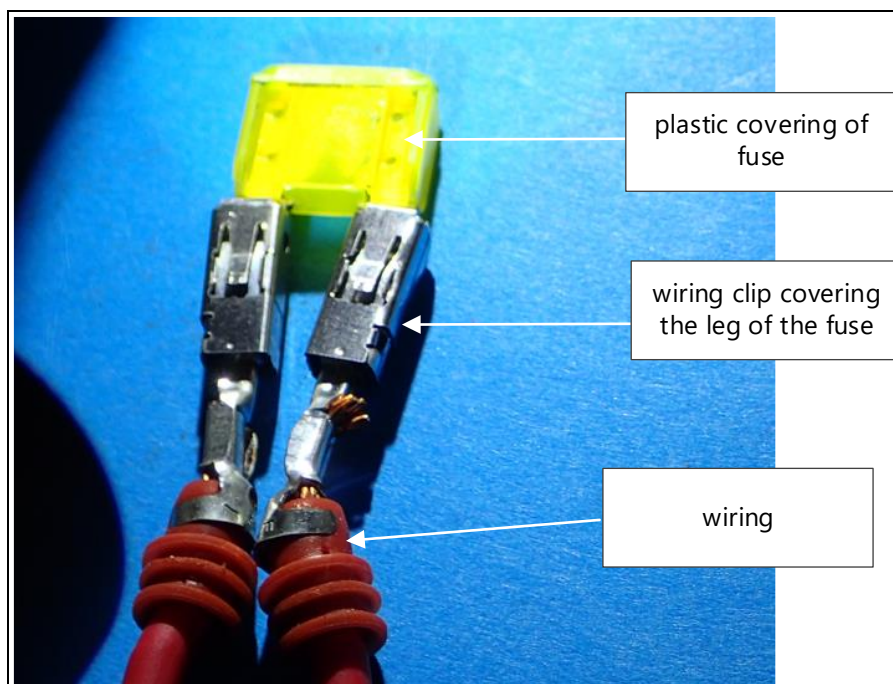
- 3.12 The mechanical failure of the fuse was **very likely** a result of a load being imparted onto the leg of the fuse from the wire of the engine wiring loom as shown in figure 13. That load was cyclic because it was also subject to engine vibrations.

Figure 13: Image of fuse with wiring attached

- 4.5 Mechanical failure was **very likely** caused by a load being imparted onto the leg of the fuse by unsupported wiring, which was susceptible to resonating with engine vibrations back and forwards.
