# **Final report**

***Marine inquiry MO-2021-202***

***Factory fishing trawler Amaltal Enterprise***

***Engine room fire***

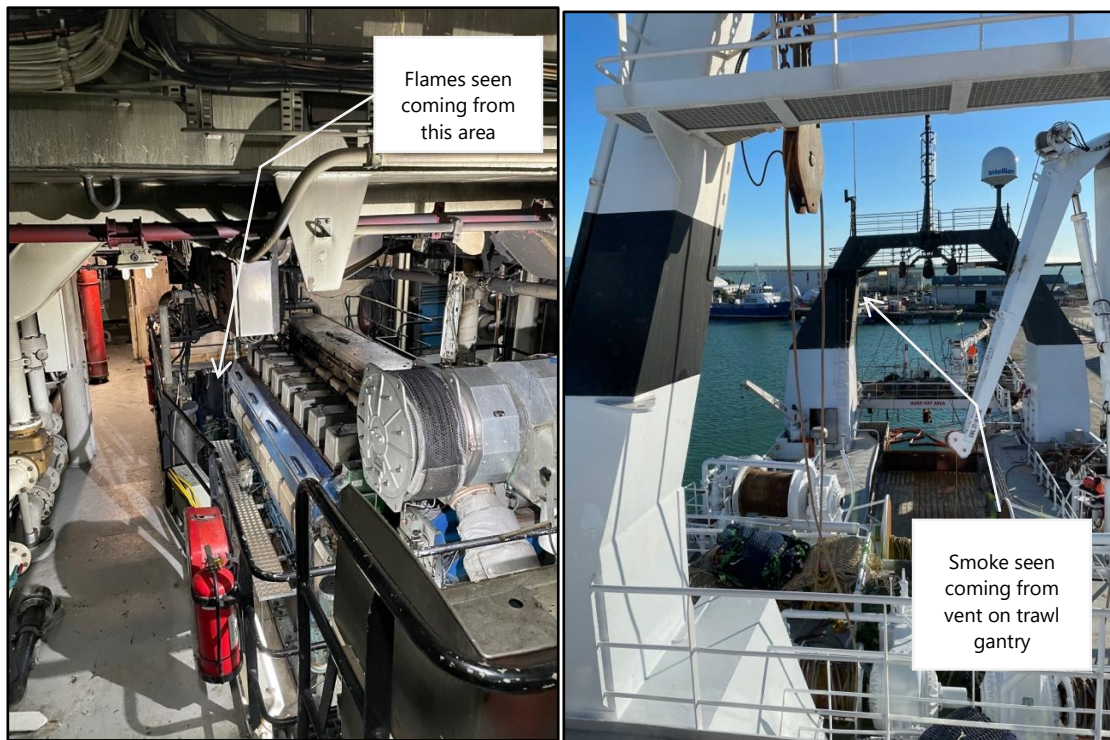
**Figure 3: Photographs showing view of main engine from the top of the stairs (left) and skipper's view from bridge looking aft (right)**

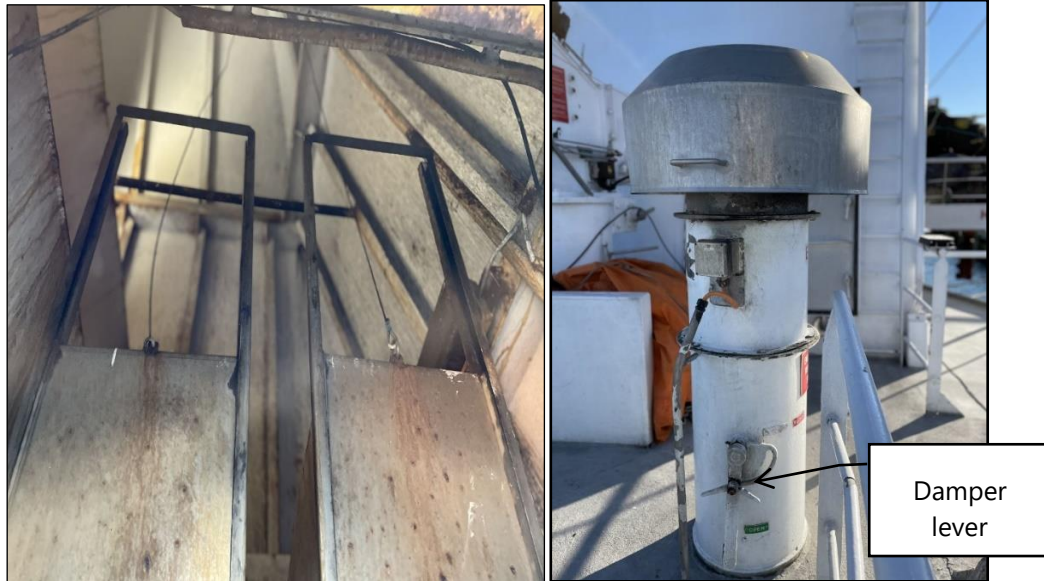
- 2.31 Ventilation for the engine room is provided by two sets of electric-driven fans (Fan 1 and Fan 2) located on the port leg of the trawl gantry (see figure 3). Both fans supplied air into the port side of the engine room. Excess air was expelled from the starboard side via a natural vent located on the starboard trawl gantry leg and an extraction fan on the trawl deck that worked in tandem with supply Fan 2. Each vent was fitted with a sliding type quick-closing fire damper and fan with a butterfly type damper within the fan trunking (see figures 4 and 5).

**Figure 4: Photographs showing sliding dampers that when released drop down in their guides to seal off the opening (left) and No. 2 extraction fan with the lever for opening and closing the butterfly damper on the trunking (right)**

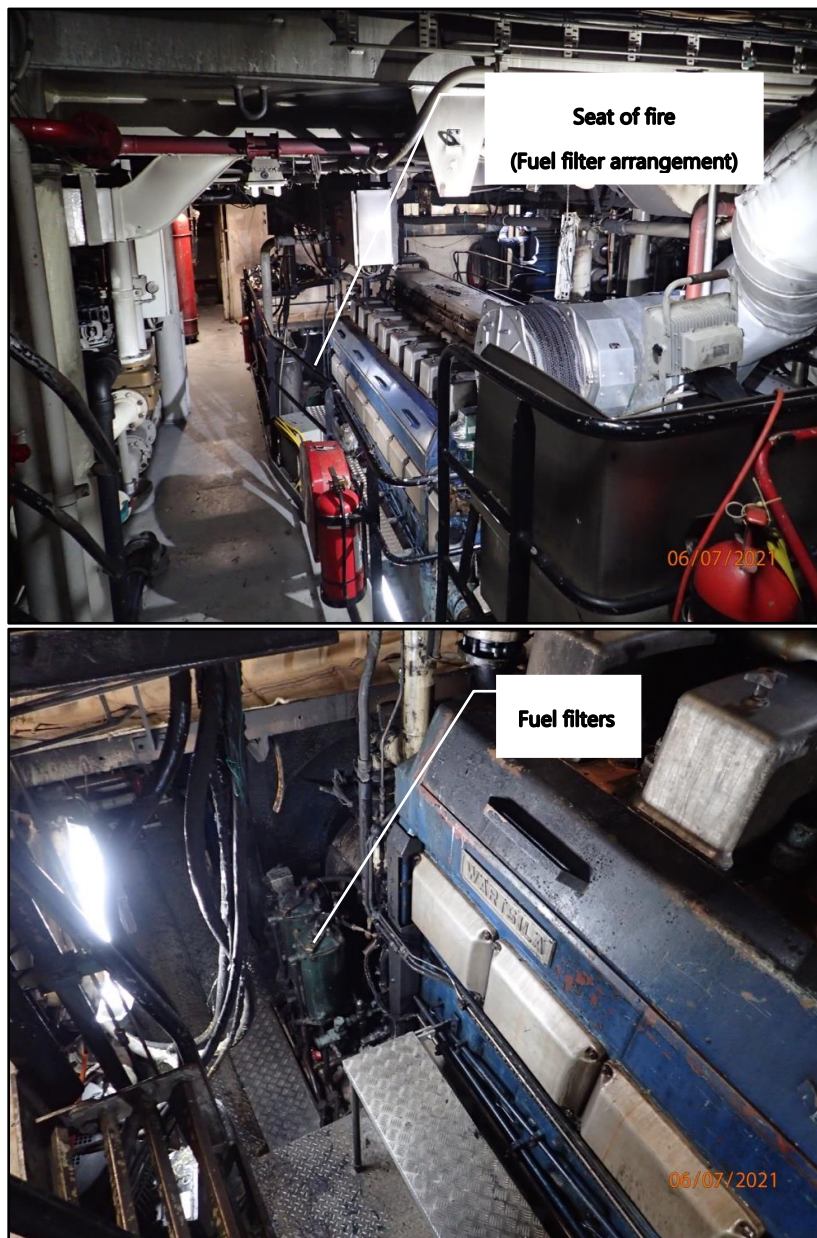
- 2.36 Fire damage was contained to the engine room, which had sustained extensive heat and smoke damage to its upper parts. The damage was more extensive in the immediate vicinity of the low-pressure fuel filter arrangement located at the forward port side of the main engine. Figure 6 includes a photograph (top) taken from where the chief engineer was standing when first entering the engine room and observing flames. Note the minimal damage in the foreground, which was limited to smoke damage around deckhead<sup>12</sup> level.

**Figure 6: Photographs of engine room looking forward from the entry stairs (top) and of low-pressure fuel filter arrangement (bottom)**

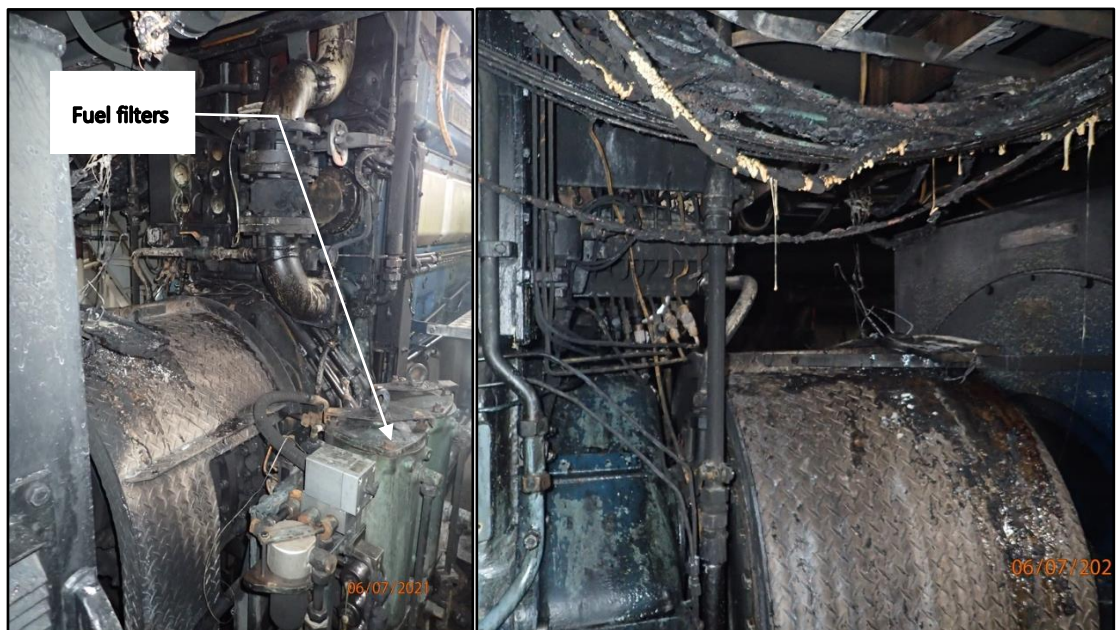
- 2.37 Heat had caused extensive damage to plastic fittings and electrical cabling near the deckhead of the main engine compartment, more concentrated at the forward end of the engine room, above the seat of the fire (see figure 7).

**Figure 7: Photographs of general heat and smoke damage around the seat of the fire (left) and heat damage to electrical cables and fittings (right)**

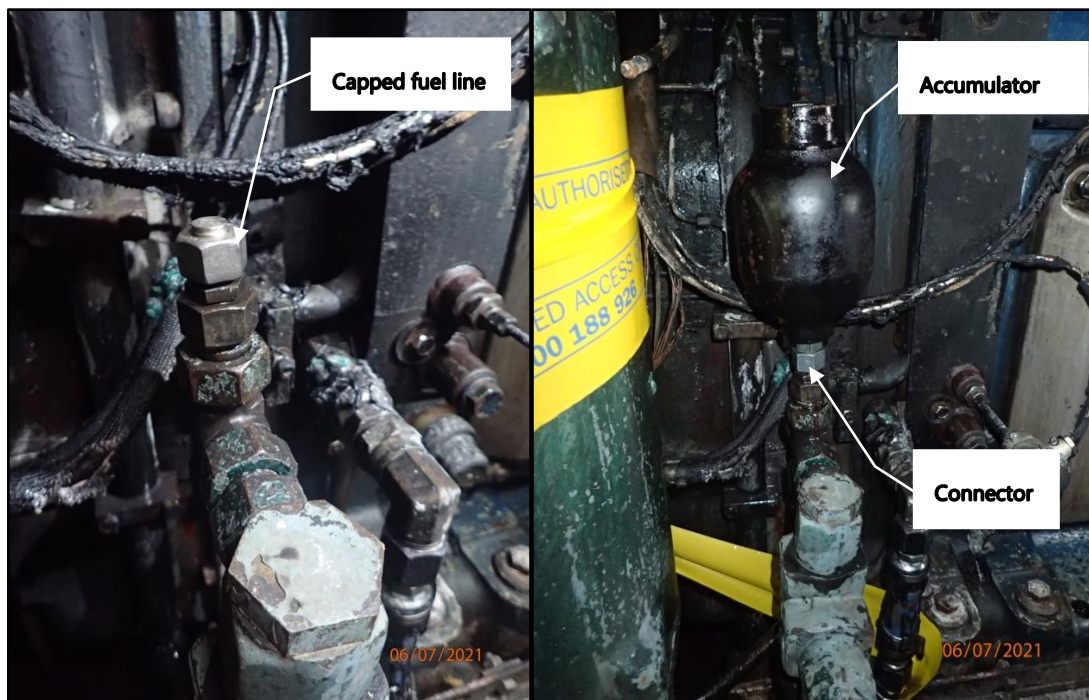
**Figure 8: Photographs of capped fuel pipe where the accumulator had been located (left) and accumulator refitted in its normal location (right)**

- 2.40 As mentioned, after the crew had extinguished the fire they found the accumulator that was normally fixed on the supply line was missing. They found it lying on the tank top directly below where it should have been fixed (refer to figure 8).

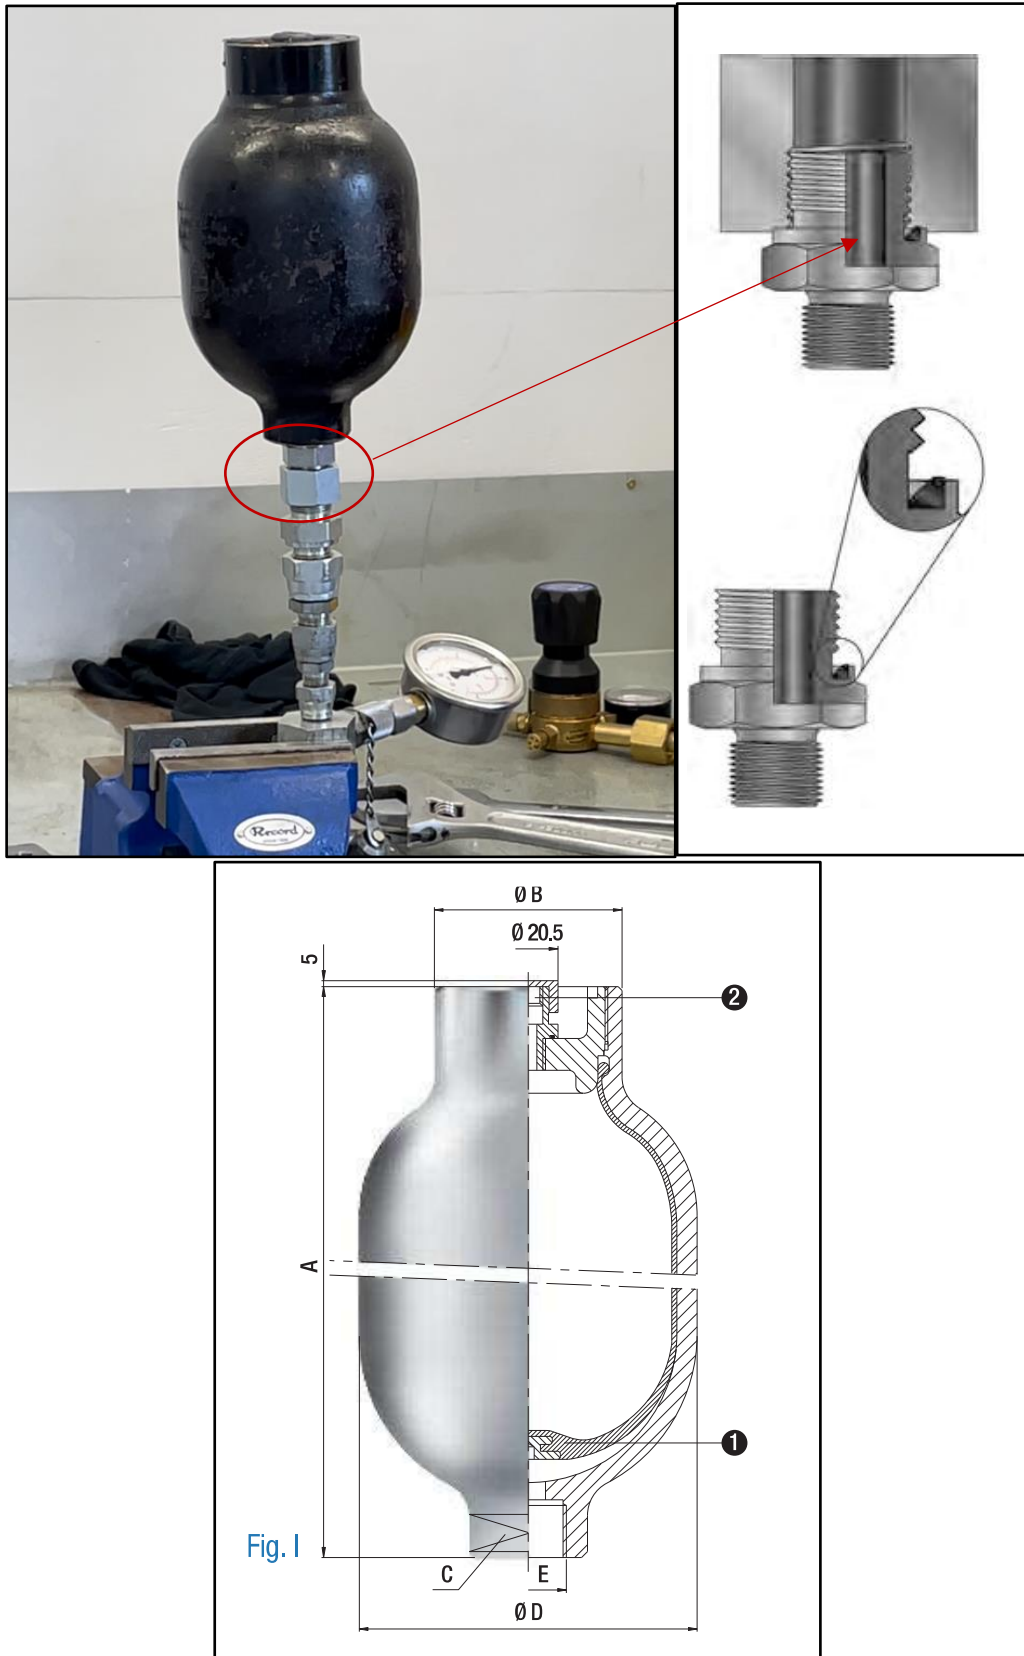
- 2.52 The connector for the accumulator was fixed to the testbed and the accumulator screwed down on to the connector (see figure 9). The hydraulics expert noted that it was a 'loose fit' between the male thread on the connector and the female thread in the accumulator. The loose fit allowed considerable lateral play between the two components until the steel-on-steel mating between the two was achieved.

**Figure 9: Photograph of accumulator with its connector on test bed (top left), detail of the type of seal between the connector and the accumulator (top right) and cross-section of accumulator (bottom)**

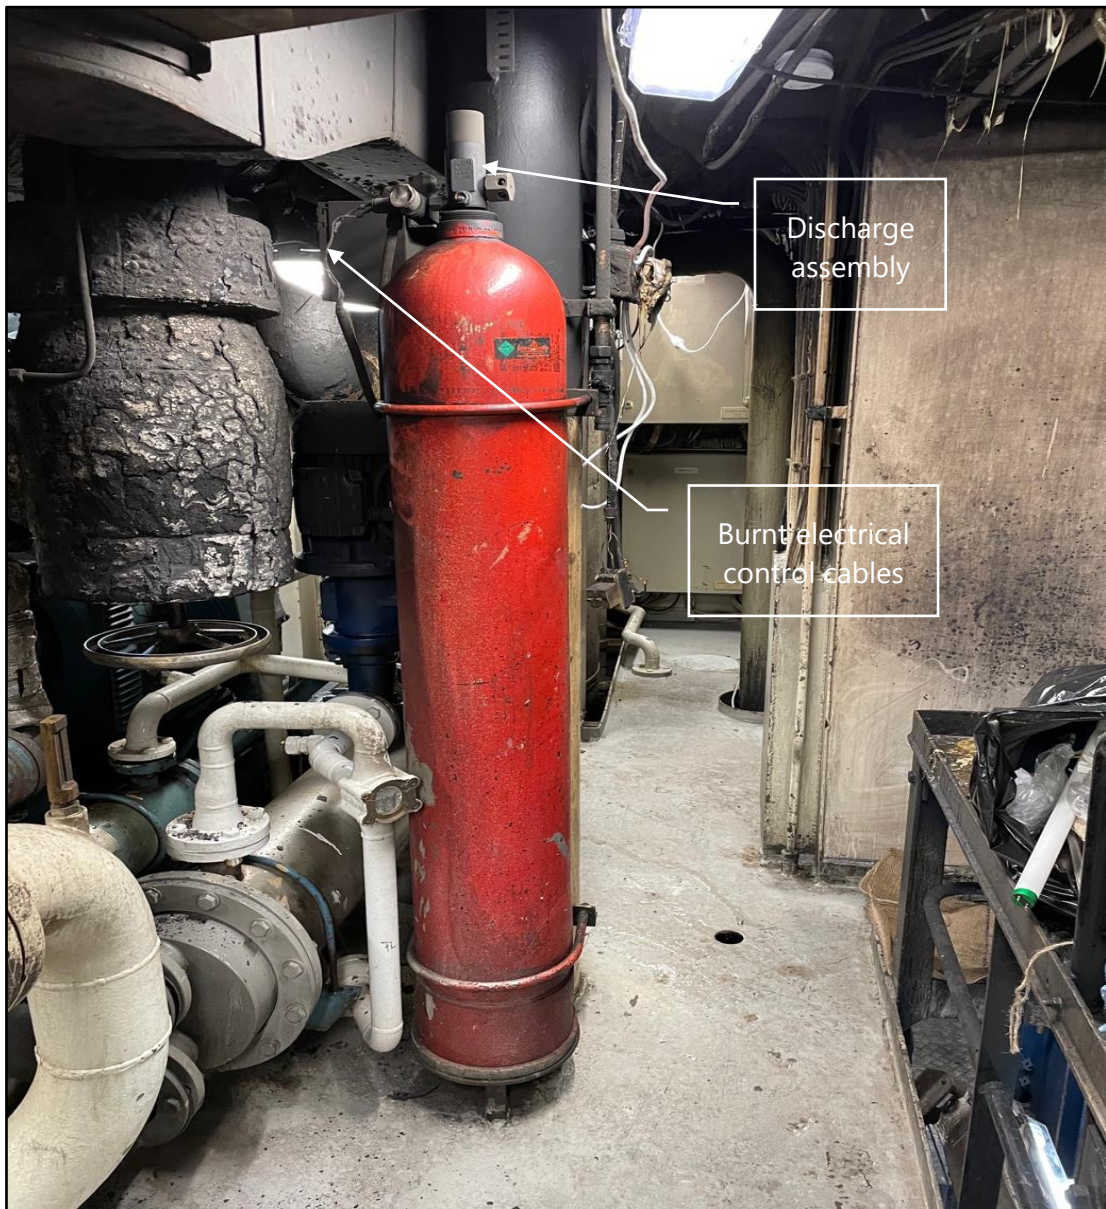
**Figure 10: Photograph of Halon bottle near seat of fire**

- 2.60 There is also a pressure sensor within each discharge assembly, which are all wired in series back to the control panel. A drop in pressure in any one of the bottles will be detected and an alarm activated in the control panel on the bridge.
- 2.61 Post-fire inspection revealed heat damage to the insulation shrouding the 24-volt cables leading to the release assembly on two of the Halon bottles. The most severe damage was to the cables on the bottle located in the immediate vicinity of the seat of

the fire. It was not possible to test the function of the Halon system for health and safety reasons and due to the extensive damage to electric cabling within the engine room.

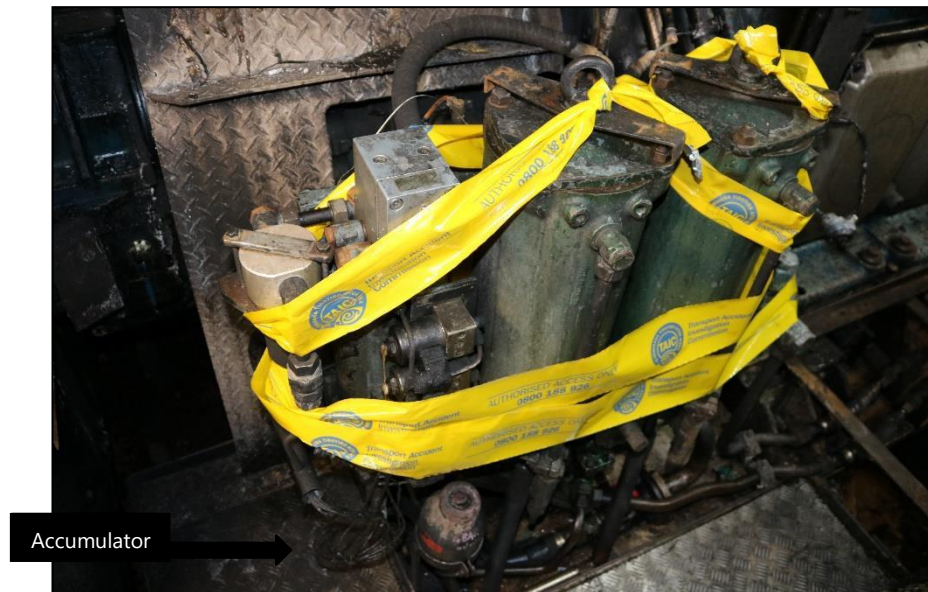
One accumulator at the front of the engine was in place and has a bracket to support its weight and prevent inadvertent movement caused by vibrations of the engine. The other accumulator was unsupported with no bracket holding it in place, instead relying on the steel pipework to support it. This accumulator is the one reported to be found in the sump. Post fire the engineers on board have capped the feed to the missing accumulator and it was in this capped condition during my investigation.

Spread of diesel oil and burn patterns from the fire directly above the accumulator support the theory that it had separated from its threaded connection allowing diesel oil to coat the structure and pipework/fittings above this point.

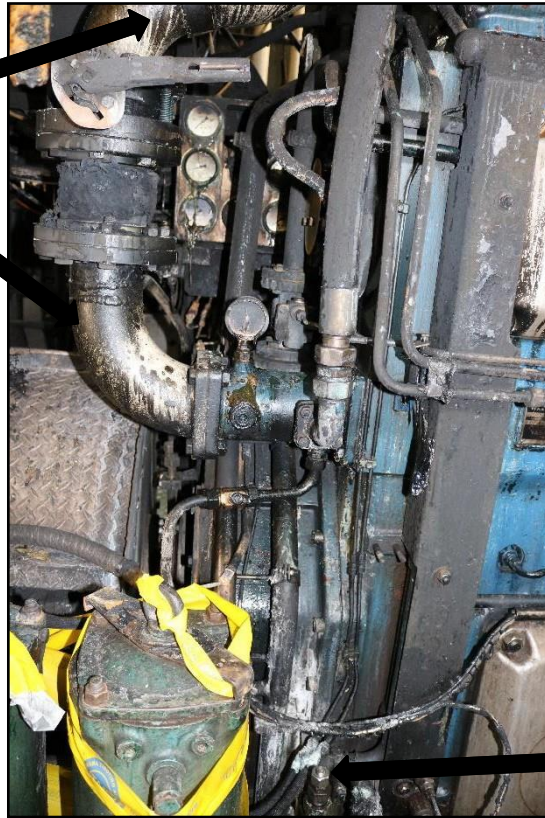
Normal location of  
2<sup>nd</sup> Accumulator,  
with cap in place.

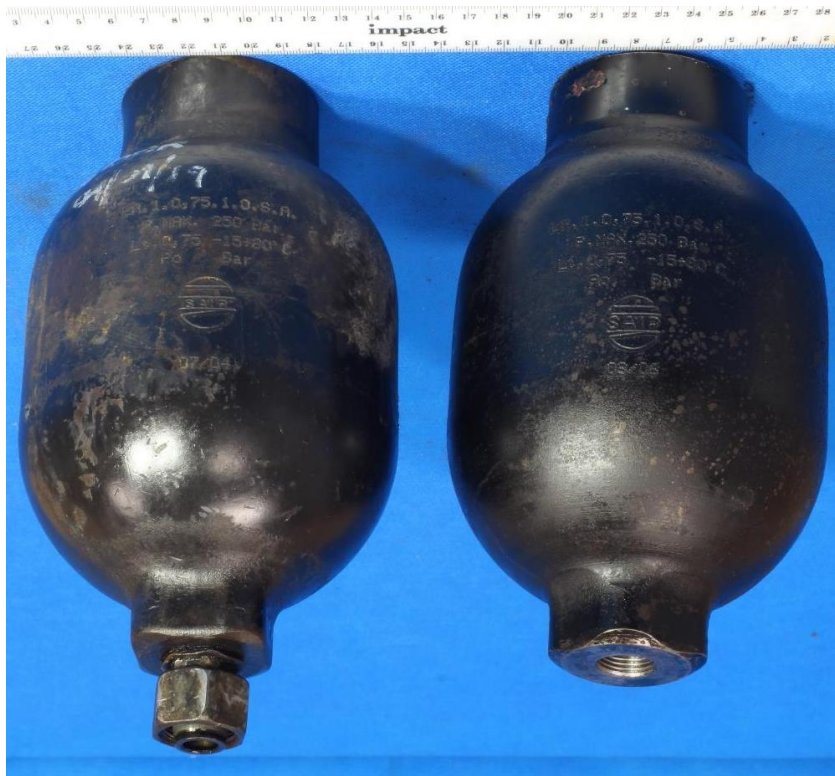
Figure 1: The old (left) and new (right) accumulators.

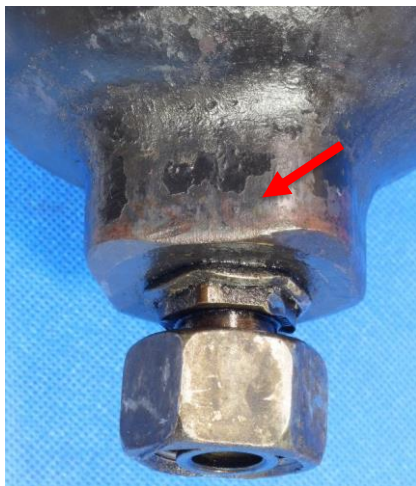
Figure 2: Old accumulator showing damage paint in area arrowed.

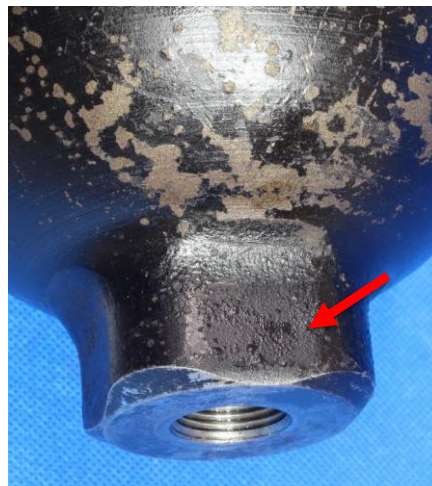
Figure 3: New accumulator showing no damage to paint in the area arrowed.

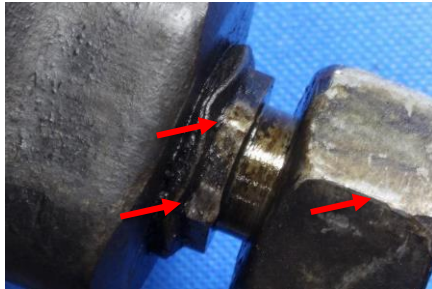
Figure 4: Old accumulator connector deformation as a result of tightening (arrowed).

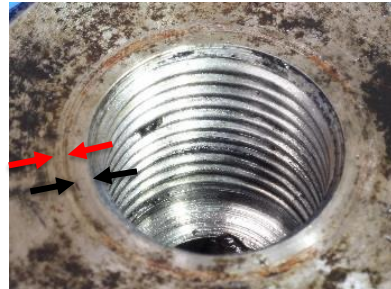
*A minor witness mark was present on the end of the accumulator where the connector had been located. However, there was no surface indentation/damage marks present as would be expected to be seen if the connector had been tightly fastened into the accumulator.*

Figure 5: End of the new accumulator showing the condition of thread and minor marks from the rubber seal (black arrows) and steel outer (red arrows) of the connector.

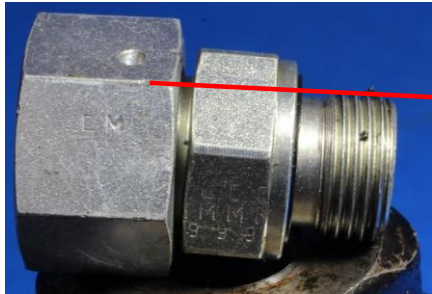
*The integral hexagonal section of the new accumulator connector (24mm across flats) was free of any contact damage, see Figure 6. This indicates that it is unlikely that this connector had been tightened to a relatively high torque, even with a correctly sized spanner.*

Figure 6: New Accumulator connector. Showing the condition of the threads and minor contact marks on large nut.

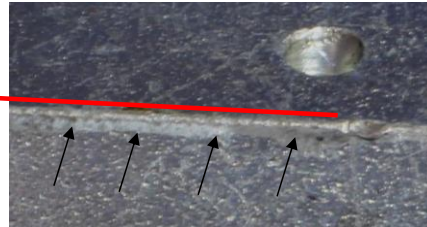
*Conversely, minor damage marks were present on the large nut on the connector (27mm across flats), where a spanner had been located. These marks are consistent with a correctly sized spanner being applied with a relatively high torque.*

Figure 7: New Accumulator connector nut contact marks.

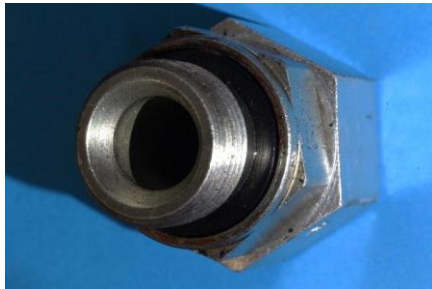
Figure 8: New accumulator connector contact face that was in contact with the accumulator the OD of the rubber seal was 20.5 mm and the OD of the metal contact was 23.6mm ie metal ring was about 1.5mm wide (red arrow).

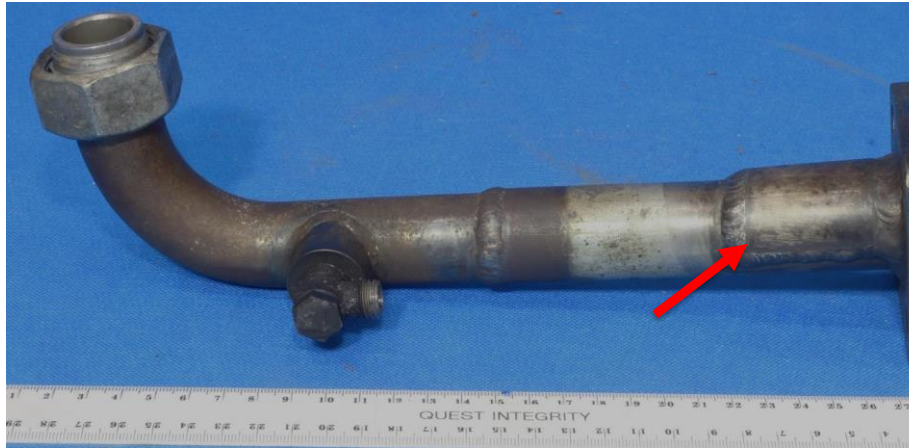
Figure 9: Pipe fitting. Showing the patch repair (doubler plate) over the leak (arrowed).

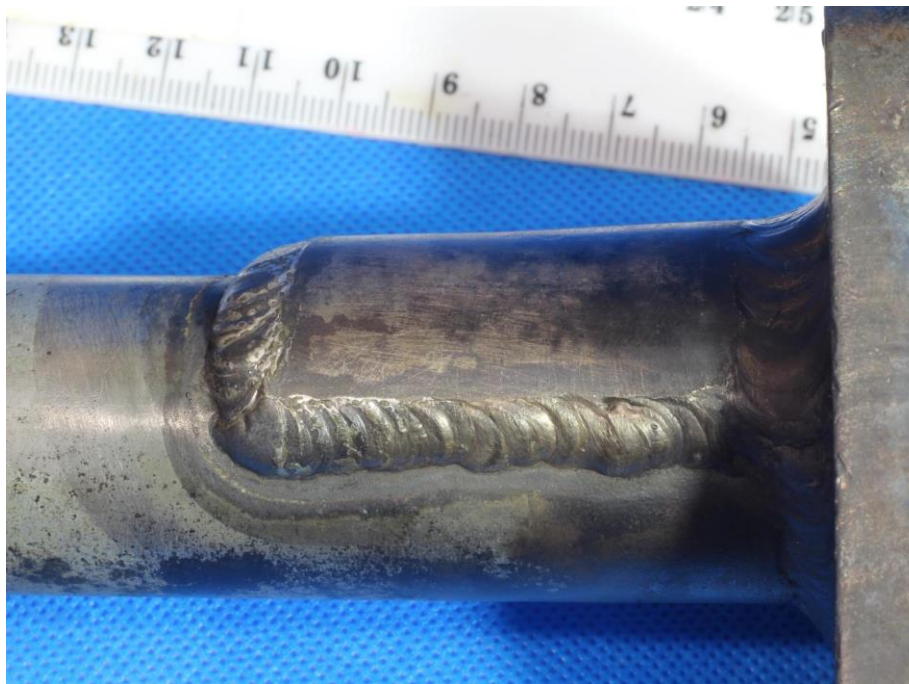
Figure 10: Repair weld and doubler plate.

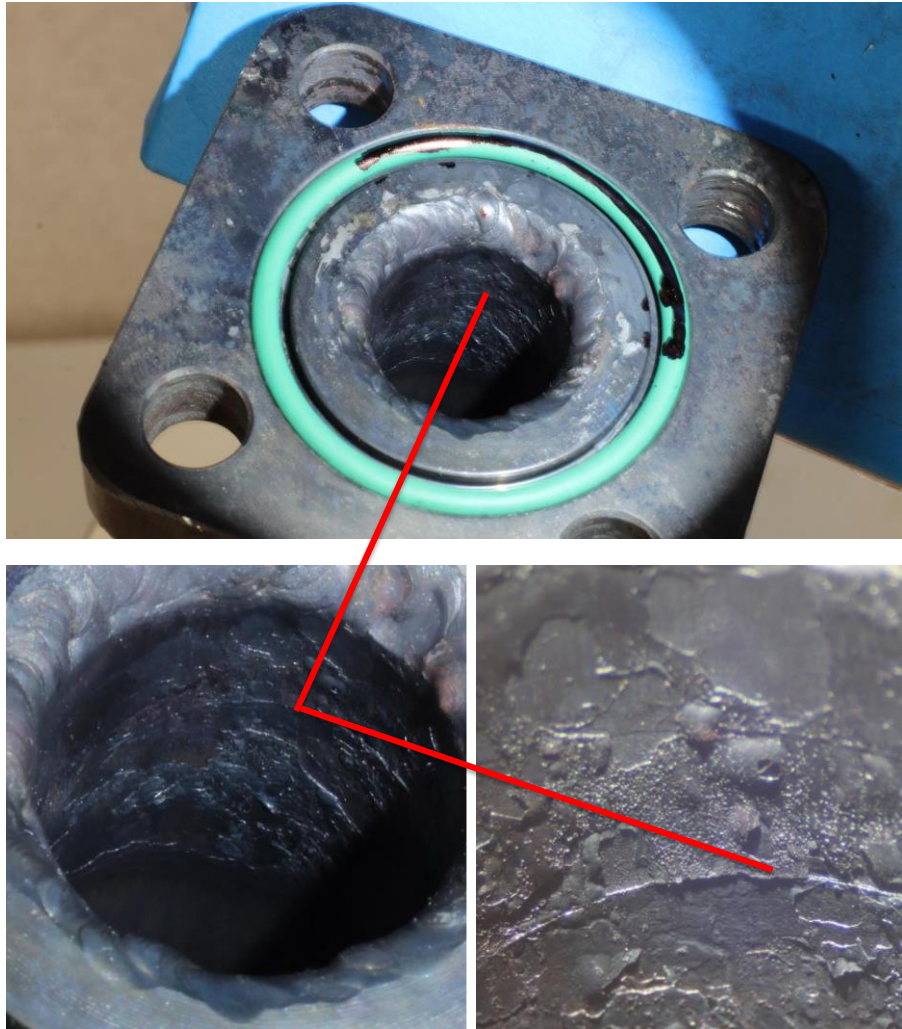
The examination of the piping revealed that it was highly likely that it had leaked as a result of the initiation of a high cycle fatigue crack at the edge of the fillet weld between the piping and the square flange. This type of failure often occurs when unsupported piping can resonate at its natural frequency. This may have occurred at certain operational conditions at a specific excitation frequency. This type of failure is typically not directly related to the age of the piping.

**Figure 11: End of the piping internal. Showing the location and extent of cracking. The black pen mark on the green ring shows the extent of cracking.**
