Transport Accident
Investigation
Commission

Final report

Marine inquiry MO-2021-203
Collision between Fishing Vessel ‘Commission’
and container ship ‘Kota Lembah’
84 nautical miles northeast of Tauranga, Bay of
Plenty, New Zealand
28 July 2021

April 2022

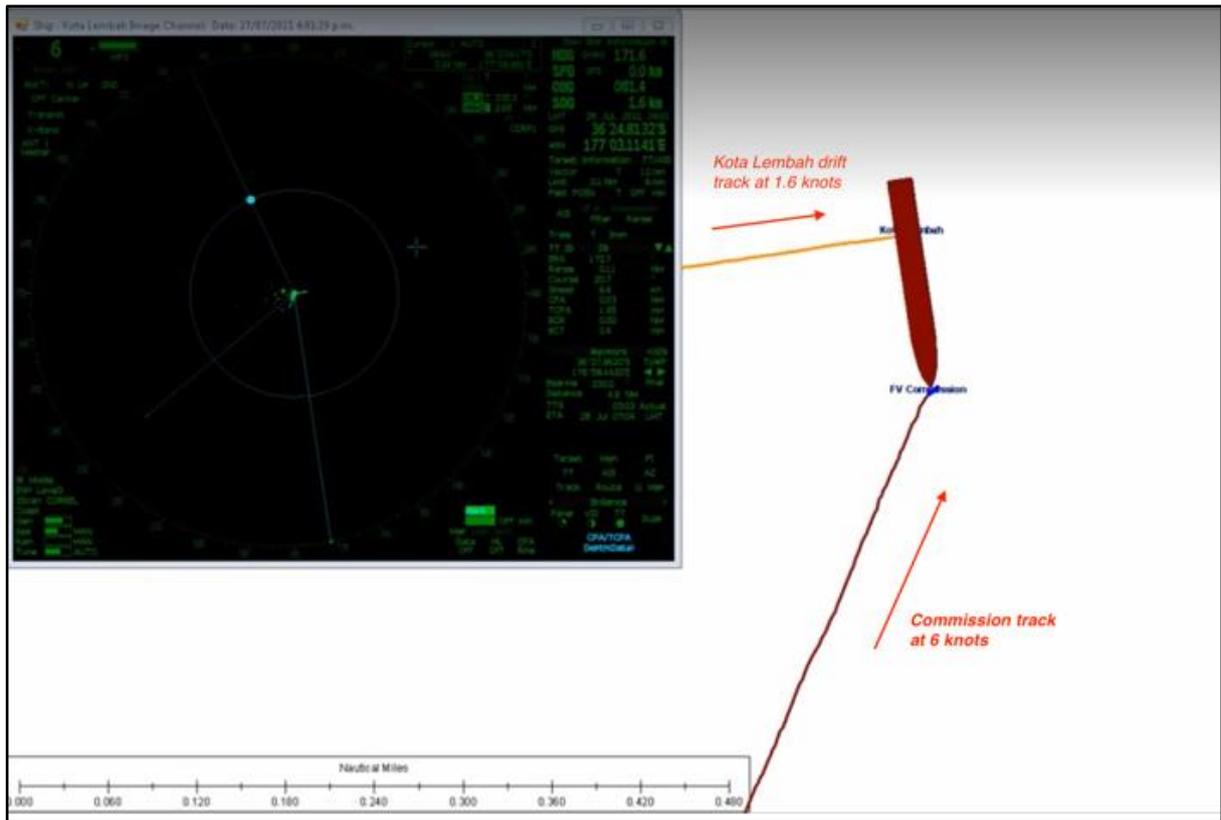
Figure 5: Screenshot at point of collision
 (Sourced from *Kota Lembah's* Voyage Data Recorder (VDR) and *F.V. Commission's* GPS)

- 2.15 The second mate was on watch, supported by a watchkeeper Able Body Seaman (AB). The ship was pointing broadly south on a heading of 172° True, but was drifting sideways towards the east under the influence of the westerly wind (refer to figure 5).

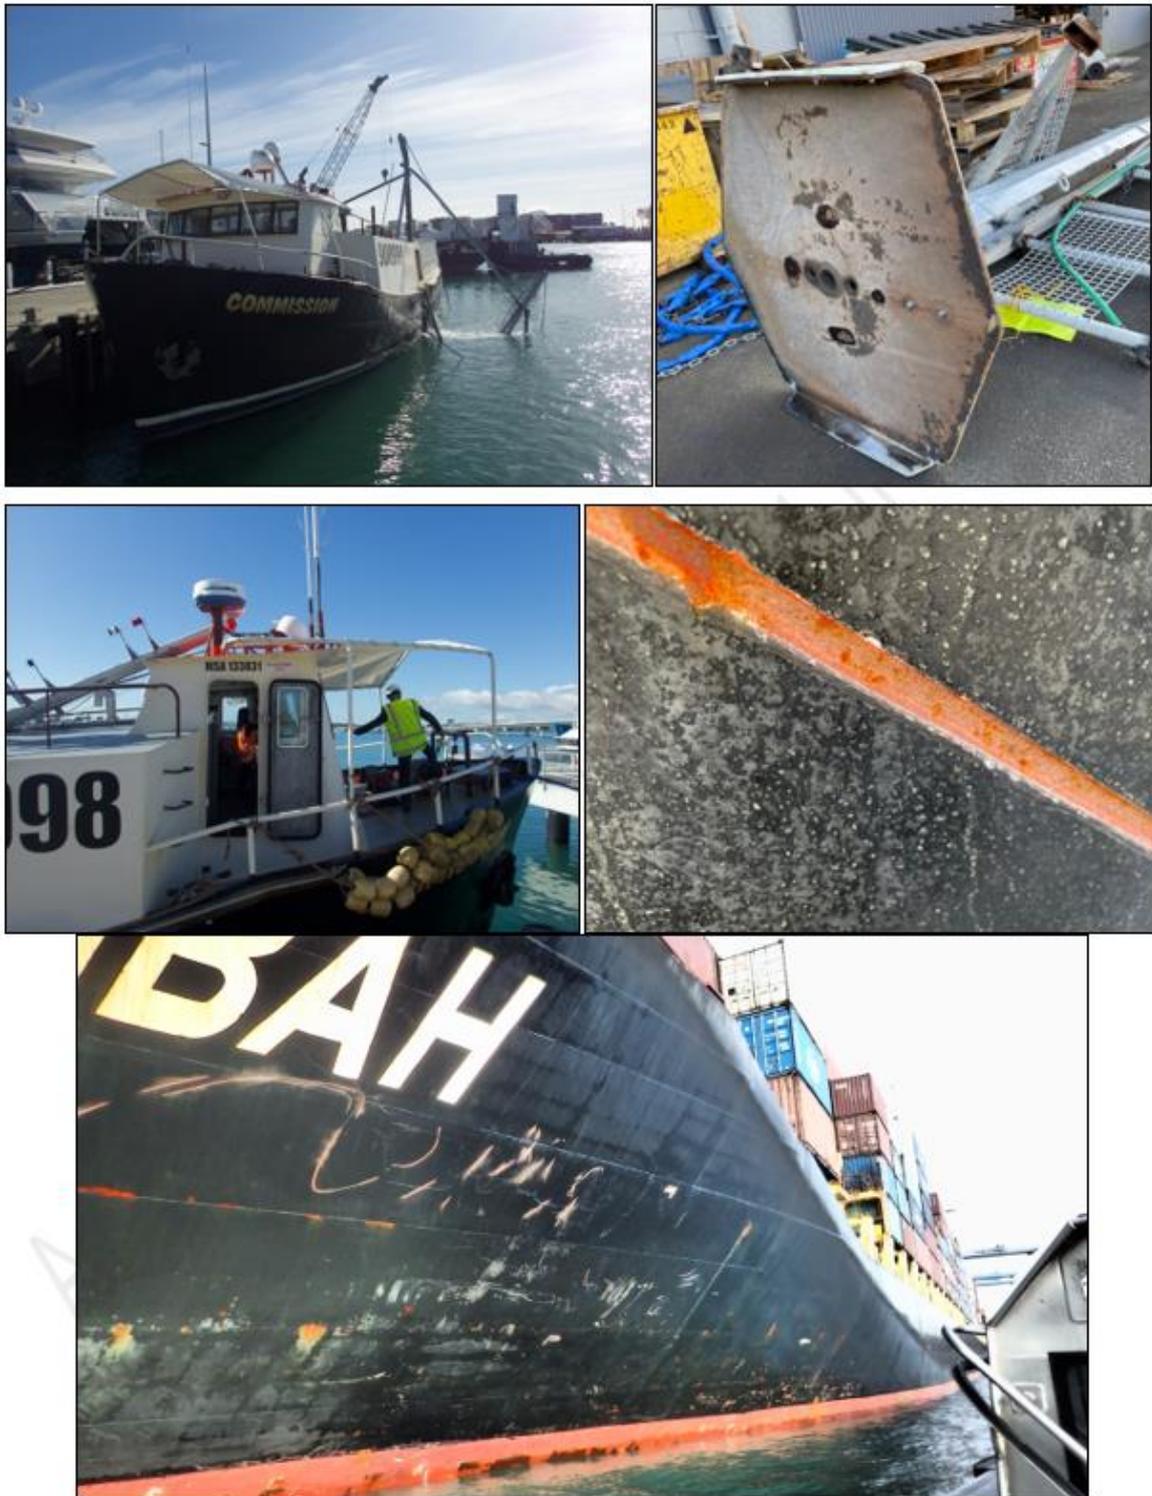
Figure 8: Photographs of damage to the *Kota Lembah* and *F.V. Commission*

- 2.26 Damage to the *F.V. Commission* was confined to the stabiliser arm and the upper wheelhouse structure.
- 2.27 The stabiliser arm was bent around the point where it struck the stem of the *Kota Lembah's* bow, with black paint transfer marks on many parts of the structure. The above-water area of the *Kota Lembah's* hull is black. Red paint transfer marks were evident on the 'foot' of the stabiliser, which would have been below the sea surface at the time of the collision. The colour of this paint was consistent with the colour of the boot-topping¹¹ and/or antifouling paint observed on the *Kota Lembah's* hull.

- 2.28 The top of the wheelhouse was scattered with black paint flakes. The main mast housed an array of navigation lights and communication antenna. The mast was broken off at base level. Several other standalone antennae were also damaged.

- 2.29 The *Kota Lembah* suffered deep gouging of the paintwork under the starboard bow but was otherwise undamaged (refer to appendix 1 for photographs).

Damage to stabiliser arm and wheelhouse (top left), foot of stabiliser arm (top right), toppled main mast (middle left) and gouging of paint on *Kota Lembah*'s starboard bow (middle right and bottom)
