Transport Accident
Investigation
Commission

Final report

Maritime inquiry MO-2021-204
Recreational vessel
Capsize and sinking with three fatalities
Manukau Harbour entrance
16 October 2021

May 2023

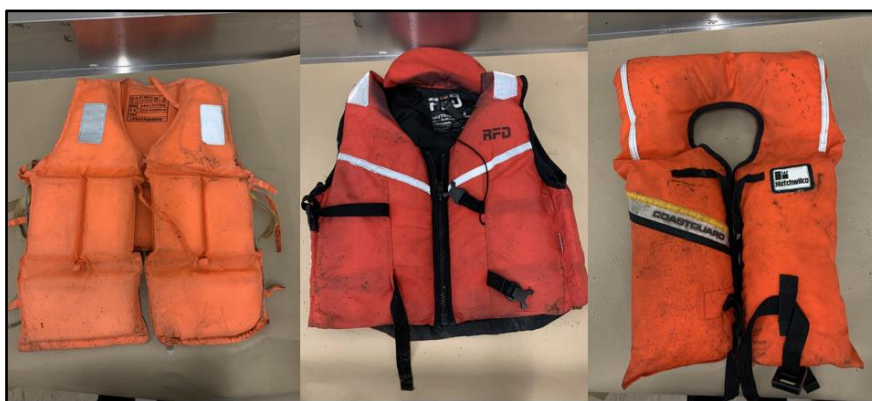
Figure 5: PFDs recovered from the water during the search and rescue

- 2.40 The skipper kept six or seven personal flotation devices (PFDs) on board the boat. Five of these were recovered during the search and rescue operation. The skipper was reported to have been wearing a PFD but was not wearing it when they were recovered from the water. Two of the other occupants wore their PFDs on the outbound trip and removed them when they started fishing. They did not wear the PFDs during the inbound trip.

- 3.11 The role of a responsible skipper is partly fulfilled by good voyage planning. The skipper is responsible for ensuring that the boat is fit for its intended voyage, that the voyage is suitable for the boat and that the boat is operated safely. Conditions can deteriorate very quickly along the New Zealand coast and skippers need to be prepared for emergencies. The participants on this fishing trip were not well prepared to survive. They had not eaten for hours, they had consumed alcohol and they were likely tired after a successful afternoon of fishing. There were PFDs on board, but they were old (see Figure 5) and did not have crotch straps, which would have made them more appropriate for use in the Manukau bar area. They were stowed in the forward cabin, and by the time anybody thought to retrieve them the accident had already happened.

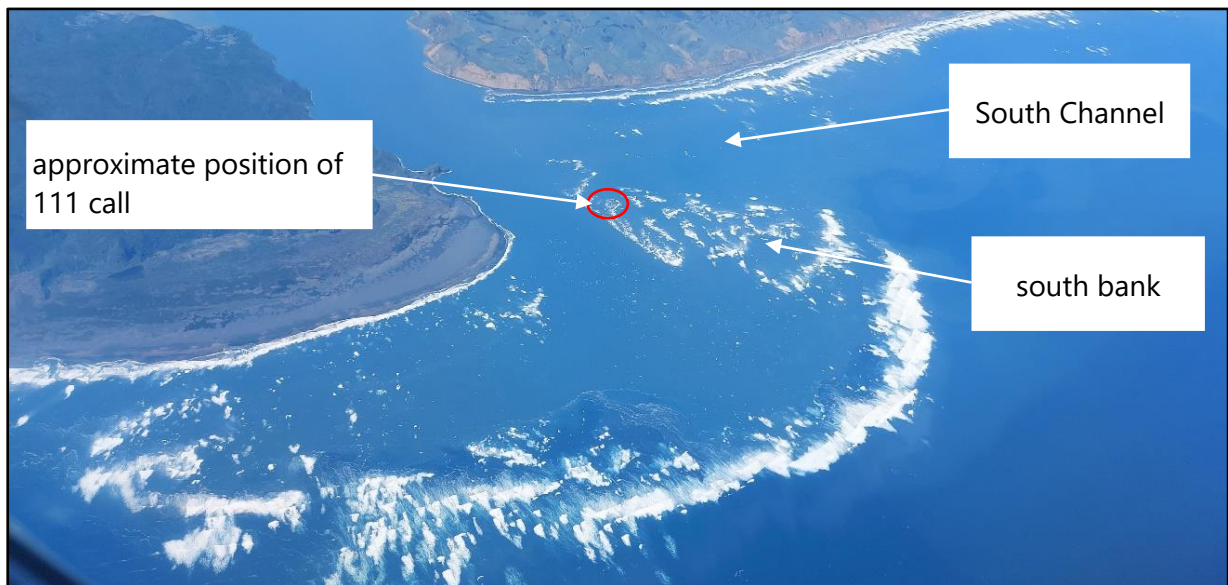
Figure 7: Aerial photo of the Manukau Harbour entrance and bar, November 2021

- 3.23 The Manukau Harbour bar is a coastal feature known commonly as a harbour bar or tidal delta. Sand, silt and sediments transported out of the harbour on the ebb tide have been deposited on the coast and become part of a supply-and-demand cycle that is driven by wind, waves, tides and currents.¹³ The sand bars formed present a particular hazard to navigation at harbour entrances and river mouths because they form natural barriers of shallows where incoming ocean swells slow down, steepen and break. The ongoing deposition and drift cycle means that the precise locations of the sand bars and the depths of the water over them are subject to constant and unpredictable changes.

- 3.27 Usually this can be achieved using a channel of relatively deeper water, such as the South Channel (see Figure 7), and by timing the bar crossing to avoid the worst conditions. When the tide is ebbing and acting in opposition to the incoming waves, steeper and more unpredictable waves are created. Mariners often describe their local bars as 'washing machines' due to the turbulence of the water over the bars. Breaking waves are dangerous to boats, and small boats are prone to swamping and capsizing if they encounter breaking waves. Figure 7 shows the turbulent water over the Manukau bar and the relatively calm water at the South Channel. It should be noted that on the day of the accident there was less wind than there was on the day the photograph was taken.

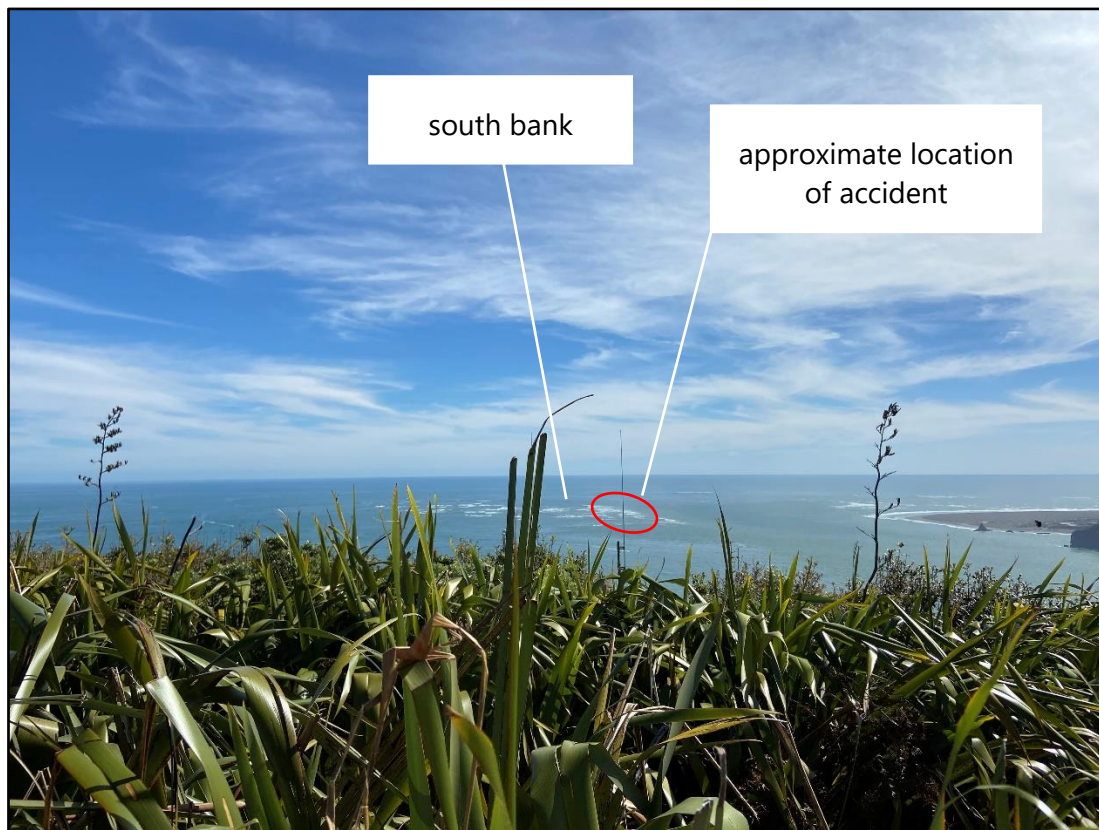
Figure 8: Looking towards the bar from the Manukau Heads lighthouse approximately 45 minutes before the accident

- 3.28 When the skipper drove the boat back towards the harbour, it was about three hours after low water, so near the midpoint of the flood tide. The wind, swell and tide were acting in the same direction as the boat. Figure 8 shows the conditions at the bar about 45 minutes before the accident occurred. Although it was a fine day and sea conditions were relatively benign, the figure shows that waves were breaking over the south bank. The survivor described the calm conditions as the boat left the harbour, but said that it was still 'rocky' going over the bar. However, the Manukau bar – or any harbour bar – is notorious for being unpredictable and dangerous. On the way back in, the waves were described as 'towering', and although the wind had only increased by a small amount, the wave heights relative to the size of the boat increased enough to make the risk of swamping and capsize a reality.

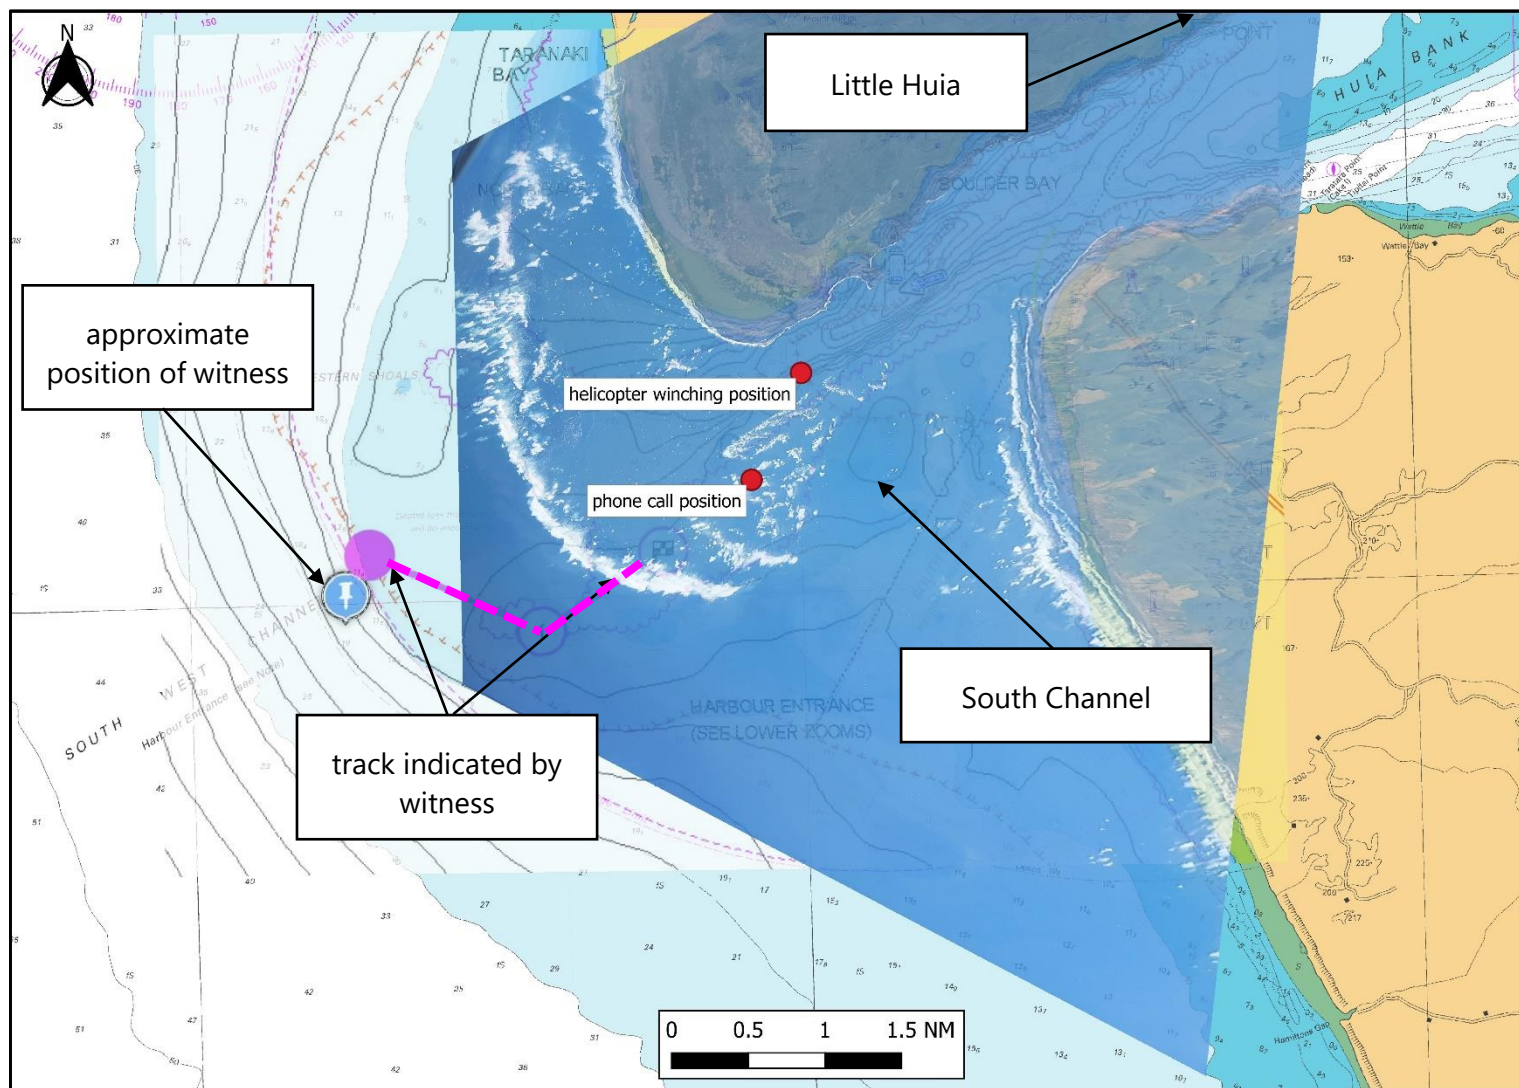
Figure 9: Chart overlaid with approximate track of the boat as described by the witness in 3.29, overlaid with aerial photograph

- 3.30 Investigators plotted the witnessed track with the location of the emergency call and the helicopter winching position (see Figure 9). The resulting composite diagram showed that it was **likely** that the small power boat witnessed was the boat that capsized. Coupled with the survivor’s description of large breaking waves that towered over the vessel, it is **virtually certain** that the skipper attempted to navigate into the Manukau Harbour over the bar rather than take the safer route through the South Channel.

- 3.31 Navigating the vessel over the bar placed the vessel at a high risk of encountering conditions in which it would be prone to capsize and swamping – especially in the case of loss of propulsion. Once the outboard motor stopped, the skipper had no way to control the vessel’s angle of encounter with the waves. It could not be determined whether the vessel was swamped by an overtaking wave and then the engine stopped or the engine stopped first and the vessel was then swamped. In either case, had the skipper elected to use the South Channel they would have been in deeper and calmer water and might have had some chance of restarting the engine. Additionally, there may have been a passing vessel that could have given assistance.
