Transport Accident
Investigation
Commission

Final report

Maritime inquiry MO-2022-201
Charter fishing vessel Enchanter
Capsize
North Cape, New Zealand
20 March 2022

August 2023

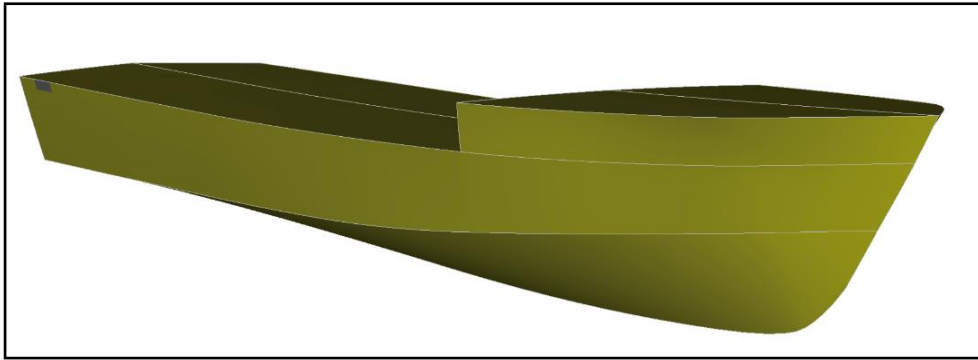
Figure 16: Extract from the *Enchanter's* stability manual showing the modelled watertight boundary

- 3.50 The modelled boundary was not watertight in the true sense of the word. Inside the main saloon there were openings leading to the sleeping quarters under the foredeck, the engine room, and the crew's accommodation aft, all of which would allow down-flooding⁴⁰ to occur should water enter the main saloon or, as in this instance, if the entire superstructure was lost when the vessel was knocked down.

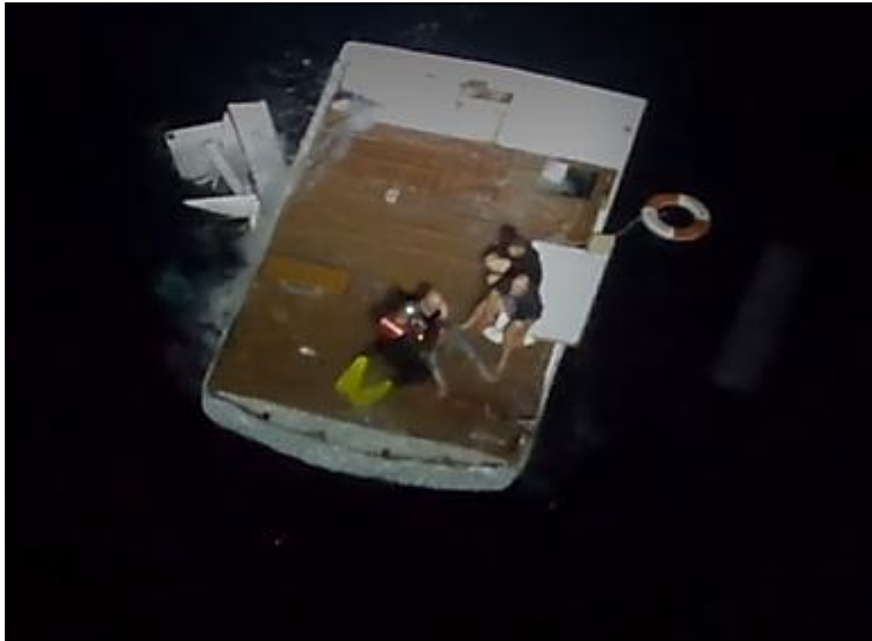
- 1.6 When the *Enchanter* rapidly rolled onto its side, the force of the water exceeded the design parameters of the vessel's superstructure. This caused the superstructure to separate from the hull, resulting in the *Enchanter* fully capsizing.

Figure 18: The inverted flybridge with a rescue swimmer and three survivors sitting atop what had been the ceiling of the main saloon and the floor of the flybridge

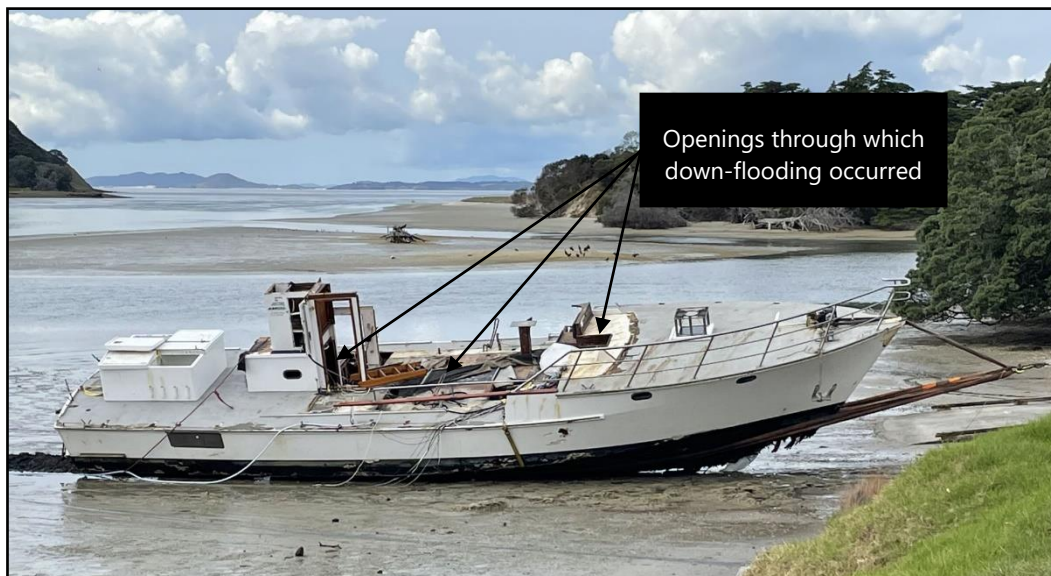
3.57 Post-salvage inspection confirmed that the separation of the superstructure from the hull was not because of poor maintenance. The timber around this connection was in good condition and the method of connection was generally in accordance with the standards of wooden boat building for the era of build. The wooden material had failed from simple overload. Figure 19 shows the *Enchanter* after it had been salvaged. Note the total absence of the main superstructure (see Appendix 4 for details of the post-salvage inspection.)

Figure 19: The Enchanter after salvage

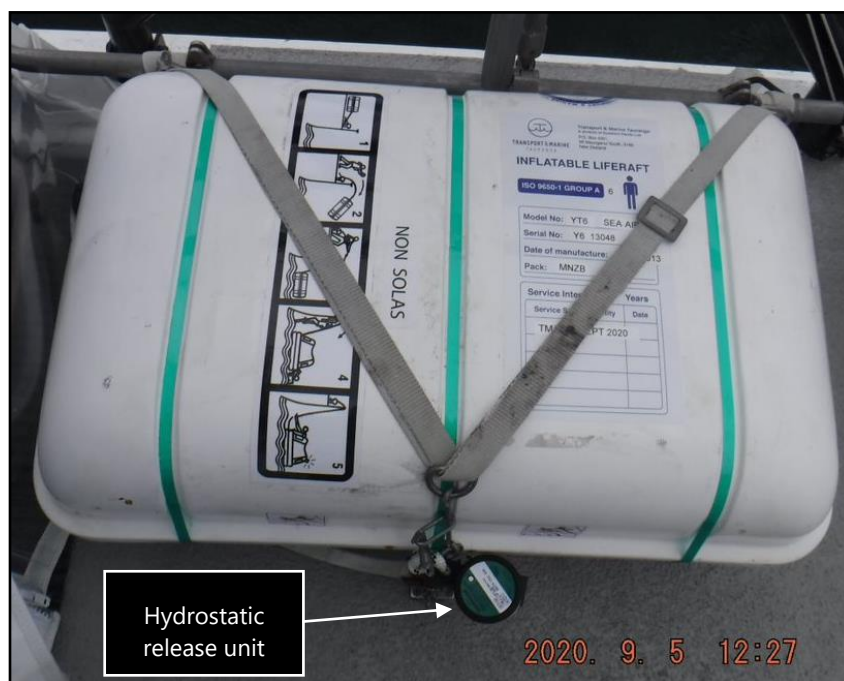
- 1.7 Due to the suddenness of the capsize none of the people were wearing or had access to life jackets, and the life rafts **likely** did not automatically deploy, which left those in the water with no or limited means of flotation.

Figure 20: Non-SOLAS life raft fitted to the Enchanter
 (Source: 2020 survey records)

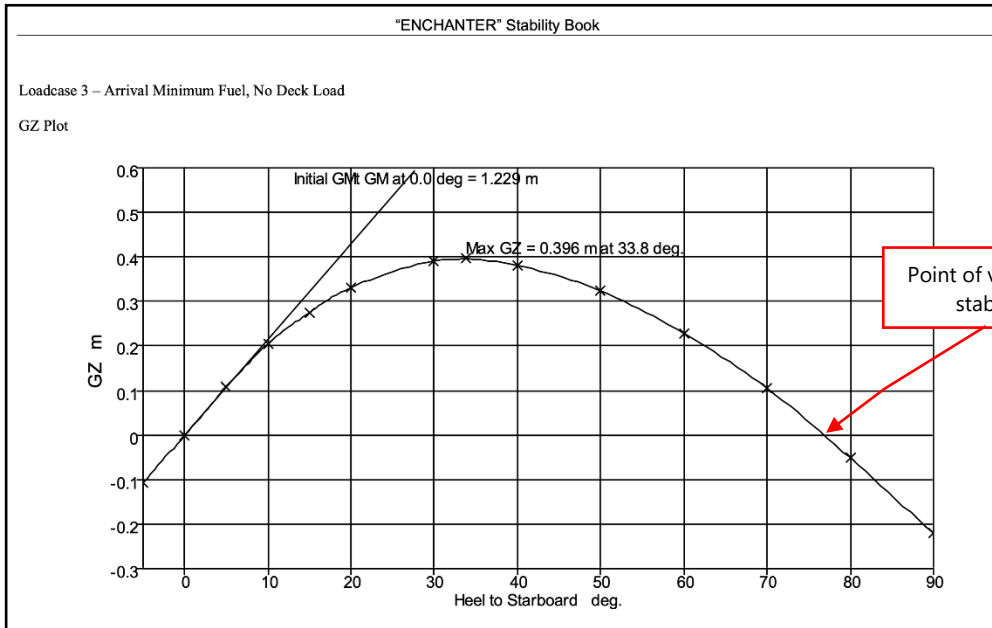
- 2.4 The value for GZ reaches zero at a heel angle of 77 degrees. This is known as the angle of vanishing stability. If the *Enchanter* heeled past 77 degrees, the value of GZ becomes negative. At that point GZ becomes a capsizing lever and the vessel will capsize.

Figure 29: GZ curve for the Enchanter, representative of its stability condition at the time of the capsizing
 (Source: The *Enchanter's* Stability Manual)

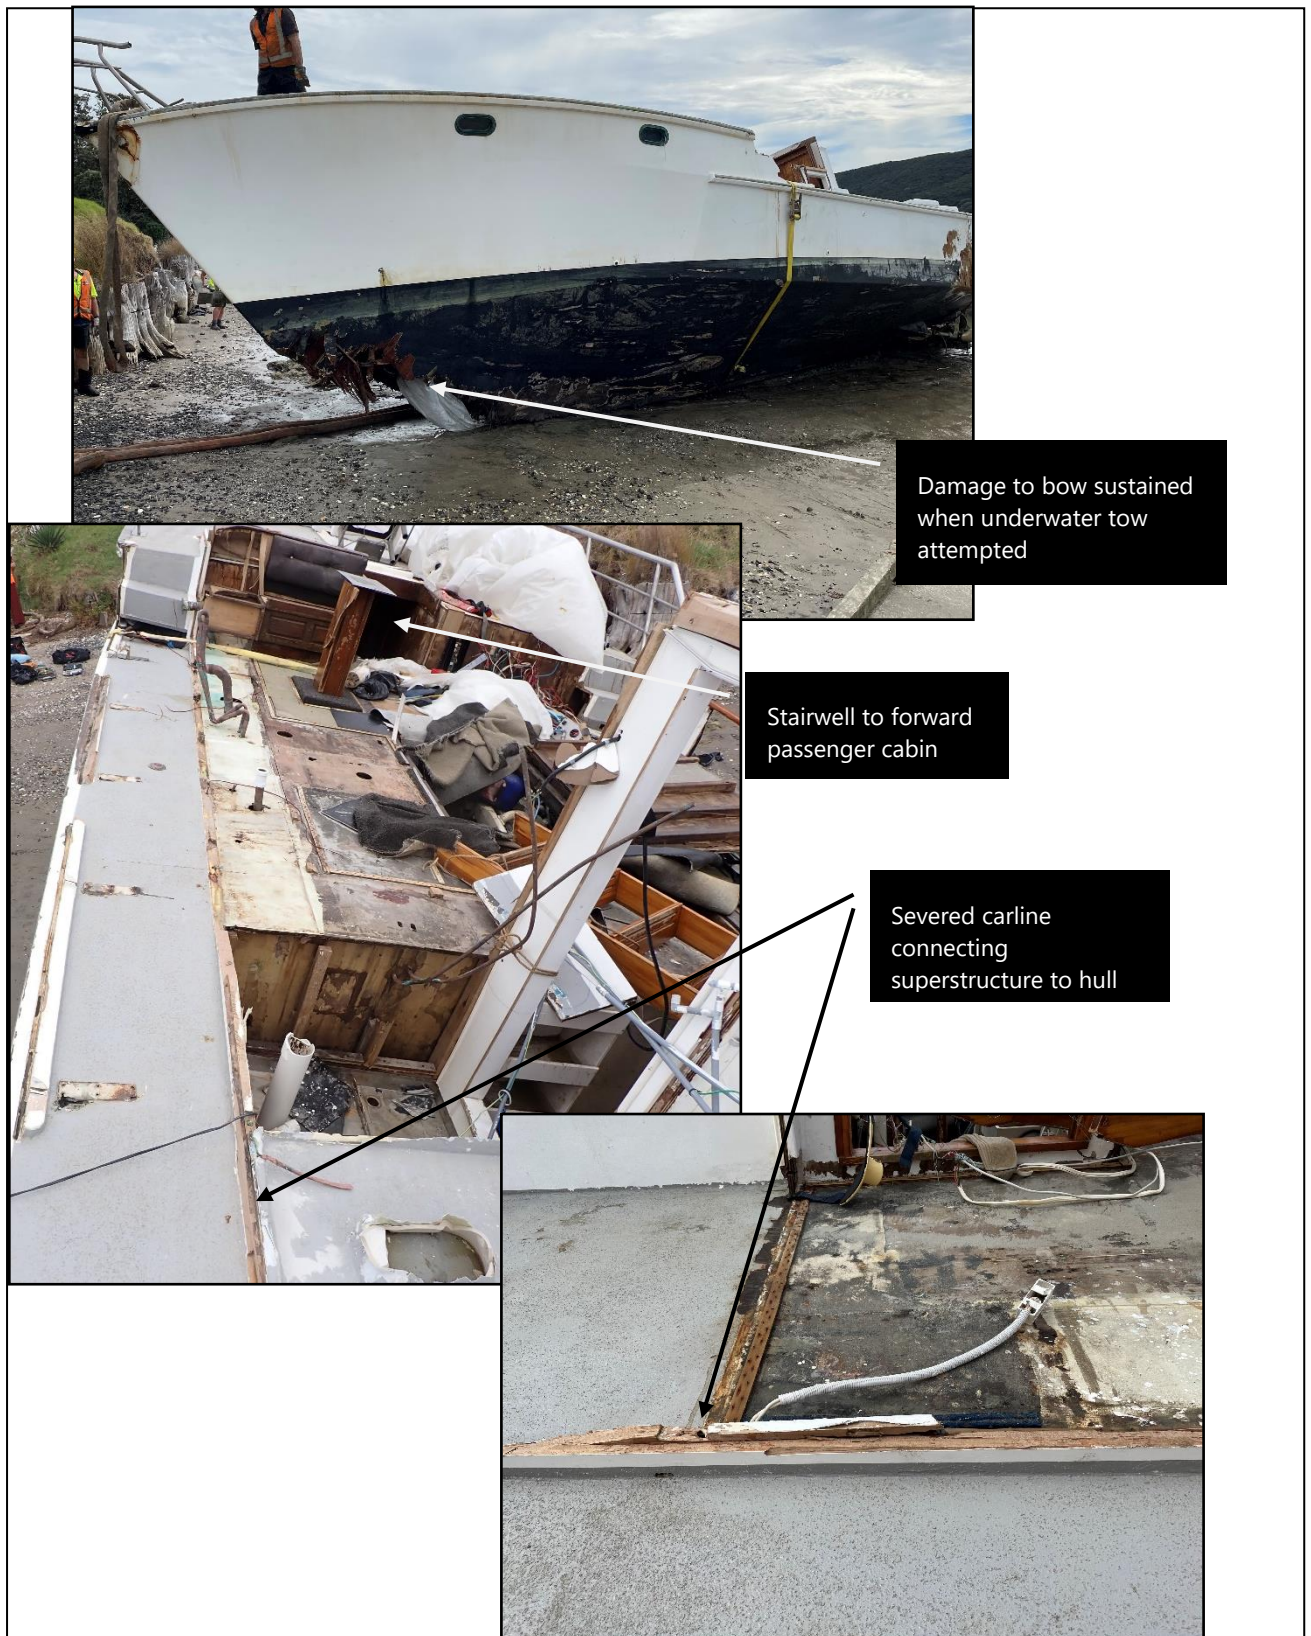
Figure 32: The Enchanter showing damage to bow sustained during salvage (top); overview of what had been the main saloon (middle); and detail of failed connection between the hull and superstructure (bottom).
