Transport Accident
Investigation
Commission

**Report of the Transport Accident Investigation Commission into
two stevedoring accidents in April 2022**

***Maritime inquiry MO-2022-203
Container vessel, Capitaine Tasman
Stevedore fatality during container loading operations
Port of Auckland
19 April 2022***

***Maritime inquiry MO-2022-202
Bulk carrier, ETG Aquarius
Stevedore fatality during coal loading operations
Lyttelton Port
25 April 2022***

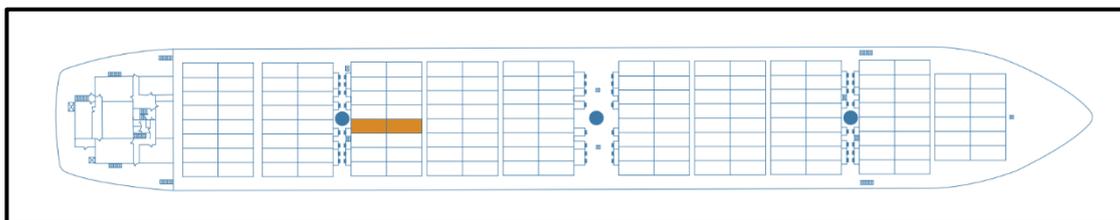
Figure 7: Plan view of Capitaine Tasman depicting container stowage in 20-foot units
The blue circles indicate the position of the three cranes.
The coloured box indicates position of the 40-foot container involved in the accident.

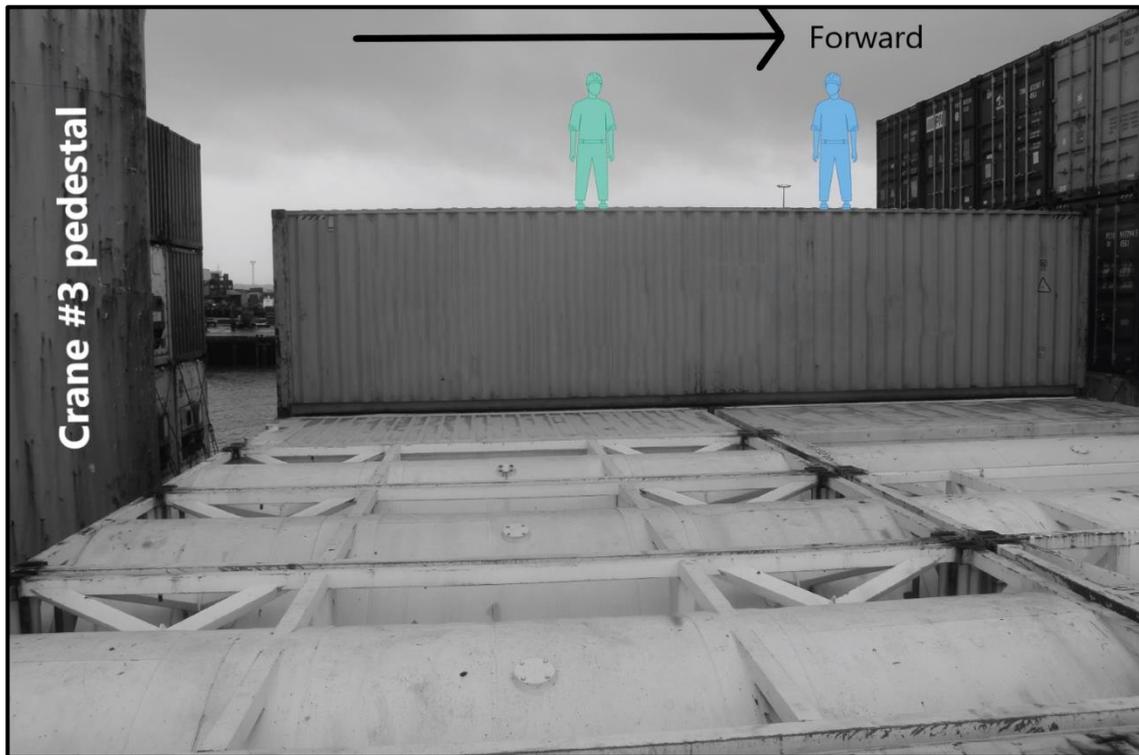
A1.11. Two stevedores in gang three (hold operators A and B) were positioned on the second tier⁴⁸ of containers (see Figure 8). The hold operators' task was to guide the containers into the correct position as the crane lowered them. At the time the container was being lifted from the wharf, the hatchman had left the vessel to collect a rain jacket.

Figure 8: Hold operators A (green) and B (blue) on the second container tier

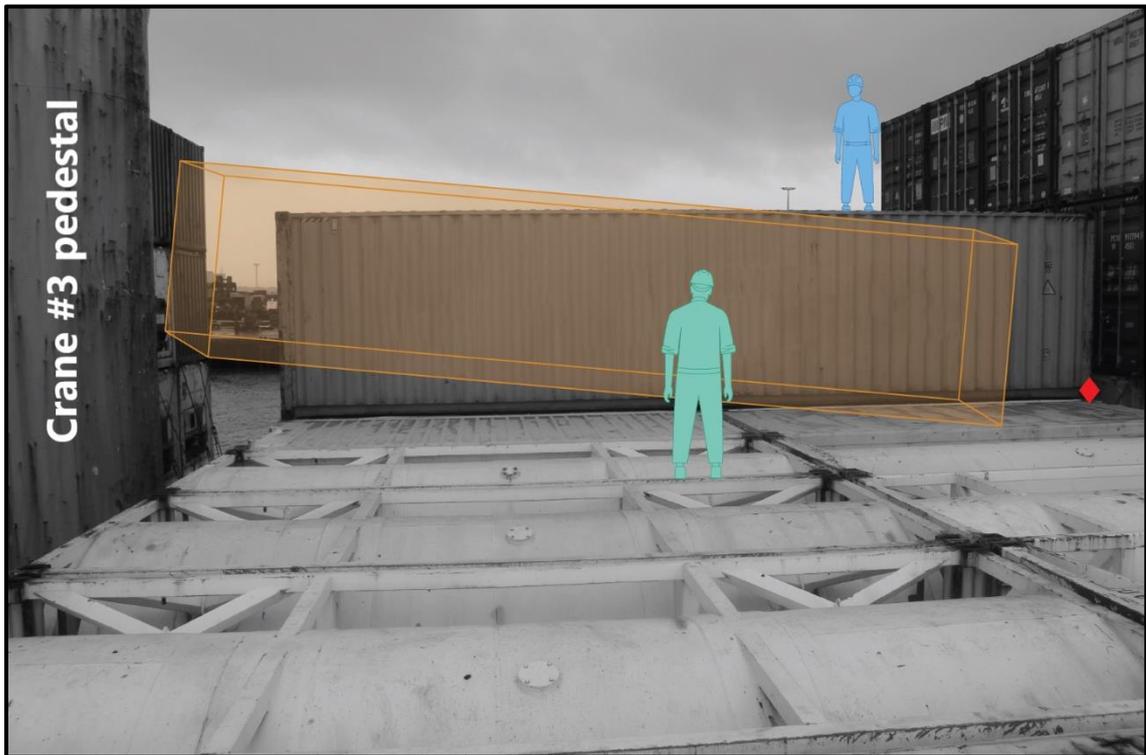
- A1.15. Once down on the first tier, hold operator A repositioned the displaced twist lock into the top corner casting of the 20-foot container.⁵¹ Hold operator A remained on the first tier of containers and hand-signalled to the crane operator that the landing could be re-attempted (see Figure 9).

Figure 9: Approximate position of hold operator A (green) after repositioning the forward port twist lock (red diamond)

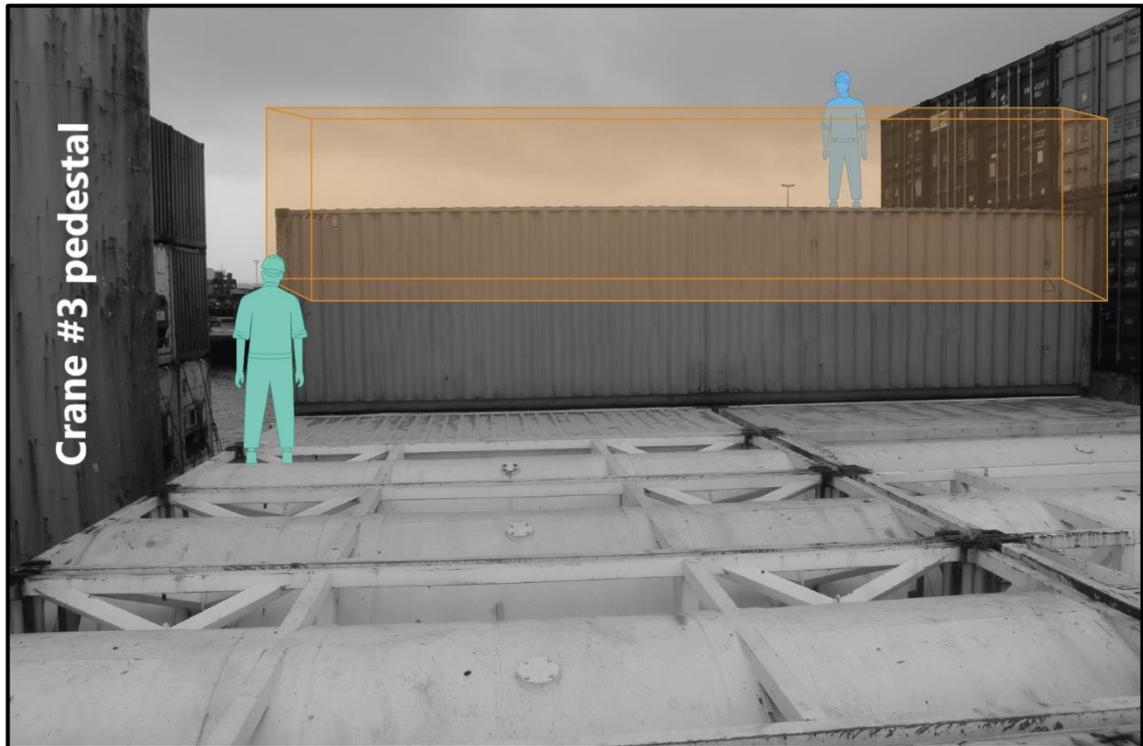
Figure 10: Approximate position of hold operator A (green) on the edge of the first tier of containers immediately before accident

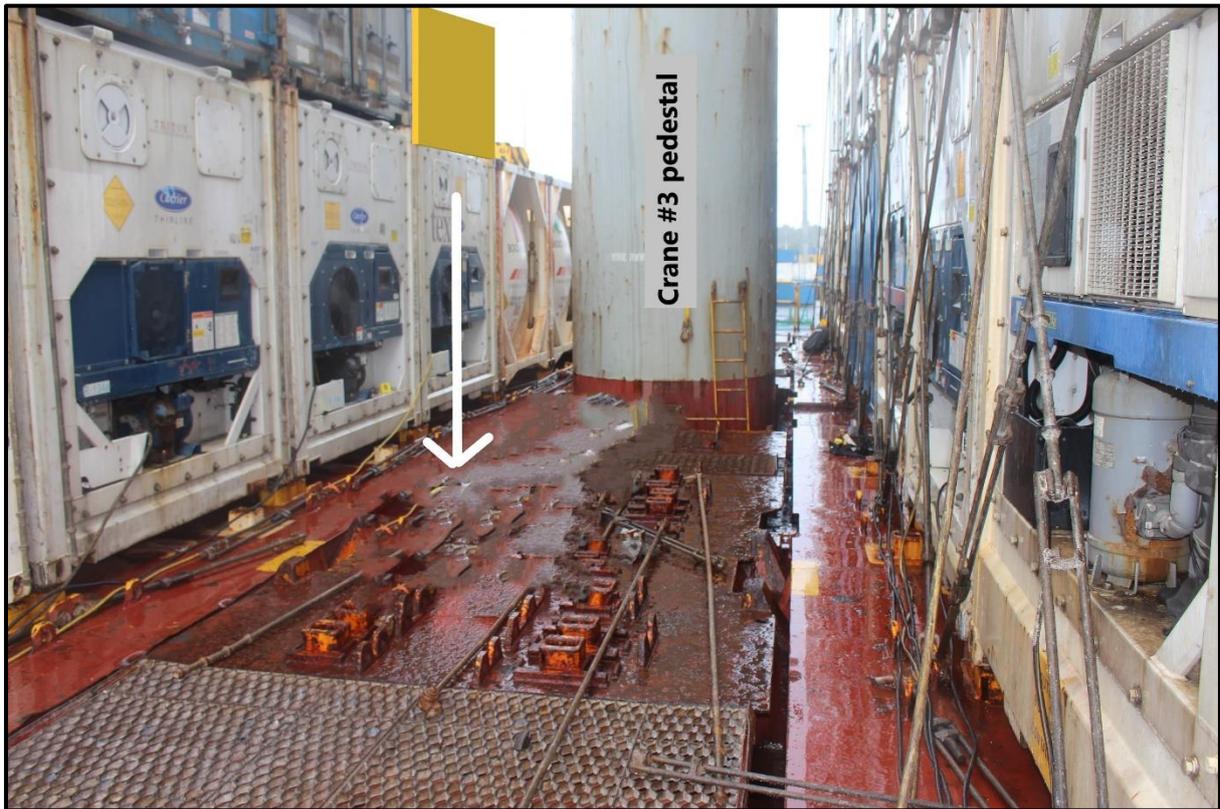
- A1.18. At the time the crew member observed hold operator A, the 40-foot container was suspended approximately 1.5 metres above the first tier. The crew member then saw the hold operator bend down and move underneath the suspended container, reaching with their arm toward the aft port side of the container.
- A1.19. Almost immediately after observing this, the crew member saw the container lower, resulting in hold operator A being pinned under the container and crushed by its weight.
- A1.20. The crew member attempted to alert the crane operator by shouting but, due to the proximity of bay 32 to the number three crane, could not signal the crane operator visually. The crew member then observed the container rise a small amount and hold operator A fell from the 20-foot container onto the main deck (see Figure 11).

Figure 11: View from where the vessel crew member was standing on the main deck towards where hold operator A fell, as indicated by white arrow.

Yellow box represents where the container was to be positioned.

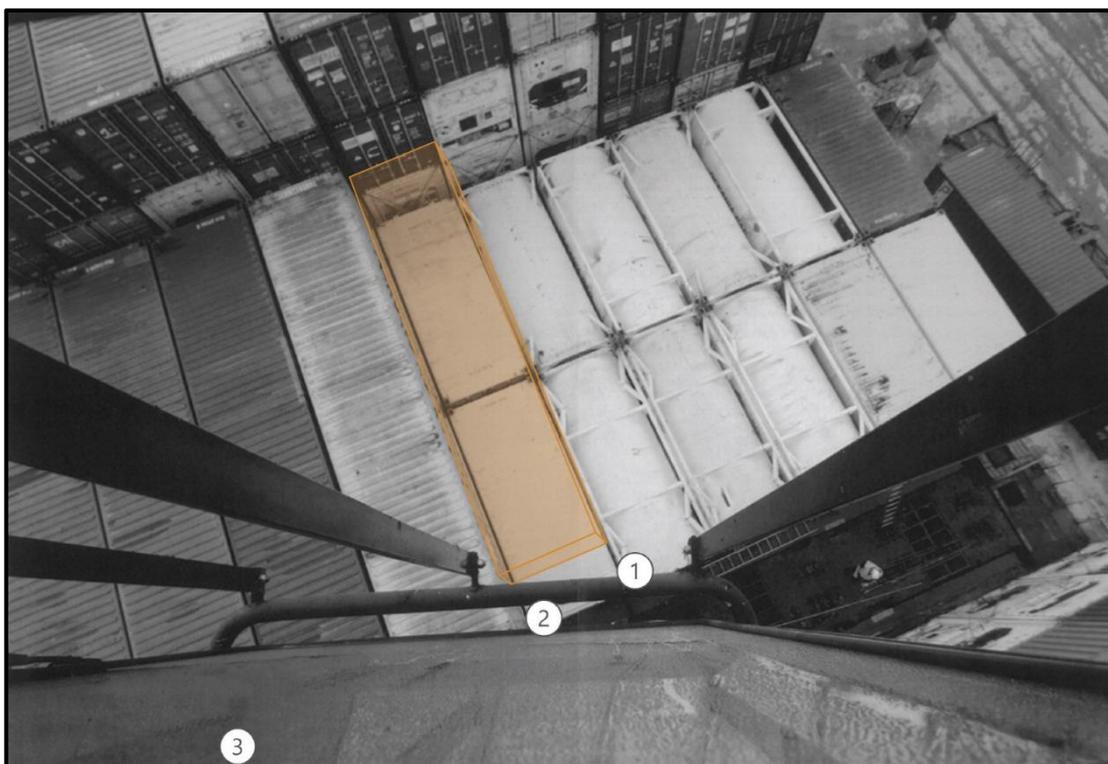
Figure 12: View looking down from outside the number three crane cab window

**Point 1 indicates where the eyewitness initially observed the victim;
Point 2 indicates the victim's position when the container was lowered;
Point 3 is the approximate location of the eyewitness
who was standing below the containers on the main deck level.**

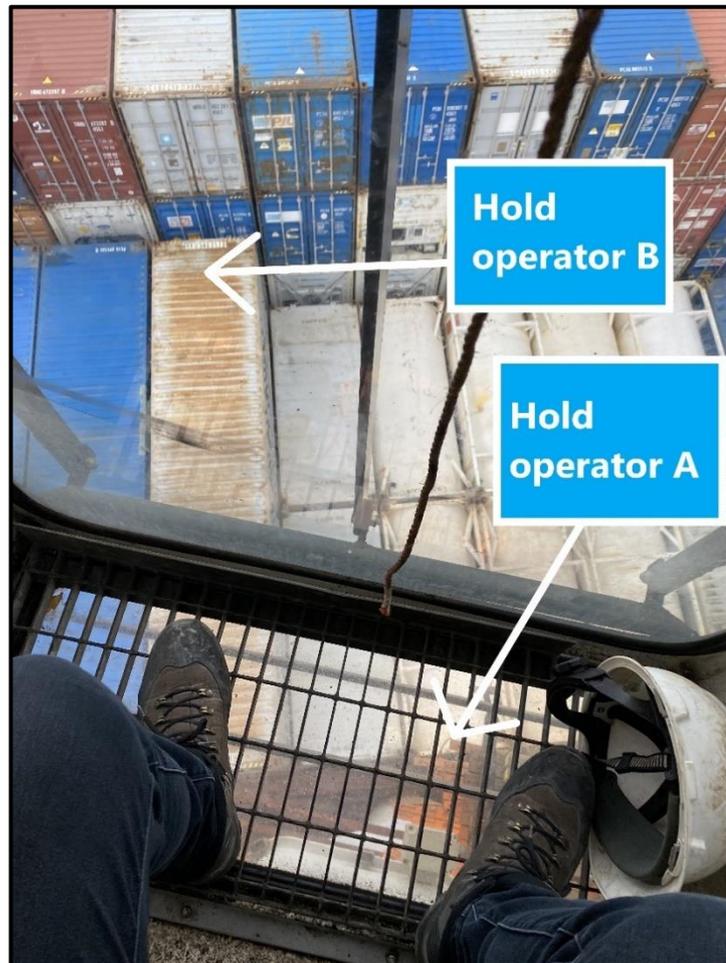
opportunity to observe hold operator A moving into an unsafe position. However, the Commission believes it is **unlikely** that the crane operator would have noticed the hold operator's movement even if they had unrestricted visibility.⁸⁰

Figure 15: View through crane floor grate

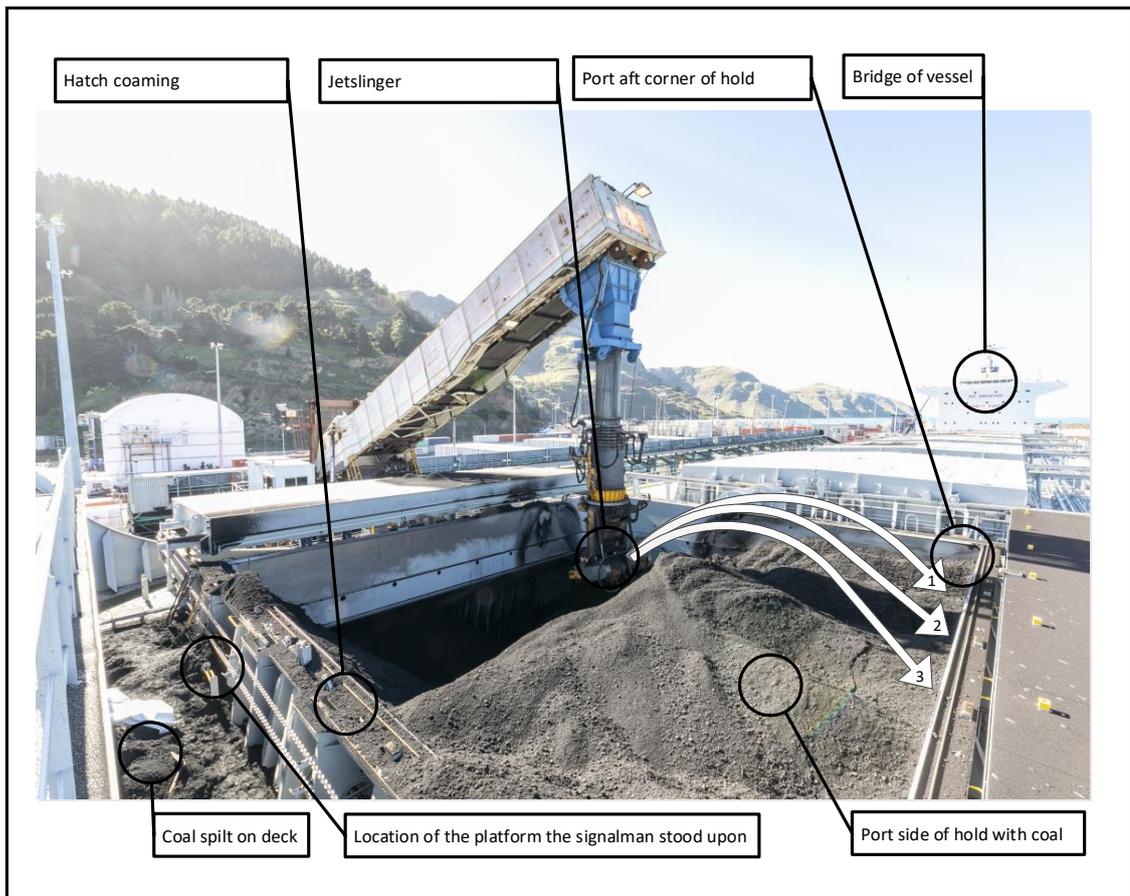
Figure 18: Number one hold after the accident, showing the ship-loader and jetslinger⁹⁵
(Credit: Maritime New Zealand)

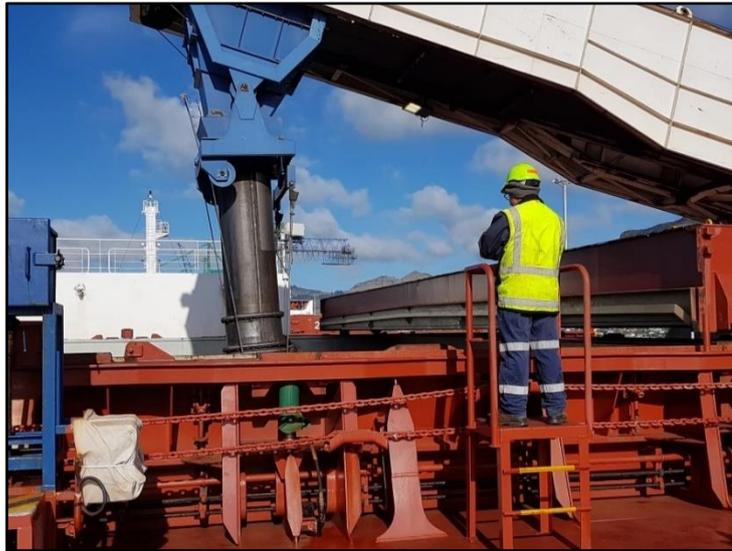
Another major hazard identified was working at heights while the signalman stood upon the pedestal to see into the hold. The photo accompanying that section of the SWMS shows the signalman standing on the pedestal onboard a different vessel (see Figure 20).

Figure 20: Photo in SWMS showing the signalman standing on a pedestal looking over the hatch coaming into the hold
