# **Final Report**

***Maritime inquiry MO-2022-206***  
***Charter fishing vessel, i-Catcher***  
***Capsize***  
***Goose Bay, New Zealand***  
***10 September 2022***

**April 2025**

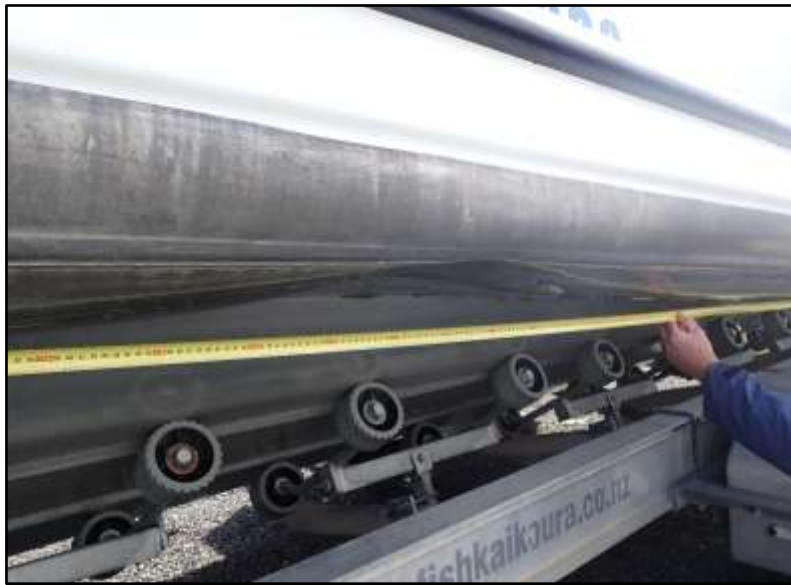
- 2.57. During its initial examination of the vessel, the Commission identified a significant smooth indentation underneath the port pontoon, measuring approximately 2.47 m in length. The depth of the indentation was greatest in the forward portion measuring 8 cm deep, tapering in depth further aft (see Figure 8).

**Figure 8: Indentation under port pontoon**

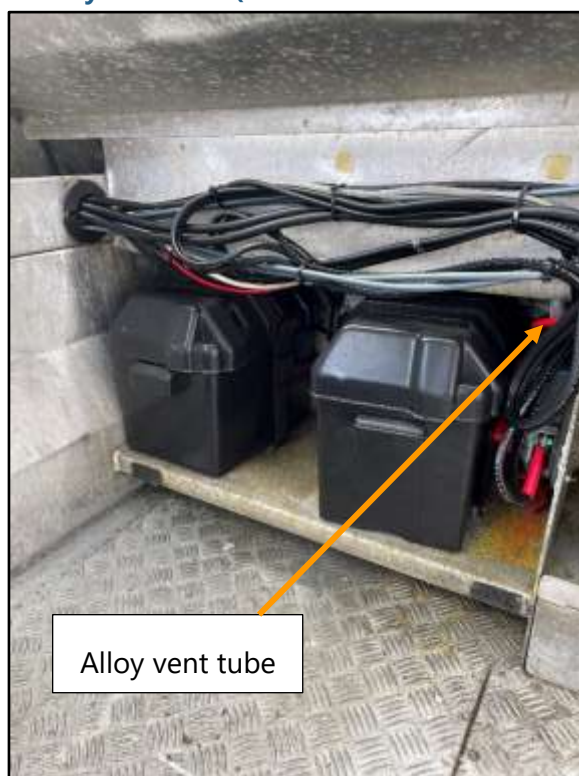
**Figure 12: Location of alloy vent (after accident)**

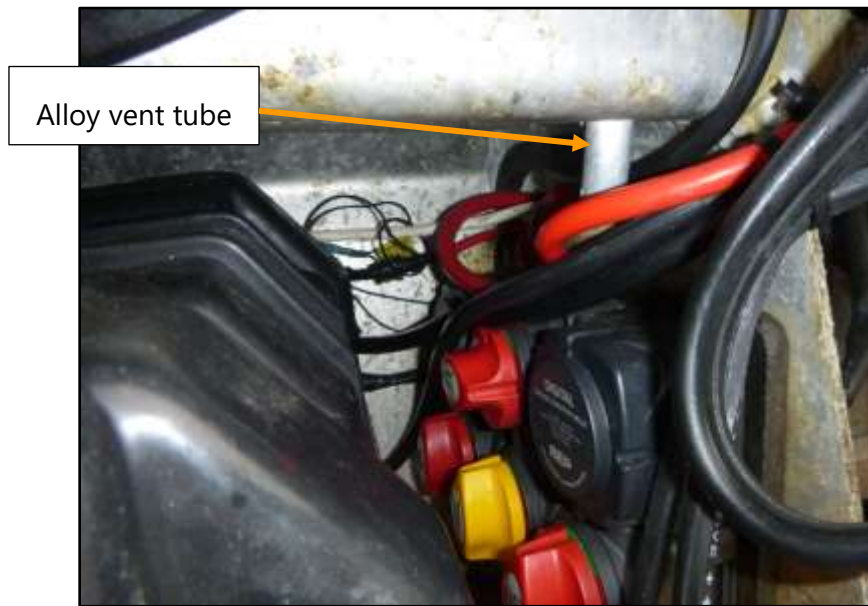
- 2.61. Identification of the hole in the alloy vent tube required a thorough examination of the venting arrangement. The alloy tube was partially restricted from view by a battery box and surrounding wiring (see Figure 13). The hole was a potential path for fuel to escape when filling the fuel tank or if the vessel overturned. It was also close to the battery leads and contact points, which presented a significant fire or explosion hazard.

**Figure 13: 2021 survey photo demonstrating restricted view of alloy vent tube with batteries in place.**

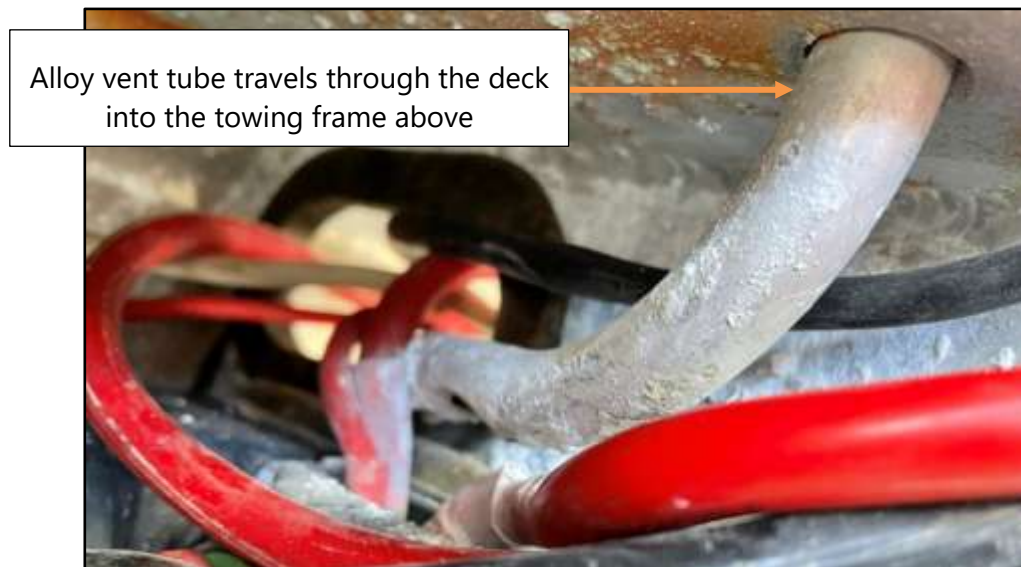
- 2.62. The alloy vent tube terminated inside an alloy towing frame on the transom just forward of the swim platform (see Figure 14 and Figure 15). A pressure test of the alloy frame revealed that it was closed off from the atmosphere, preventing fuel vapours from venting to open air and rendering it ineffective as a fuel-tank vent.

Alloy vent tube travels through the deck into the towing frame above

**Figure 14: Alloy vent tube joining towing frame**

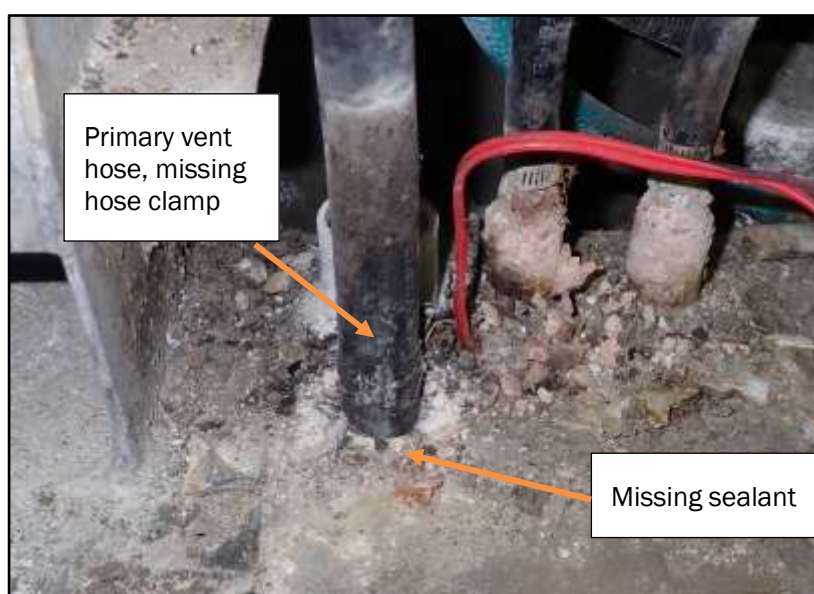
- 2.64. To enable inspection of the fuel tank and its connections, investigators removed the cover plate and the deck plate and partially disassembled the fuel system. Upon disassembly, investigators found the primary vent hose was not secured with a hose clamp, a critical component to ensure a secure connection to the fuel tank (see Figure 17).
- 2.65. A sealant had been applied around the plating where the fuel and vent hoses connected to the fuel tank. It was observed that a portion of the sealant had broken away, leaving a section of the primary vent hose connection exposed. The fuel tank and its fuel hoses were pressure-tested by Commission investigators, which revealed a leak from the base of the primary vent hose.

**Figure 17: Primary vent hose connection to fuel tank (underneath the deck plate)**

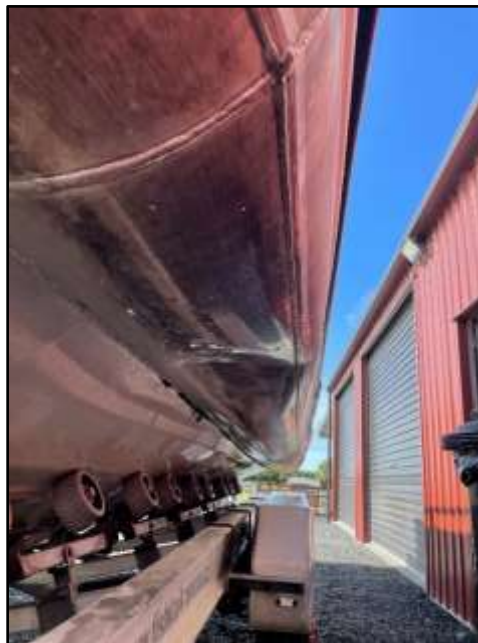
- 3.9. The indentation underneath the vessel's port pontoon was smooth and of significant size (see Figure 23), indicating that it was caused by a soft but dense material rather than a hard object. Contact with hard objects usually result in significant abrasions, definitive markings, transfer of material and possible holing in the hull.

**Figure 23: Indentation under port pontoon**

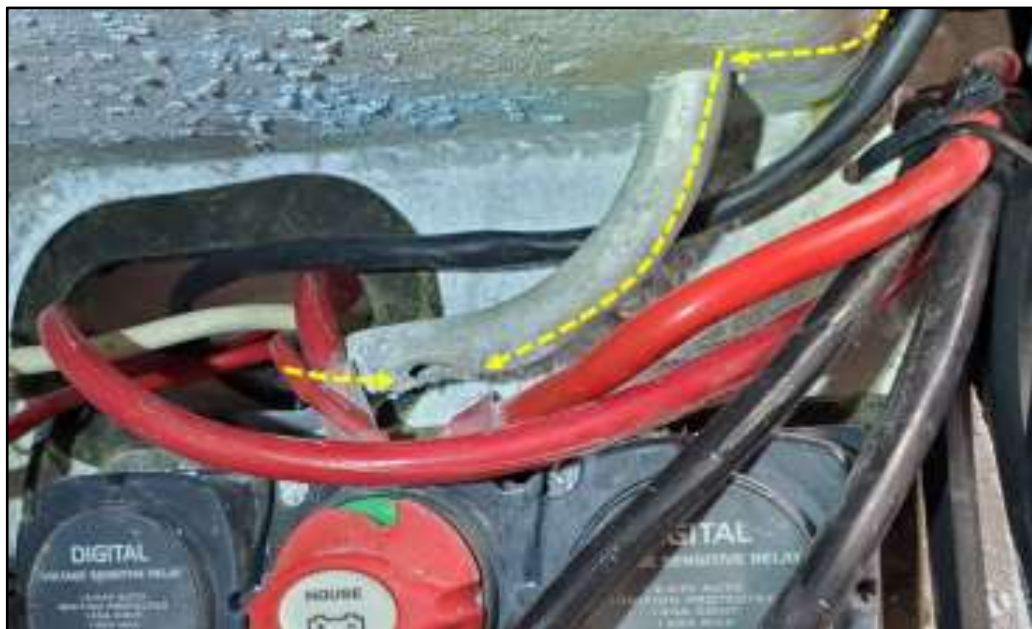
*the most likely cause of the hole was an accelerated external corrosion that occurred locally in-service, before the capsizing. The accelerated corrosion was likely because of crevice corrosion conditions caused by contact of the electrical cables with the pipe and/or accumulation of debris.*<sup>34</sup>

- 3.14. The corroded hole was located at a low point in the system, which would allow water and dirt to run and collect (see Figure 24). When the alloy tube was removed from the system it was evident that there was further abrasion and corrosion where the battery leads had been in contact with the alloy tube (see Figure 25). With time it can be expected that these areas would also develop into holes.

**Figure 24: Low point of alloy vent tube**  
(Credit: Quest Integrity)

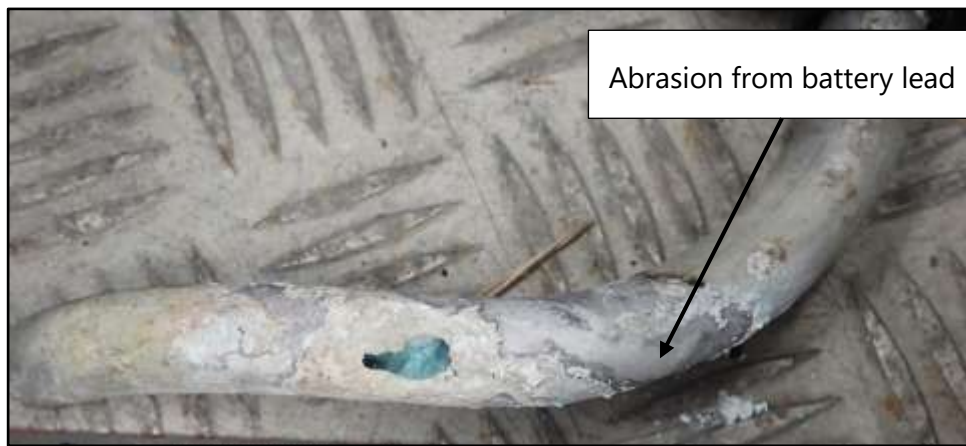
**Figure 25: Abrasion from battery lead**

- 3.16. At the time the battery selector switch was replaced, the alloy vent tube may have been subject to abrasion and the hole may not yet have formed. With the aluminium's natural passive layer damaged or removed by the battery leads, it would just be a matter of time before a hole developed.

- 3.17. It is **likely** that before the battery selector switch was replaced, the battery leads had been in contact with the alloy vent tube contributing to the corrosion that later developed into a hole.

- 3.18. The Commission found that the hole in the alloy vent tube was **very likely** a result of crevice corrosion over time, because of one or a combination of the following factors:

- mechanical abrasion from electrical cables
  - the collection of dirt/salt in the immediate area
  - saltwater evaporation from the localised area.

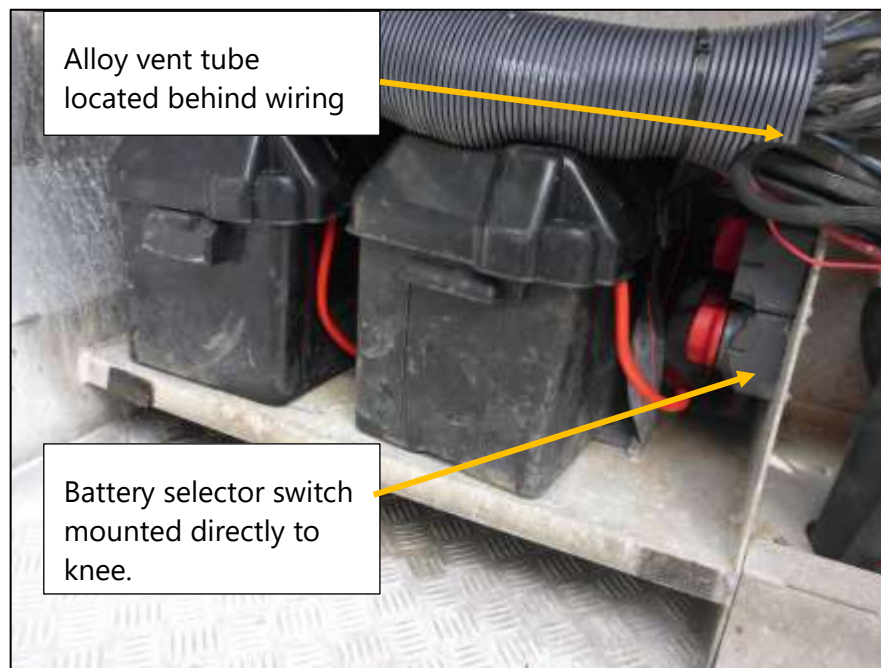
- 3.15. The *i-Catcher's* battery selector switch was replaced in 2019. The original battery selector switch was mounted directly to the knee of the transom (see Figure 26). When the new battery selector switch was installed, an insulator pad was added to absorb vibrations between the knee and the switch. This would have changed where the battery leads contacted the alloy tube.

**Figure 26: Original battery selector switch arrangement (2016)**

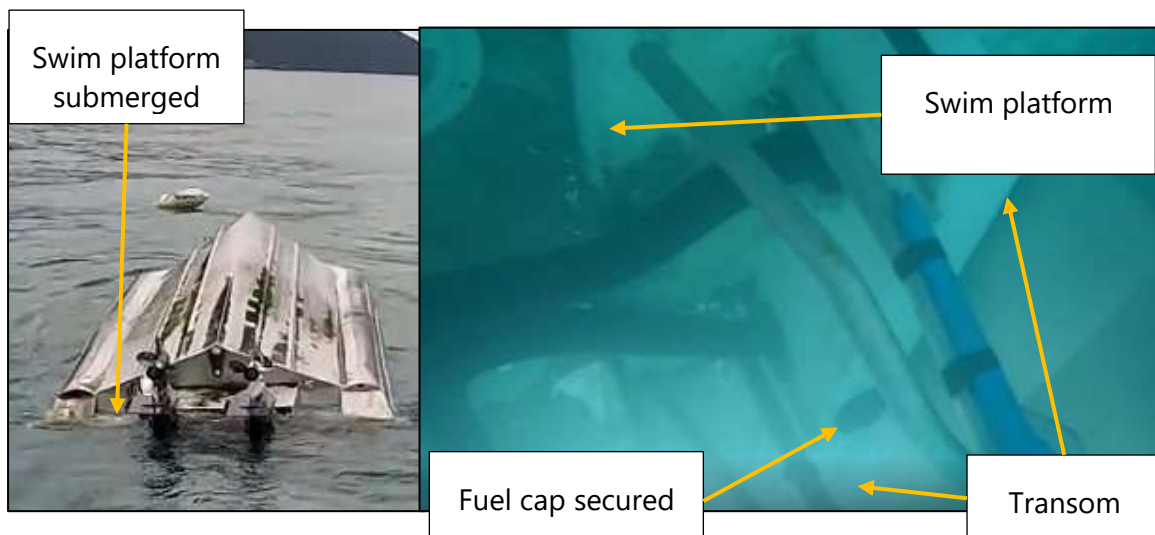
**Figure 28: Photo on left: *i-Catcher* capsized, Photo on right: Fuel cap secured**

- 3.23. When an inverted cap is submerged in sea water, the sea water applies an upward force to the surface area on the outside of the cap, countering the force applied by the fuel. The *i-Catcher's* fuel cap was mounted on the transom, which remained submerged with the vessel capsized in relatively calm conditions. Inspection of the vessel by the Police dive squad immediately following the accident found that the fuel cap was secured (see Figure 28).

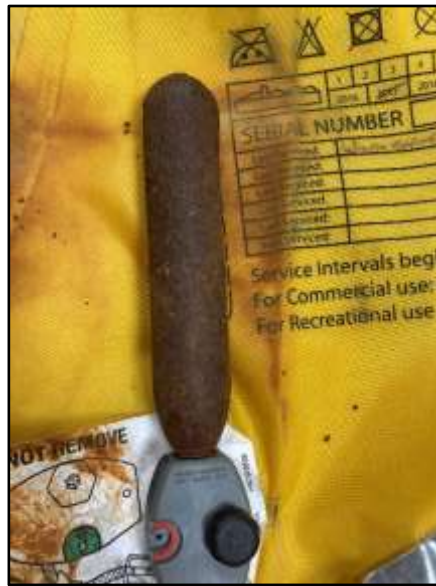
**Figure 30: Corroded lifejacket cylinder**

- 3.78. The CO<sub>2</sub> cylinder had corroded to a point where the cylinder wall had significant pitting (see Figure 30). This level of corrosion posed a significant risk to the wearer as the canister was at risk of failing while pressurised, which could have led to the lifejacket not inflating, or the canister exploding.

- 3.81. While Maritime Rule 42A.38 requires inflatable lifejackets to be serviced by an approved servicing station at periodic intervals, it should be expected that inflatable lifejackets may be activated and inflated in-between scheduled servicing and will require re-arming and re-packing for continued use. The rule does not require that the servicing of inflatable lifejackets in commercial use must always be completed at an approved servicing station by trained technicians.
