Transport Accident  
Investigation  
Commission

# **Final Report**

***Maritime inquiry MO-2022-207***  
***Fishing vessel Boy Roel***  
***Serious workplace injury***  
***Off Tauranga, Bay of Plenty, New Zealand***  
***12 December 2022***

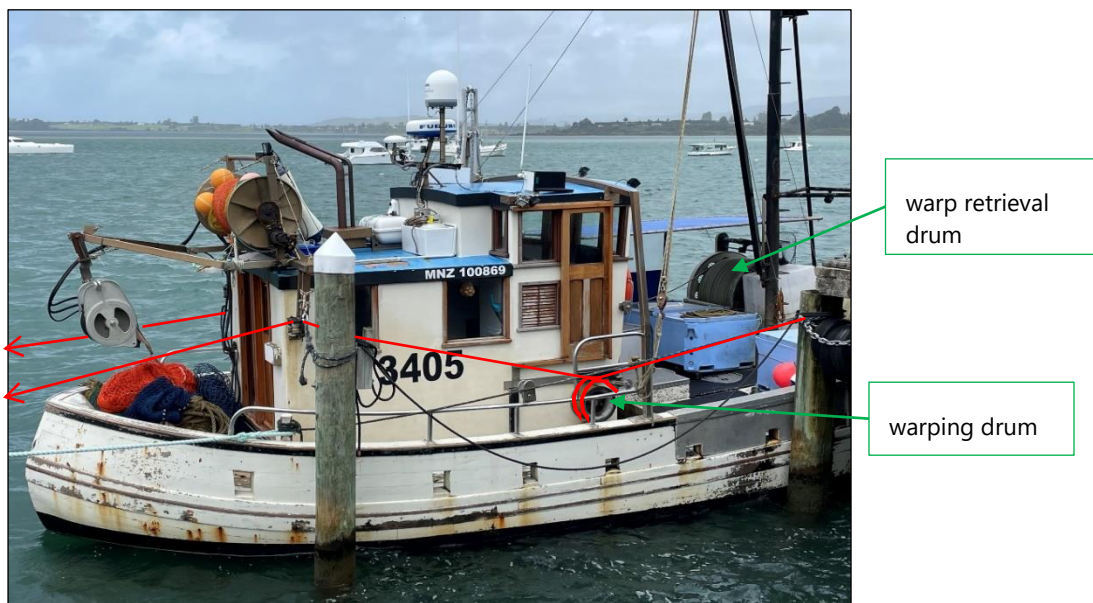
**Figure 3: *Boy Roel* at the dock showing the typical trawl warp arrangement (red lines depict the trawl warp)**

- 2.3 From the winch drum, each trawl warp was fed onto a large, hydraulically driven warp retrieval drum (see Figure 3). Each warp retrieval drum rotated to apply sufficient tension to the trawl warp to keep the turns tight around the warping drum. If the warp retrieval drums were exerting tension on the trawl warp, the trawl warp would be wound in by the rotating warping drum. If the tension were released (by slowing the speed of the warp retrieval drum), the trawl warp would surge (slip) on the warping drum and stop hauling the net. The speed of the warp retrieval drums could be adjusted from the wheelhouse (see Figures 3 and 4).

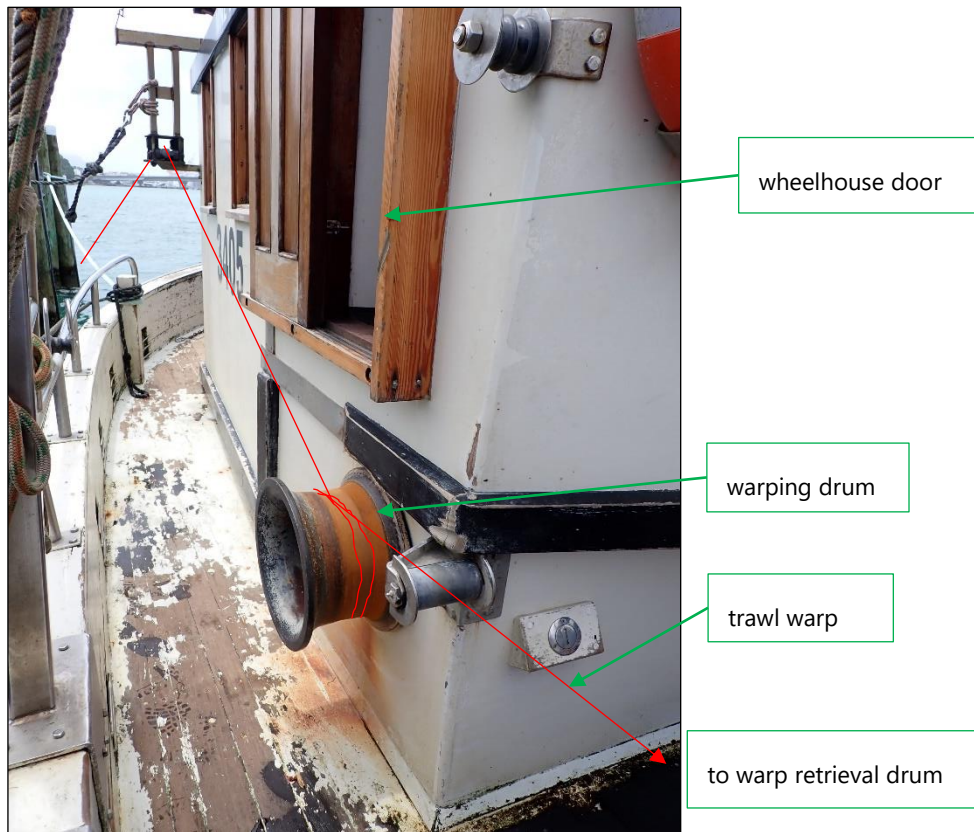
**Figure 4:**

- 2.2 On board the *Boy Roel*, each trawl warp was wound several times around one of two warping drums<sup>3</sup>, located on either side of the wheelhouse. The two warping drums were connected to a common shaft that ran through the engine room below the wheelhouse, driven by a single hydraulic winch motor. The speed and direction of the winch motor could be adjusted using a controller on a short lead in the wheelhouse.

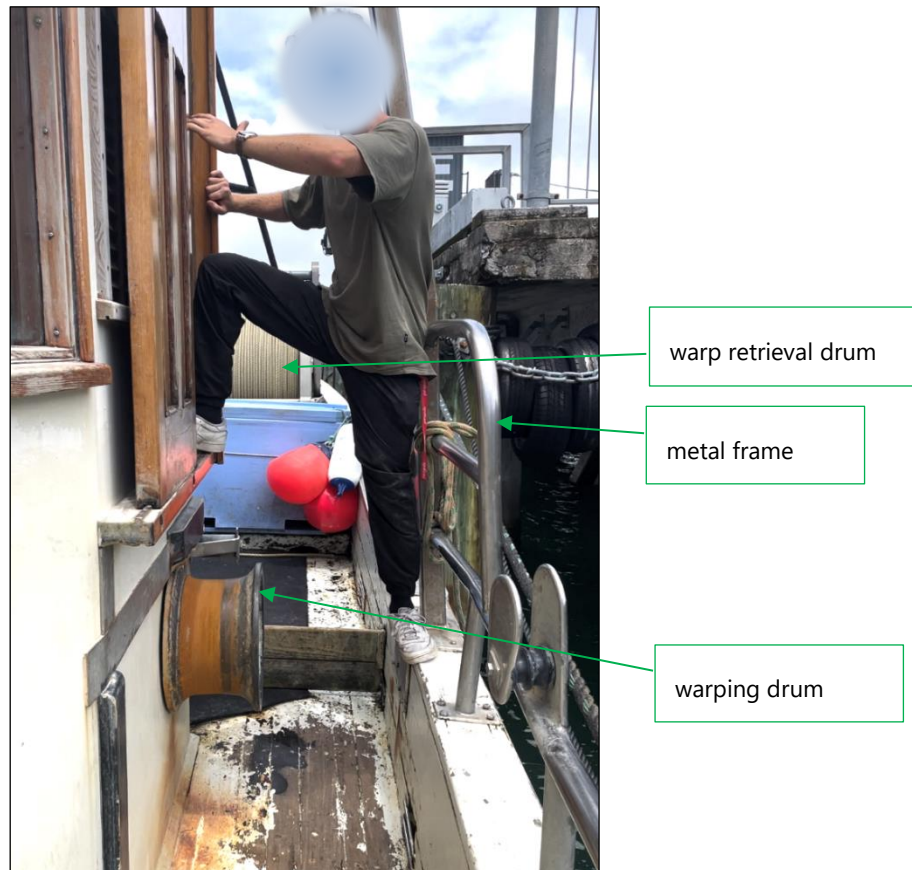
the large step up to the wheelhouse door. The skipper was looking at and explaining to the deckhand their intention to slow the winch as they stepped up on top of the bulwarks and up to the wheelhouse door. The skipper misplaced their feet, and the unsecured bottoms of their waterproof leggings became trapped in the trawl warp as it wound around the warping drum below (see Figure 5).

**Figure 5: A crew member recreates the process of stepping onto the bulwarks to climb into the wheelhouse**

- 2.8 The skipper's leg was drawn in and trapped between the trawl warp and the warping drum. One of the deckhands, who was close by, saw what had happened and climbed up and over the entangled skipper and into the wheelhouse, where he stopped the winch.

- 3.8 The *Boy Roel* crew were in the habit of climbing over the rotating warping drum on the starboard side to gain access to the wheelhouse while fishing. They were aware that the trawl warp winding around the rotating warping drum was a hazard to be avoided, but this hazard had not been documented in the MTOP hazard register and had not been adequately addressed.

- 3.9 The hazard could not be removed, as these components were essential for the purpose of catching fish. However, several measures could reasonably have been taken to reduce the likelihood of this accident occurring. Examples include forbidding crew from routinely accessing the wheelhouse via the outside doors when the warping drums were moving and instead accessing the wheelhouse from the aft

working deck via the cabin; and providing an alternative method for controlling the winches outside the wheelhouse by duplicating the controls outside the wheelhouse or lengthening the remote winch control to allow more freedom of control.

- 3.11 Since the accident, the operator has constructed a platform over the warping drums to aid crew in accessing the wheelhouse from the deck. The procedures in the MTOP have also been amended to forbid crew accessing the wheelhouse through the side doors when warping drums are being operated.
