Transport Accident  
Investigation  
Commission

# **Final Preliminary Report**

***Maritime inquiry MO-2023-201***  
***Passenger vessel Kaitaki***  
***Loss of power***  
***Cook Strait, New Zealand***  
***28 January 2023***

**May 2023**

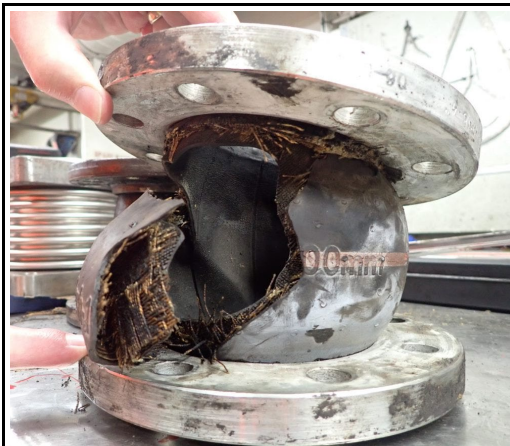
- 1.3. At about the same time, a rubber expansion joint (REJ) – a component of the vessel's engines' high-temperature cooling water system – ruptured. This resulted in the cooling water draining out from the cooling system, passing through the ruptured REJ and into the engine room bilge system<sup>3</sup>.

A photo of the ruptured rubber expansion joint from the high temperature cooling water system of the *Kaitaki*

- 2.4 The ruptured REJ that was installed on the *Kaitaki* had been in service about five years, but evidence indicates it was manufactured in 2005. The nature of the failure of the *Kaitaki's* REJ, in particular cracking and delamination, was consistent with deterioration due to age.

- replaced all REJs onboard *Kaitaki*
  - assessed the condition of all REJs installed on all vessels in the KiwiRail fleet
  - started a detailed assessment of critical equipment by an independent expert for all vessels in the KiwiRail fleet

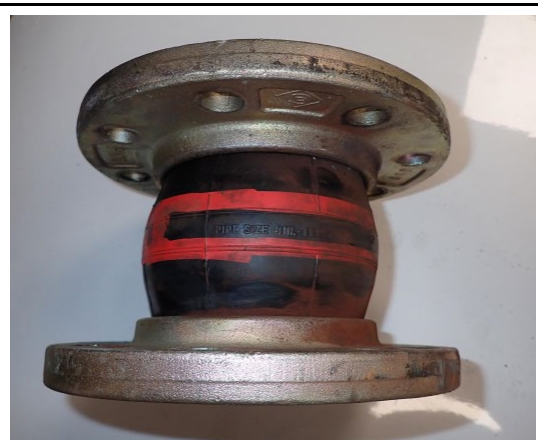
A photo showing an example of a rubber expansion joint in serviceable condition, also from the *Kaitaki*

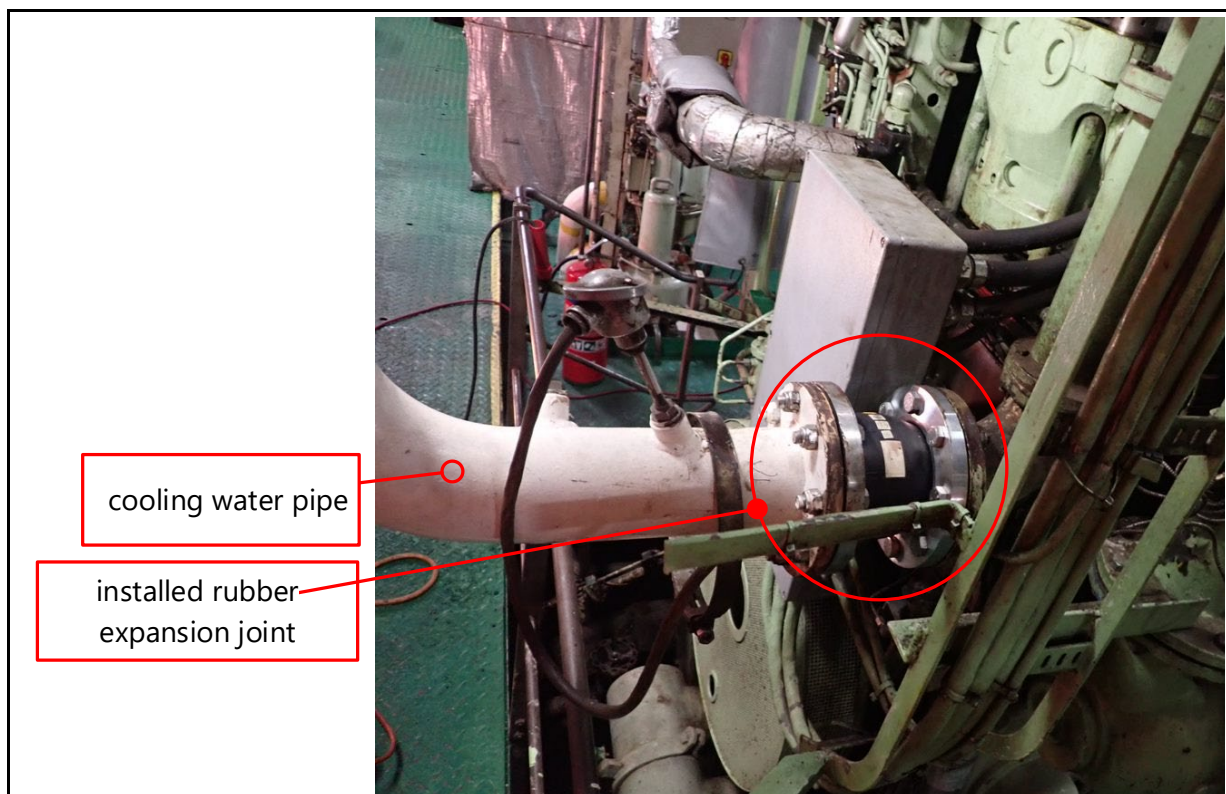
**Figure 4: An installed REJ onboard the *Kaitaki***

installed rubber expansion joint

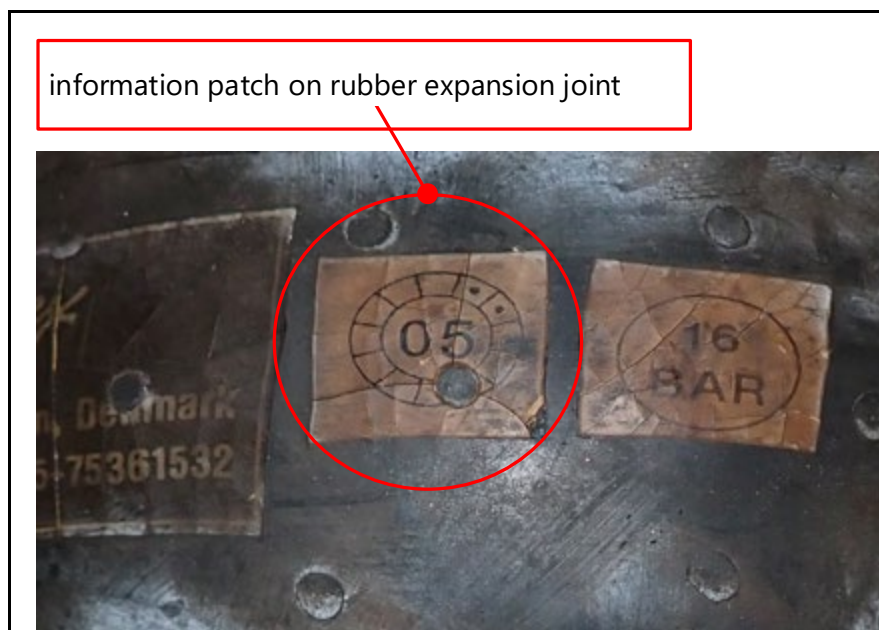
**Figure 5: The information patch attached to the ruptured REJ**

- 1.13. The ruptured REJ had information patches attached to it indicating it was manufactured in February or March 2005 (see Figure 5). It had been installed on the Kaitaki in 2018. This information indicates that at the time of rupture, the REJ had been installed when it was about 13 years old, had been in service for about a further five years, and it was about 18 years since it was manufactured.

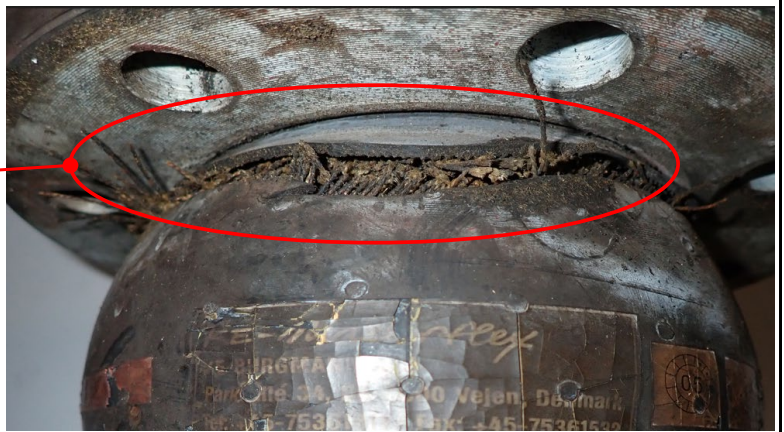
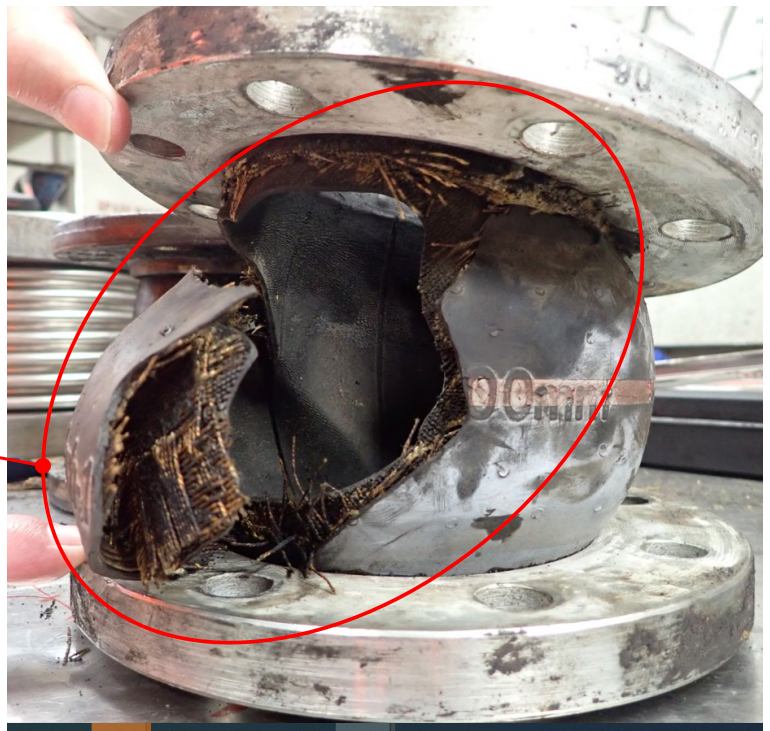
**Figure 6: Ruptured REJ with cracking and delamination**

- 1.18. The nature of the failure of the *Kaitaki's* REJ, in particular the cracking and delamination as shown in Figure 6, was 'evident of aging failure' according to the manufacturer.

ruptured rubber with  
cracking and delamination

- 3.3 **On 30 April 2023, the Commission recommended that Maritime New Zealand require KiwiRail to provide evidence to Maritime New Zealand's satisfaction that safety-critical rubber expansion joints onboard all vessels within KiwiRail's Interislander fleet are fit for purpose taking into account the manufacturer's guidance, namely:**

- they should be no older than eight months from the date of manufacture when installed
  - they are inspected annually including visual, tactile and hardness measurements

- regardless of inspection findings, safety-critical REJs should be replaced after five years. (008/23).
- 3.4 **On 30 April 2023, the Commission recommended that Maritime New Zealand alert all vessel operators using rubber expansion joints within a vessel's safety-critical system to the importance of taking into account the date of manufacture, in addition to the time in service, in their maintenance schedules to ensure they are fit for purpose. (009/23).**
