Transport Accident  
Investigation  
Commission

# **Final report**

***Maritime inquiry MO-2023-204***  
***Bulk carrier Poavosa Brave***  
***Serious injury***  
***Off Tauranga***  
***23 June 2023***

**October 2024**

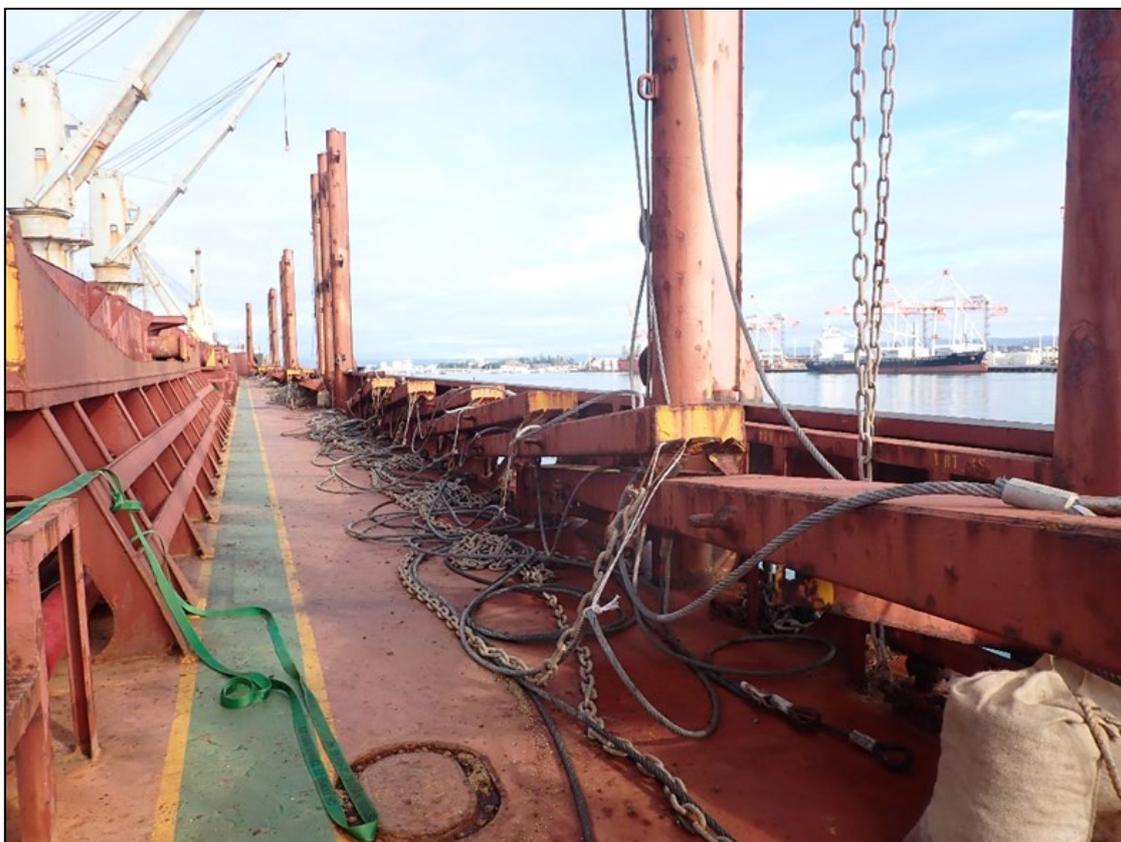
**Figure 3: Starboard stanchions, lowered position**

- 2.1. On 5 June 2023, *Poavosa Brave* departed Port Pirie (Australia) on a voyage charter<sup>5</sup>, bound for Tauranga with a cargo of wheat and beans.
- 2.2. At 0618<sup>6</sup> on 14 June 2023, the vessel arrived and anchored at Tauranga roads.<sup>7</sup> A pilot<sup>8</sup> boarded at 0846 and at 1030 the vessel was secure alongside number 7 berth, Mount Maunganui. Over the next five days, the cargo was discharged and the voyage charter ended.
- 2.3. At 2100 on 19 June 2023, the vessel departed the berth and returned to Tauranga roads, where at 2233 it was brought up to anchor at number 3 anchorage. Whilst at anchor, a new voyage charter started. The crew was required to prepare the vessel for a full cargo consignment of logs. This included erecting sets of collapsible stanchions (see Figures 3 and 4) on the main deck.

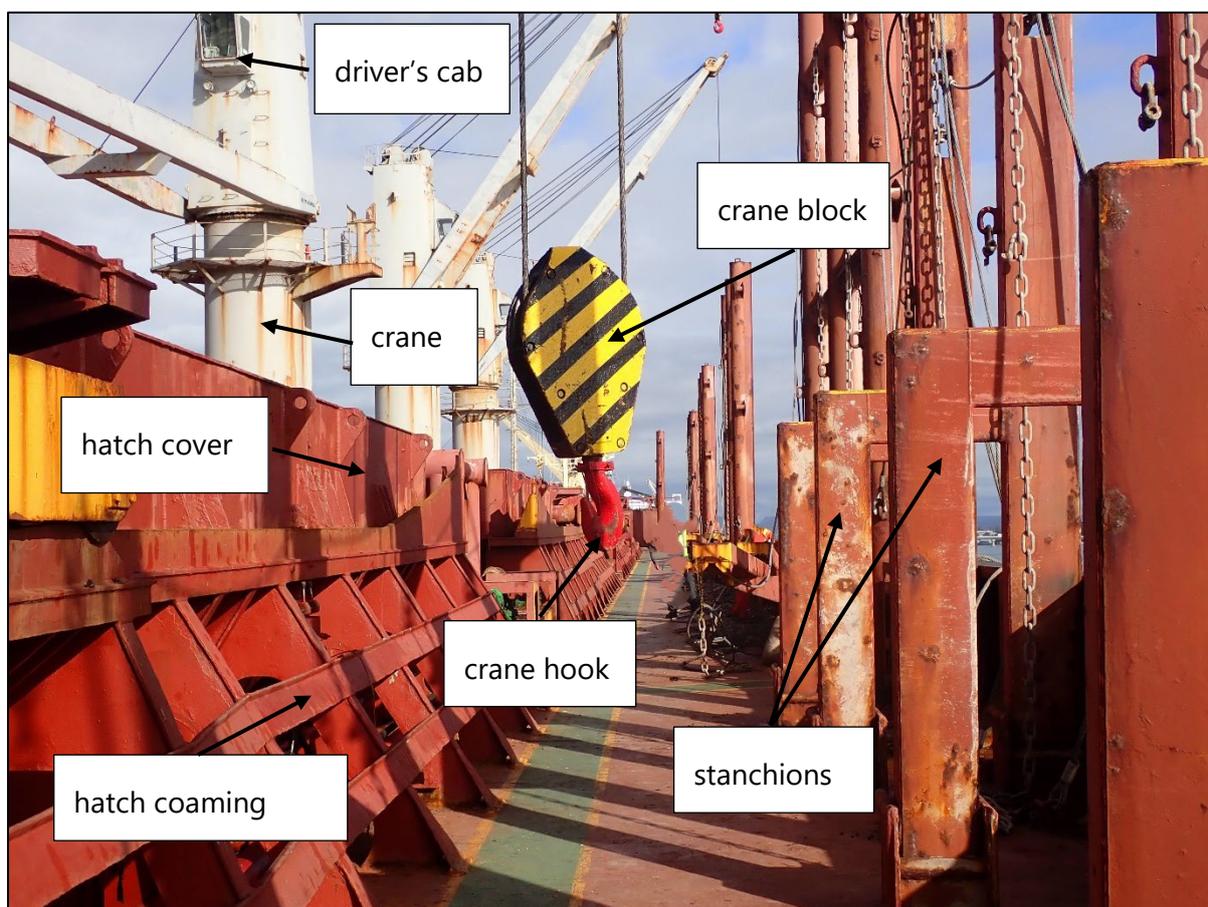
**Figure 5: Starboard main deck beside number 5 hatch, facing towards the bow of *Poavosa Brave***

- 2.8. The bosun's workplan was for the crew to unhook the pull wire after the crane hook was landed and stable on the deck next to number 5 hatch (see Figure 5). However, the bosun mis-landed the hook on top of number 5 hatch. As the bosun started to reposition the hook from the hatch top to the deck, the chief officer told the crew to go up to the hatch top to unhook the pull wire. There was no communication between the chief officer and the bosun.

- 2.9. Shortly after 1350, as the bosun repositioned the crane hook and as the three ABs began to climb up to the hatch top, the vessel started to roll. As the vessel rolled, the suspended crane block started to swing. Two of the ABs, who were further away from the crane block, ran away from the reach of the crane block and hook. The third AB had climbed further up the hatch coaming<sup>12</sup> and did not run away. The hook swung back and struck the third AB, pushing them up against the hatch coaming and hatch cover. They climbed back down the hatch coaming and sat down on the deck, injured. The other two ABs quickly moved their colleague away from the crane block.

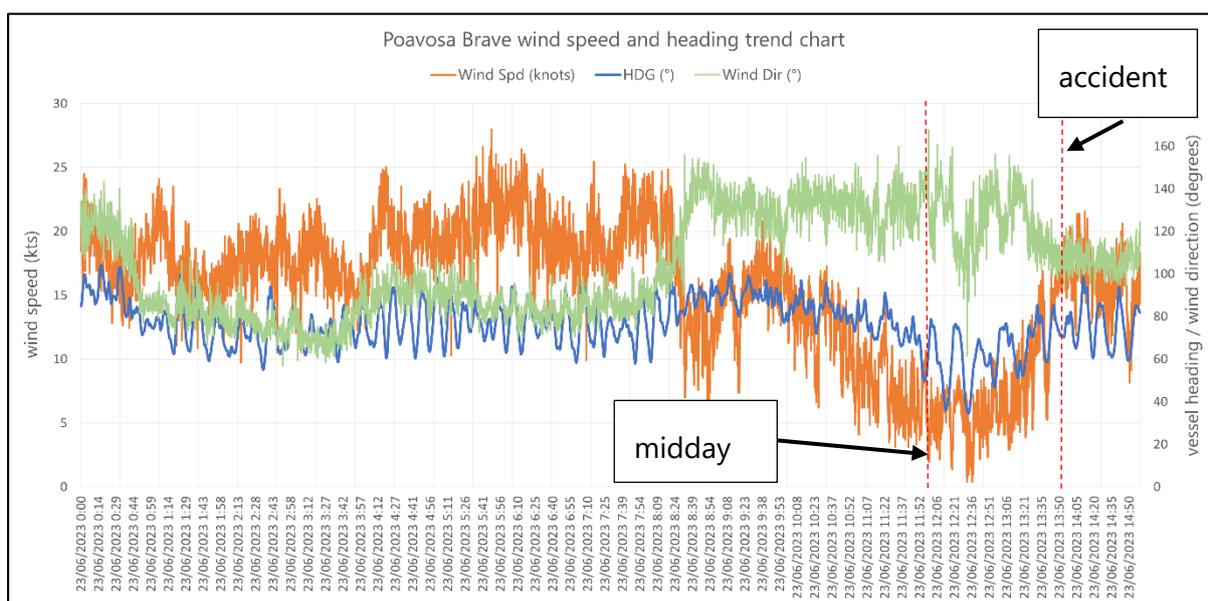
**Figure 7: Wind speed, direction and vessel heading data from the vessel's ECDIS**

- 3.14. Data recorded by the vessel's ECDIS showed that the weather conditions eased off throughout the morning, but the wind speed increased gradually from around midday (see Figure 7).

- 3.16. Despite the wind easing to around 5 kts during the morning, winds of about 16 to 17 kts, gusting to 23 kts were forecast for the afternoon. The significant wave height<sup>19</sup> forecast for the afternoon of 23 June was around 1.9 to 2.1 metres (m) with a maximum wave height of about 3.5 m. These conditions were only a slight improvement on the morning's conditions.
