Transport Accident  
Investigation  
Commission

# **Final report**

***Maritime inquiry MO-2023-206***  
***Fishing vessel, Austro Carina***  
***Stranding at Red Bay, Banks Peninsula***  
***24 September 2023***

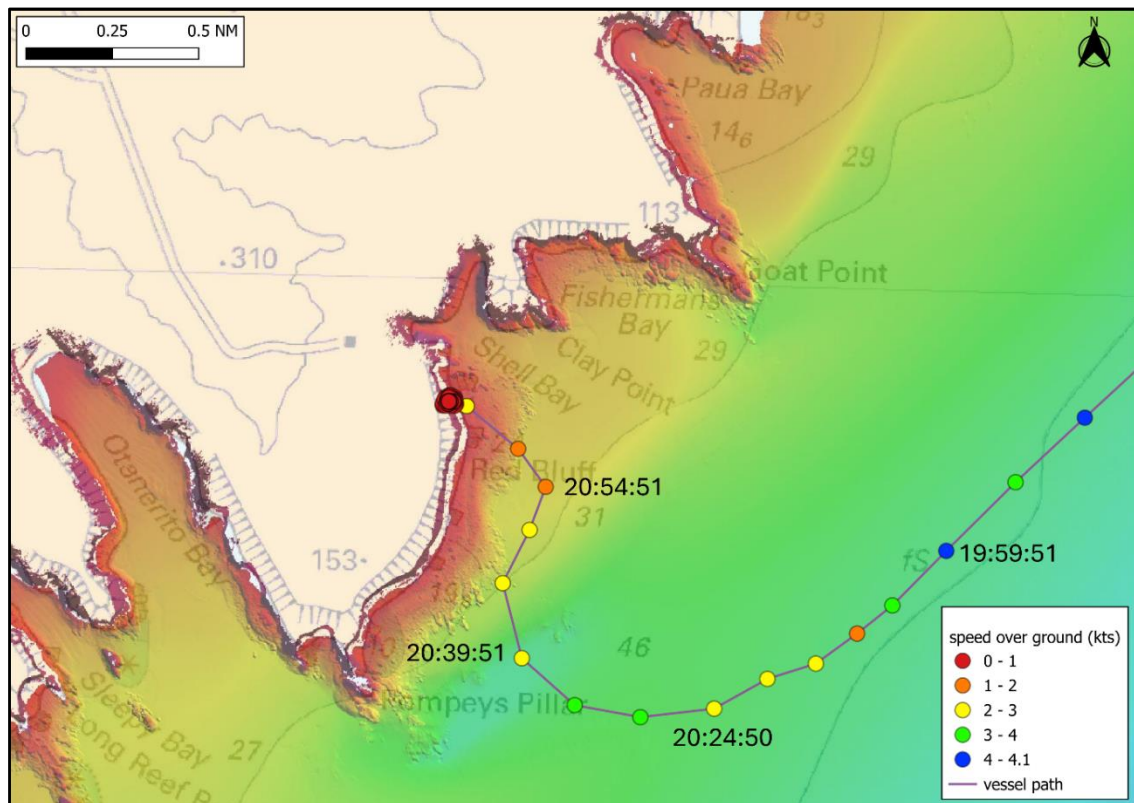
- 2.21. At about 2040, the *Austro Carina* was about 0.35 NM from land (see Figure 4). Figure 4: The track of the *Austro Carina* with timestamps
- 2.22. At about 2050, the master was on deck when they felt the vessel shudder. During their interview, the master recalled that when they returned to the wheelhouse, they noticed on the engine monitor that the engines were under more load than usual. From the wheelhouse they observed the net laden with fish hanging over the stern of the vessel, and that a synthetic rope<sup>18</sup> from the aft deck had washed overboard and looked like it was being pulled underwater. The master returned to the deck, retrieved a knife and cut the synthetic rope, which disappeared under the vessel.

- 2.23. During their interview, the master stated that after the rope was cut, they felt the vessel make two small shudders followed by a large shudder. The master suspected that the rope might have entangled in the propeller and broken the long shaft. The master checked the freezer room and the engine room but found no damage. During this time the prevailing swell was pushing the vessel towards land.
