Transport Accident  
Investigation  
Commission

# **Final report**

***Maritime inquiry MO-2023-206***  
***Fishing vessel, Austro Carina***  
***Stranding at Red Bay, Banks Peninsula***  
***24 September 2023***

**March 2025**

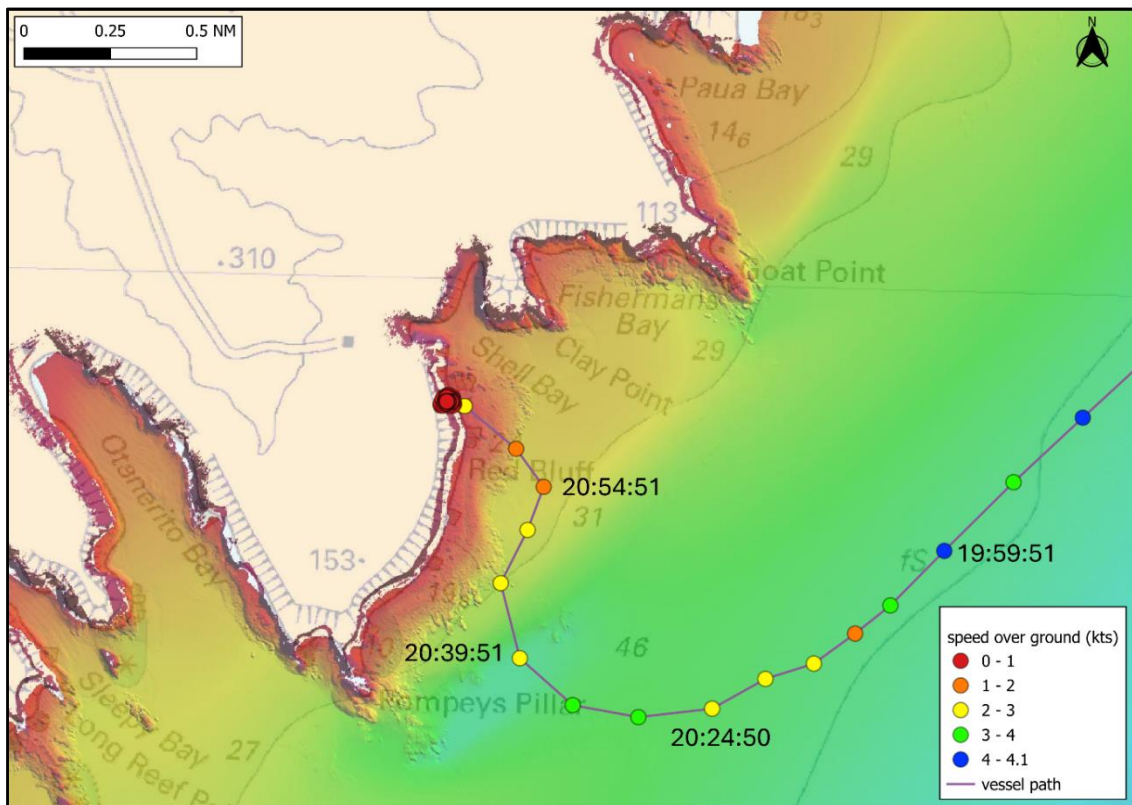
- 2.21. At about 2040, the *Austro Carina* was about 0.35 NM from land (see Figure 4). Figure 4: The track of the *Austro Carina* with timestamps
- 2.22. At about 2050, the master was on deck when they felt the vessel shudder. During their interview, the master recalled that when they returned to the wheelhouse, they noticed on the engine monitor that the engines were under more load than usual. From the wheelhouse they observed the net laden with fish hanging over the stern of the vessel, and that a synthetic rope<sup>18</sup> from the aft deck had washed overboard and looked like it was being pulled underwater. The master returned to the deck, retrieved a knife and cut the synthetic rope, which disappeared under the vessel.

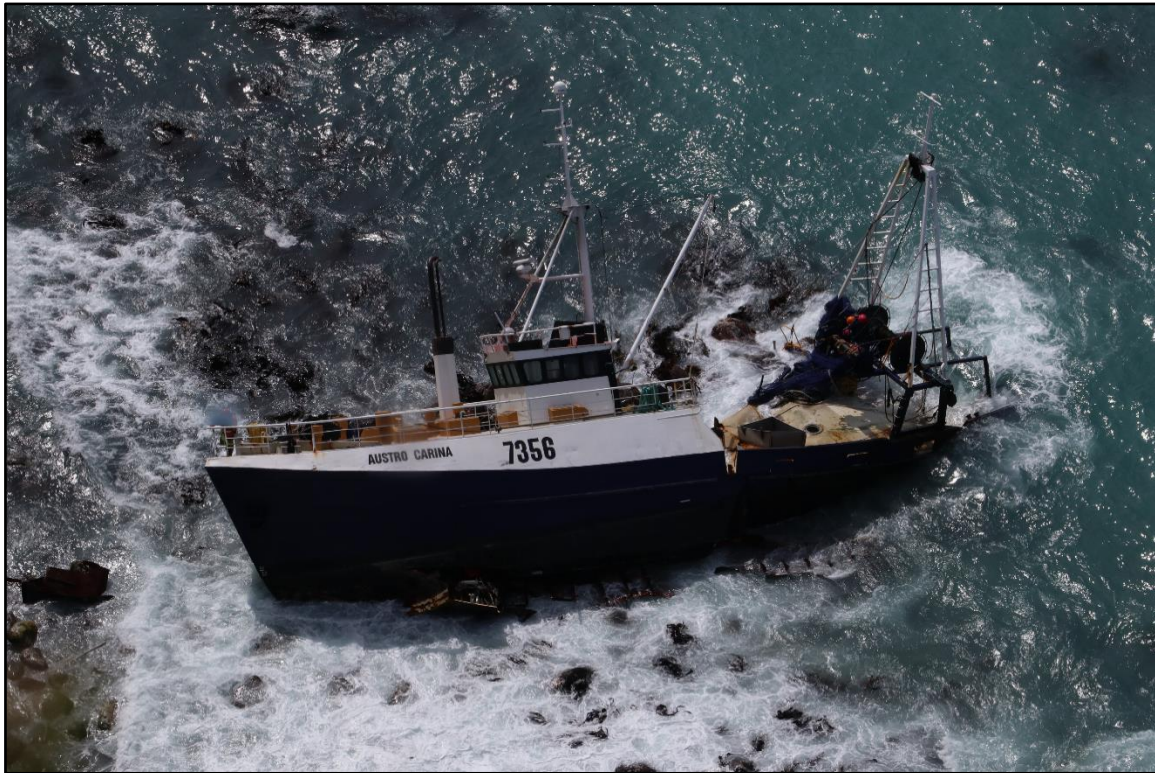
**Figure 5: The stranded *Austro Carina***  
(Credit: Mr G Finlayson)

- 1.1. On 24 September 2023, at about 2137, the *Austro Carina* stranded<sup>1</sup> while fishing at Red Bay, Banks Peninsula. The vessel suffered extensive damage and was unsalvageable. It was subsequently declared a constructive total loss<sup>2</sup> by the insurer.
- 1.2. The four crew members abandoned the vessel and were rescued by helicopter and returned to Christchurch.

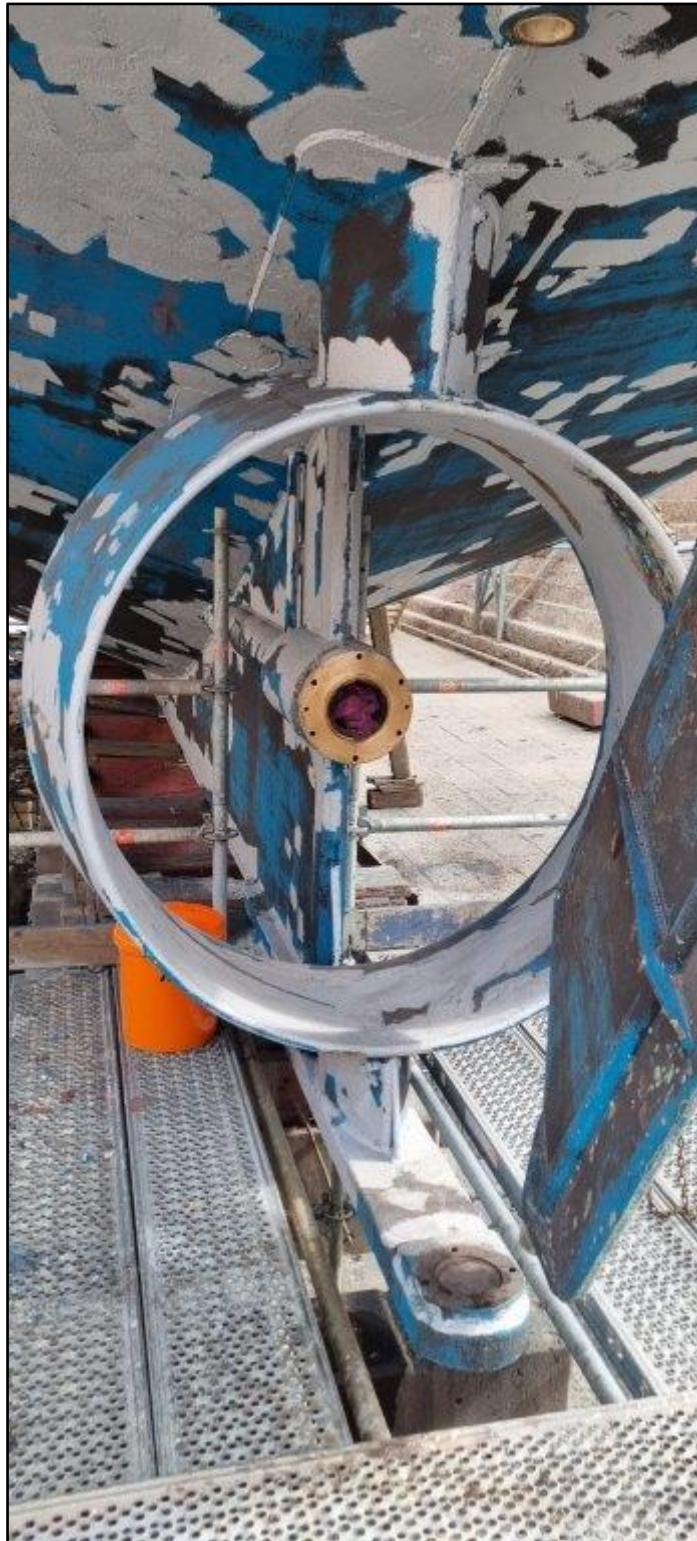
**Figure 6: Kort nozzle**  
(Credit: Mr A Chandler)

- 2.41. During interview, the master stated that they believed that a rope became entangled around the propeller. The Police dive squad made a video recording from an underwater survey of the vessel and its surroundings before the salvage operations to remove the wreck started. From the video, the Commission was unable to determine if there were any fragments of rope or fishing net entangled around the propeller. After the vessel was salvaged, TAIC investigators inspected the propeller. There was no indication of a rope or net around the propeller, shaft or wedged between the kort nozzle<sup>25</sup> (see Figure 6) and propeller. The Commission was unable to determine whether a rope may have become entangled around the propeller.
