Transport Accident
Investigation
Commission

Final Report

Maritime inquiry MO-2024-201
Passenger vessel, Fiordland Navigator
Grounding
Doubtful Sound
24 January 2024

April 2025

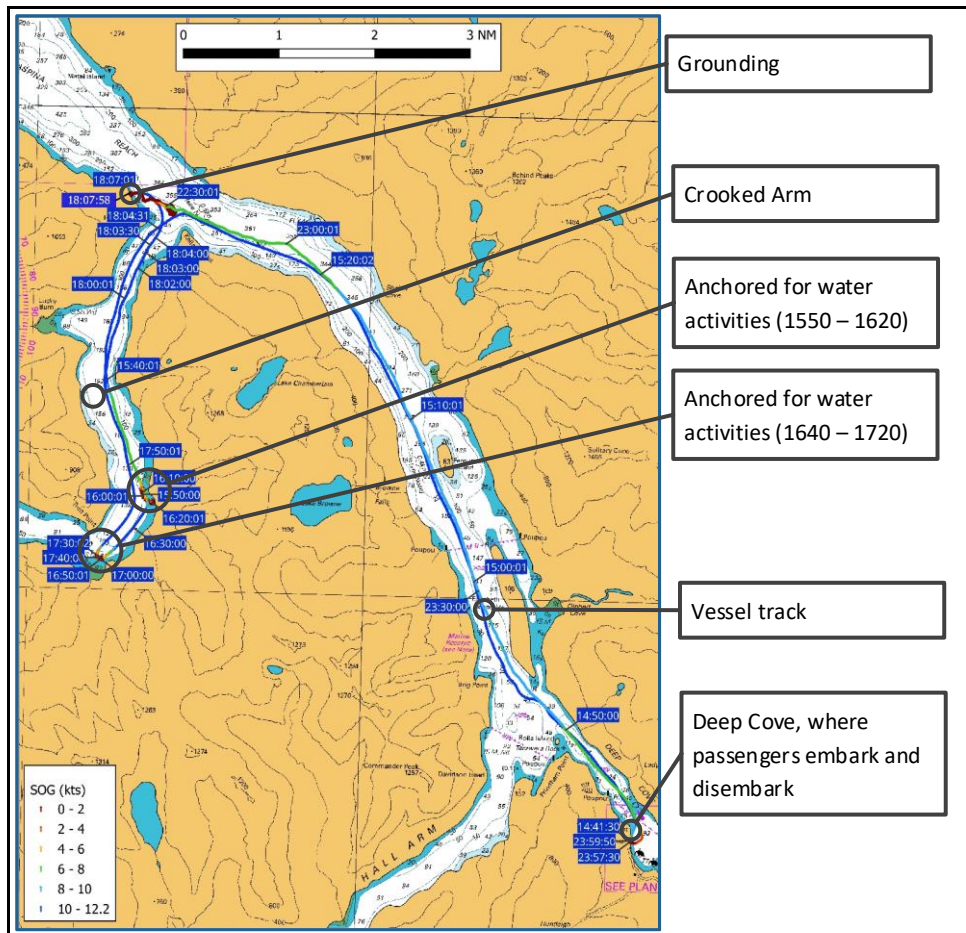
Figure 3: Accident voyage of Fjordland Navigator

- 2.12. The crew began embarking passengers at 1430. Once this was complete, the vessel departed for Crooked Arm at about 1445. The *Fiordland Navigator* anchored for water activities⁴ between 1550 and 1620, then was moved and anchored again from 1640 to 1740 (see Figures 3 and 4).

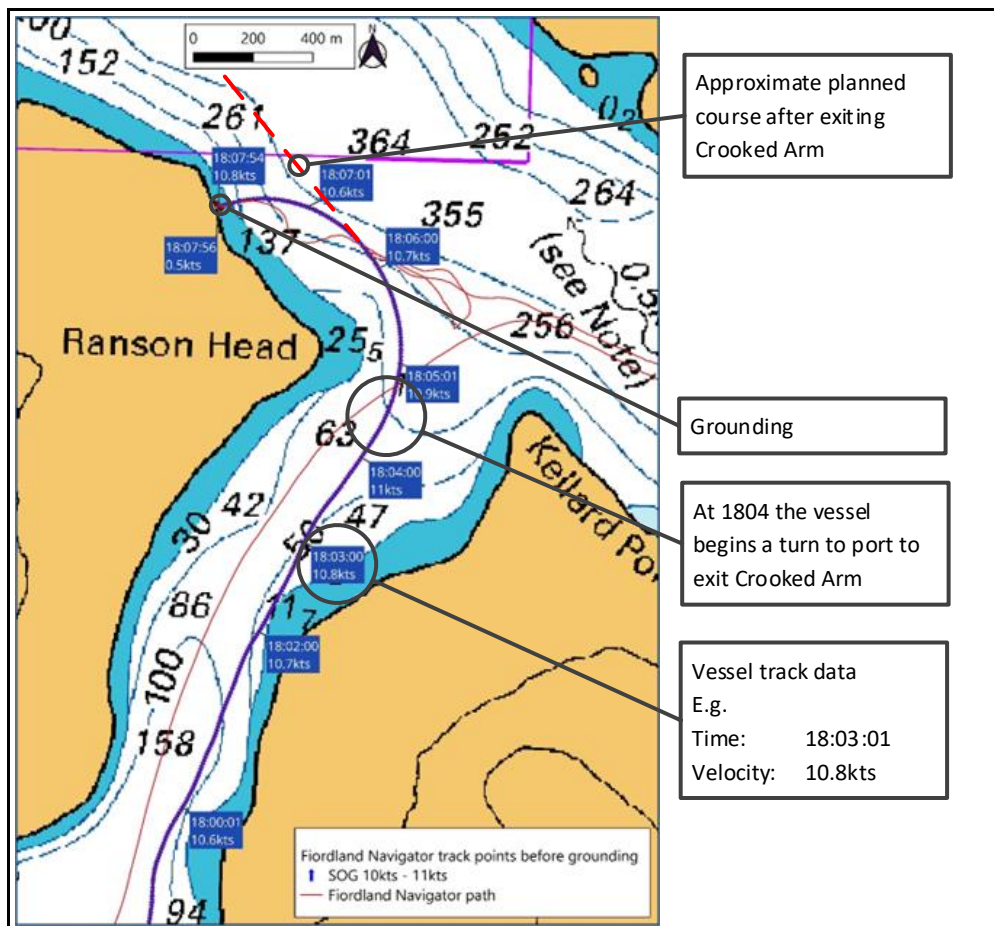
Figure 4: Track of vessel immediately prior to grounding

- 2.13. The master commenced the transit out of Crooked Arm, and at approximately 1804 began the turn to port.
- 2.14. It is **virtually certain** that the master fell asleep during the turn to port and the vessel continued turning. At approximately 1807 the *Fiordland Navigator* ran aground while travelling at about 10.8 knots (20 kilometres per hour).
