Transport Accident
Investigation
Commission

Final interim factual report

Maritime inquiry MO-2024-204
Passenger and freight Ferry Aratere
Grounding
Titoki Bay, Picton
21 June 2024

October 2024

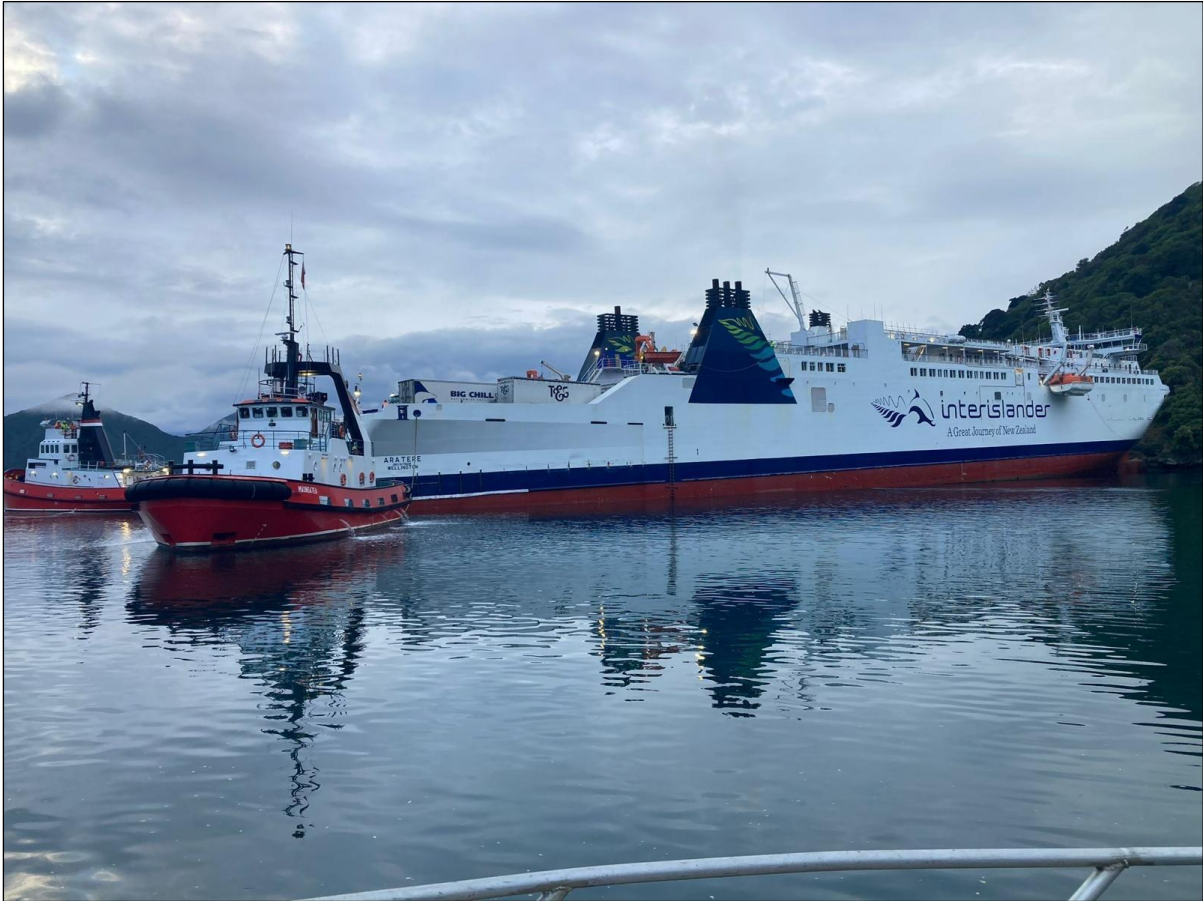
Figure 1: Passenger and freight ferry *Aratere* aground in Titoki Bay

- 1.37. The watertight integrity of *Aratere*'s hull was not compromised, but the ship did sustain damage to the internal structure of the bulbous bow that required remedial repair before its being put back into service. There were no injuries.

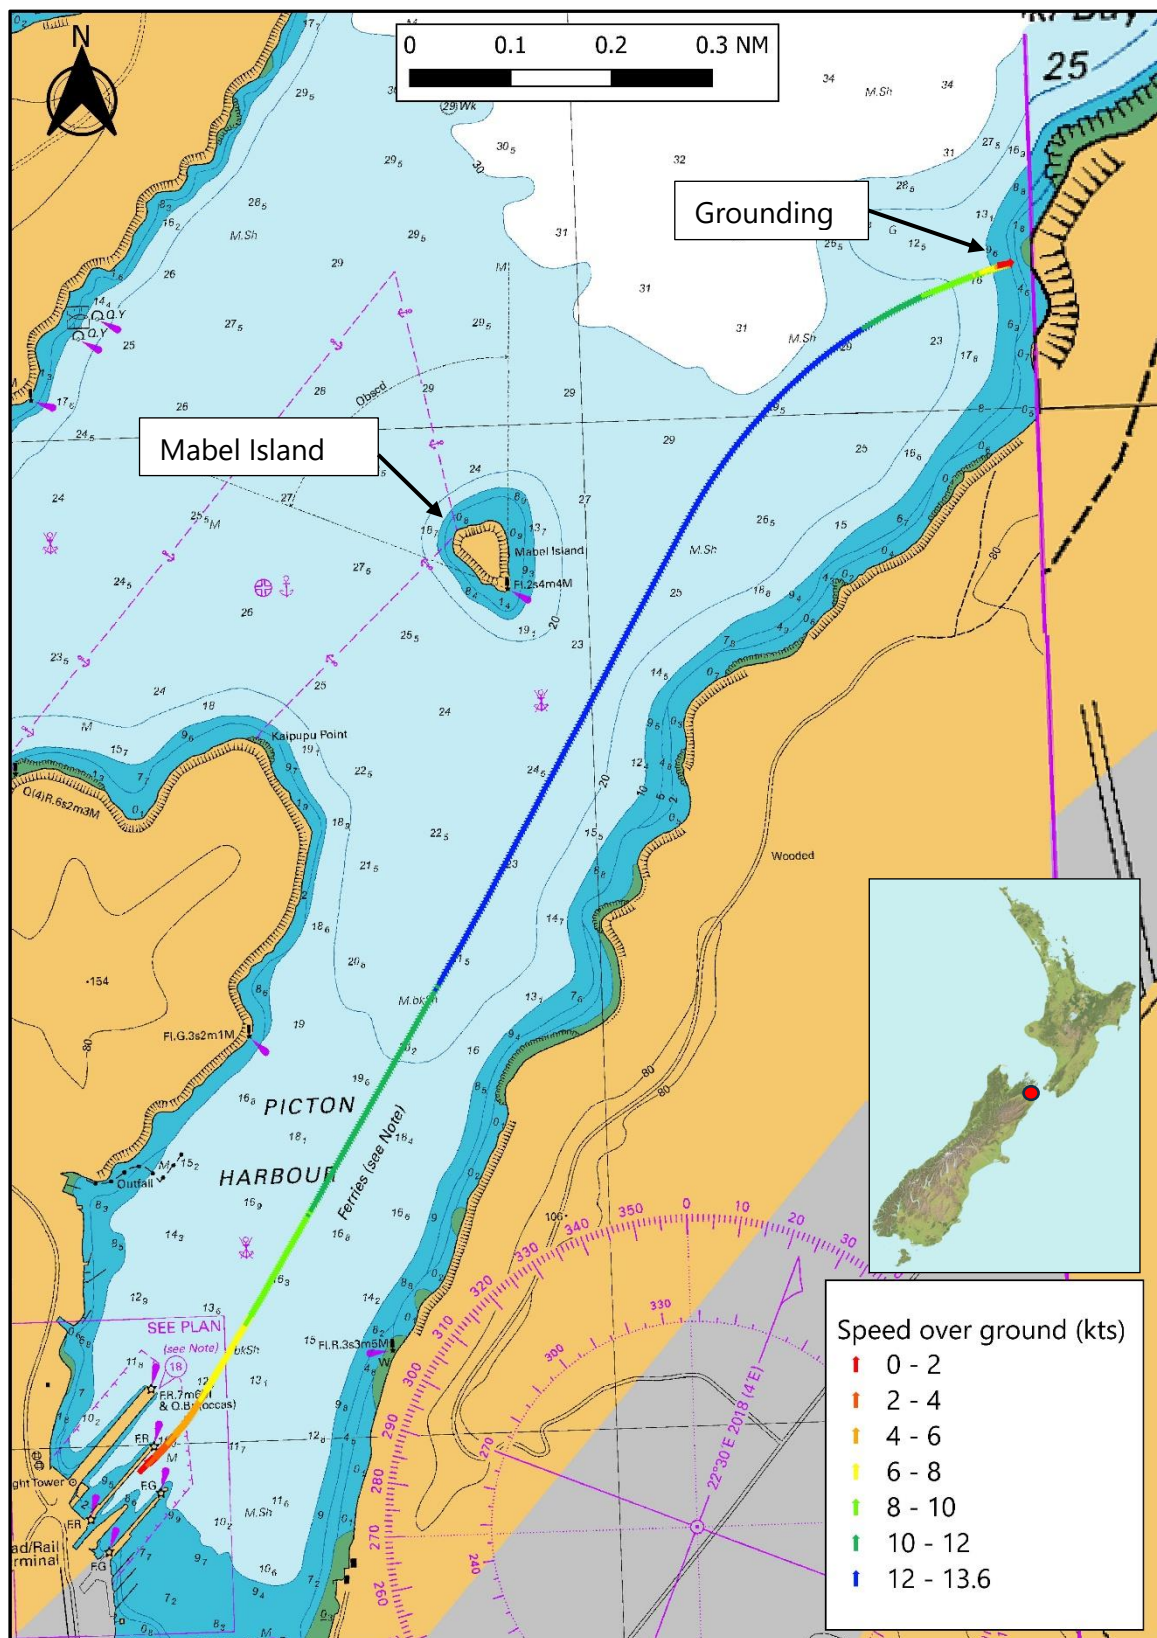
Figure 2: Track of *Aratere* and location of grounding (derived from automatic identification system data)

- 1.35. During this sequence the night master instructed the OOW to start one of the ship's bow thrusters²⁶ to assist the manoeuvring of the ship.
- 1.36. At 2128:34 *Aratere* crossed the 10 metre sounding²⁷ at about 7 knots, at 2128:46 the speed had dropped to about 3 knots. By 2128:50 the vessel had stopped and was aground on a heading of 76.5°²⁸.

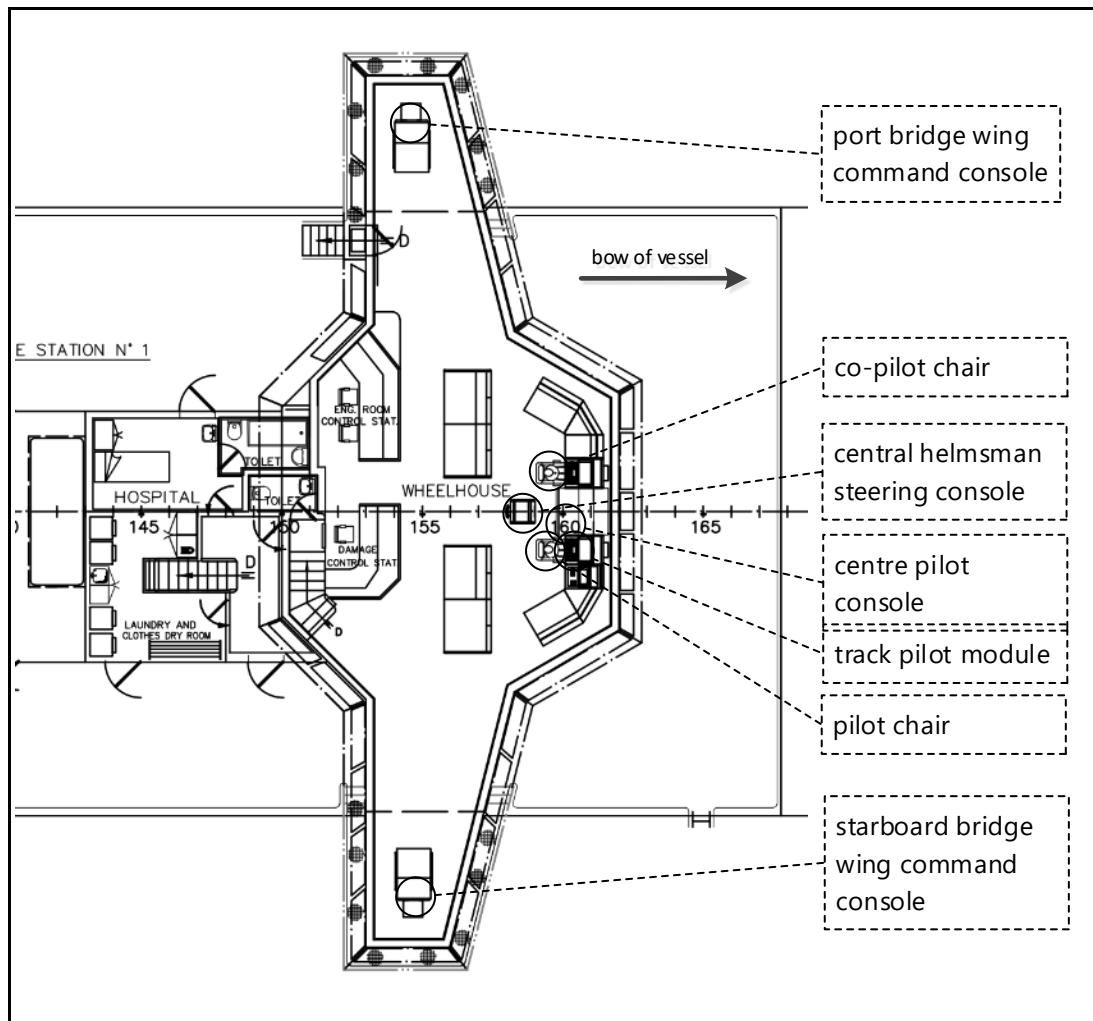
- 1.4. On the bridge, steering could be controlled from any one of five command consoles (see Figure 3):
 - the port⁴ bridge wing console
 - the starboard⁵ bridge wing console

- the centre pilot console
 - the central helmsman⁶ steering console (which contained the wheel)
 - the track pilot module⁷ (incorporating the autopilot).

Figure 3: General arrangement of *Aratere*'s bridge

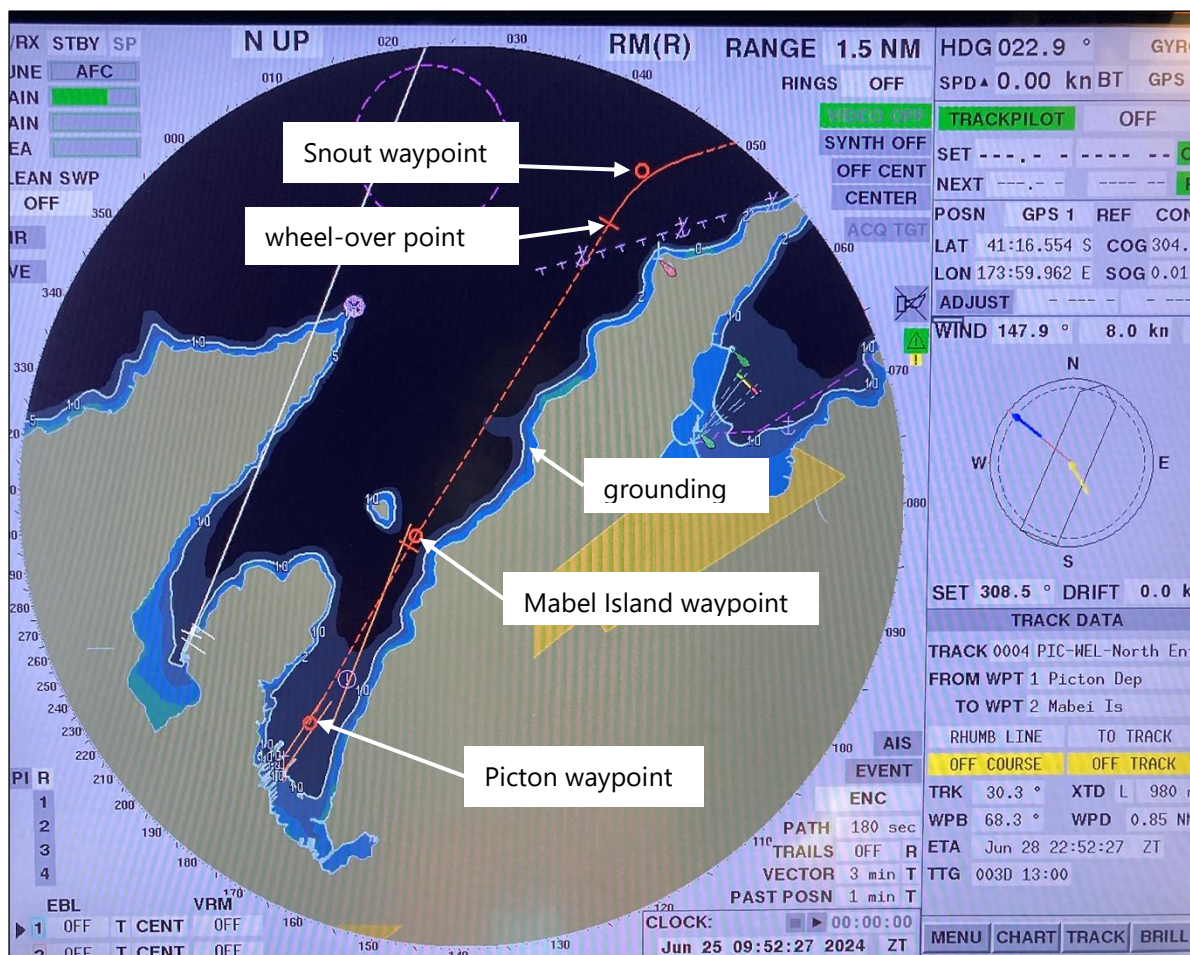
- 1.17. The course between the Mabel Island waypoint and the next waypoint, being Snout waypoint¹⁵, was 033° true. This was a small alteration of 3 degrees to starboard (see Figure 4).

Figure 4: Screenshot from *Aratere*'s electronic chart display and information system showing planned tracks as red dotted lines and waypoints as red circles

course to the next at each waypoint was programmed as an arc with a set radius. A wheel-over point¹⁹ was displayed prior to each waypoint (see Figure 4).

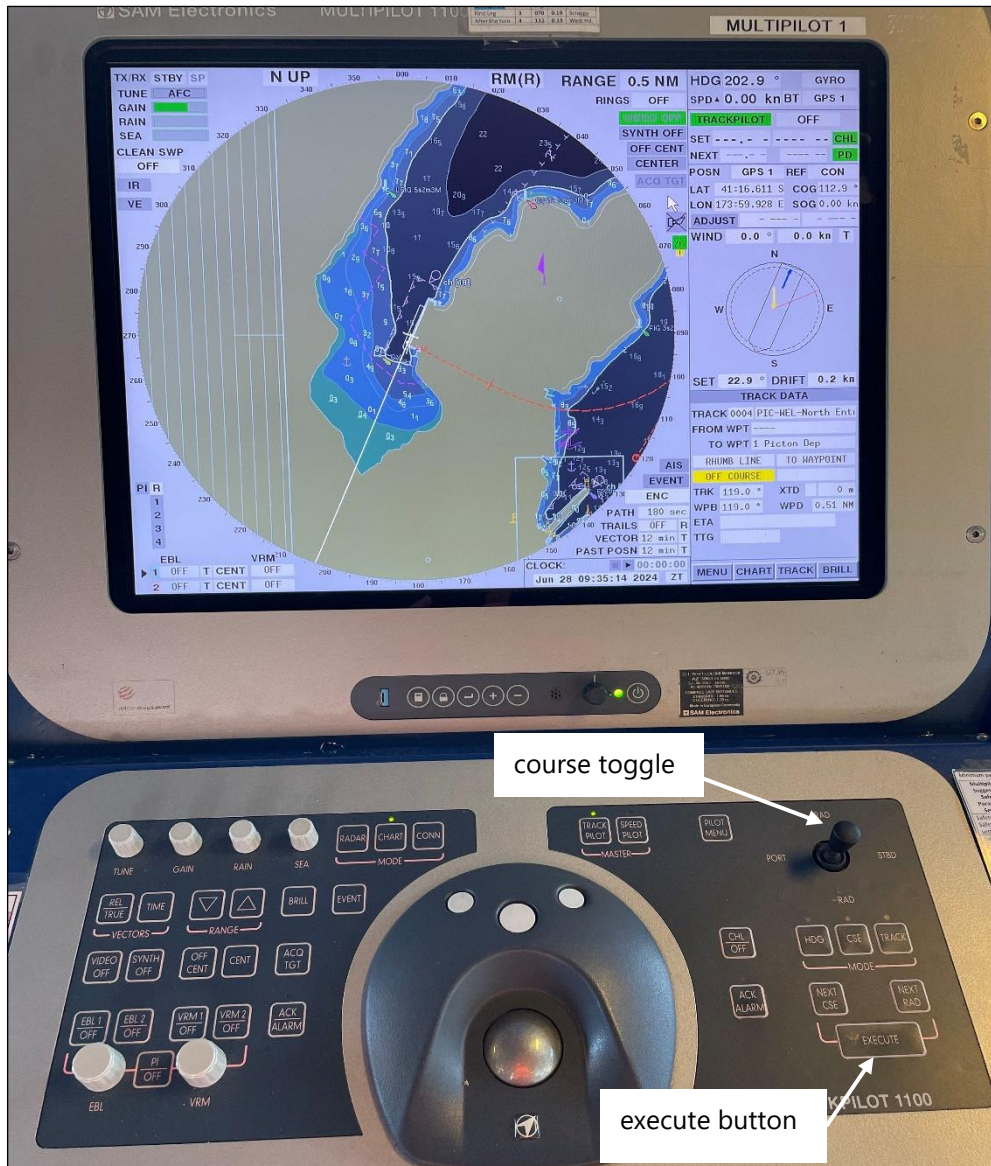
Figure 5: Track pilot incorporating autopilot function

- 1.21. When in course or track mode, pilot data mode can be selected, which results in the track pilot module alarms to warn the pilot when the ship is approaching a wheel-over point. However, in course mode the track pilot will not automatically begin the turn. The pilot must push the 'execute' button, upon which the track pilot will apply the required rudder to take the ship around the programmed arc onto the next course. The pilot can make manual adjustments to the course using the course toggle control (see Figure 5).

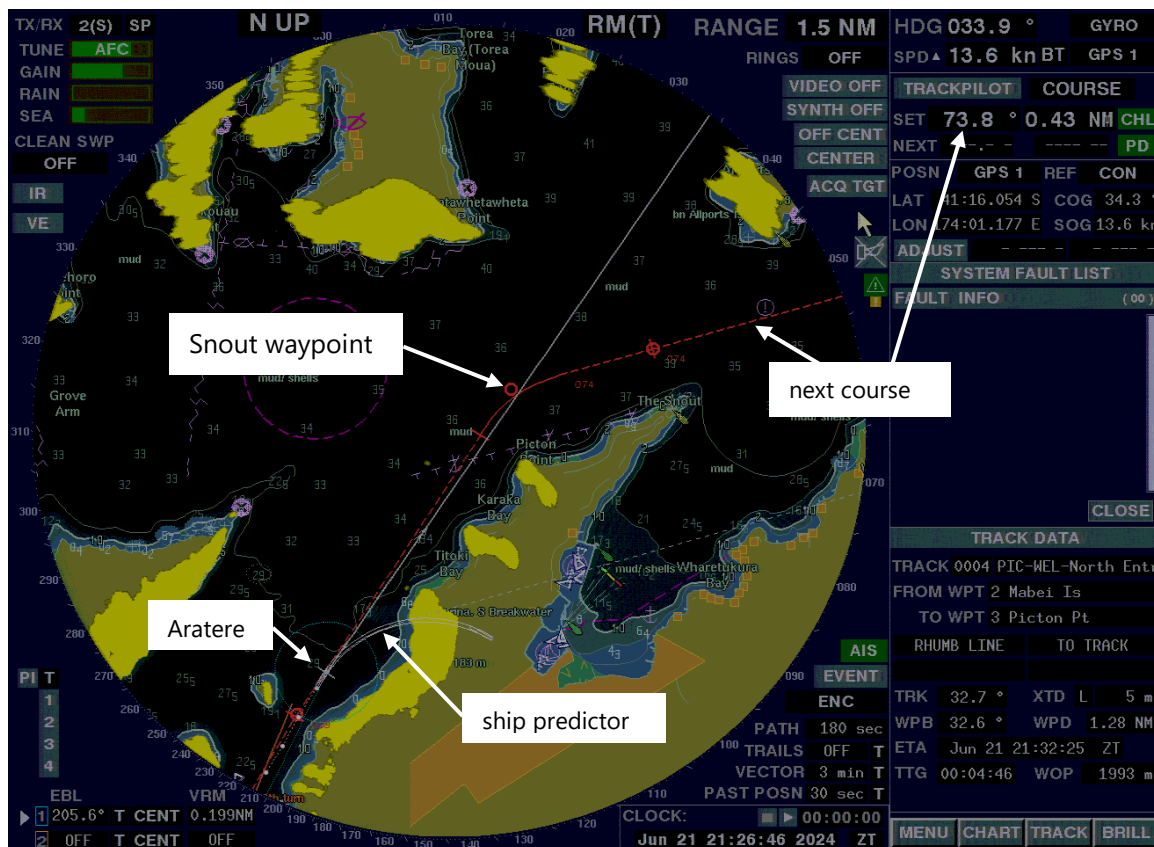
- 1.23. The autopilot was engaged at 2126:01 when the ship was on a heading of 028°. The re-familiarisation master pushed the execute button at 2126:30²⁰. However, *Aratere* had already passed the Mabel Island waypoint 36 seconds earlier and the track pilot had already automatically locked on to the next, more substantial turn around the Snout waypoint.

- 1.24. The track pilot module applied 9° of initial starboard rudder and began to make a controlled turn as if the ship were making the turn around the Snout waypoint.

- 1.26. Figure 6 shows a marked-up screenshot of *Aratere*'s ECDIS near the time the night master became aware that *Aratere* was deviating from the planned track. The set course was displayed as 73.8° with a radius turn of 0.43 nautical miles, which was the next turn and course around the Snout waypoint. The ship predictor is a feature that shows the pilot where the ship will be in the immediate future based on the ship's current speed and rate of turn.

Figure 6: Screenshot from *Aratere* ECDIS near the time the night master became aware that *Aratere* was deviating from the planned track
