Final report RO-2017-103: Potential collision between passenger trains,
Wellington Railway Station, 15 May 2017

Rail inquiry RO-2017-103
Potential collision between passenger trains
Wellington Railway Station

15 May 2017

Approved for publication: August 2018

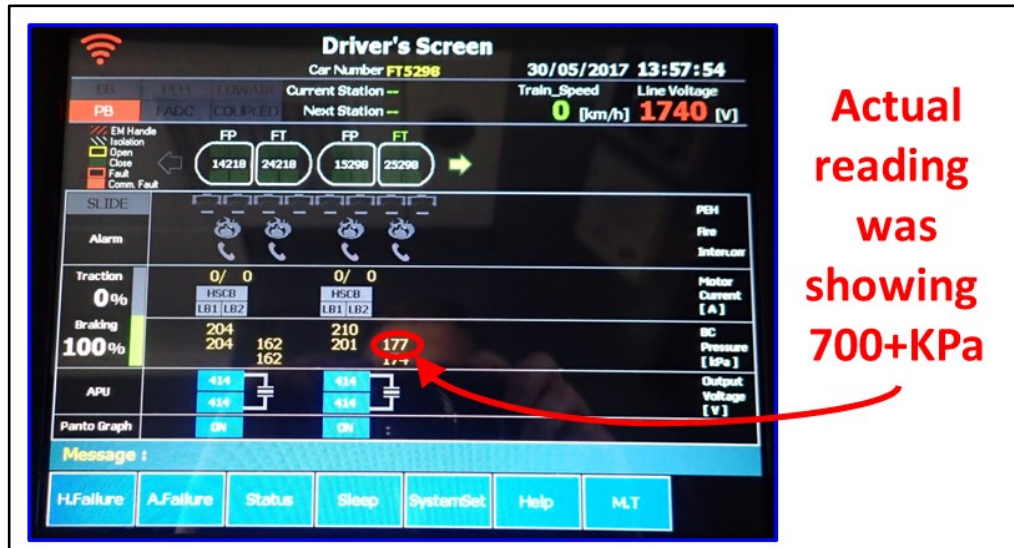
Figure 2
Train monitoring system screen in a sample Matangi train cab

3.1.3. The platform maintainer tested the train at the platform and concluded that the high reading of 700+KPa was not possible to achieve. The new driver was informed that the train was fit for service and that the problem was most likely a sensor fault. The platform maintainer planned to remove the two-car set⁹ from service for further investigation at the maintenance depot once the train returned to Wellington later that evening.

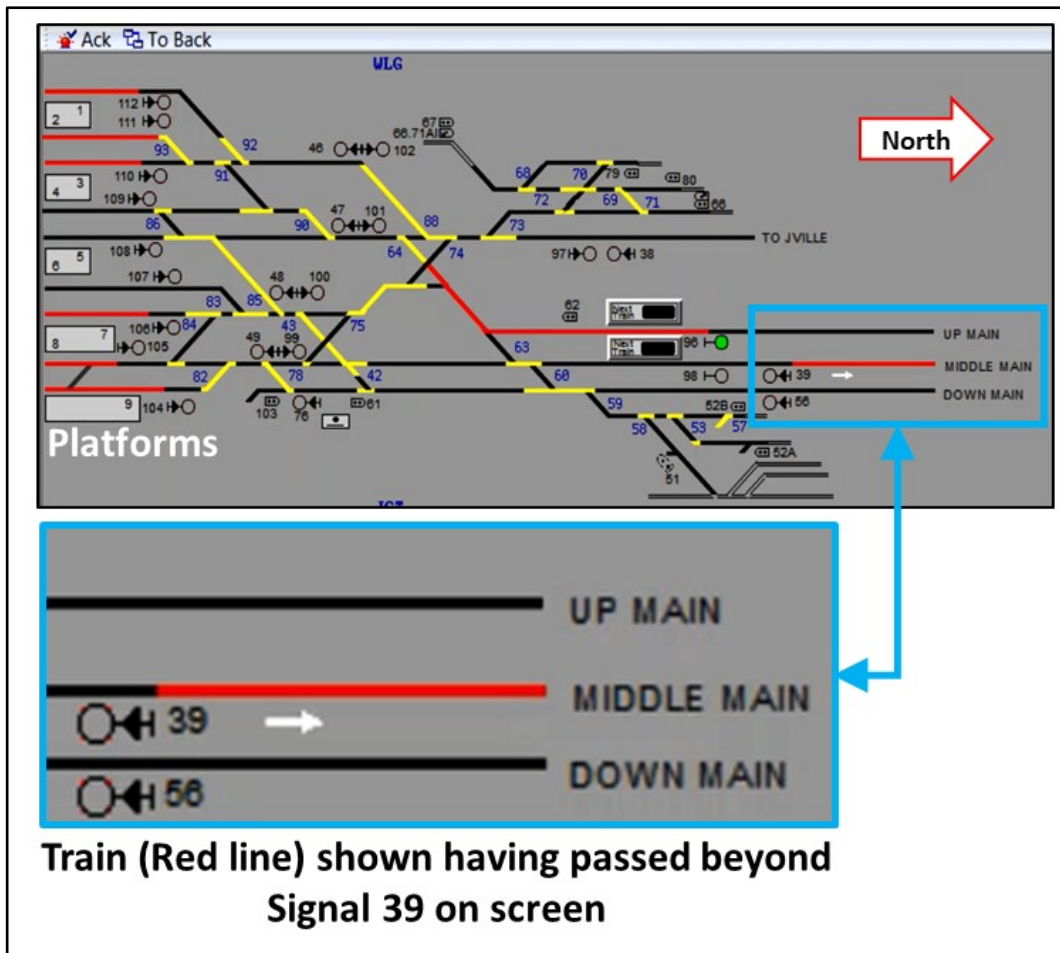
Figure 3
Extract from mimic screen in Wellington signalbox

- 3.1.7. The driver radioed the signaller to explain that the train needed to return to the station. The signaller looked at the mimic screen and noted that it showed the train occupying the section of track north of Signal 39 (see Figure 3). The signaller planned to use Signal 39 to authorise the train south back to the station.

- 3.1.8. The signaller confirmed to the driver that the train had passed beyond Signal 39, and that the driver was to change driving ends in readiness for the move back to the platform. However, when the train had stopped, the rear of the train was about four metres short of going past Signal 39 (see Figure 4). The insulated joint¹⁰ in the track that marked the end of one section and the beginning of the next section of track was eight metres behind the signal. Because the train had passed over this insulated joint, the signalling system indicated to the signaller that the train had passed north of Signal 39 and fully entered the next section of track on the mimic screen.

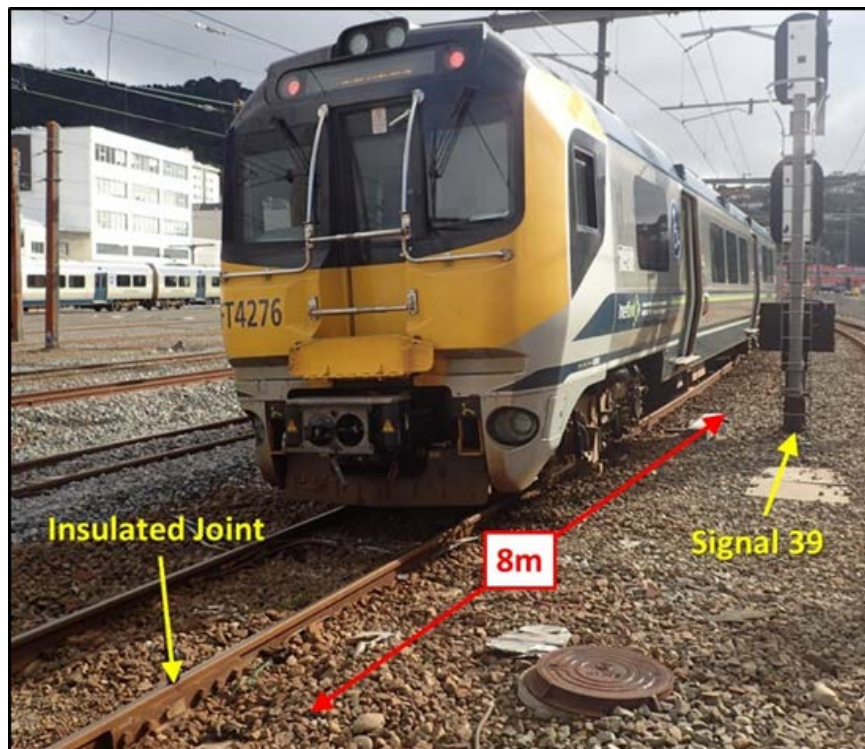
Figure 4

the station platform. Once the driver had changed ends, Signal 39 was about four metres behind the driving cab outside the driver's forward view.

- 3.1.10. The driver contacted the signaller. The signaller authorised the driver to “come around to the signal”. The signaller was referring to Signal 39 and the driver correctly understood that the train could move as far as Signal 39. Signal 39 was set to ‘All Red – Stop’.

Photograph showing position of the rear of the train in relation to Signal 39

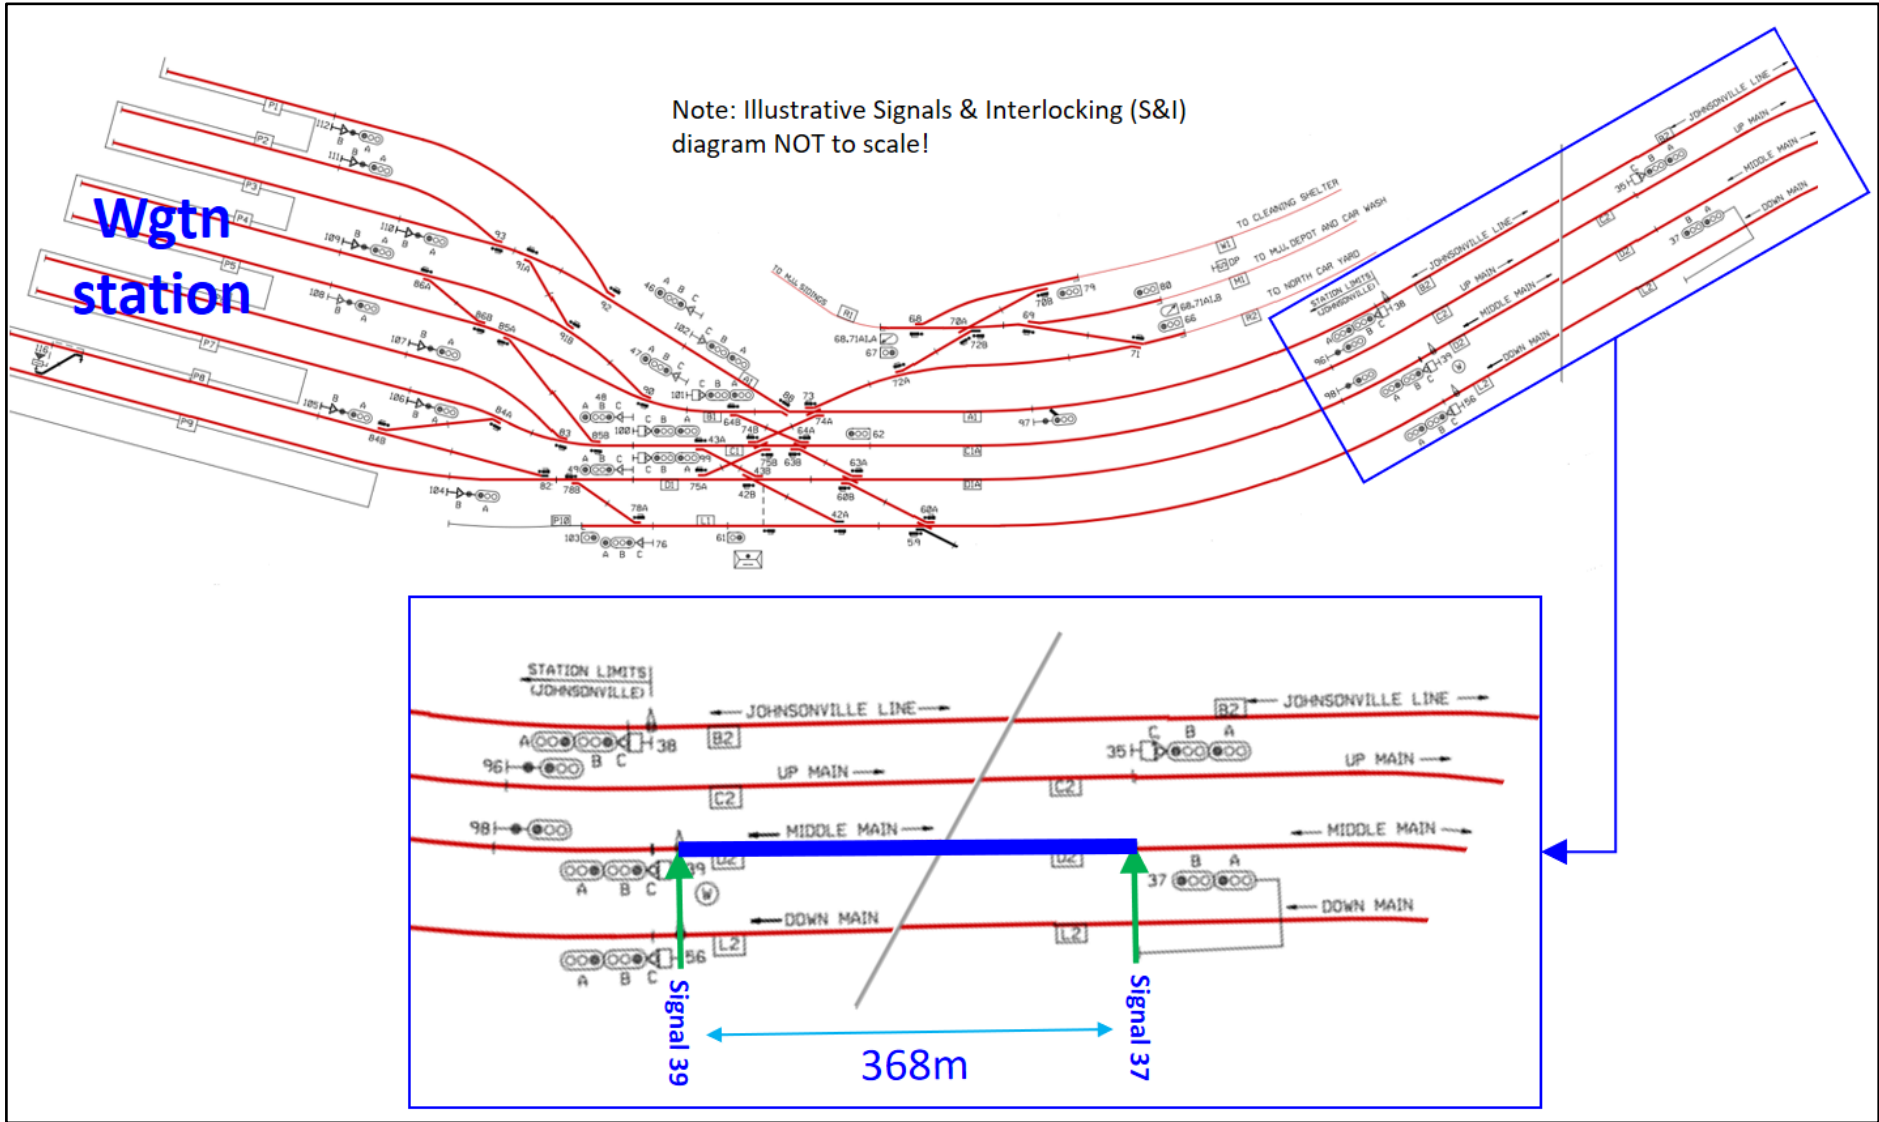
Figure 5
Section of track occupied by the train as seen on the signaller's mimic panel

- 4.2.3. The problem arose because the train stopped with its rear bogie positioned within the eight-metre length of track between the insulated joint and Signal 39. The location was unfortunate. Having passed over the insulated joint, the track signalling system displayed to the signaller on the mimic panel that the rear of the train had passed Signal 39, when in fact it had not. The mimic screen showed the signaller that the train had stopped somewhere within the 368-metre section of track between Signal 39 and the next signal (see Figure 5). The signaller had no reason to doubt the accuracy of the information being presented on the mimic screen.

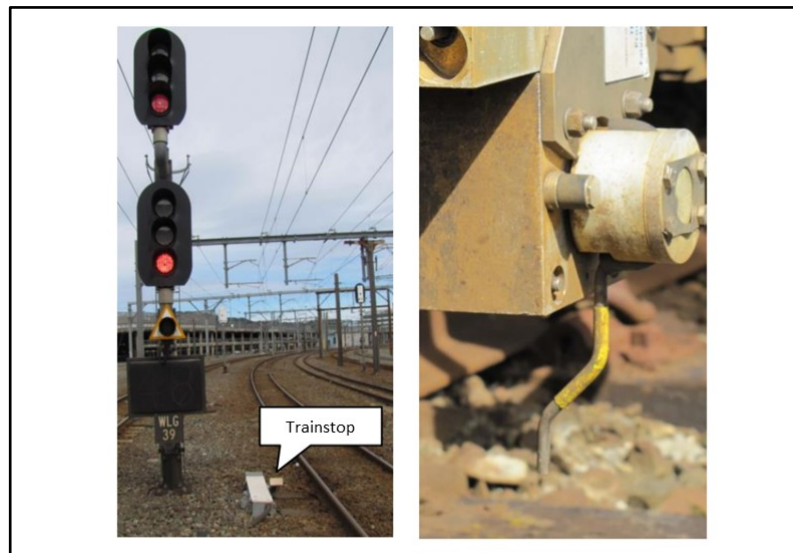
Figure 6
Example TrainStop (left) and trip lever on a Matangi train (right)

- 4.3.3. Signal 39 is protected by a TrainStop for inbound Wellington trains. The device was installed next to the signal and was designed to activate the brakes of an inbound train automatically if it passed the signal at red. It is a means of protecting the busy and congested approaches to Wellington Station from trains that do not stop at red signals. The device works via a lever that is raised when the signal is at red and the last set of train wheels has passed over the insulated joint associated with the signal. This raised lever catches on a trip lever device mounted on the side of the train and activates the train brakes (see Figure 6).

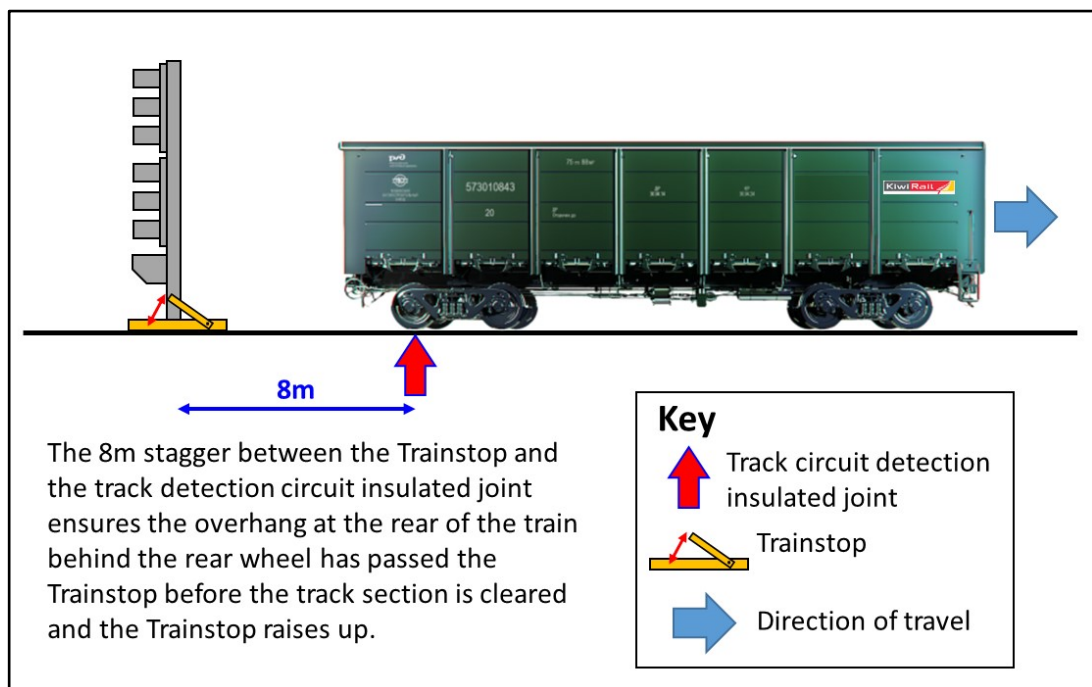
Figure 7
Signal and TrainStop position diagram

4.3.4. The insulated joint was placed eight metres behind the TrainStop device (and the signal) so that any part of the train that was overhanging the last set of wheels would not catch on the raised TrainStop lever and damage the device (see Figure 7).
