Final report R0-2017-105: Collision between freight Train 353 and heavy motor vehicle,
Lambert Road level crossing, near Kawerau, 6 October 2017

Rail inquiry R0-2017-105
Collision between freight Train 353 and
heavy motor vehicle
Lambert Road level crossing, near Kawerau

6 October 2017

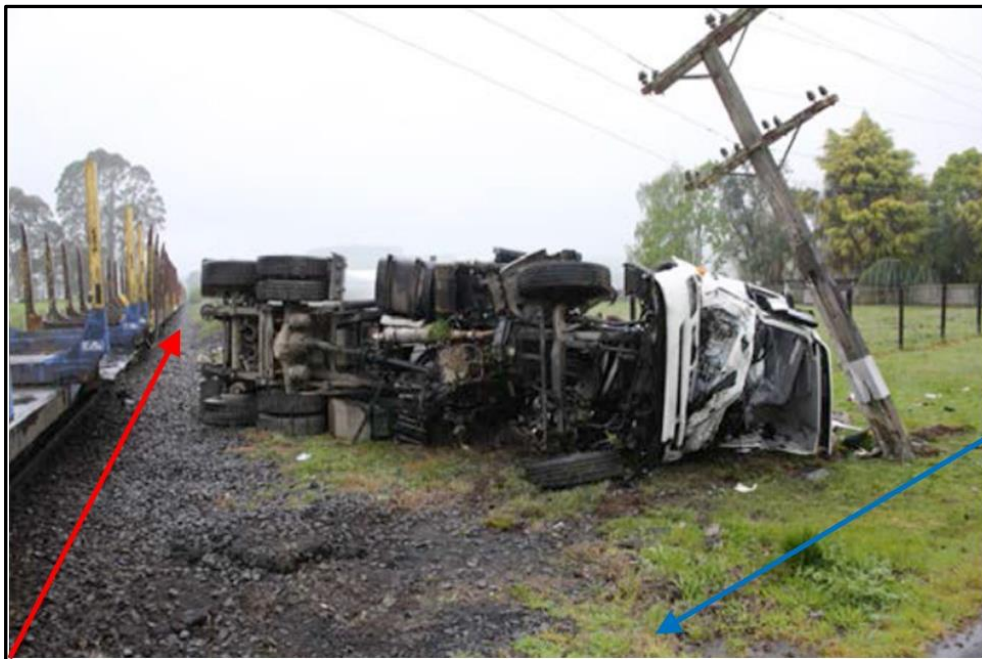
- 1.3. The train struck the left side of the truck at a speed of about 63 kilometres per hour. The truck driver was thrown clear of the truck and was fatally injured. The truck was significantly damaged.

Figure 2
The damaged truck
(photograph provided by New Zealand Police)

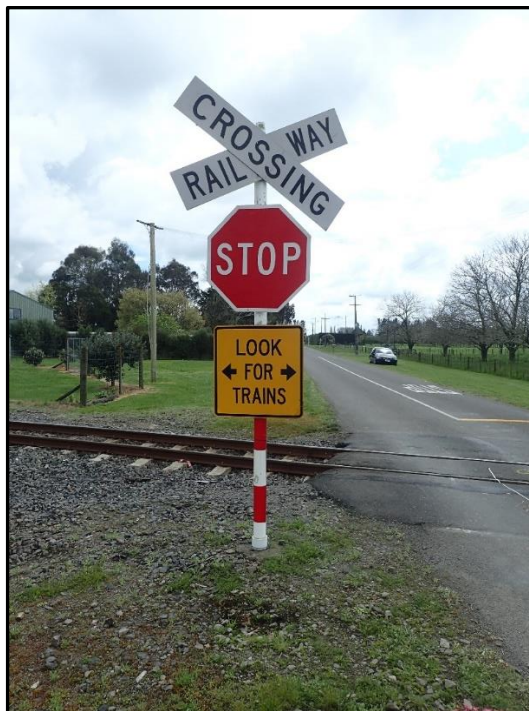
- 3.2.4. KiwiRail Holdings Limited (KiwiRail) was the licensed rail access provider and was responsible for all signage within the rail corridor. Signage was located on the left-hand side of the crossing in the direction the truck was travelling at the time. It was the standard pole-mounted STOP assembly consisting of a crossbuck 'RAILWAY CROSSING' mounted above a 'STOP' sign, and the optional 'LOOK FOR TRAINS' sign (see Figure 3). The signage was in good condition.

Figure 3
The STOP sign assembly for the northbound approach to the Lambert Road level crossing

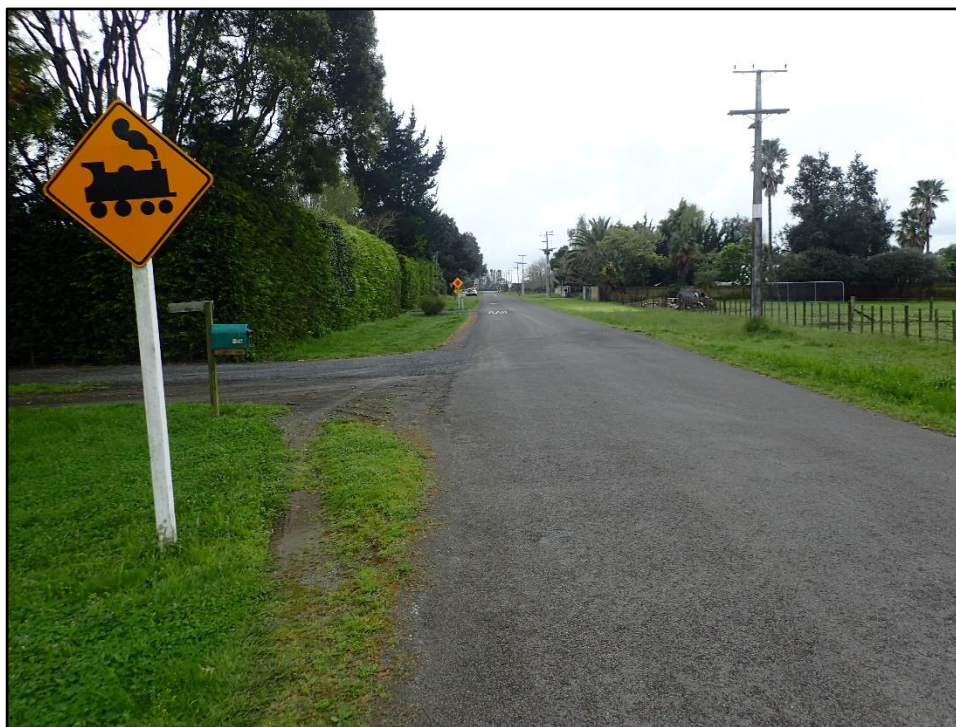
- 3.2.5. The Council was responsible for installing and maintaining signage in advance of a level crossing. A 'Level Crossing Ahead' warning sign in the form of a symbolised steam locomotive was installed on the left-hand side of the road on the northbound approach, 174 metres back from the level crossing (see Figure 4).

Figure 4
The warning sign for the northbound approach to the Lambert Road level crossing

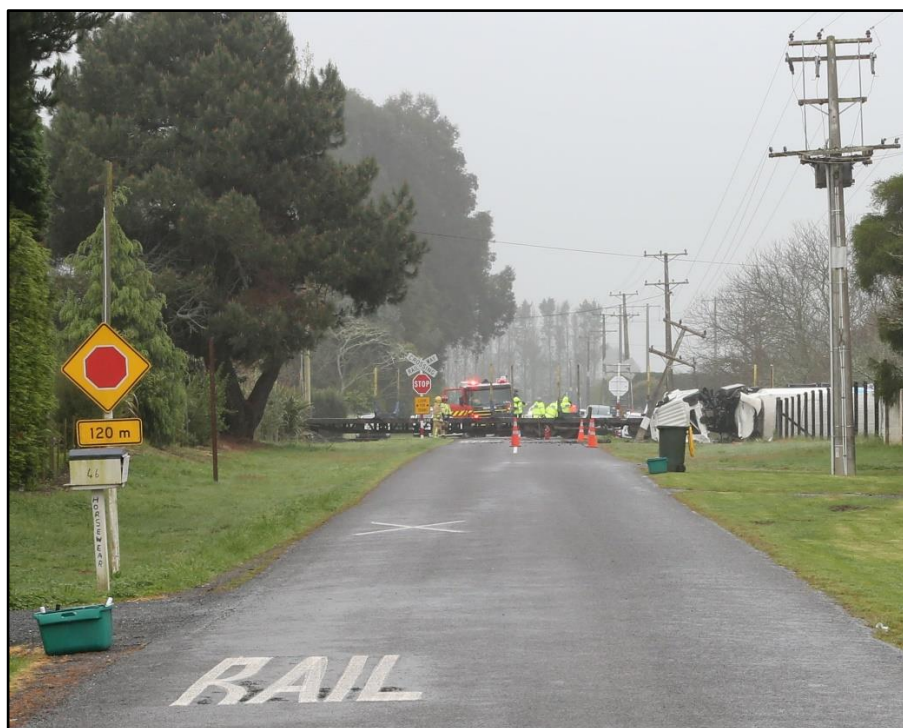
- 3.2.6. An advisory sign was positioned on the left-hand side of the road, a few metres past where the truck last stopped to service a waste bin. The sign advised that a compulsory stop sign was 120 metres ahead (see Figure 5). The sign assembly was positioned correctly and was in good condition.

Figure 5
The warning sign and road markings for the northbound approach to the Lambert Road level crossing (photograph provided by New Zealand Police)

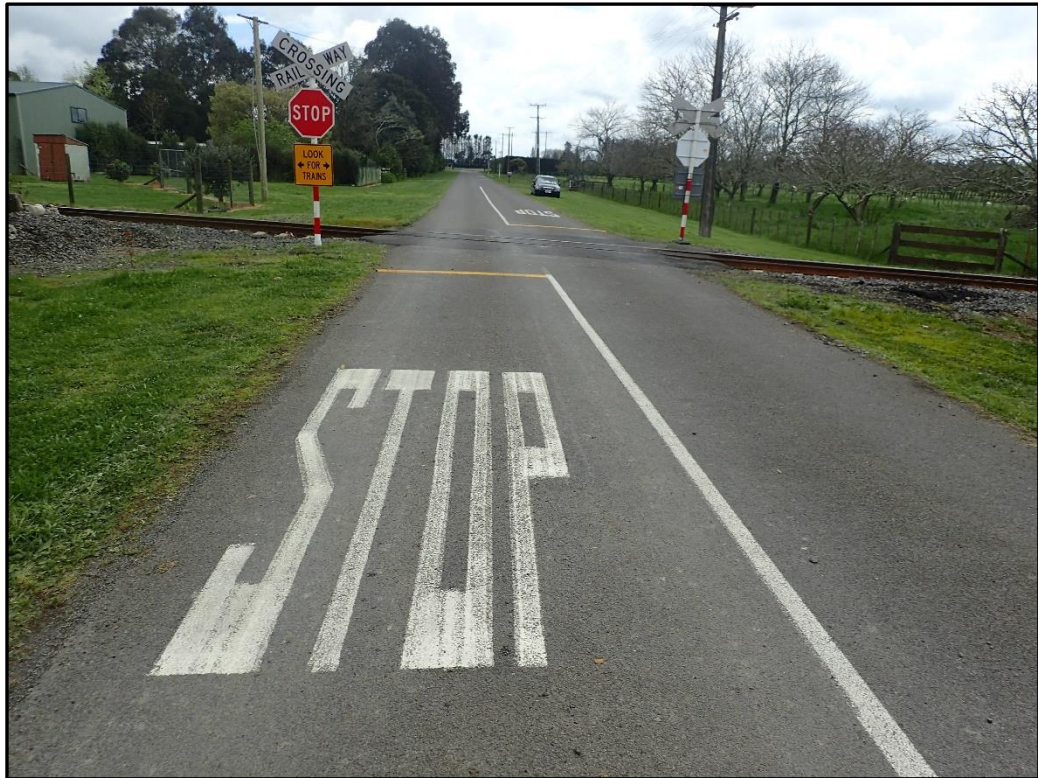
- 3.2.7. The Manual required the Council to install and maintain the road markings. When approaching the level crossing northbound, the word 'RAIL' and the letter 'X' were painted on the road before and after the railway level crossing warning sign (see Figure 5). The road markings at the level crossing included a yellow limit line, a centreline and the word STOP (see Figure 6).
- 3.2.8. The yellow line was 4.3 metres from the nearest rail when measured along the road centreline. The Manual required the limit line to be not less than 2.4 metres from the nearest rail.
- 3.2.9. Records provided by the Council showed that there had been a non-injury accident in 2010. A car had stopped too close to the rail tracks and had been clipped by a passing train.

Figure 6
The road markings for the northbound approach to the Lambert Road level crossing

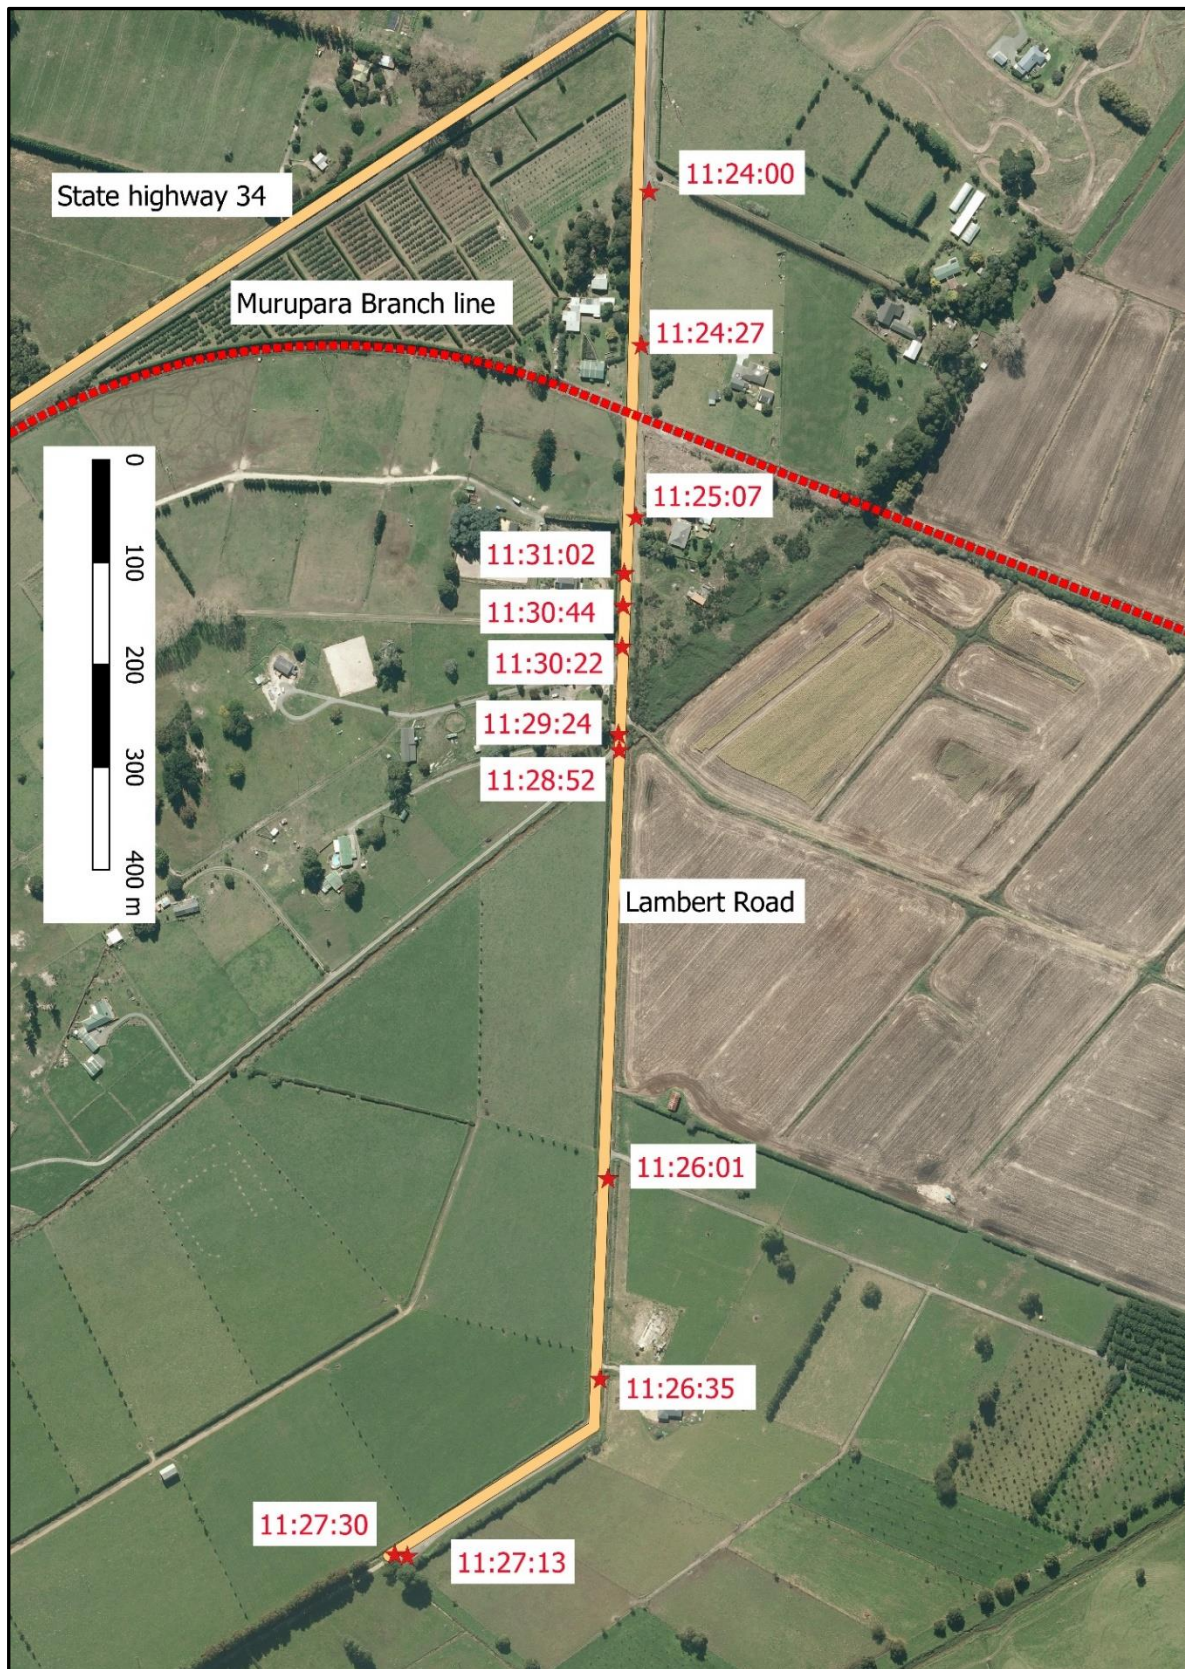
- 4.2.3. The truck continued south to the end of Lambert Road, turned around and proceeded northbound, stopping to service bins positioned on the other side of the road. The last recorded stop was made at 1131:02, when the truck was 126 metres from the level crossing.

Figure 8
Diagram showing truck stopping times on Lambert Road
(underlying imagery courtesy of Land Information New Zealand¹³)

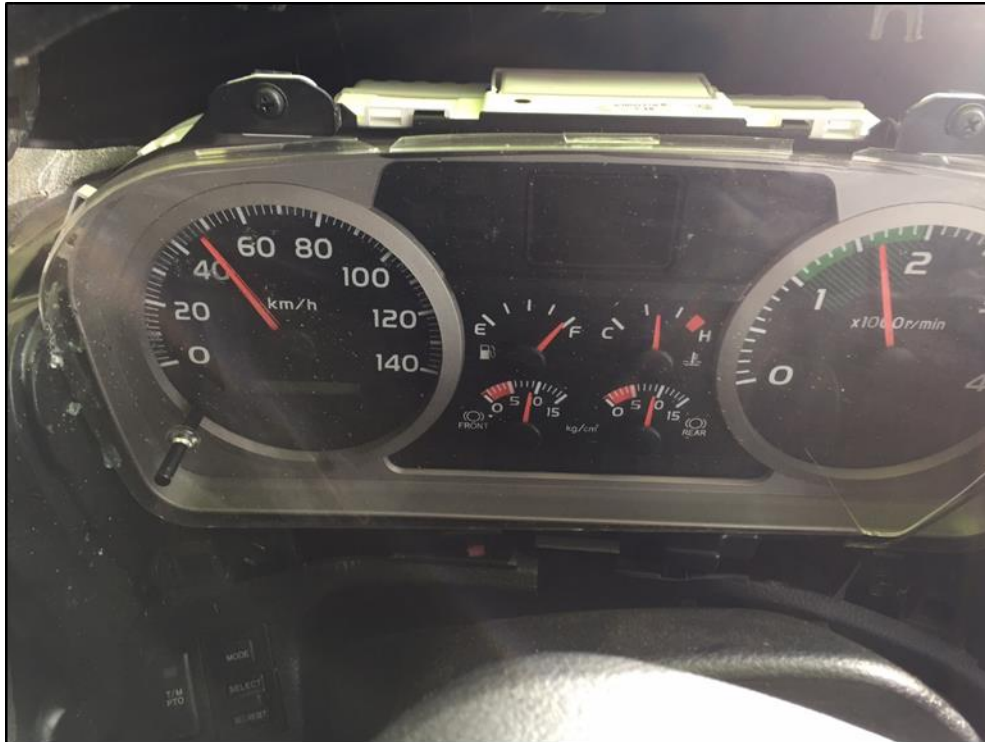
- 4.2.4. The train and the truck collided at 1131:33 according to the train event recorder, about 31 seconds after the truck had last stopped¹⁴. The post-accident examination of the truck instrument panel identified that the speedometer had 'captured' the speed at about 48 kilometres per hour and the tachometer similarly 'captured' the revs at 1,700 revolutions per minute (see Figure 9). The speed and rev counter readings were likely to have been the readings when power was lost to the instrument panel as a result of the collision. Therefore, the truck was likely to have been travelling at close to 48 kilometres per hour at the time of impact.

Figure 9
The truck instrument panel after the collision
(photograph courtesy of New Zealand Police)

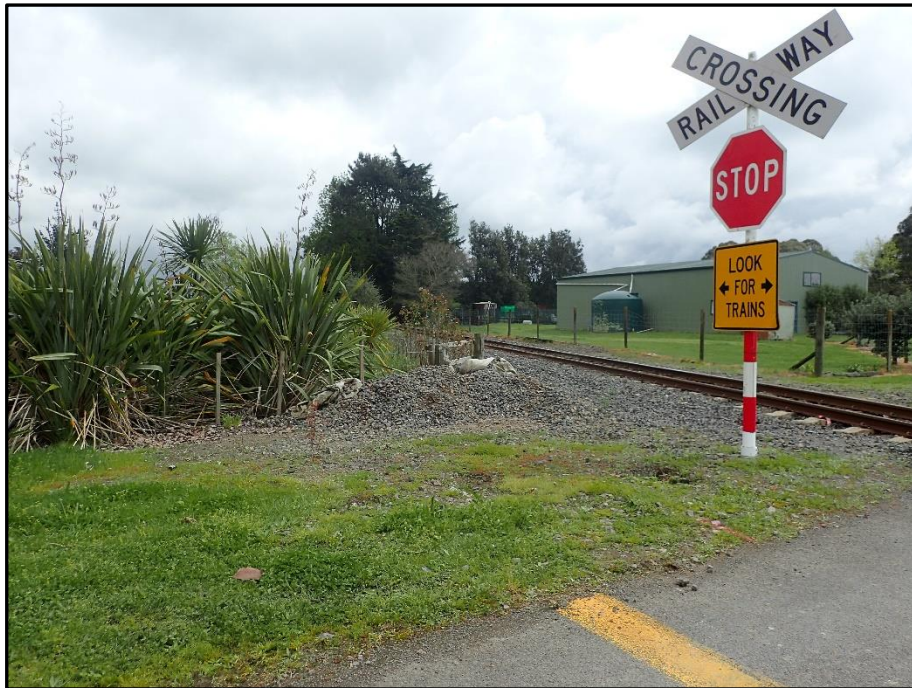
- 4.4.8. During the seven years since the ALCAM survey, vegetation on the boundary of a private property adjacent to the level crossing had grown to a height of about two metres. As a result, the maximum sighting distance available to the truck driver had been reduced from 423 metres to 83 metres (see Figure 10). This meant that even if the truck had stopped at the yellow limit line, the truck driver would not have had sufficient time to clear the level crossing safely in the event of a train approaching from just out of the driver's view.

- 4.4.9. Furthermore, even if the driver had tried to look for trains as the truck approached the level crossing, the train would have been obscured by a high hedge that ran parallel to the road.

Figure 10
The view looking east towards Kawerau when stopped at the yellow limit line

- 4.5.5. The Commission is also recommending that, in the short term, where KiwiRail becomes aware of vegetation affecting the sighting distances at level crossings for which it is the licensed access provider, it work with the relevant road controlling authority to remove or control that vegetation.

- 4.5.6. The Commission is also recommending to Local Government New Zealand that, in the short term, where road controlling authorities become aware of vegetation affecting the sighting distances at level crossings, they work with the relevant licensed access providers to remove or control that vegetation.

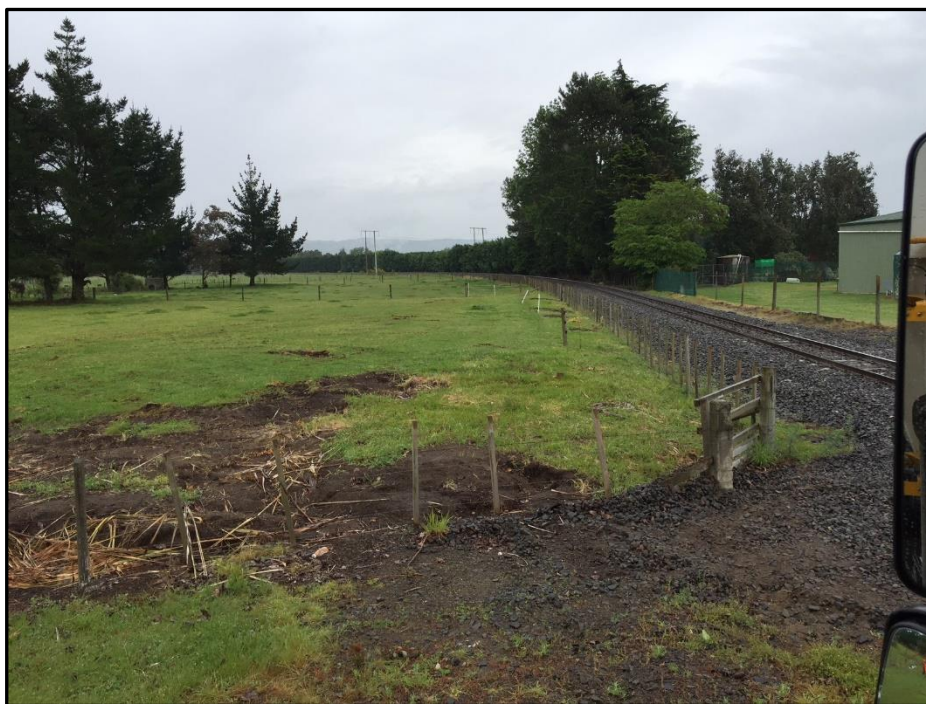
Figure 11
The view from a truck looking towards Kawerau after the vegetation was cleared
(photograph courtesy of New Zealand Police)

- 4.4.10. Subsequent to the accident KiwiRail worked with the owner of the adjacent property to improve the sighting distance (see Figure 11).
