Transport Accident
Investigation
Commission

Rail inquiry RO-2018-102

Freight train SPAD and wrong-routing

Taimate

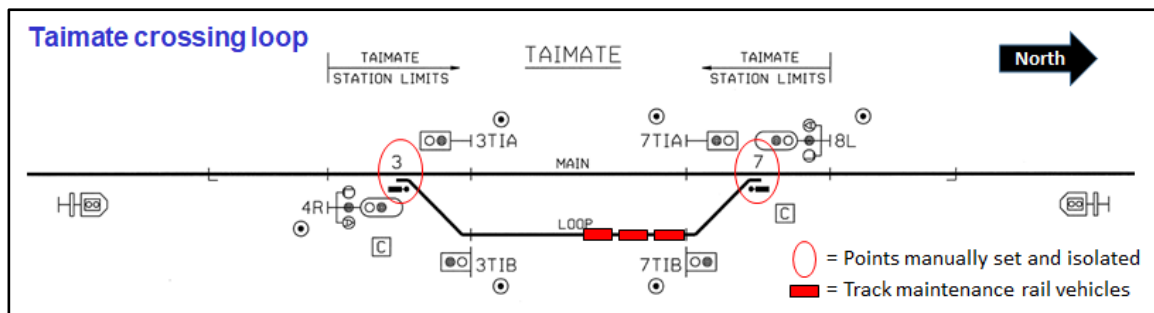
Figure 1: Crossing loop layout (not to scale)

- 1.2. There was a set of rail points coming off the adjacent main line at each end of the loop. The points were supposed to have been isolated and manually set for the main line to prevent trains travelling on the main line entering the loop and colliding with the mobile track maintenance vehicles.

- 2.2. At the end of the work shift, two of the work groups stabled³ their track maintenance vehicles in sidings⁴ at Wharanui and Lake Grassmere. Because there were no sidings located in the Taimate area, the Taimate work group stabled their maintenance vehicles on the main line crossing loop at Taimate (see Figures 1 and 2). The RPO relayed this information to train control. The team leader for the work group at Taimate also informed train control that their track maintenance vehicles were stabled on the loop.

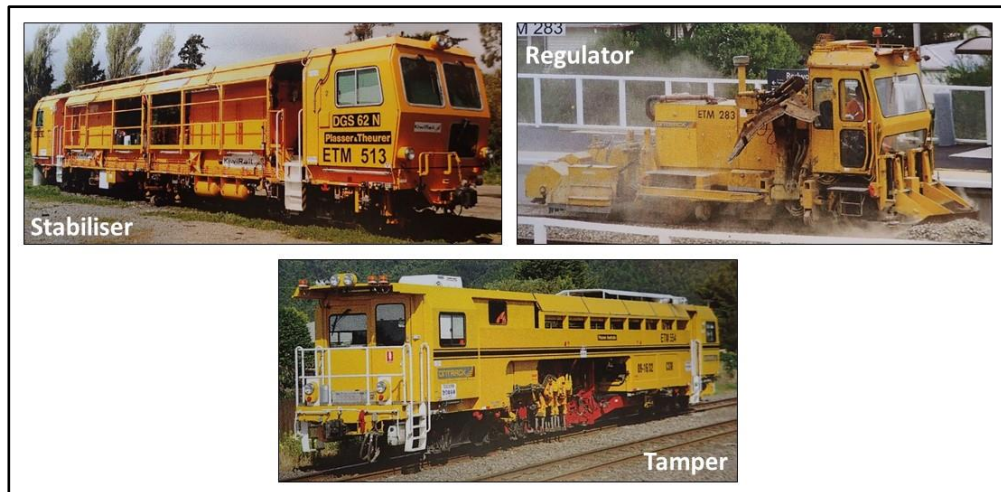
Figure 2: Track machines stored overnight at Taimate

- 2.4. At the end of their shift at approximately 1730, the work group returned to Taimate and stabled the maintenance vehicles in the crossing loop. Once all the rail maintenance vehicles were secured, the work group 'locked off'. The site protector then contacted the RPO at Wharanui by mobile phone and reported the track machines at Taimate as "off and clear of the main line" and stabled in the loop, after which the site protector left the site.

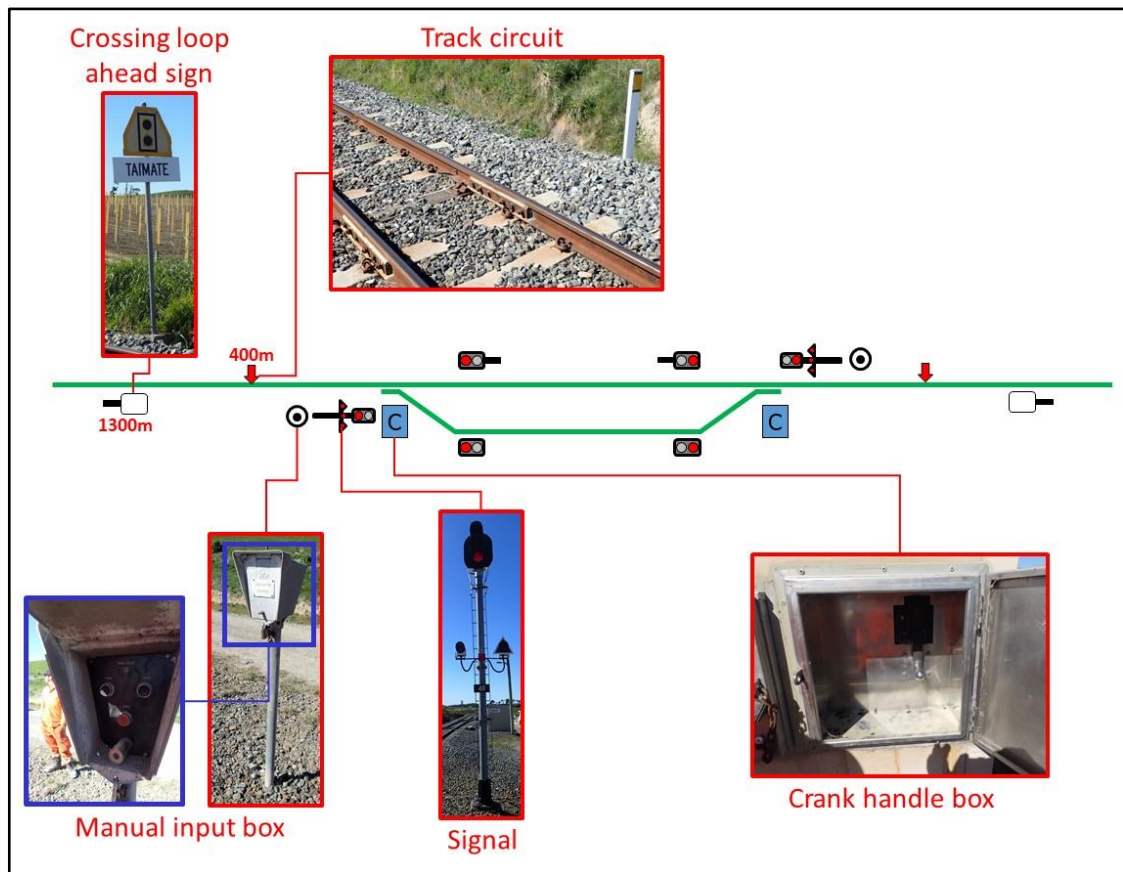
Figure 4: Crossing loop layout

- 3.4. When a train is required to enter a crossing loop for an opposing train, the train driver stops the train short of the signal and unlocks the manual input box (see Figure 4). The train will have activated the track circuit⁹ located 400 m back from the crossing loop. The train driver is able to press the 'loop' button to set the points to access to the loop. An 'L' illuminates on the signal when the points are set. Once the train has entered the loop, the points and signals automatically reset to allow the opposing train to pass on the adjacent main line. When the opposing train has passed clear of the crossing loop track circuits, the points and signals automatically reset to allow the train sitting in the loop to depart through the opposite end of the loop.

- 3.7. Points isolation is accomplished by removing a crank handle from the locked crank handle box (see Figure 4) by the points and hand winding¹⁰ them into the correct position, before placing the crank handle loosely in the bottom of the crank handle box. This means the crossing loop is no longer automatic, and train drivers approaching the crossing loop encounter a Red signal that does not automatically change to yellow as the trains approach. The team leader of the workgroup had overall responsibility for ensuring that the points were correctly set and isolated¹¹.

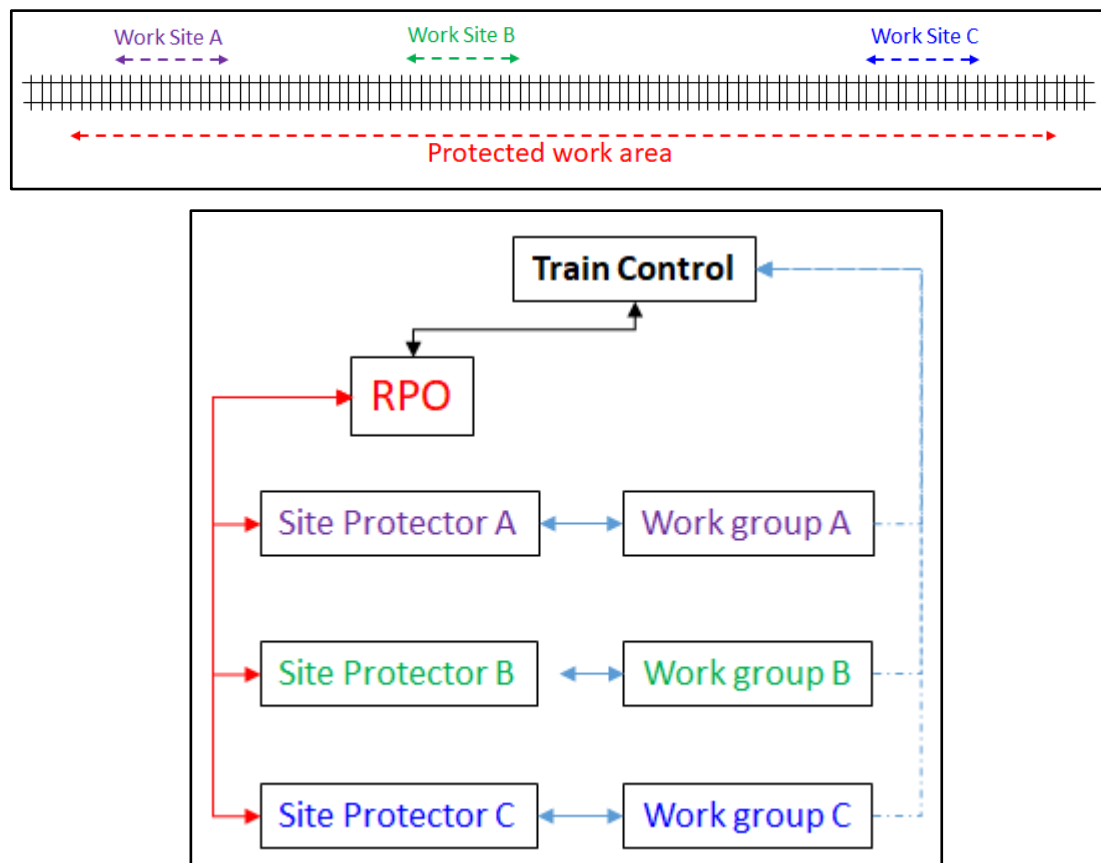
Figure 5: Hierarchy of control and communications at multiple worksites protected work area

- 3.12. KiwiRail Rule 902¹³ explains the flow of information through a multiple worksite protected work area (see Figure 5). Each individual worksite has a site protector who co-ordinates with the RPO, who in turn communicates directly with train control to control the movement of rail vehicles through the protected work area.

- 3.13. RPOs and site protectors are not required to be trained or authorised to operate signals or points, but work group team leaders and the drivers of maintenance rail vehicles are. Staff who are appropriately trained within work groups liaise directly with train control to obtain permission to, in this case, stable equipment on a crossing loop. It is then their responsibility to ensure that the points at both ends of the loop are properly set and isolated, and pass this information to train control (see Figure 5 – dotted blue line).
