Transport Accident  
Investigation  
Commission

# **Final Report**

***Rail inquiry R0-2019-103  
Derailment of Train 626  
Palmerston North  
4 April 2019***

**April 2020**

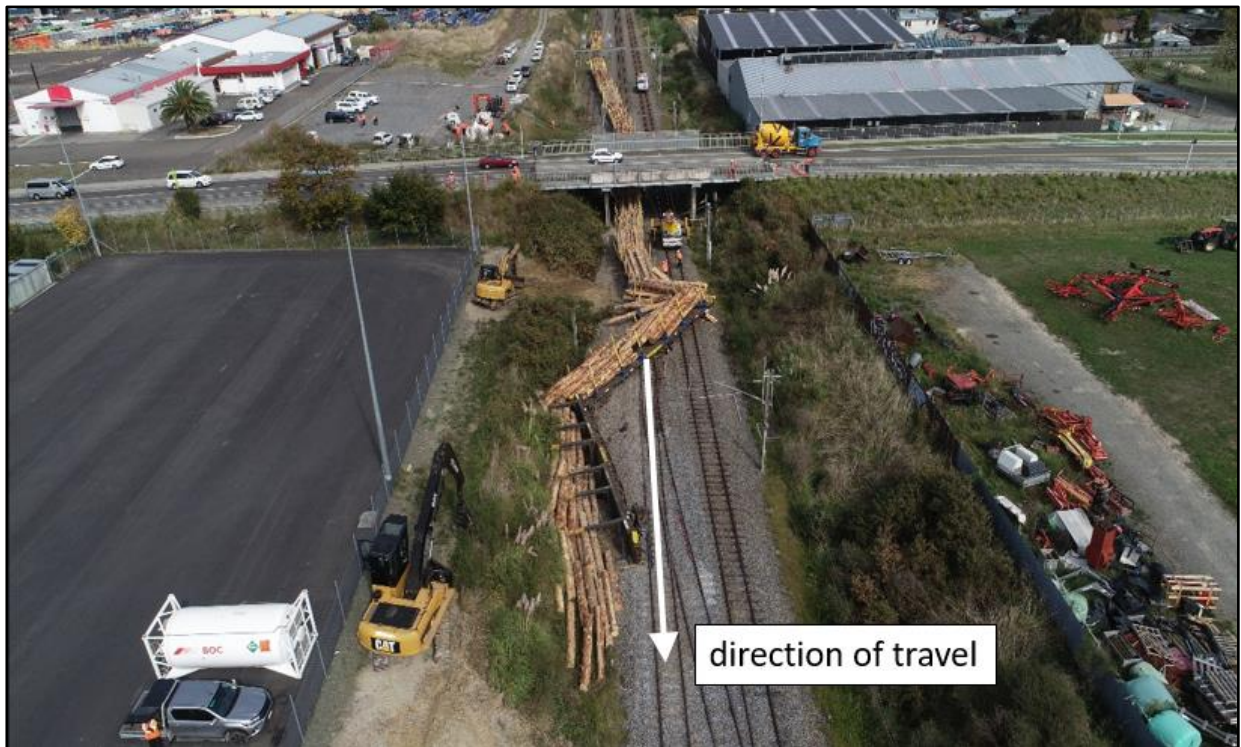
**Figure 3: Derailed wagons (photograph provided by KiwiRail)**

- 2.11. A witness mark<sup>14</sup> on the rail indicated that the leading bogie of wagon UKN143, 28 wagons behind the locomotives, climbed the right-hand-side curved rail, in the direction of travel, and dropped into the ballast on the outside of the rail. The derailed wagon was dragged through two more sets of points before it came to rest on its side about 155 m past the POD. During the derailment sequence, the three wagons immediately behind wagon UKN143 also derailed (see Figure 5). There was a separation of about 136 metres between the last wagon of the front portion of the train and wagon UKN143.

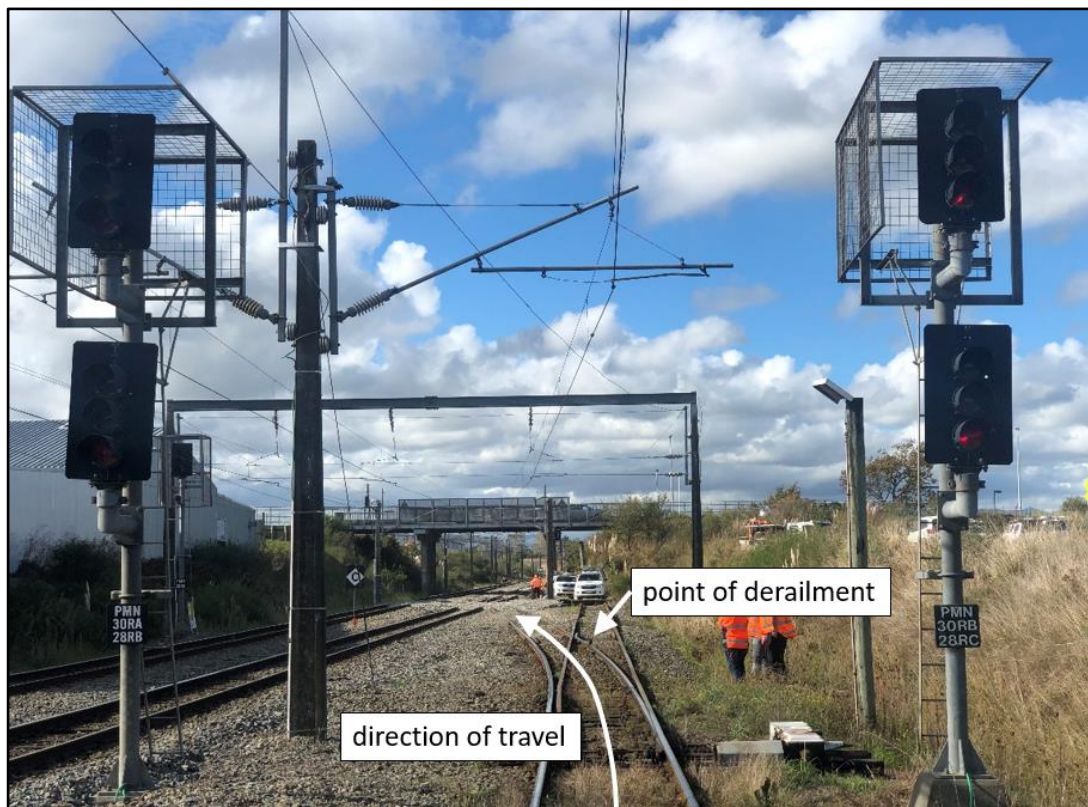
**Figure 4: 29B set of points**

- 2.9. The point of derailment<sup>13</sup> (POD) was on the outer rail of the rail for 29B crossover points in the direction of travel (see Figure 4).

- 2.10. The 29B set of points had been laid in 1984, using heavyweight rail fixed to treated *Pinus radiata* sleepers with standard fastenings. The timber sleepers and fastenings were in fair condition, with signs of some sleeper deterioration.

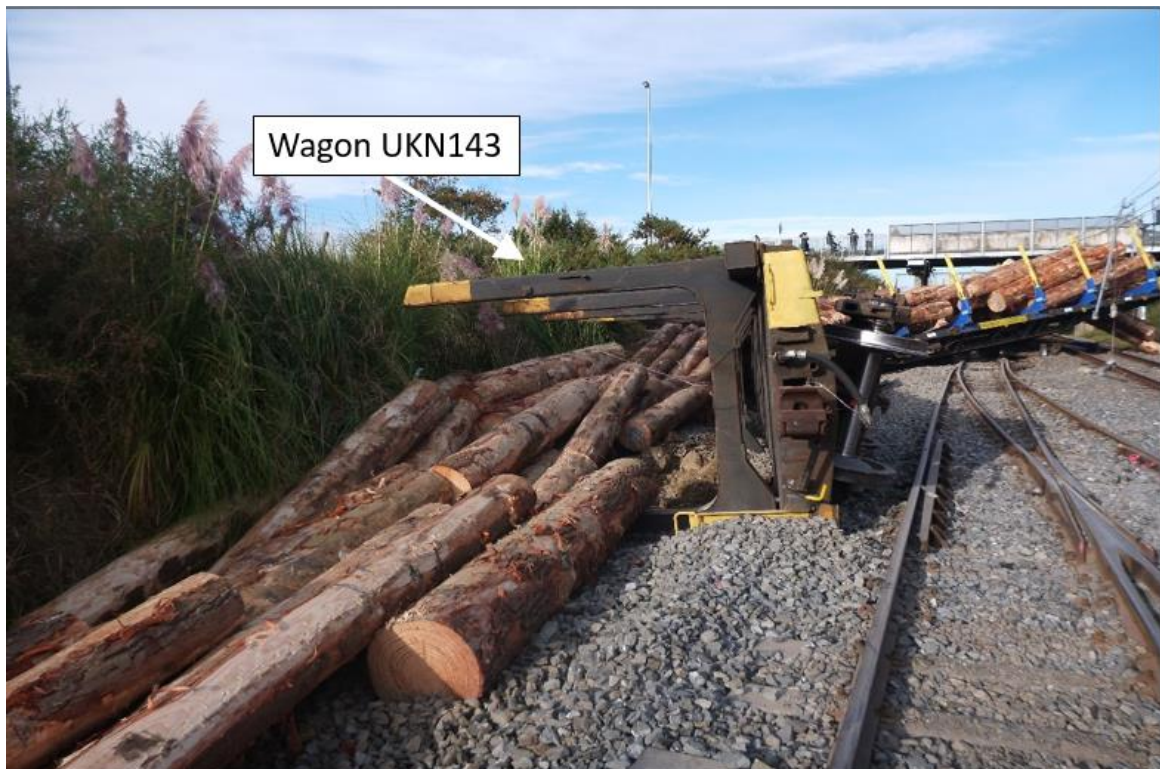
**Figure 5: Derailed wagons**

- 3.1. While the overall likelihood of a freight train derailment is low, a derailment can potentially cause significant damage and injury. In this accident the derailed wagons ripped up a section of track and points, damaged traction masts and brought down an overhead traction line while passing under an overbridge supporting a major roadway.

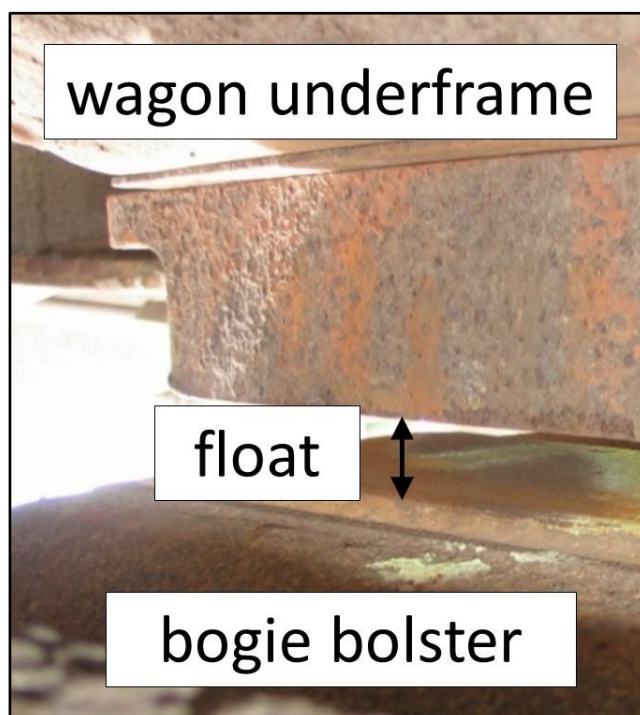
**Figure 7: Measurement of side bearer float**

- 2.23. Float measurements recorded at the handbrake end were 5 mm on the A-side and 5 mm on the B-side, making a total of 10 mm, which was at the upper limit. The measurements recorded for the non-handbrake end were 5 mm on the A-side and 8 mm on the B-side. While the float of 13 mm at the non-handbrake end of the wagon was within tolerance limits, the respective measurements were not the same.
- 2.24. During the C-Check, wedge heights on the leading bogie were recorded as 30 mm on the A-side and 31 mm on the B-side (see Figure 13 in Appendix 2). Wedge heights on the trailing bogie were recorded as 30 mm on the A-side and 29 mm on the B-side.

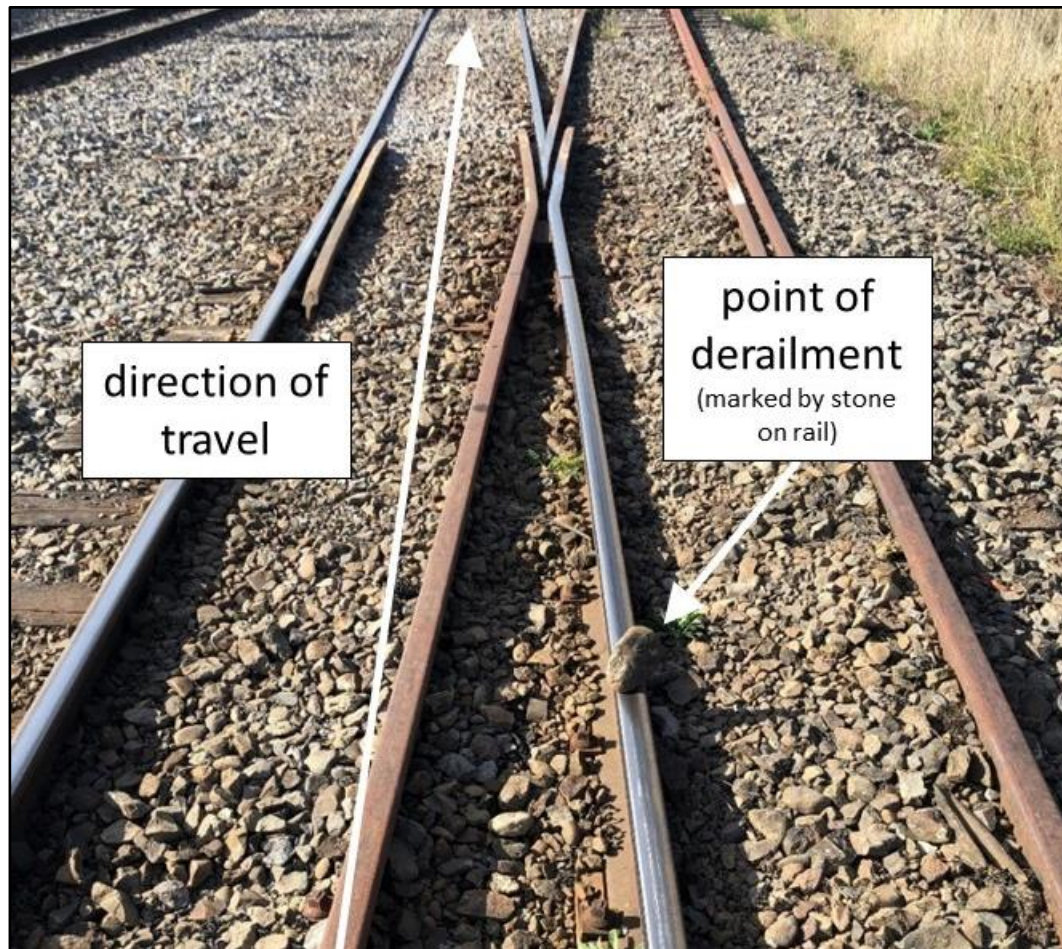
**Figure 8: Point of derailment**

- 3.7. In respect of this derailment, the Commission found there was an insufficient vertical load on the leading bogie of log-carrying wagon UKN143 to prevent it climbing the outer (right-hand) curved rail on the 29B set of points (see Figure 8).

- 3.9. The Commission found that no single factor led to this derailment. Instead, it is very likely that a combination of factors contributed to the wheel climb that resulted in the derailment:

- the track condition and its alignment
  - the train travelling at nearly 36% above the authorised line speed, which was close to its critical rocking speed<sup>26</sup>

- the condition of the wagon's suspension system and its sensitivity to the track conditions
- the multiple cyclic twists that accentuated the wagon oscillation
- the high, but nevertheless within limits, centre of gravity of the loaded log wagon.

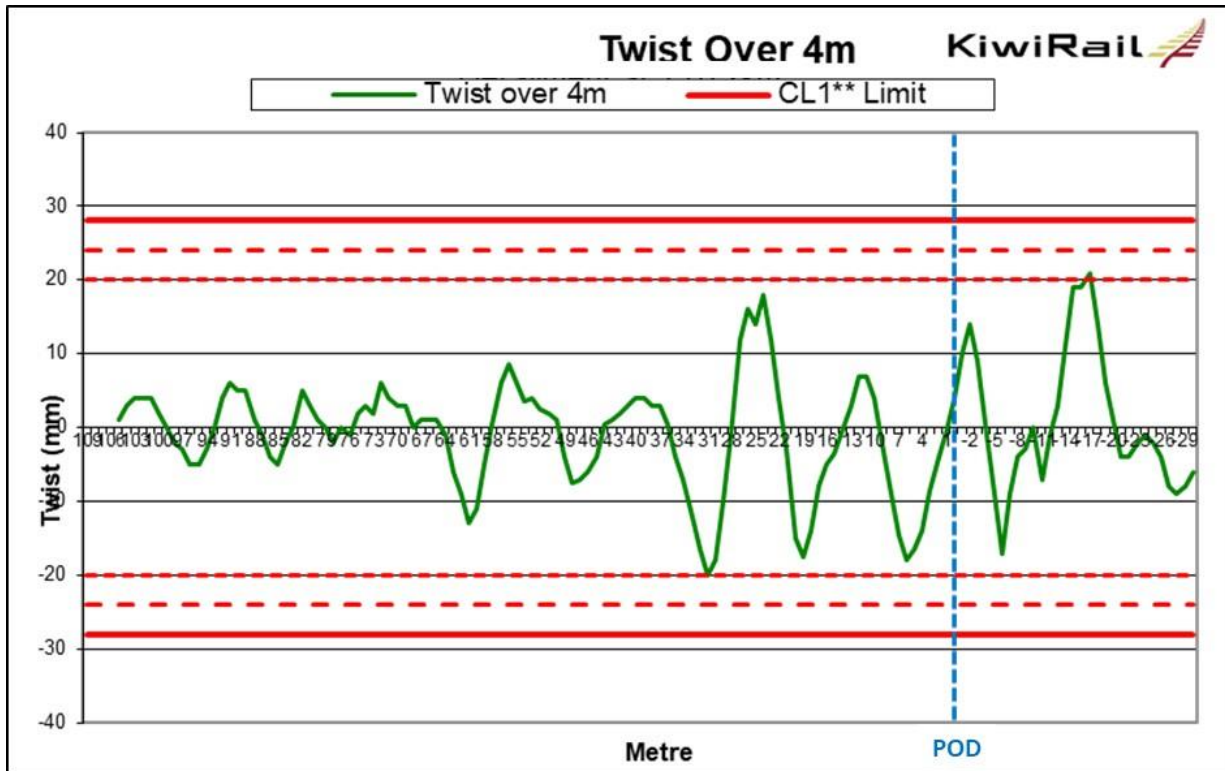
**Figure 9: Output graph of twists over 4 m (provided by KiwiRail)**

- -20 mm twist, 31 m before the POD
- +8 mm twist, 24 m before the POD
- -18 mm twist, 19 m before the POD
- +7 mm twist, 12 m before the POD
- -18 mm twist, 6 m before the POD
- +14 mm twist, 2 m past the POD
- -17 mm twist, 6 m past the POD

- +21 mm twist, 16 m past the POD.

- 3.11. The KiwiRail Standard T-ST-AM-5120, Track Geometry, effective since 3 March 2017, categorises manually found twists within a yard environment of 17-19 mm as Priority 4, requiring the condition to be fixed within 26 weeks. Twists of 20-23 mm are deemed to be Priority 3, requiring the repair to be completed within four weeks. The standard refers to individual track twists but makes no reference to the effects of cyclic twists.

- 3.12. It was unlikely that each twist would have been identified during a scheduled visual inspection. The post-derailment track measure-up showed that the value of each twist did not meet the threshold for immediate repair action. However, the twists' combined effects and contribution to wagon oscillation were not analysed. Currently there is no procedure for identifying, evaluating and rectifying track twists of a repetitive cyclic nature that promote the unintended oscillation of wagons, potentially resulting in a derailment. A recommendation has been made to the Chief Executive of KiwiRail to address this issue.

- 6.4. **On 6 April 2020 the Commission recommended that the Chief Executive of KiwiRail identify cyclic track conditions on the national rail network and develop a standard that prioritises actions to be taken in order to reduce the likelihood of a derailment. (003/20)**

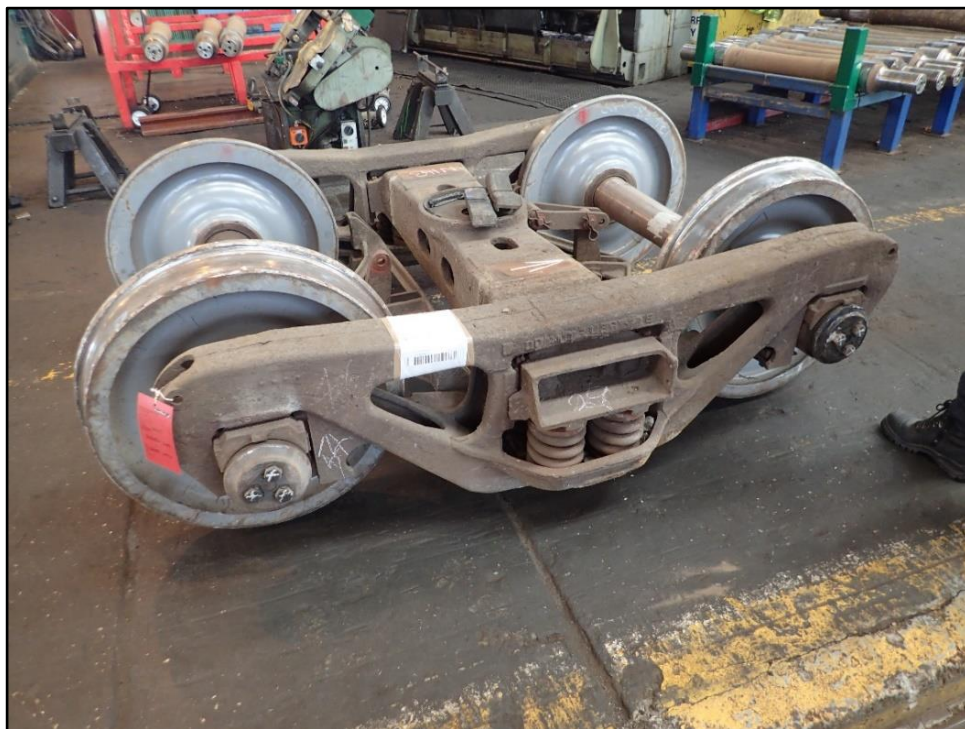
**Figure 10: Leading bogie from UKN143 before examination**

- 3.23. Following the derailment, the bogies were transported to KiwiRail's Hutt Workshops for further examination (see Figure 10). On 9 May 2019 the bogies were dismantled, their components were examined, and critical measurements of the components were recorded.

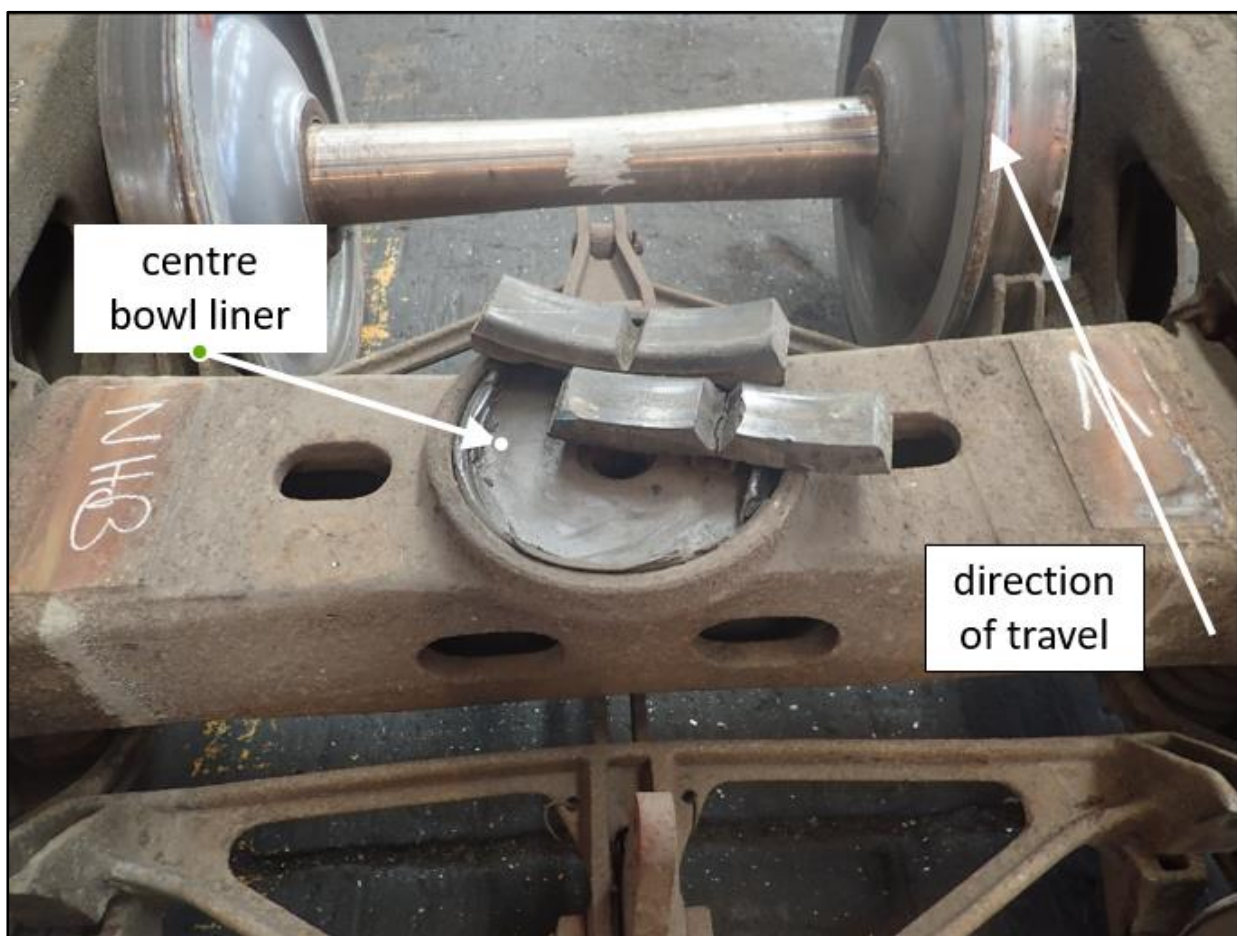
**Figure 11: Centre bowl liner on leading bogie**

- 3.24. The centre bowl liner on the leading bogie showed significant wear and distortion (see Figure 11). The trailing bogie was relatively undamaged. It was likely that the damage to the bowl liner on the leading bogie was sustained during the derailment sequence.

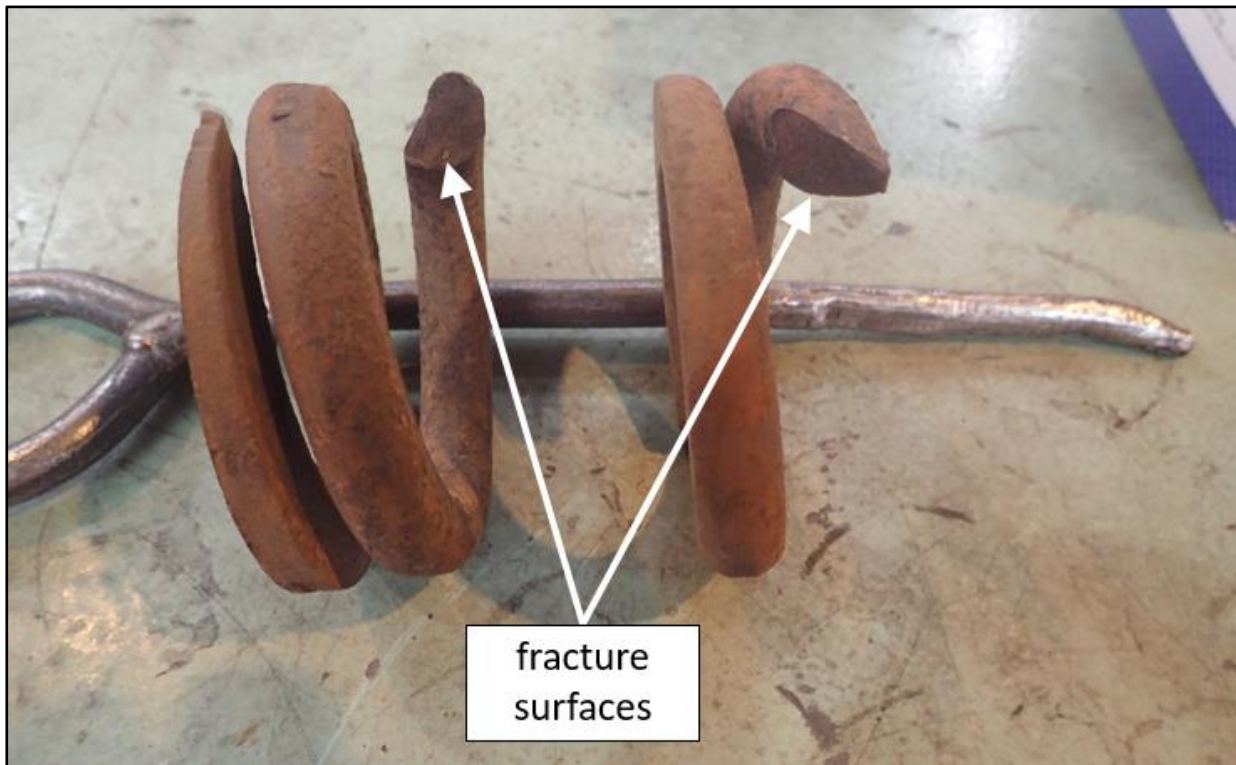
**Figure 12: Fractured inner springs**

- 3.25. Further examination of the leading bogie revealed two broken inner cylindrical helical springs on the right-hand side in the direction of travel. Both failures had occurred at similar heights, about one turn from the top (see Figure 12). The significant levels of corrosion on the fracture surfaces indicated that the springs had very likely fractured before the derailment.
- 3.26. A similar fracture of an inner spring had also occurred on the right-hand side of the trailing bogie.
- 3.27. The two broken inner springs on the leading bogie would have reduced the effectiveness of its suspension stiffness by about 8.5%. The reduced spring performance and its detrimental effects on the suspension would have likely contributed to the wagon's inability to recover from an oscillation and, in doing so, likely contributed to the derailment.

- 4.4. A combination of three broken springs and out-of-code float readings resulted in wagon UKN143 having ineffective damping on its leading bogie.
- 4.5. More than 12 years had passed since a full overhaul check had taken place on wagon UKN143.

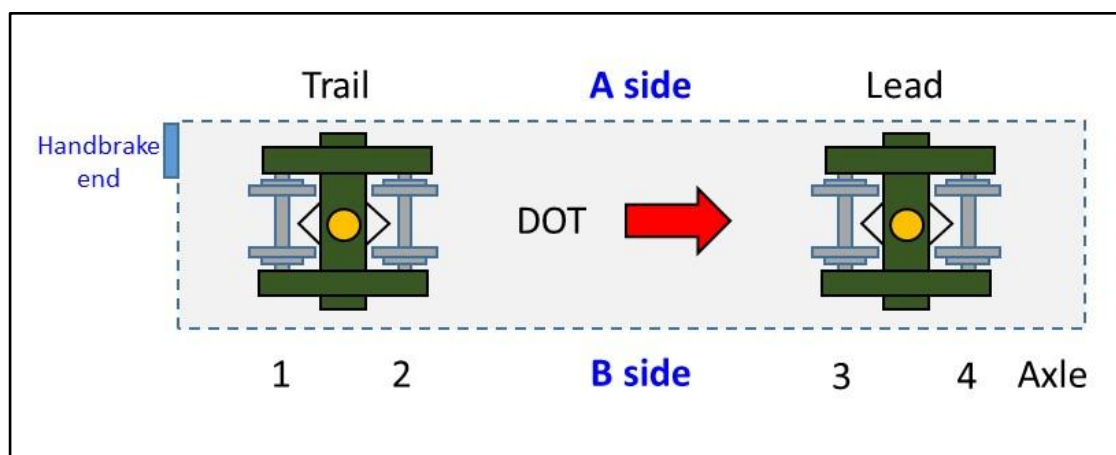
Figure 13: Wagon and bogie layout

The wedge height depot condemning limit is 39 mm and above.

Wheel From (HB)	Wheel 'Z' [mm]	Wheel 'X' [mm]	Wedge [mm]	Float [mm]	Wedge [mm]	Wheel 'X' [mm]	Wheel 'Z' [mm]	Wheel
A1	54	2				2	54	B1
			28	4 + 12	30			
A2	54	2				2	54	B2
A3	54	2				2	54	B3
			28	4 + 16	29			
A4	54	2				2	54	B4
