Transport Accident  
Investigation  
Commission

# Final Report

***Rail inquiry RO-2019-104***  
***Unsafe entry into worksite***  
***Taimate***  
***5 June 2019***

December 2020

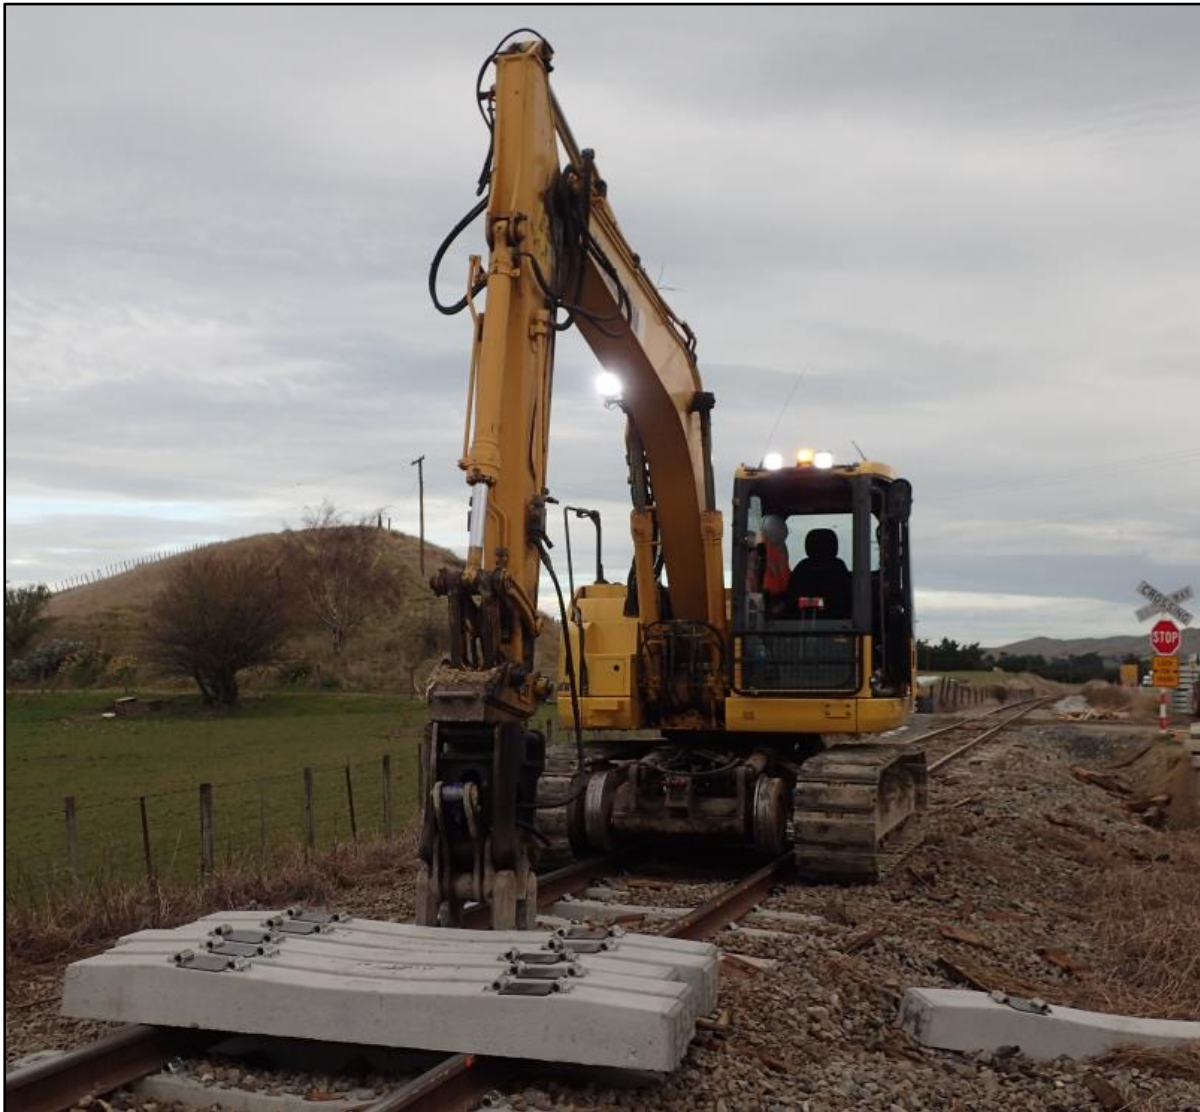
**Figure 1: Re-enactment of hi-rail excavator and sleeper position on the track at the location of the incident**

- 1.3 The rail protection officer granted permission and the work train entered the protected work area. It travelled safely through the northern worksite but was unintentionally authorised through the southern worksite by the southern site protector while a hi-rail excavator was still on the track.

- 1.4 The hi-rail excavator driver overheard the work train being authorised into the southern worksite and immediately removed the excavator and materials from the track. As a result there was no collision and no-one was injured.

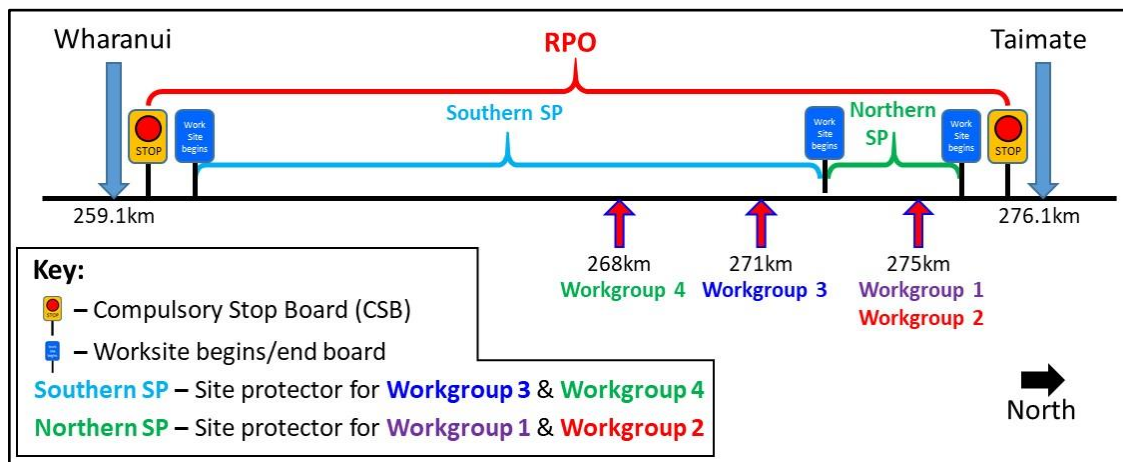
**Figure 3: Worksite layout**

- 1.1 On 5 June 2019, planned work was being undertaken to repair derailment damage between Taimate and Wharanui. A protected work area had been established, which contained two adjoining worksites and four separate workgroups. A rail protection officer was responsible for overall safety in the protected work area, and northern and southern site protectors were each responsible for one worksite, with two workgroups in each (see Figure 3).

- 2.6 On the day of the incident, 5 June, each of the two worksites contained two individual workgroups. The RPO had overall control of the PWA, and the two site protectors were each assigned responsibility for two workgroups in the PWA (see Figure 3).

- 2.7 Two workgroups (at workgroups 1 and 2 in Figure 3) at the 275-kilometre (km) position were within sight of the northern site protector. The remaining two workgroups (at workgroups 3 and 4 in Figure 3) were located 3 km apart. Workgroup 3, at the 271 km position, was within visual range of the designated safe place<sup>7</sup> and the

southern site protector. Workgroup 4 was at the 268 km position and out of sight of the southern site protector.

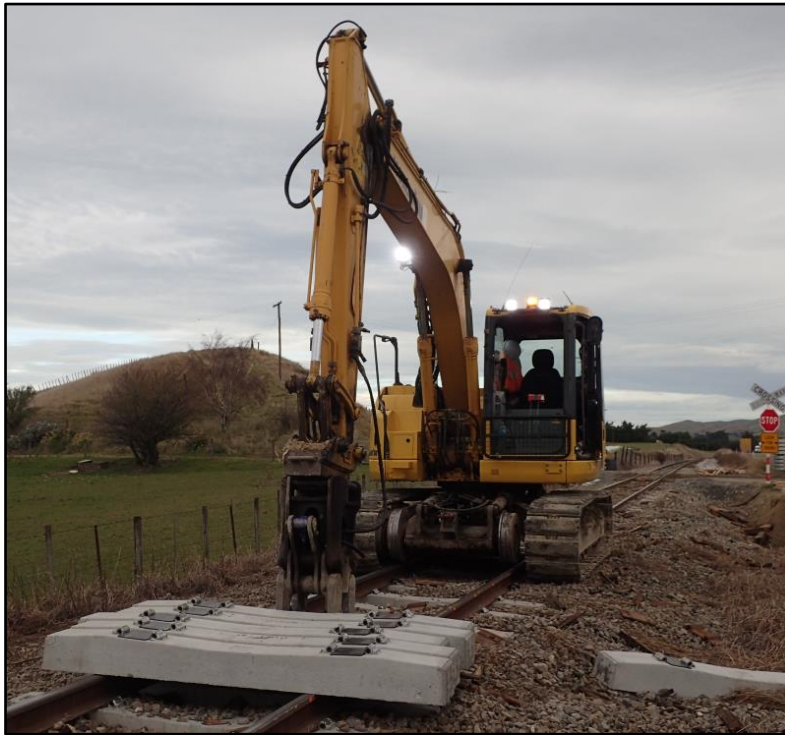
**Figure 4: Re-enactment of hi-rail excavator and sleeper position on track**

- 2.17 However, workgroup 4 had not heard the radio call from the southern site protector and as a result had not informed the site protector that a hi-rail excavator<sup>10</sup> was still on the track, together with approximately six concrete sleepers (see Figure 4).

- 2.18 The hi-rail excavator operator overheard on the radio that the work train had been authorised through the southern worksite and took action to remove the sleepers and the excavator from the track.

- 2.19 The work train passed workgroup 4 approximately 13 minutes after being authorised past the worksite boards. The hi-rail excavator and sleepers were clear of the track and the work train continued to Wharanui.
