Transport Accident
Investigation
Commission

Final report

***Rail inquiry RO-2019-105
Express freight Train 268
Derailment
Wellington
2 July 2019***

December 2020

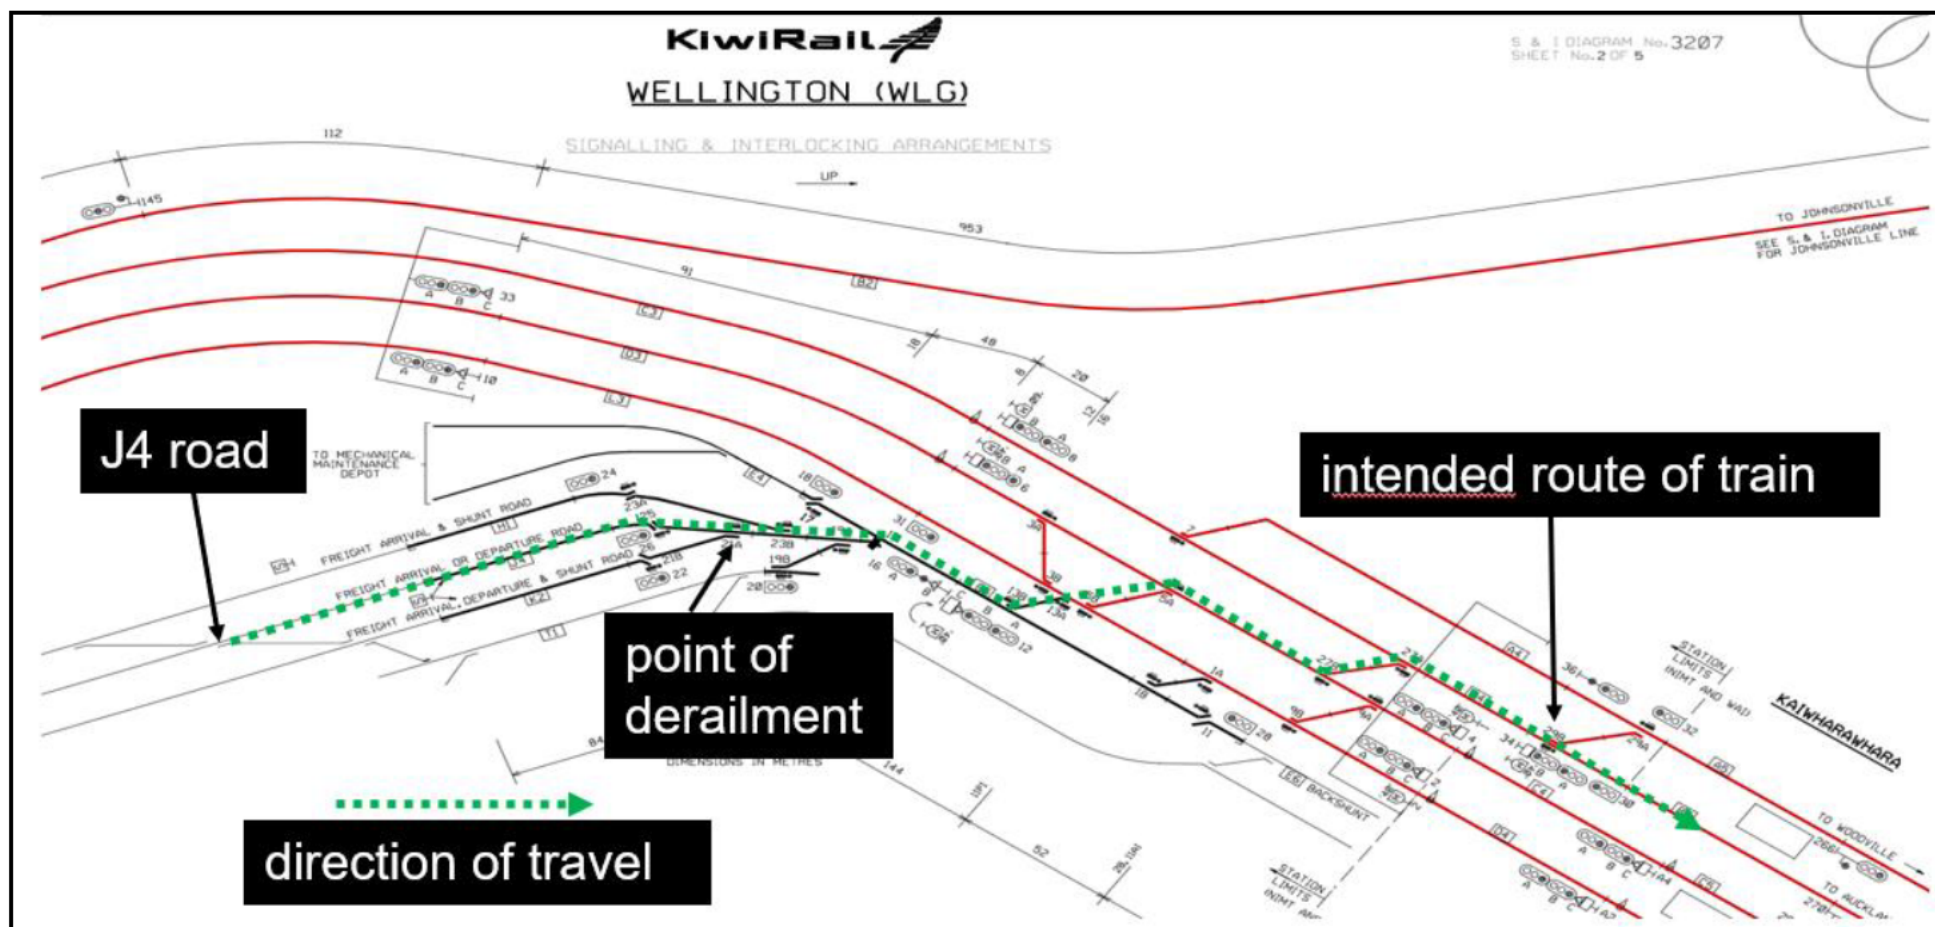
Figure 3: Location of derailment

- 2.3 The pre-departure train examination and terminal brake test⁴ had been completed and the train examiner⁵ walked to the head of the train and handed over the signed train inspection form to the driver. Once the driver had confirmed that the train was “ready to go”, the train examiner radioed the signaller in A-Box⁶ and requested that the route be set for the train’s departure from J4 road (see Figure 3).

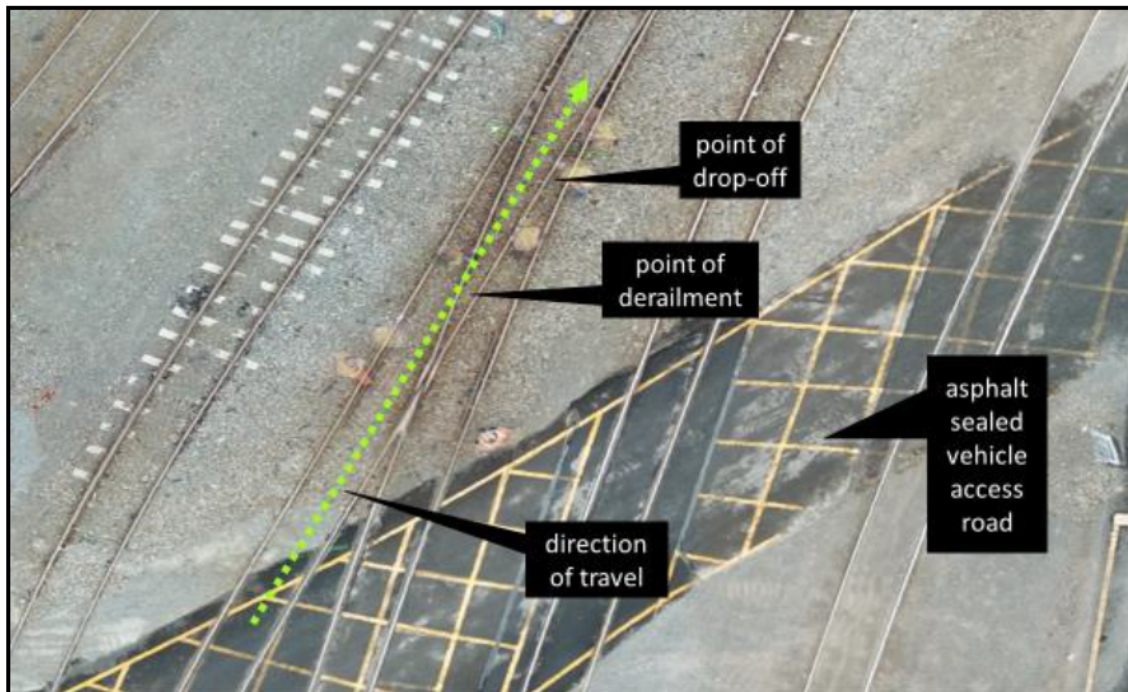
Figure 4: Point of derailment

- 2.12 The track measure-up after the derailment showed a 360-millimetre (mm)-long witness mark¹⁵ on the inside face of the right-hand rail (in the direction of travel) that then ran along the head of the rail for a further 3.10 m before dropping on the outside of the rail. The derailed wagon had been dragged through six more sets of points before coming to a stop 256 m past the POD. During the derailment sequence three other wagons had derailed: the 10th, the 11th and the 15th, all UKK-class wagons.

- 2.13 The 21A set of points had been renewed in 2012, with 50-kilograms-per-metre rail fixed to new composite sleepers¹⁶ with standard fastenings. There was no sign of sleeper deterioration and no wear was evident on either the top or the side of the rail at the POD.

- 2.14 The curved track through the vehicle access roadway leading up to the 21A set of points had been renewed in February 2018 with 50-kilograms-per-metre rail fixed to concrete sleepers with standard fastenings. The rail sections had subsequently been welded to form continuous welded rail before an asphalt coating was applied across the access-road level crossing (see Figure 4).

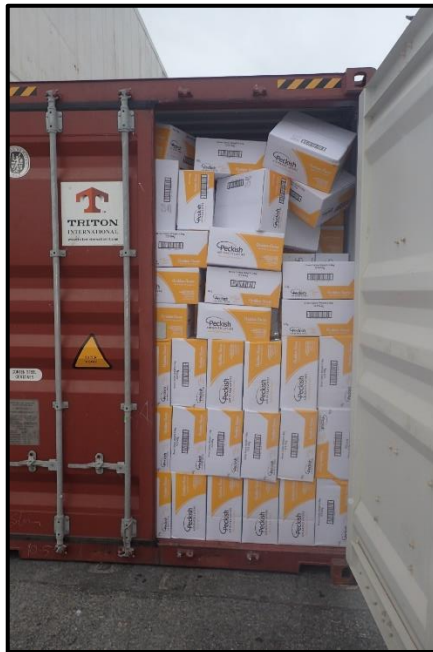
Figure 5: Loaded container from wagon UKK9599

- 2.24 Following a scheduled maintenance check, wagon UKK9599 had been hauled empty from Auckland to Wellington, arriving on the morning of 30 June 2019. There had been no alerts generated when the wagon passed over the wagon condition monitoring unit located near Palmerston North. The wagon had been loaded the next day and hauled to Palmerston North. It had returned to Wellington as an empty wagon at about 0350 on 2 July 2019. The wagon had then been placed in the container terminal where, at about 0815, 40-foot (12-metre) container TLLU4655018 was secured on it.
- 2.25 The declared load weight for the container and product was 8.24 t. Following the derailment, the container was check-weighed at 8.12 t and opened to examine the load distribution (see Figure 5). The load was shown to be evenly distributed.

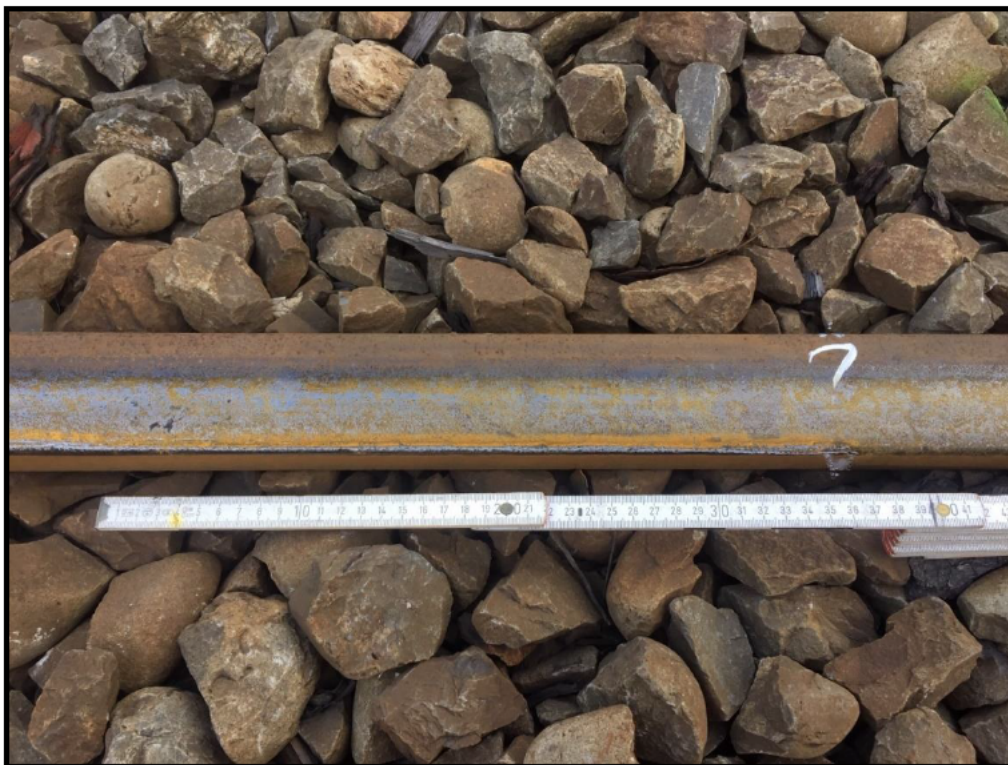
Figure 7: Rail climb at the point of derailment

- 3.4 With respect to this derailment, the Commission found that there was insufficient vertical load³² on the leading bogie to prevent it climbing the right-hand rail (in the direction of travel). See Figure 7.

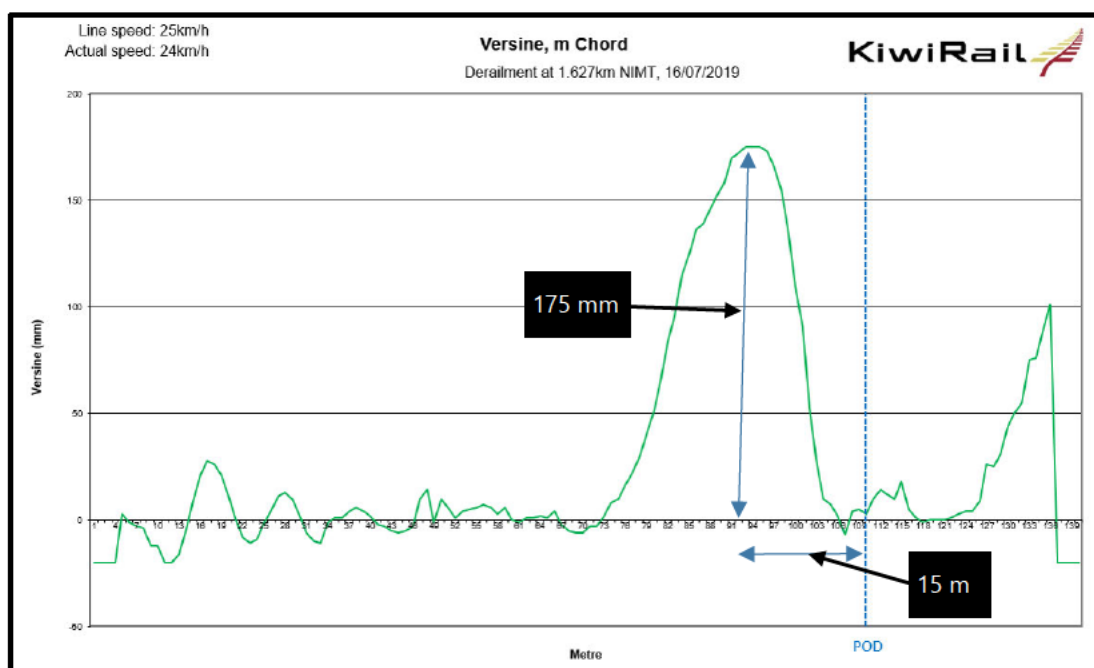
Figure 8: Versine measurements from the curve leading up to the point of derailment (Credit: KiwiRail)

3.7 The approach track curve leading up to the POD had been constructed in February 2018. A detailed measure-up of the track geometry after the derailment recorded the maximum versine³³ at 175 mm within the sealed vehicle access road and 15 m before the POD (see Figure 8).

3.8 The standard formula of $R=C^2/8V$ was used to calculate the curve radius, where C was the chord length (in metres) and V was the versine (in metres). In this case the chord length was 10 m and the maximum recorded versine was 0.175 m. The minimum or tightest curve radius was therefore determined as 71.4 m.

- 3.12 The 71.4 m-radius curve leading up to the POD was therefore significantly tighter than the absolute minimum prescribed in the current standard. When combined with other track defects described in the next section, and the absence of lubrication on the rail, it was likely that the tight-radius curve contributed to the derailment.

- 3.13 KiwiRail has since introduced a revised track design standard and undertaken a national project to identify and programme remedial work to achieve a minimum curve radius of 90 m on all curves within freight yards and sidings. Had this not happened, the Commission would have likely made a recommendation.

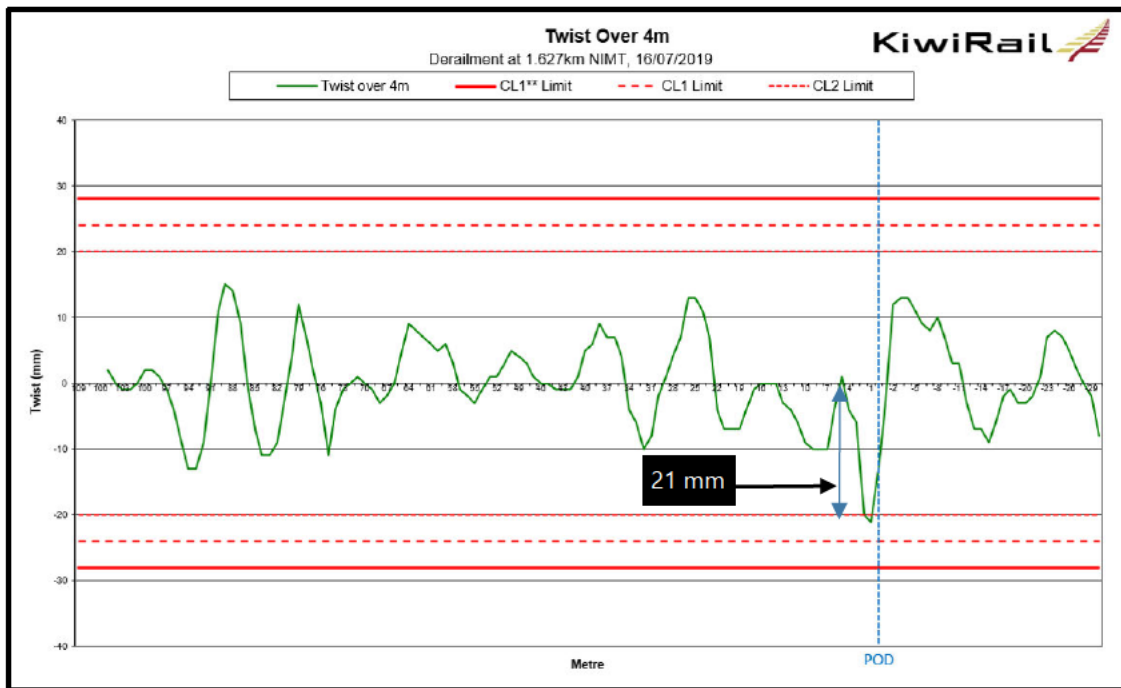
Figure 9: Post-derailment output graph of track twists
(Credit: KiwiRail)

- 3.17 KiwiRail could not provide evidence that the 21 mm twist had been repaired by the target date of 3 June 2019. An analysis of the post-derailment manual track geometry measure-up provided confirmation that the 21 mm twist had not been attended to (see Figure 9).

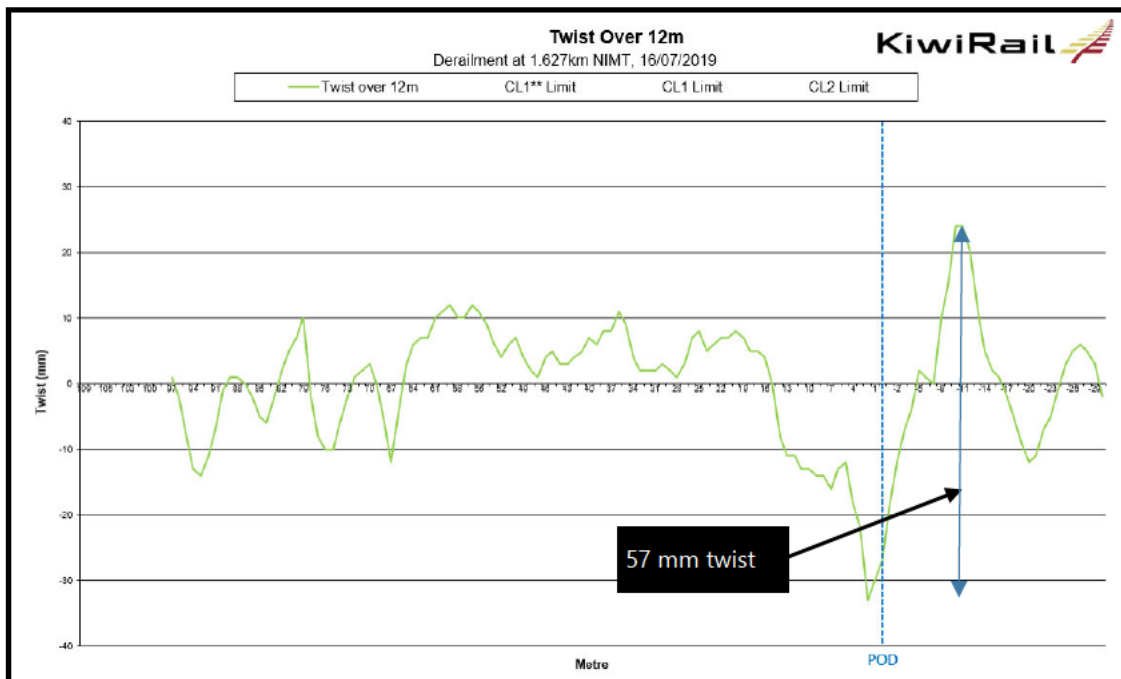
Figure 10: Post-derailment output graph of twists over 12 m
(Credit: KiwiRail)

3.18 The distance between the bogie centres of the first wagon to derail was 12.19 m. One of the output graphs from the post-derailment track measure-up showed a long-wheelbase reverse twist (over 12 m) of 57 mm (see Figure 10). Wagons are designed to negotiate a long wheelbase twist of up to 62 mm. The 57 mm twist was therefore near the wagon's design limit and likely contributed to the derailment.

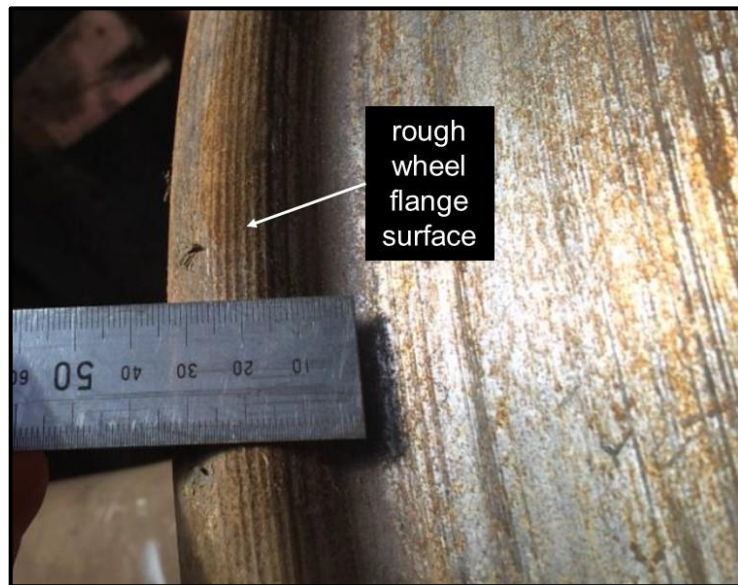
Figure 11: Tread and flange surface roughness

- 3.24 The out-of-code flange surface roughness increased the friction on the wheel/rail interface. This factor, when combined with the track geometry contributing factors mentioned in the earlier section, increased the likelihood of a wheel climb derailment.
- 3.25 In October 2019 KiwiRail updated its M6000-500 Wheelset Manual – Wheel Lathes standard to include, in part:

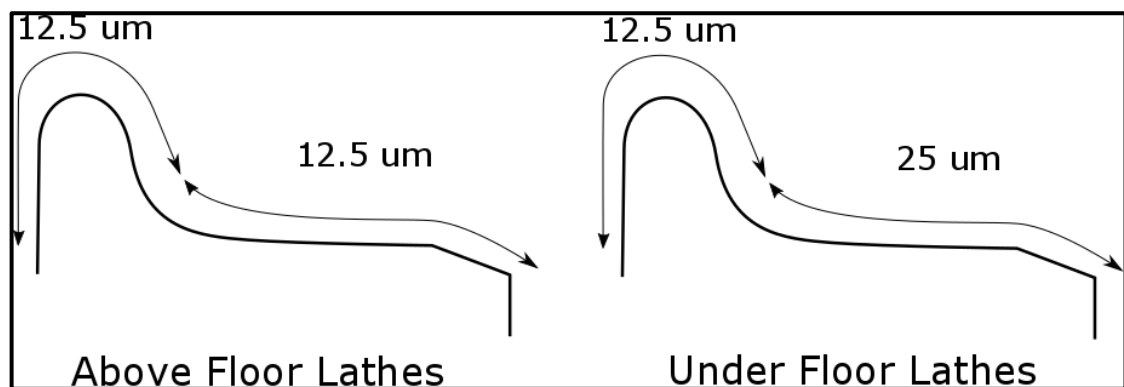
Figure 12: Surface finish on flange and tread

For underfloor lathes, the surface finish on the tread part only, can be [up to] 25 micrometres.

Hutt Wheel Shop Facility Procurement is underway. When completed, this will remove the need to loose turn wheelsets on under floor lathes. The CNC portal lathe associated with the new facility will be able to achieve a much smoother finish.

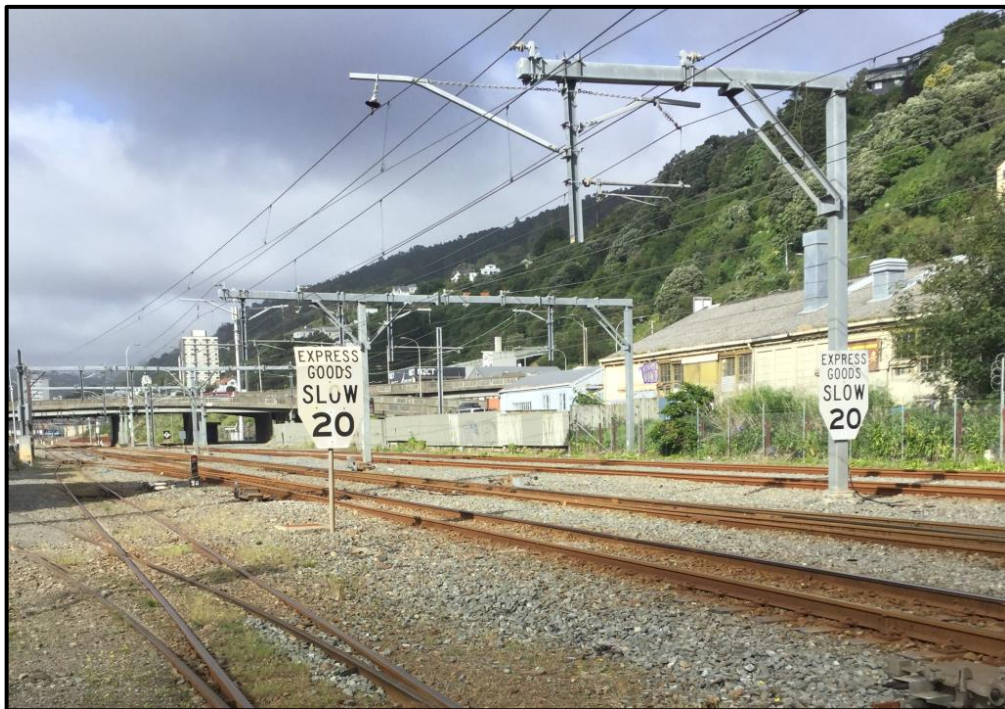
Figure 13: Permanent speed board on entry to the Wellington Freight Terminal

- 3.30 Express freight trains entering the Wellington Freight Terminal were restricted to a maximum speed of 20 km/h (see Figure 13). However, there was no corresponding board to show the maximum speed for trains departing the Freight Terminal. The driver thought that departing trains were restricted to a maximum speed of 20 km/h. KiwiRail's Joint Yard Operating Plan did not identify the maximum operating speed for trains departing the Wellington Freight Terminal. However, KiwiRail has confirmed that the maximum authorised speed at the time of the derailment was 25 km/h.

- 3.31 The train was travelling at 25 km/h when the driver reduced power to slow the train to 20 km/h, what they understood was the maximum authorised line speed, at the same time as wagon UKK9599 derailed.
- 3.32 The Commission determined that the marginal difference between the actual train speed and the posted line speed was unlikely to have contributed to the derailment.
