Transport Accident  
Investigation  
Commission

***Rail inquiry RO-2019-106***

***Passenger train 804***

***Irregular disembarkation of passengers***

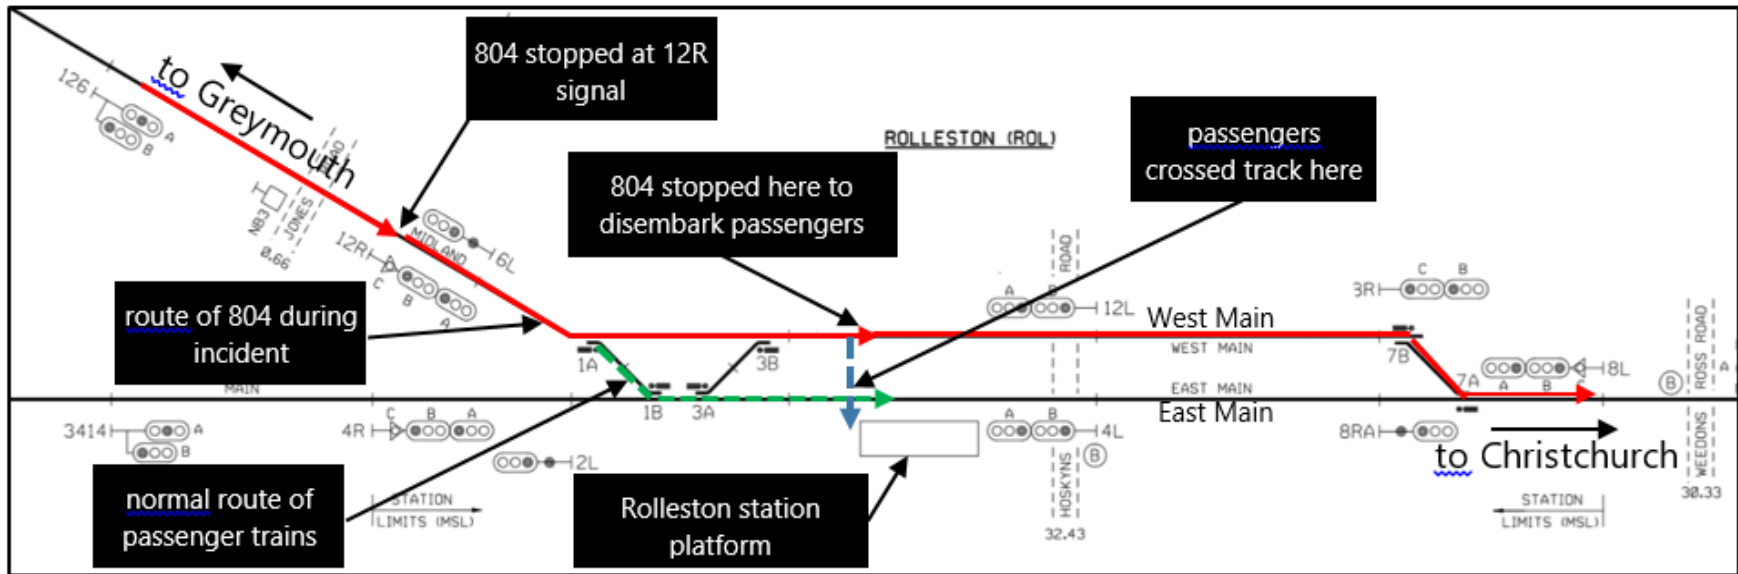
**Figure 3: Rolleston signal and interlocking diagram**  
 (Credit: KiwiRail, modified by the Transport Accident Investigation Commission)

- 2.5 The train controller was engaged in other control activities and service 804 was stopped briefly at 12R signal (see Figure 3), which was required to be cleared to proceed by the train controller. When the controller became aware that 804 was stopped at 12R signal, they set the signal for 804 to proceed to the MSL control area and traverse Rolleston via the West Main Line (see Figure 3). The usual route for passenger trains was to traverse the East Main Line to allow the train to stop alongside the platform if required.

- 2.6 At 1802:59, 12R signal was cleared to proceed and the train driver (the driver) started to move the train forward. When 12R signal was set to proceed, the signalling system locked the route ahead of the train to ensure that the points<sup>3</sup> could not be moved. At 1803:30 the train passed 12R signal and entered Rolleston station limits.

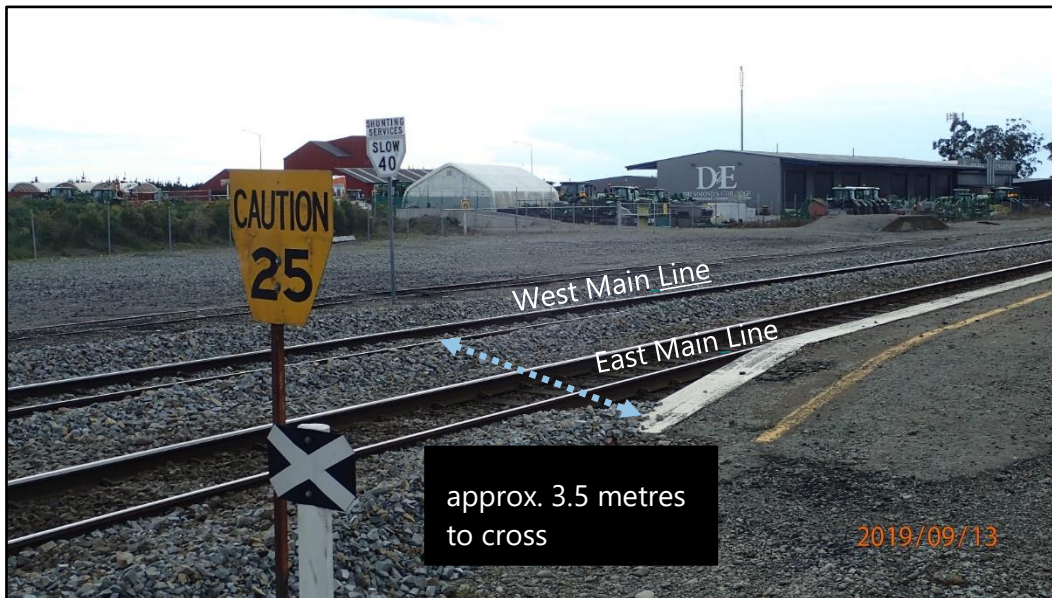
**Figure 4: Passenger disembarkation route**

At 1807:14 the driver continued along the set route and stopped the train on the West Main Line, adjacent to the platform but separated from it by the East Main Line (see Figure 4).

- 2.8 The driver, having decided to disembark the passengers from the West Main Line, discussed the situation with the train manager, who then arranged for the passengers to be disembarked. Two passengers disembarked from the train onto the ballast between the train and the East Main Line. They then walked across the East Main Line track to reach the platform at Rolleston station.
- 2.9 At 1808:56 the train departed Rolleston en route to Christchurch.

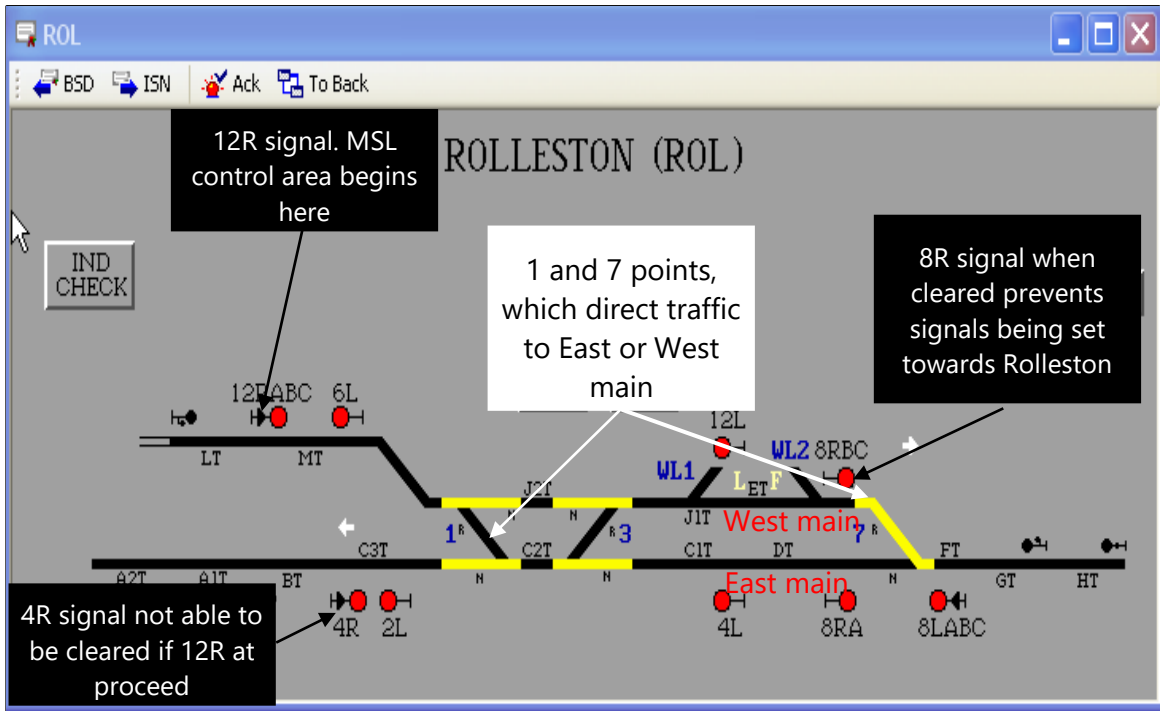
**Figure 5: Train control panel for Rolleston signalling area**  
 (Credit: KiwiRail, modified by the Transport Accident Investigation Commission)

- 3.6 Although the train controller reported that they thought they had set the route for the East Main Line in preparation for the arrival of 804, the route at Rolleston was set for rail traffic to travel via the West Main Line. The train control graph<sup>4</sup> showed that the most recent train movement through Rolleston had been routed via the West Main Line about four hours earlier. Routing rail traffic to either the East or West Main Line required the train controller to move two sets of points, namely 1 and 7 points (see Figure 5).

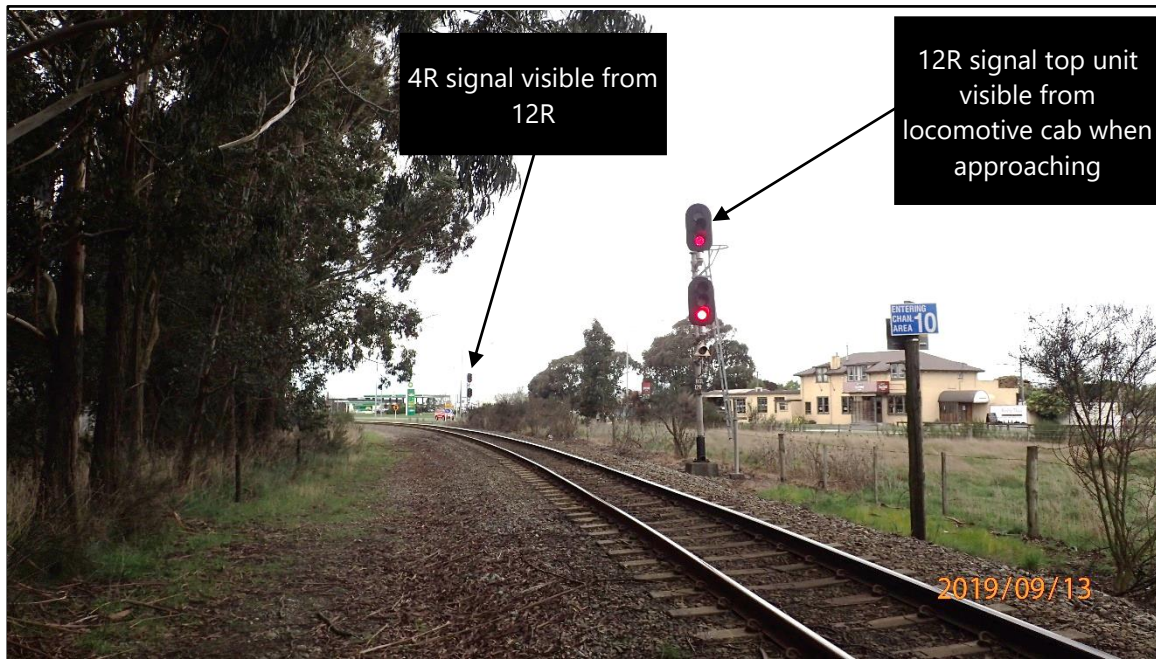
**Figure 6: Approach to 12R signal**

- 3.10 On approach to the MSL control area, the driver observed signals that indicated the train would have to stop at 12R signal (see Figure 6). The driver was aware that stopping at the normal distance from 12R signal meant the train would be stopped across the Jones Road level crossing, which was to the west of the signal. This would result in road traffic being blocked until the signal was cleared. Because of this, the driver decided to pull the train up as close as possible to the signal to clear the level crossing behind the train.

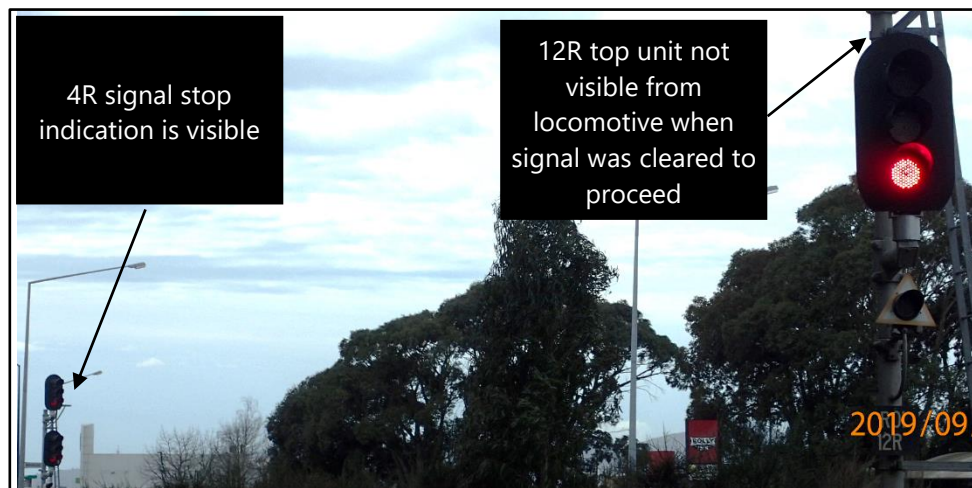
**Figure 7: 12R signal as sighted by the driver**

- 3.11 By pulling the train up close to the signal, the driver's view of the signal was partially obscured from inside the locomotive. Only the bottom unit of the signal was visible (see Figure 7).

- 3.13 Had the driver taken action to observe the entire 12R signal and not just the bottom unit, they would very likely have seen that the top unit was showing that the route was set for the West Main Line. This would have provided an opportunity for the driver to stop and speak to the train controller and rectify the wrong-routing issue. However, the driver only observed a proceed signal on the bottom unit and acted on it in the expectation that the route was correctly set for the passenger train.
