Transport Accident
Investigation
Commission

Final report

Rail inquiry RO-2019-107

Passenger service SPAD and near collision

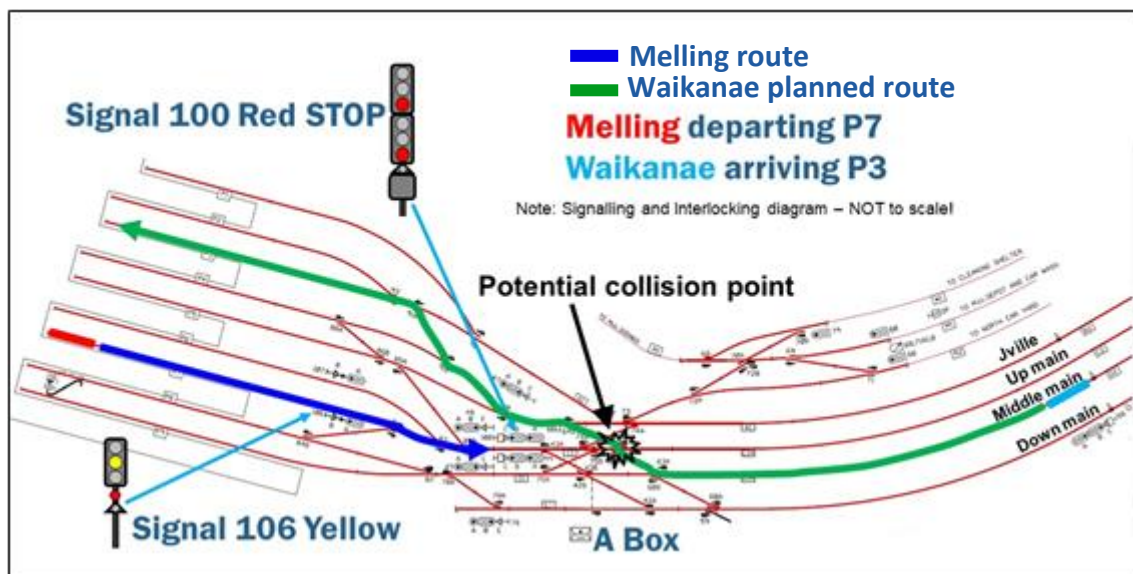
Figure 3: Route and signals for Melling train and clear route for Waikanae service
(See Appendix 1 for larger version)

- 2.5 Around the same time, the driver of the departing Melling service was approaching the next signal (signal 100, see Figure 3) and overheard a radio call between a train and a worksite on the Johnsonville line. The Melling service driver focused on the radio call, which was similar to the Melling service driver's worksite radio call the previous day, when they had operated a Johnsonville service. The Melling service driver later recalled at interview being temporarily distracted by the radio call, resulting in a loss of concentration while approaching the signal.

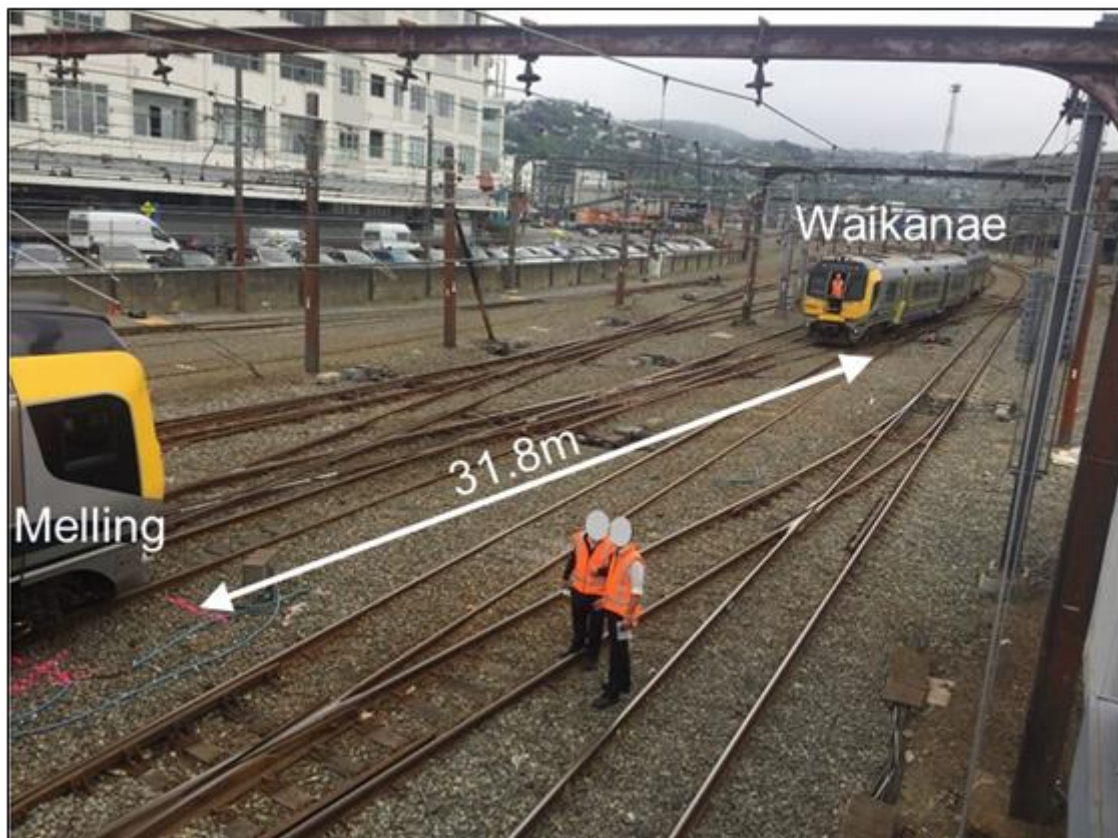
Figure 4: Final positions of both trains
(Credit: KiwiRail A Box signaller – view from A Box window)

- 2.7 The driver of the Waikanae service had already started to brake after noticing that the opposing train was approaching the same set of points that were not set for the departing train. Both trains came to a halt 31.8 metres apart, adjacent to A Box (see Figure 4).
