Transport Accident  
Investigation  
Commission

# Final Report

***Rail inquiry RO-2019-108***  
***Level crossing collision***  
***Piako Road, Morrinsville***  
***7 December 2019***

November 2021

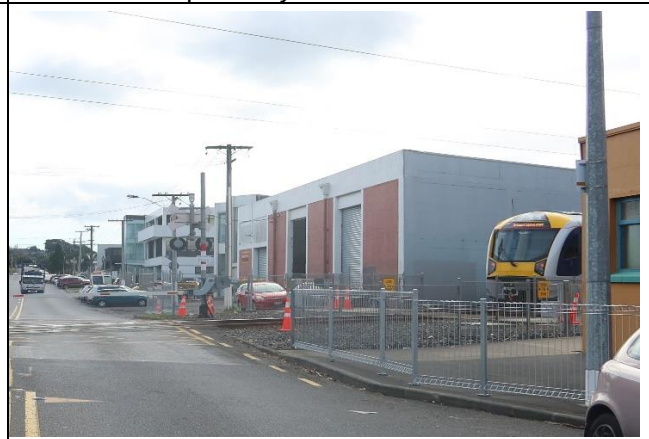
View of signalling when crossing is activated on the wrong side of the road (half-arm barrier has very low visibility and flashing lights are not observable)
