Transport Accident
Investigation
Commission

Final report

***Rail inquiry RO-2020-101
Level crossing collision
Mulcocks Road, Flaxton
10 February 2020***

February 2022

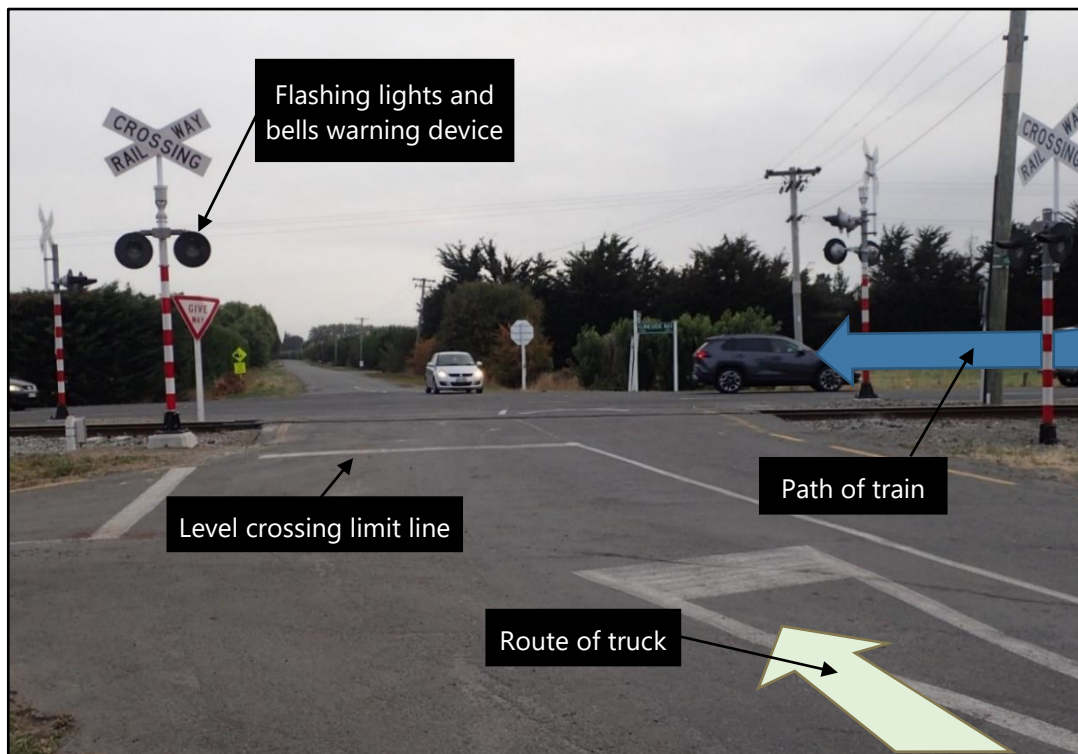
Figure 4: Mulcocks Road level crossing and approach to State Highway 71 (photo taken after accident and subsequent repair of damaged flashing lights and bells)

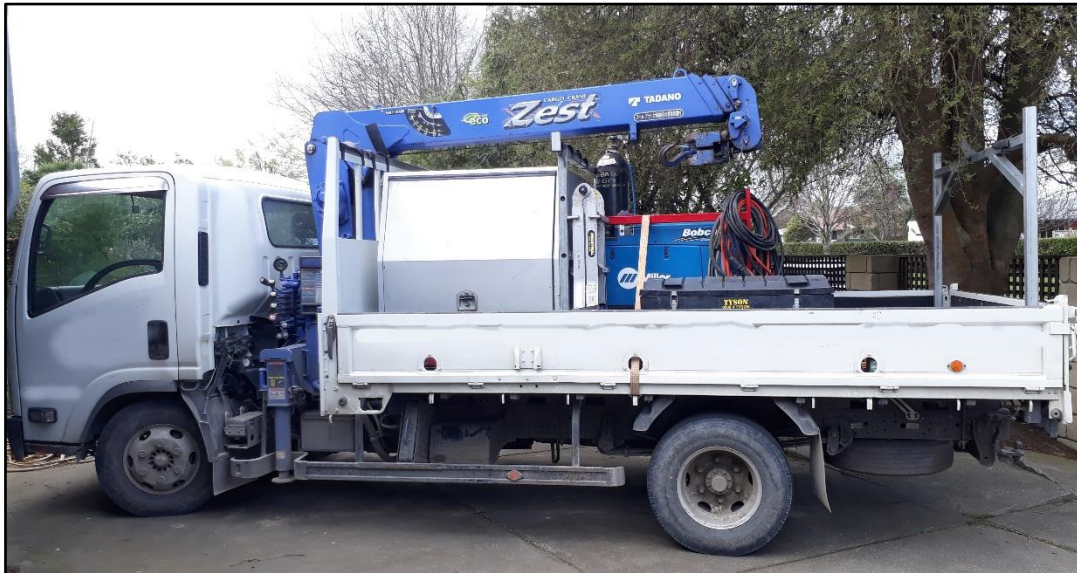
Figure 5: The truck prior to the accident

- 2.22 On 3 February 2020, a week prior to the accident, the truck driver presented the truck for a Certificate of Fitness (CoF) inspection. The truck failed the inspection because three of the truck's four rear tyres had a tread depth below the legal limit. These three tyres had not been replaced at the time of the accident. In all other aspects the CoF inspection found the truck to be in good working order, including its braking system.

- 2.23 Post-accident, a New Zealand Police Commercial Vehicle Safety Team officer inspected the truck and found the brake linings to be in good condition, with no signs of excessive wear or damage.

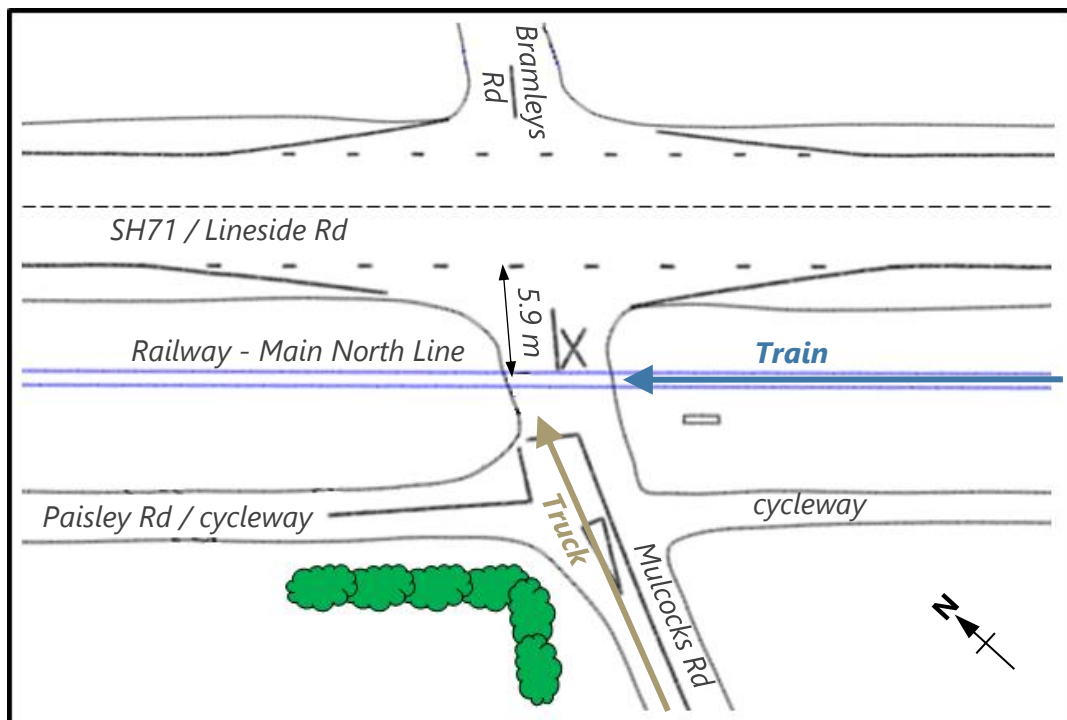
Figure 6: Mulcocks Road level crossing and surrounding road junctions
(Credit: New Zealand Police Christchurch Serious Crash Unit post-accident scene survey
with additional information superimposed)

- 2.30 There is limited stacking distance¹⁰ on the north-eastern side of Mulcocks Road level crossing, with only 5.9 metres between the centre of the rail tracks and the edge of SH71.
- 2.31 The road rises on both approaches to the level crossing, making it difficult for road users to assess the available stacking distance before they commit to traversing the level crossing.
- 2.32 There are no deceleration or acceleration slip roads off or on to SH71 Lineside Road for negotiating the turn, both for:
- north-west bound road traffic on SH71 entering Mulcocks Road
 - left-turning road traffic exiting Mulcocks Road to join SH71 Lineside Road.
- 2.33 There is no turning bay for south-east bound road traffic on SH71 Lineside Road turning right into Mulcocks Road.

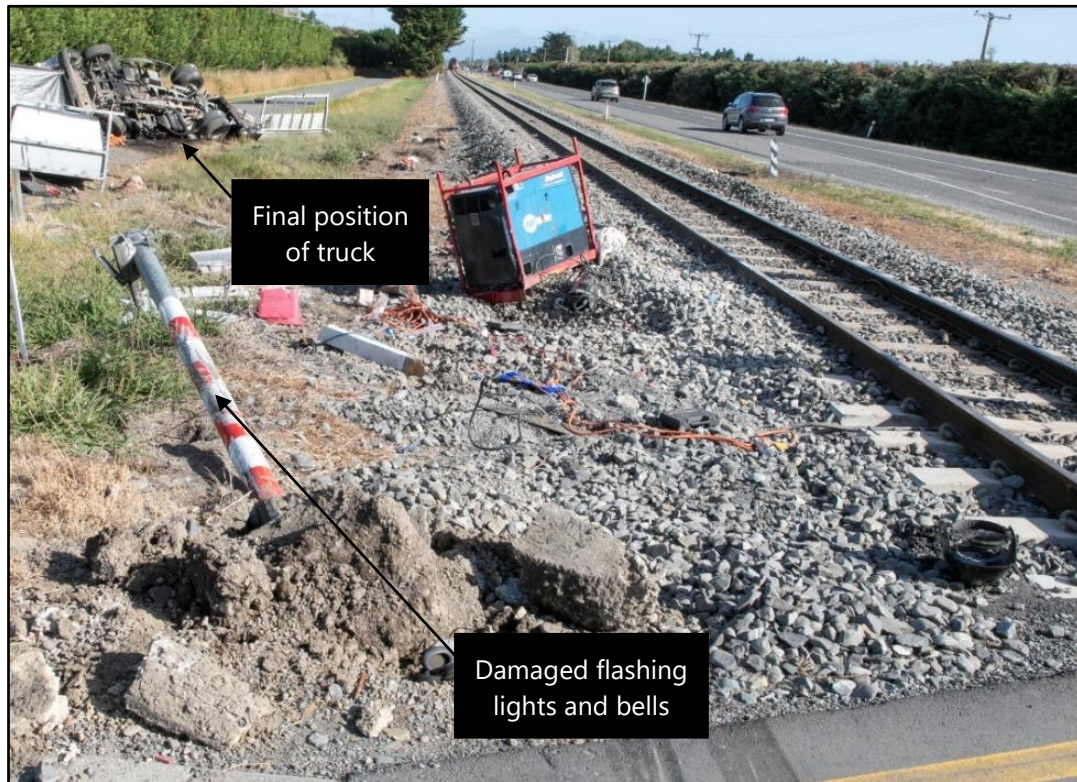
- 2.36 KiwiRail's attending Rail Incident Coordinator (RIC) confirmed the bells were sounding when they arrived at the scene at about 0809. The bells were later shut off by a KiwiRail signalling technician.
- 2.37 The flashing lights and bells that faced the truck as it approached the level crossing were heavily damaged in the collision (see Figure 7).

Figure 7: Damaged flashing lights and bells, and truck wreckage

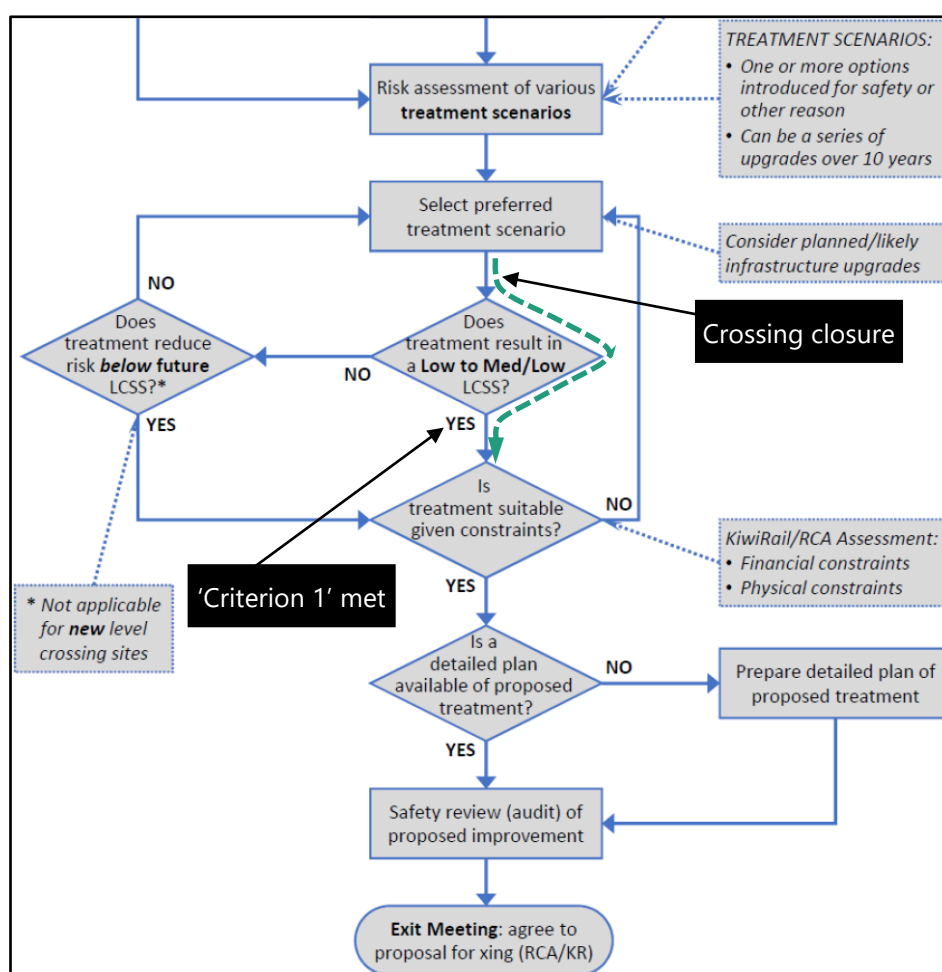
- 3.14 The LCSIA report's recommended 'Criterion 1' risk treatment, closure of Mulcocks Road level crossing, would **virtually certainly** have prevented this accident.
- 3.15 The LCSIA process requires 'Criterion 1' risk treatments be given first consideration. Its guidance documentation provides a flowchart, an excerpt of which is shown in Figure 8 below. The path overlaid in green shows the process that crossing closure should have followed, arriving at 'Is treatment suitable given constraints?' This step represents a joint SFAIRP assessment between KiwiRail and the Council.

Figure 8: Process for new and modified existing level crossings, Mulcocks Road level crossing closure overlaid

- 3.16 Neither the Council nor KiwiRail could provide a documented SFAIRP assessment for the LCSIA report's recommendation to close Mulcocks Road level crossing. Such an assessment – if it had occurred – may legitimately have concluded crossing closure as being not reasonably practicable, but this was not formally conducted or documented.

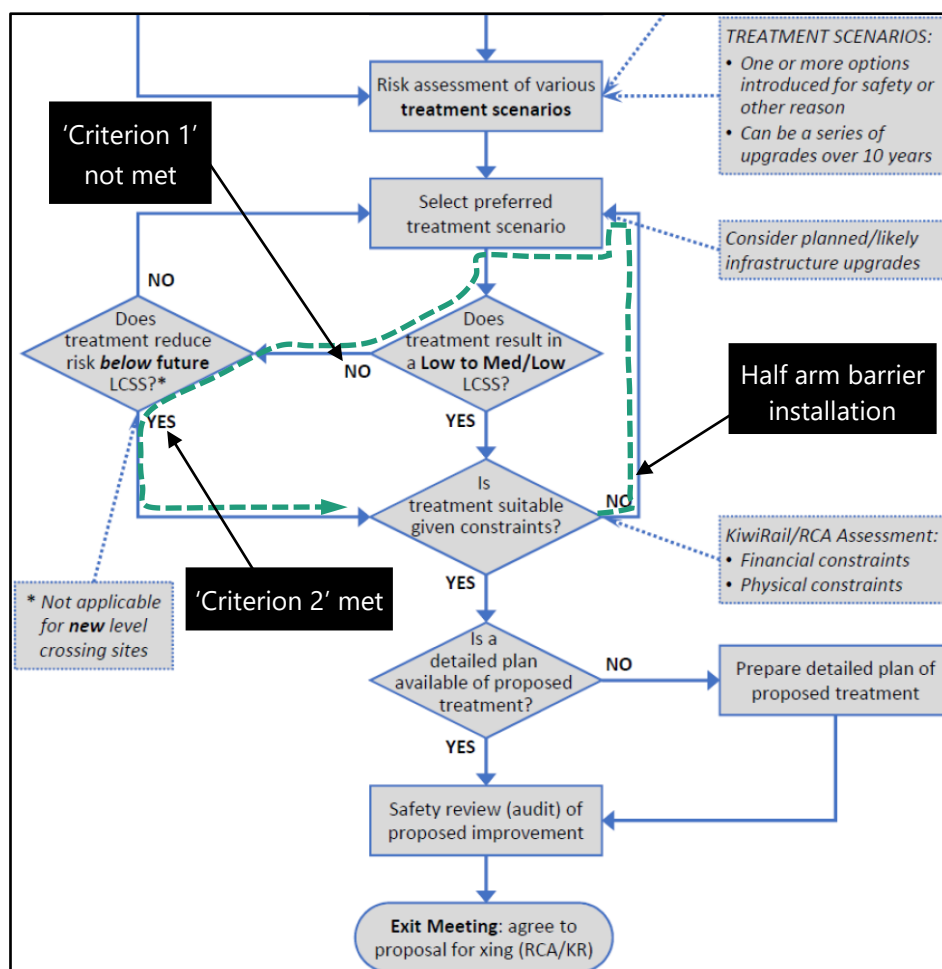
3.17 Amongst the LCSIA report's recommended 'Criterion 2' risk treatments was the installation of half-arm barriers, which would **very likely** have prevented this accident either by:

- the truck driver becoming alert to the truck's movement, by sound or feel, when it struck the barrier arm
- the barrier arm physically preventing the truck from crawling forwards.

Figure 9: Process for new and modified existing level crossings, installation of half-arm barriers for Mulcocks Road level crossing overlaid

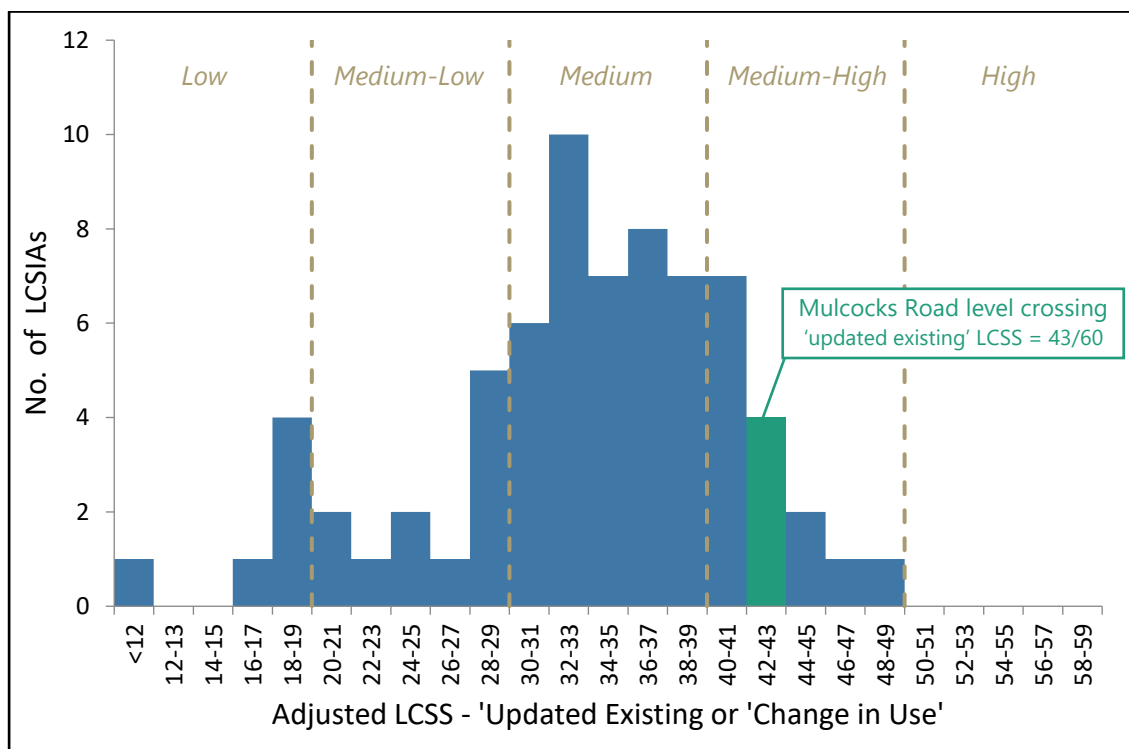
Figure 10: LCSS distribution for comparable LCSIA

- 3.30 This puts Mulcocks Road level crossing in the 94th percentile, or fifth-ranked overall, for LCSIA-estimated risk amongst this sample group.
- 3.31 This position demonstrates how Mulcocks Road level crossing, despite its ALCAM risk score and being outside KiwiRail’s ‘Top 200’ ALCAM list, was identified by the LCSIA process as comparatively high risk.

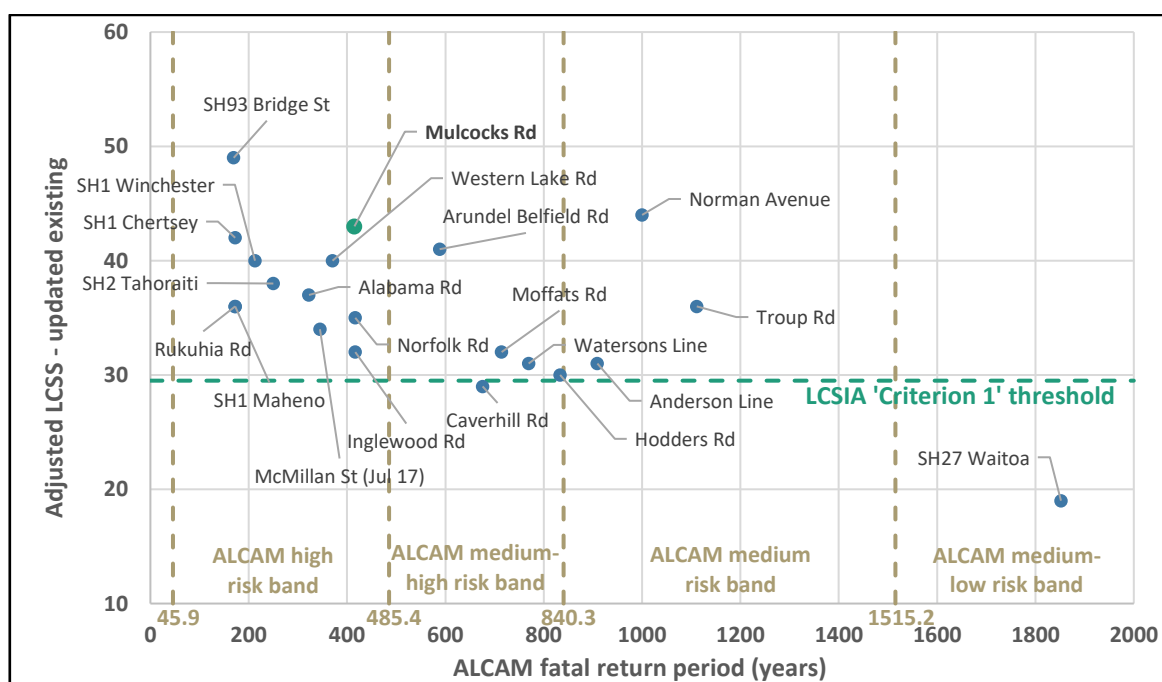
**Figure 11: LCSIAs undertaken for regular risk review
(and Mulcocks Road level crossing), by ALCAM fatal return period**

- 3.39 Figure 11 indicates where selection for 'regular risk review' LCSIAs has not been effectively prioritised by ALCAM data. 45 per cent are outside of ALCAM's 'high risk' band and 55 per cent have a longer ALCAM fatal return period than Mulcocks Road

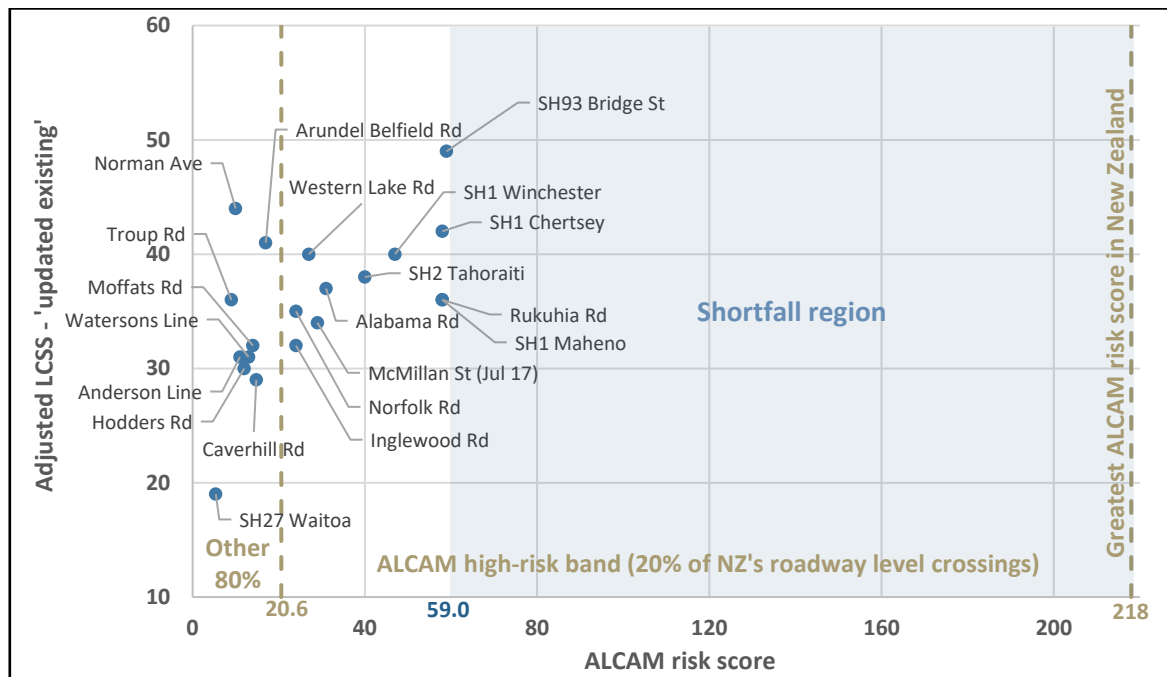
Figure 12: LCSiAs undertaken for regular risk review, by ALCAM risk score

3.46 Figure 12 indicates that level crossings identified using ALCAM's estimate as having the greatest risks are not being prioritised for 'regular risk review' LCSiAs and action.
