Transport Accident
Investigation
Commission

Rail inquiry RO-2020-102

Express freight Train 932

***strikes hi-rail vehicle at Limeworks Road public
level crossing between Milton and Henley***

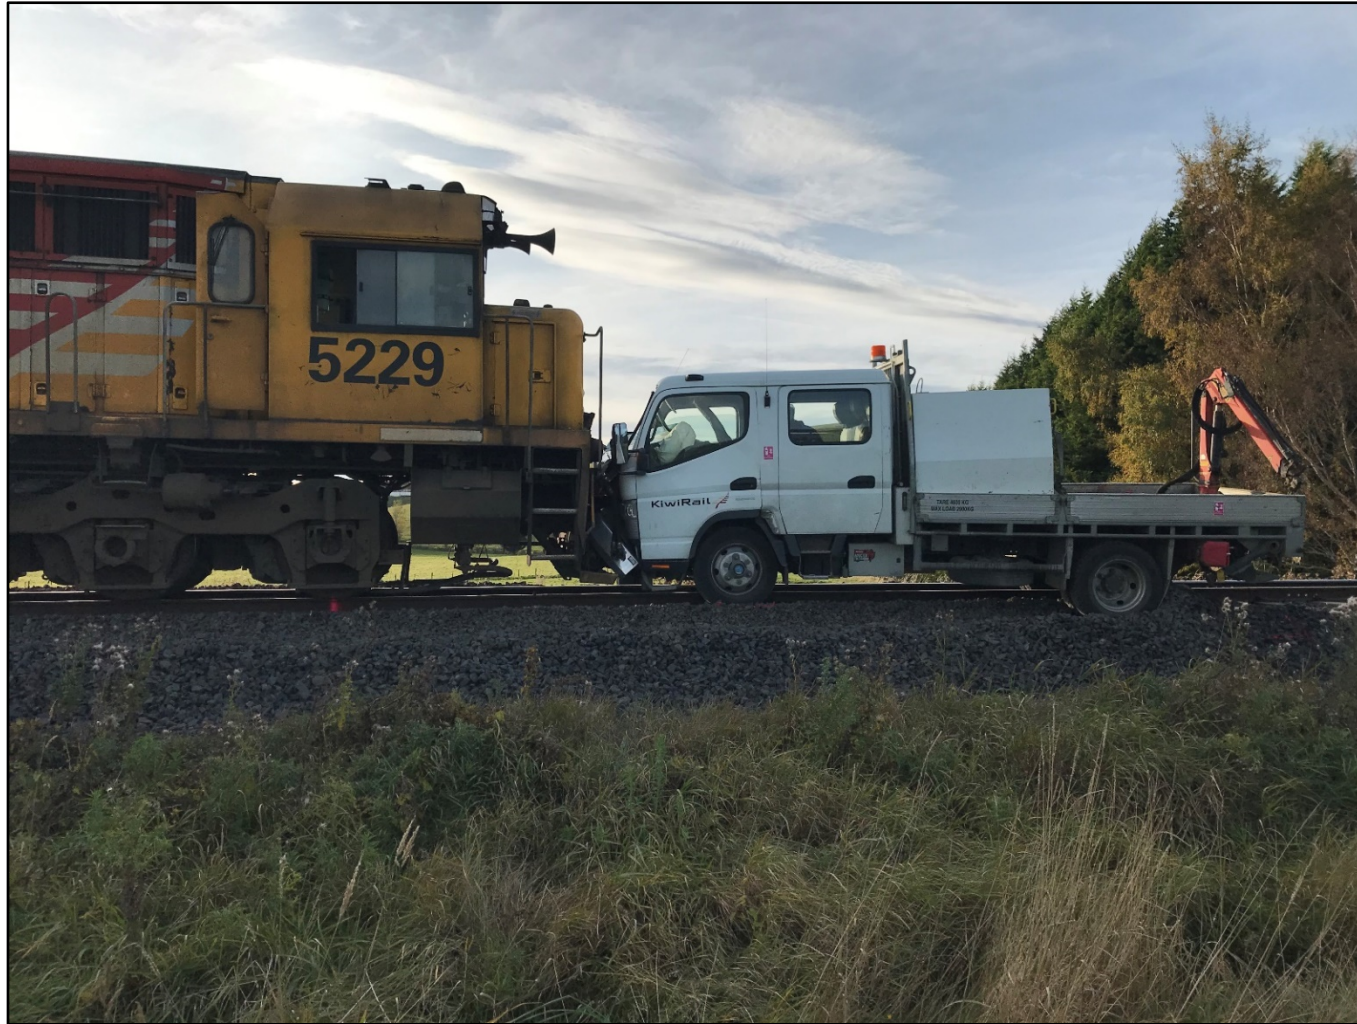
Figure 1: Train 932 and hi-rail vehicle after collision
(Credit: KiwiRail)

- 1.5 The hi-rail vehicle was extensively damaged and the locomotive sustained minor damage.
- 1.6 There were no injuries.

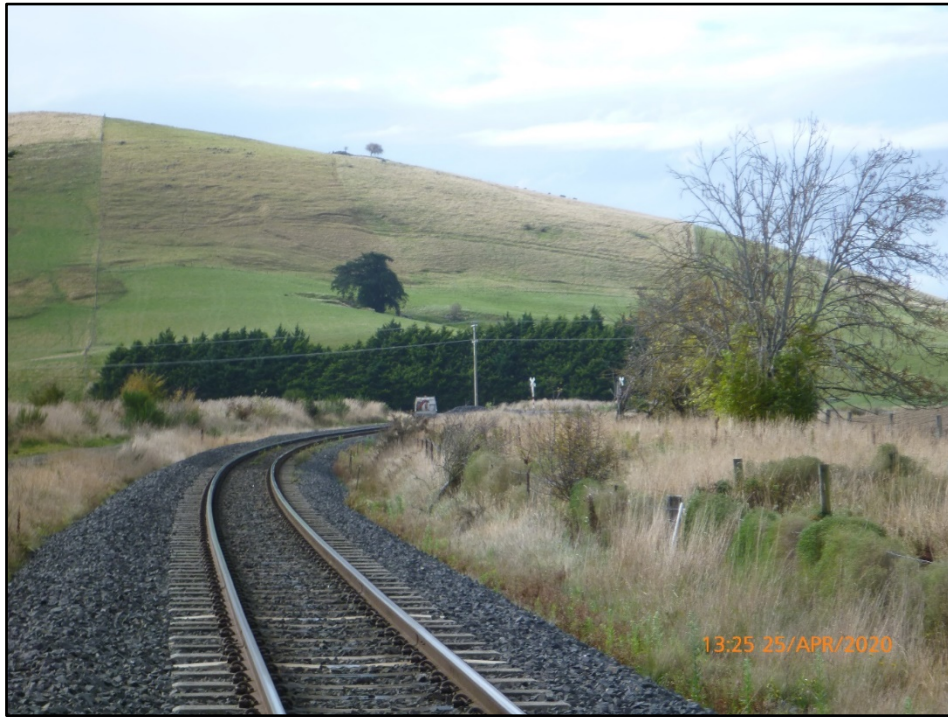
- 2.21 The train approached Limeworks Road public level crossing on a 1000-metre-radius right-hand curve with a gentle rising gradient changing from 1 in 300 to 1 in 185. When the train was about 370 metres from the level crossing the driver sounded the train horn for about one second as a precautionary measure for what he thought was a hi-rail vehicle parked clear of the track. At that time the track ganger was at the rear of the hi-rail vehicle, checking that the rear hi-rail wheels had lowered and engaged correctly between the rails.

**Figure 4: Sight line when the driver sounded the train horn
(Credit: KiwiRail)**

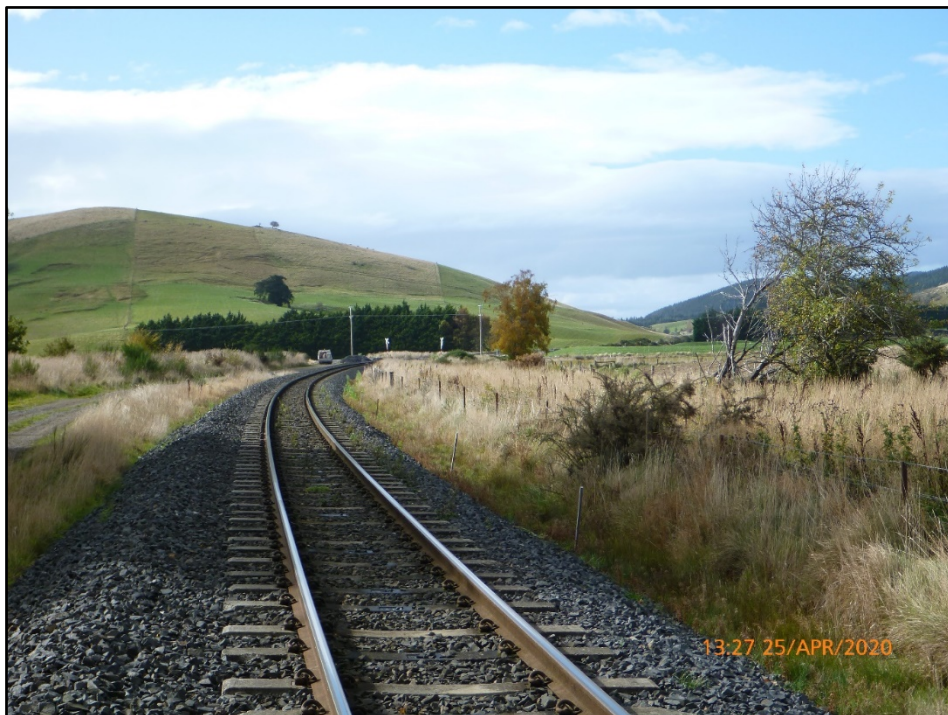
- 2.23 The train was travelling at 57 kilometres-per-hour and was about 200 metres from the level crossing when its driver realised that the hi-rail vehicle was not trackside but on the track. The train driver made a full-service brake application at 1504:02, before vacating the driver seat and taking refuge behind the control stand.

**Figure 5: Sight line when full-service brake application made
(Credit: KiwiRail)**

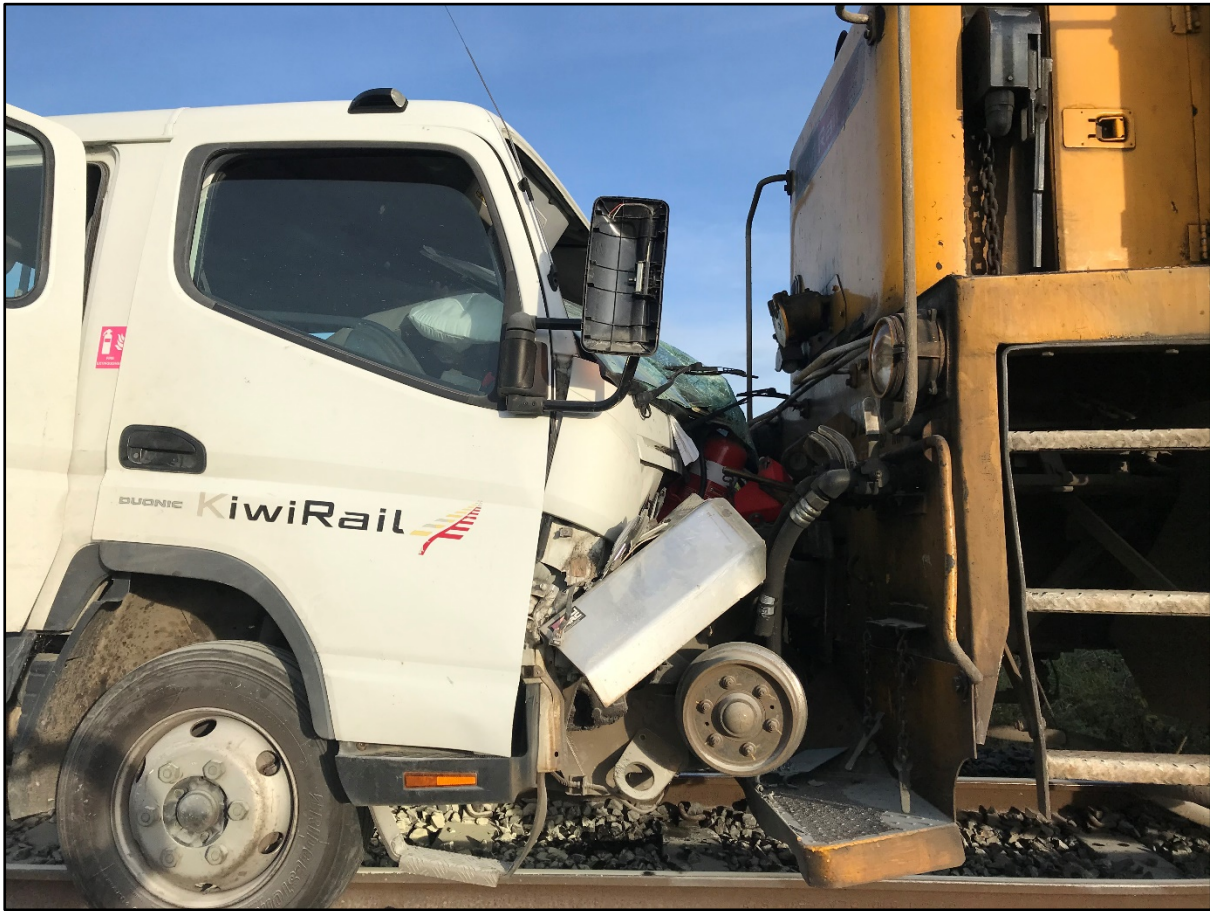
- 2.24 The track ganger abandoned the hi-rail vehicle on the track when they realised that it could not be driven clear of the track before the train reached the level crossing. The train had slowed to 44 kilometres-per-hour when it struck the hi-rail vehicle on the

**Figure 6: Impact damage
(Credit: KiwiRail)**

- 3.31 While the application of the emergency brake would not have prevented the collision, the impact speed would have been lowered significantly, and as a result the impact damage to both the hi-rail vehicle and the locomotive would have been less severe.
