Transport Accident
Investigation
Commission

Rail inquiry RO-2020-104

Safe Working Irregularity

East Coast Main Trunk Line, Hamilton – Eureka

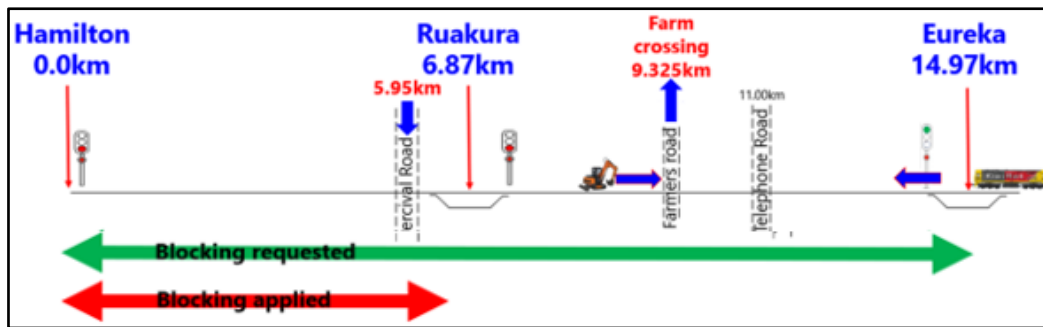
Figure 2: Hamilton to Eureka diagram (not to scale)
(Credit: Transport Accident Investigation Commission)

- 2.6 At 0705 the RPO contacted Train Control (TC) using the radio fitted inside the KiwiRail vehicle. Protection in the form of signal blocking was requested, which allowed the HRV operator to work on the track between Hamilton and Eureka (see Figure 2).

- 2.8 Track occupancy protection was in place by 0706, the RPO and HRV operator locked onto⁴ the RPO's frame,⁵ and the vehicle on-tracked. The vehicle made its way towards Eureka, carrying out ballast work at pre-designated places (see Figure 2).

- 2.9 When the vehicle was safely on track, the RPO drove his road vehicle to the agreed off-tracking point, located about 3 kilometres (km) to the east (see Figure 2).

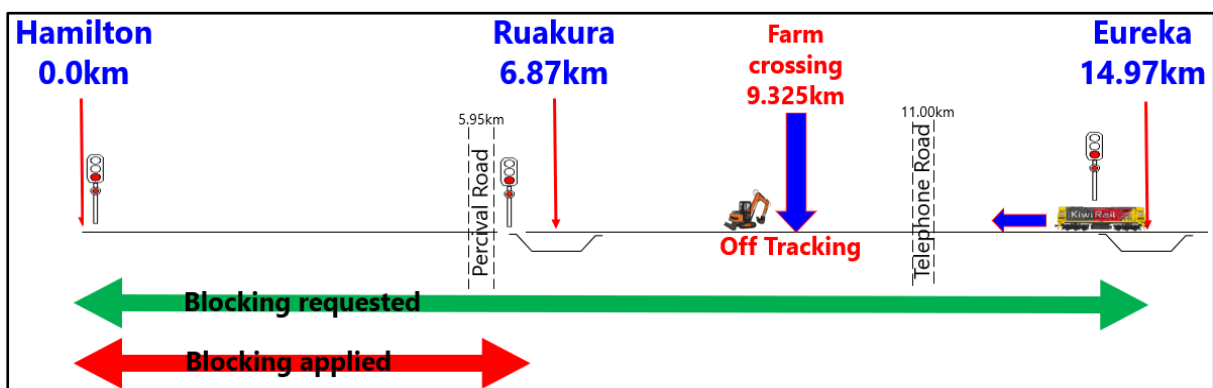
Figure 3: Planned off-tracking location
(Credit: Transport Accident Investigation Commission)

- 2.11 After they received the call, the HRV operator made their way to the agreed off-tracking safe place.
- 2.12 At about 0747 a train entered the Eureka to Ruakura section while it was still occupied by the HRV operator. The train and the vehicle were separated by a distance of about 5 km (see Figure 3).

- 3.23 Once the RPO had possession of the track occupation authority, valid until 0800, both the RPO and the HRV operator discussed the working limits and agreed that the recommended off-tracking location would be at a farmer's private access track at about the 9.35 km mark. The agreed off-tracking location was about 3 km outside the limit of the PWA, thereby potentially putting the HRV into the path of the next train travelling towards Te Rapa, Hamilton.

- 3.24 Witness statements confirmed the HRV voluntarily cleared the track at about 0750, 10 minutes before the authorised 'clear by' time of 0800. However, at the time of clearing the track the HRV was 3 km outside the limits of the PWA.

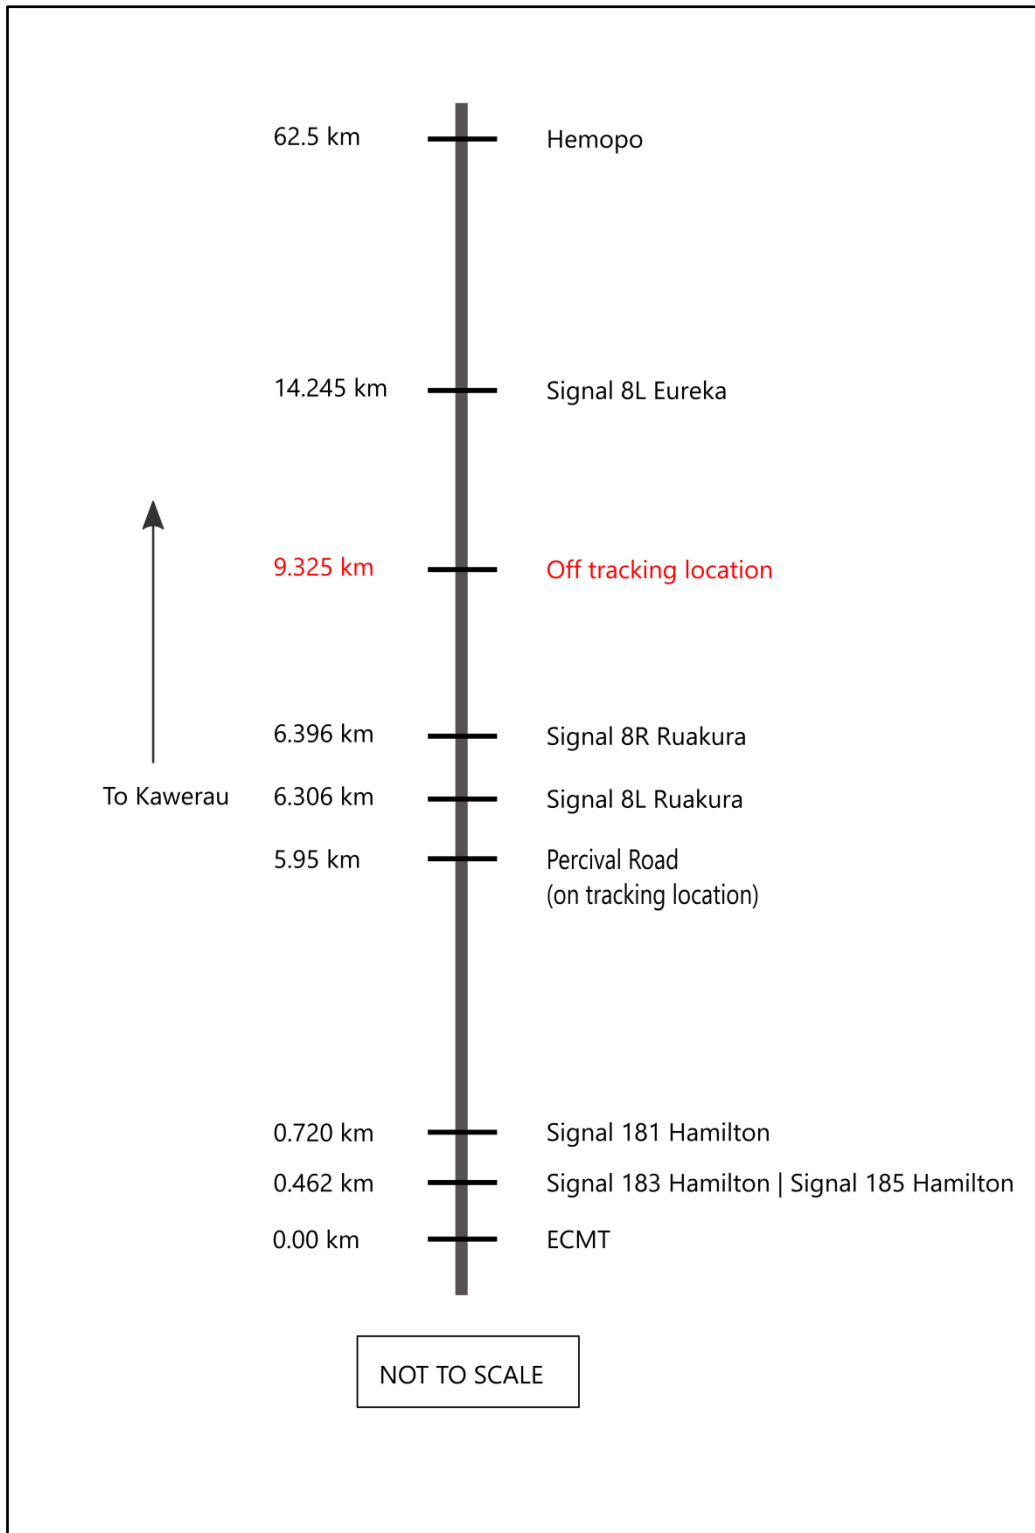
**Figure 4: Schematic diagram showing features recorded on the Mis 71 Track Occupation Cross Check form
(Credit: Transport Accident Investigation Commission)**

3.14 Features and locations referred to in the communication between the RPO and the train controller are shown in Figure 4.

- 3.20 When the RPO asked for an authority to work between Te Rapa 181 Signal and Eureka 8L Signal, the train controller gave authority to work between Hamilton 181 Signal and Ruakura 8L Signal. Blocking had been applied to Hamilton 183 and 185 Signals and Ruakura 8R Signal. The RPO's read-back stated that work between Te Rapa 181 Signal and Eureka 8L Signal and blocking applied to Signals 183 and 185 Te Rapa and Ruakura 8R.

- 3.21 The train controller verified the RPO's read-back as being correct, despite the RPO stating a work between limit as Eureka 8L Signal and not Ruakura 8L as authorised and as drawn on the TC diagram. The opportunity to correct the RPO's understanding of the limits of the track occupation was therefore lost.

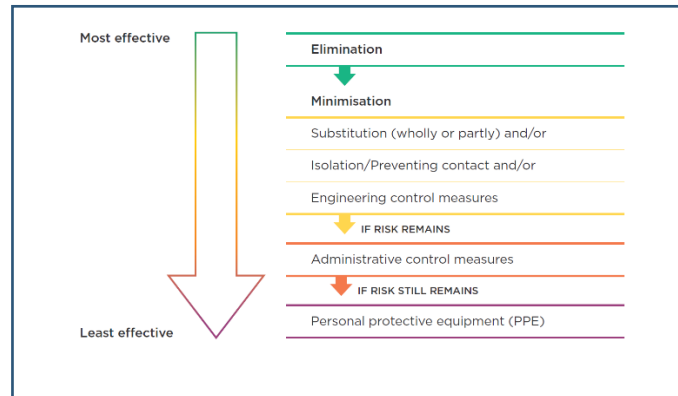
Figure 6: Recommended hierarchy of safety controls

- 3.39 Figure 6 explains the effectiveness of the various safety control measures that may be used to help reduce the risk to workers. In this incident, the primary safety control was an administrative control and relied upon those involved following Rule 908 – Blocking completing the correct paperwork, communicating effectively and identifying the correct signals to isolate. If the process is administrated correctly then blocking control is successfully achieved.

- 3.40 However, as can be seen from the number of track occupancy irregularities, 21 were due to a discrepancy between the authority and the location on-site. In the hierarchy of safety controls, it is evident that administrative controls are the least effective and can fail to provide the protection that track workers (working in the rail corridor and faced with the danger of trains moving through their worksite) require.

- 3.42 The Commission has made a recommendation to the Chief Executive of KiwiRail to provide an enhanced level of protection for track workers by adopting the use of engineering control measures when establishing PWAs.

- 6.4 **On 8 December 2021, the Commission recommended that KiwiRail carry out an analysis of how it could best incorporate engineering control measures into both its current and future operations to minimise the risks that human factors play in effective protection for track workers. (009/21)**
