Transport Accident  
Investigation  
Commission

# **Final report**

***Rail inquiry RO-2021-101***  
***Serious injury during shunting operations on***  
***board the Aratere, Interislander ferry terminal,***  
***Wellington***  
***9 April 2021***

**September 2022**

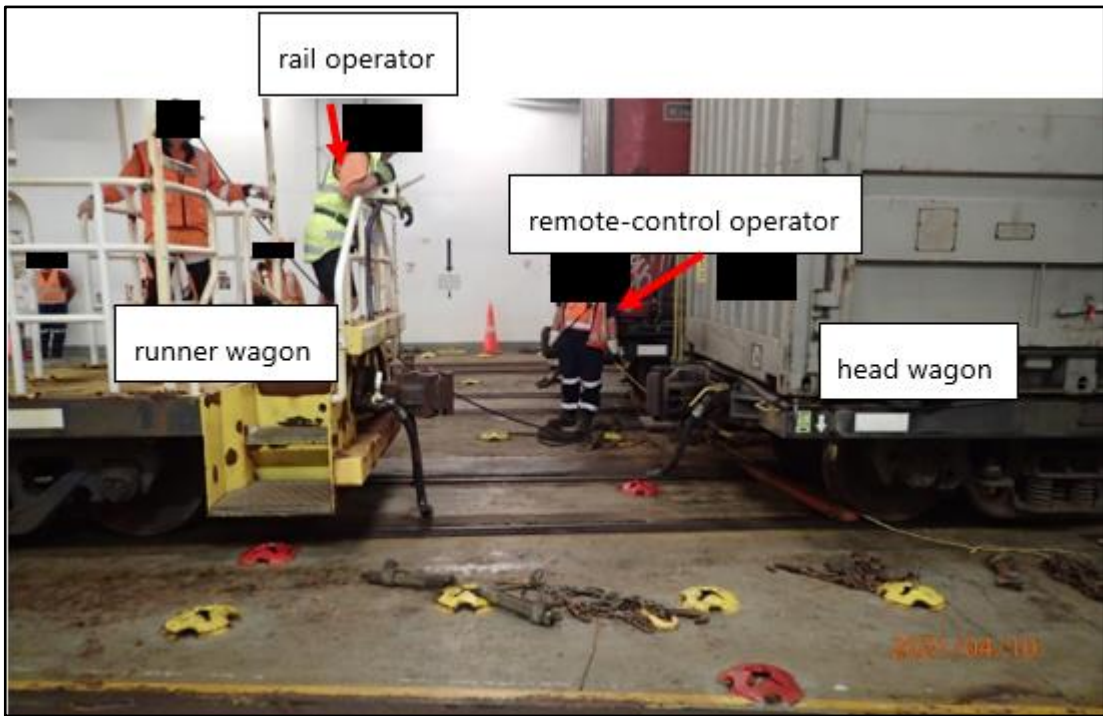
**Figure 4: Locations of the RCO and RO relative to the runner and head wagons**

- 2.8 The curvature of the track caused a misalignment between the coupler on the runner wagon<sup>5</sup> and the coupler on the head wagon on the rake (see Figures 4, 5 and 6).

- 2.9 The RCO made multiple attempts to couple the wagons. After every unsuccessful attempt the RCO did an 'out short'<sup>6</sup> and went between the wagons to physically realign the couplers and open the knuckles of the couplers of both wagons before the next coupling attempt.

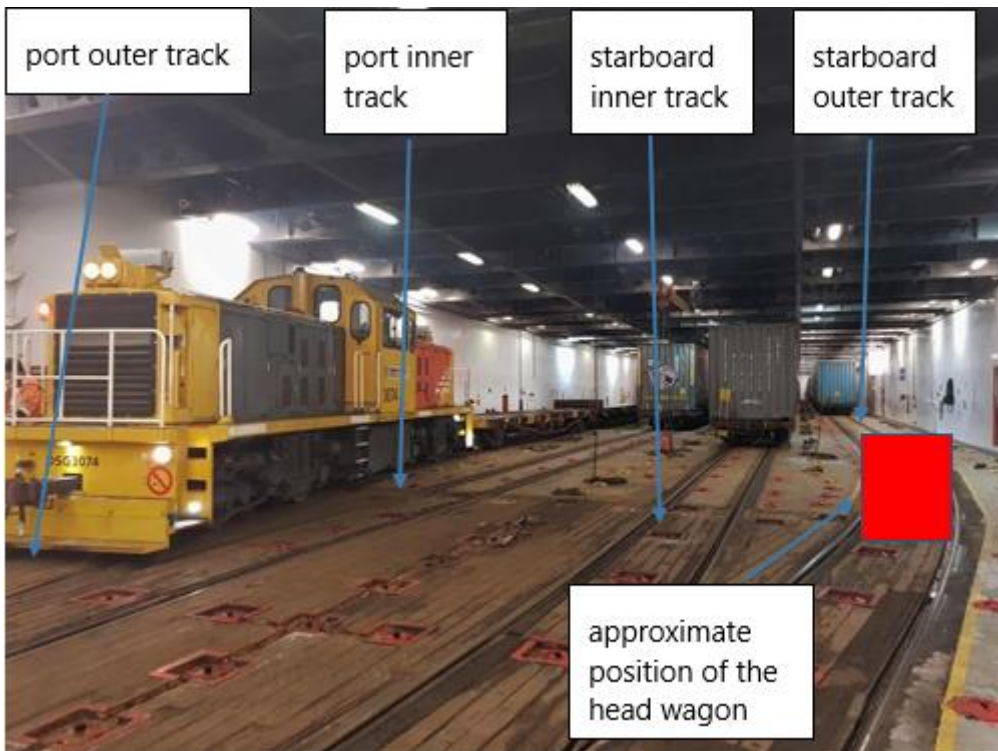
**Figure 5: Approximate position of the head wagon**

- 2.7 Once on board, the shunt team set about their first task of removing the long outer rake from the starboard<sup>3</sup> side. Due to the length of this rake (134 metres), the head wagon<sup>4</sup> was positioned on a curved part of the track on the rail deck (see Figure 5).

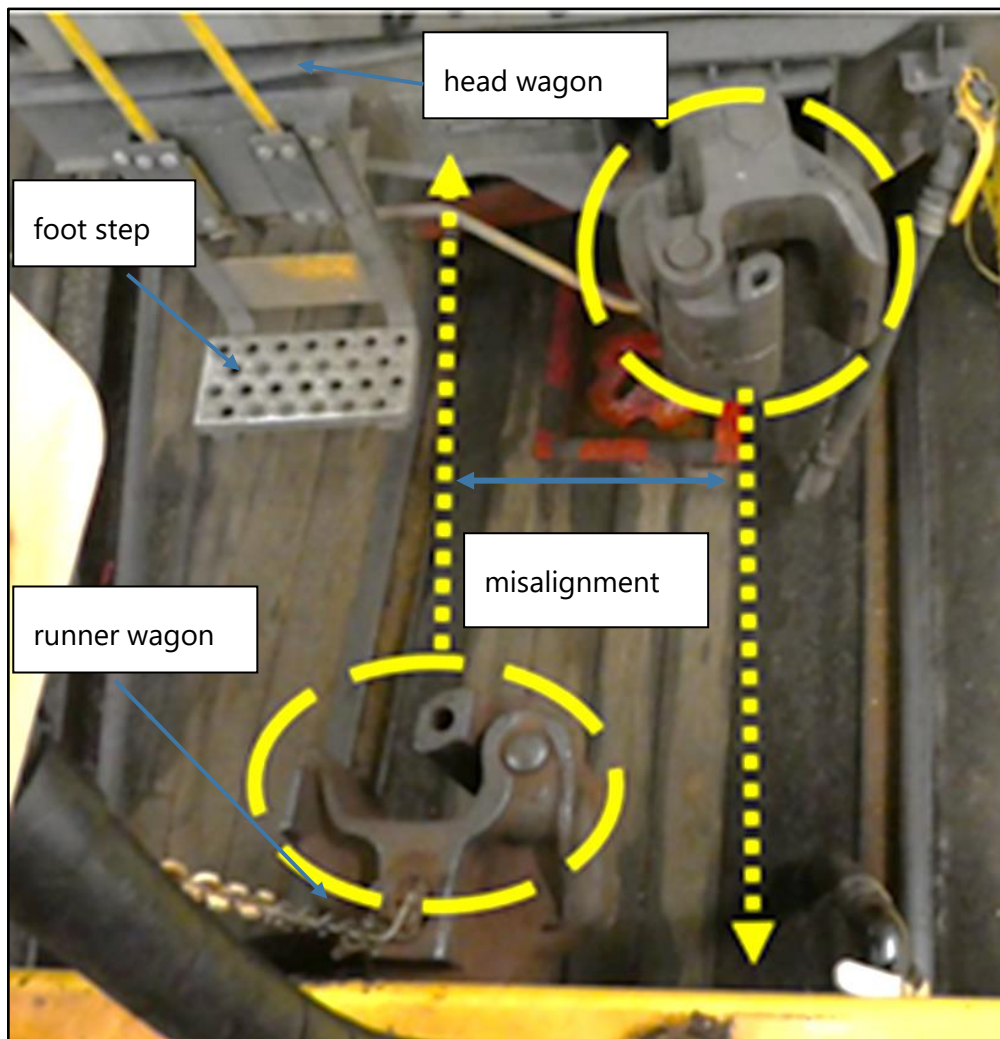
- 2.10 On the seventh attempt to couple the wagons, the RCO remotely operated the shunt locomotive to move the runner wagon towards the rake, without retreating to the safe zone. The couplers were still misaligned and glanced off each other, resulting in the runner wagon moving further forward than expected (see Figure 7).

- 2.11 The RCO's position between the two wagons meant his right leg was jammed forcibly between the runner wagon and the foot step of the head wagon.
- 2.12 The RCO suffered a serious injury to their leg and was subsequently admitted to hospital for treatment.

**Figure 7: Misalignment between the runner wagon and the head wagon**  
(Credit: KiwiRail)

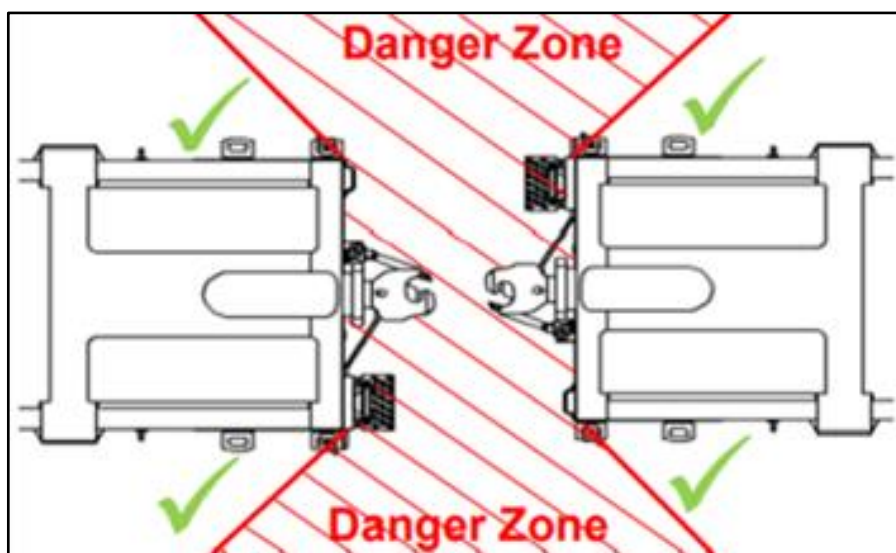
Figure 11: Danger zone between wagons

- 3.4 The automatic knuckle couplers fitted to freight wagons are designed for shunting on straight or near-straight track. Difficulties can occur when personnel attempt to couple wagons on tightly curved track. During normal discharge operations on the *Aratere*, one of the shunt team is positioned at the head of the rake in order to give verbal instructions to the RCO to aid the coupling process. Should there be any difficulty with the coupling, the coupler can be aligned from a safe position on the deck of the runner wagon. Immediately prior to this accident, the RCO disembarked from the safe position on the runner wagon to attempt to align the coupler of the head wagon manually. In doing so they placed themselves within the danger zone (see Figure 11).

- 3.5 In this case, the impediment to what is typically a straightforward process was caused by the degree of curvature of the track where the wagons were positioned. While the amount of sideways movement possible on the coupler on the EUF-class runner wagon is greater than that on standard wagons, it was still difficult to align it with the open knuckle of the coupler on the head wagon.

- 3.8 Once the RCO had manually adjusted the coupler, they attempted the next coupling manoeuvre while still within the danger zone. By this seventh attempt to couple, it is likely that the RCO had become fixated on the task at hand and experienced a lapse in concentration during which they did not reposition themselves clear of the danger zone before attempting to couple the wagons again.

- 3.10 The RCO was positioned on the inside of the curve between the wagons when bringing the locomotive and runner wagon onto the rake. The couplers were still misaligned, and as a result the couplers glanced off each other when the locomotive moved. This caused the runner wagon to move towards the head wagon unexpectedly. The RCO, standing between the runner wagon and the head wagon, was struck with sufficient force that their leg moved rapidly forward and connected with the footstep of the head wagon positioned at shin height, and this resulted in an injury to the leg.

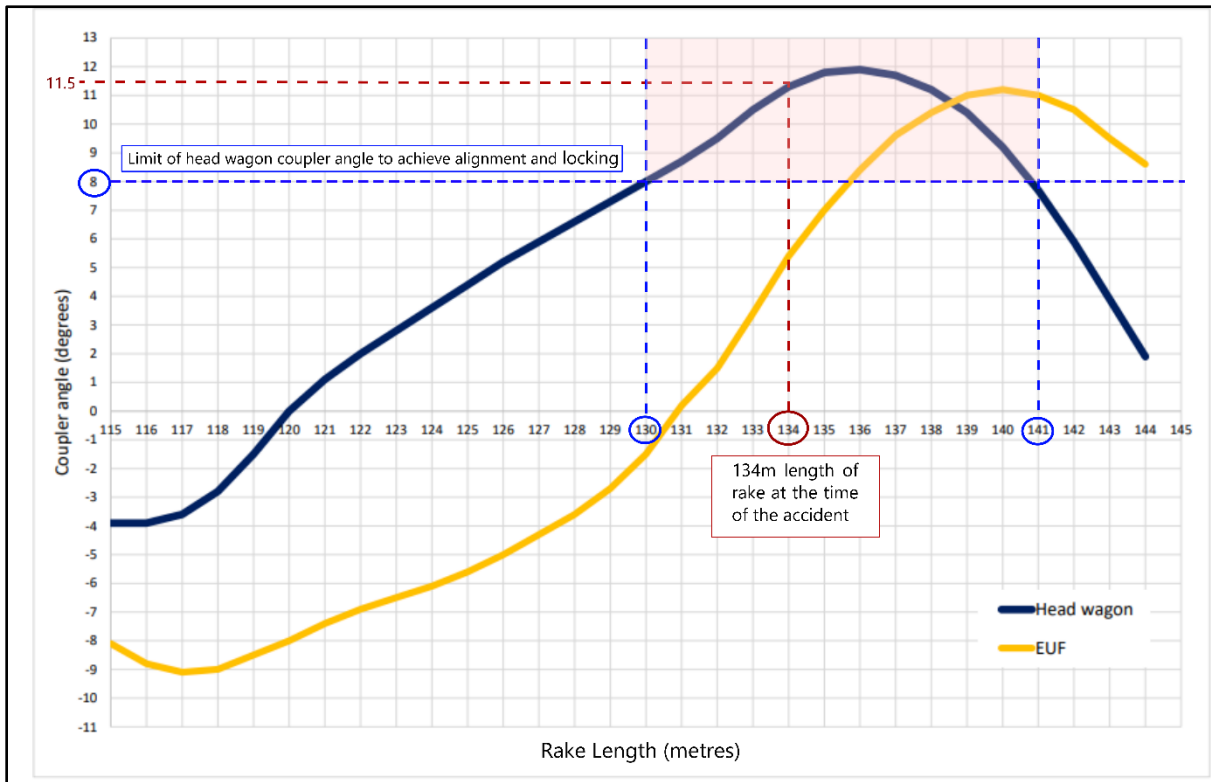
**Figure 12: Coupler angles at different rake lengths**

3.20 The limit of the coupler angle on the head wagon (see Figure 12) to achieve alignment and locking is about 8 degrees. When rake lengths are between 130 and 141 metres, the head wagon requires a coupler angle greater than 8 degrees to achieve alignment and locking. This region of the head wagon coupler angle curve (highlighted red in figure 12) is the most difficult section of the starboard track on which to achieve coupler alignment and therefore coupling of wagons.

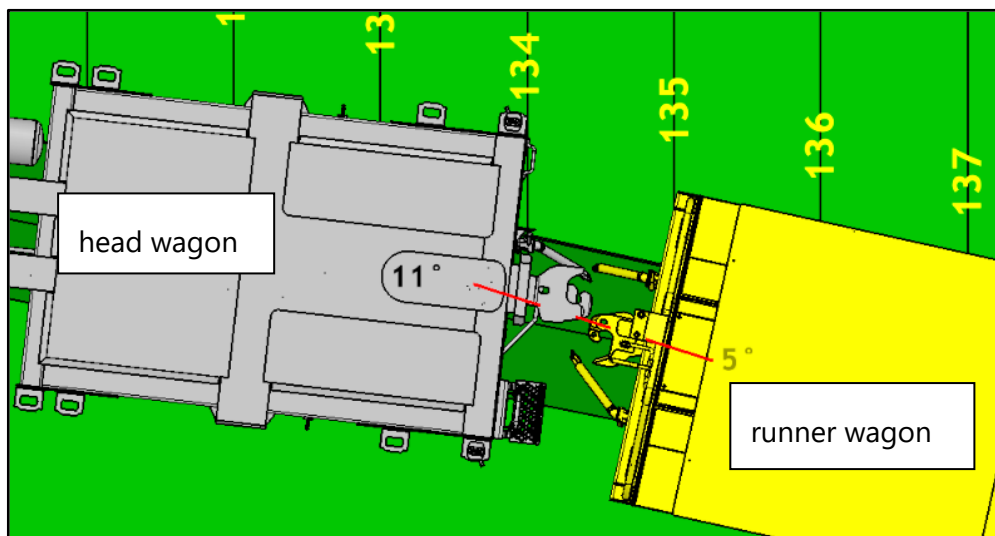
**Figure 13: Head wagon 134 metres from buffer**

- 3.21 With a rake of 134 metres<sup>9</sup>, the head wagon is within the range where coupling is most difficult. The coupler of the head wagon is required to be moved 11 degrees to couple to the runner wagon (see Figure 13). The 11-degree angle movement required is well past the 'free' movement of the head wagon coupler, and even if coupling is achieved there may not be sufficient capacity for the pneumatic system on the runner wagon to shift the head wagon coupler into a good enough alignment to allow the couplers to lock. (Refer Appendix 1 for the runner wagon operating quick guide.)
- 3.22 The length of the rake on the starboard outer track was 134 metres when the accident happened. Figure 14 shows that at 134 metres the physical carrying capacity would have been equivalent to eight 50-foot (15-metre) wagons.

- 5.8 On 1 October 2021 Semi-Permanent Bulletin No. 525 was cancelled and replaced with Semi-Permanent Bulletin No. 752. This bulletin extended the maximum rail lane metres on the outer tracks of the *Aratere* to 123 metres.
